Aviation Investigation Final Report

Location:	Forks, Washington	Accident Number:	WPR19FA091
Date & Time:	March 8, 2019, 07:05 Local	Registration:	N64RA
Aircraft:	Bell UH1B	Aircraft Damage:	Destroyed
Defining Event:	Loss of engine power (total)	Injuries:	1 Fatal
Flight Conducted Under:	Part 133: Rotorcraft ext. load

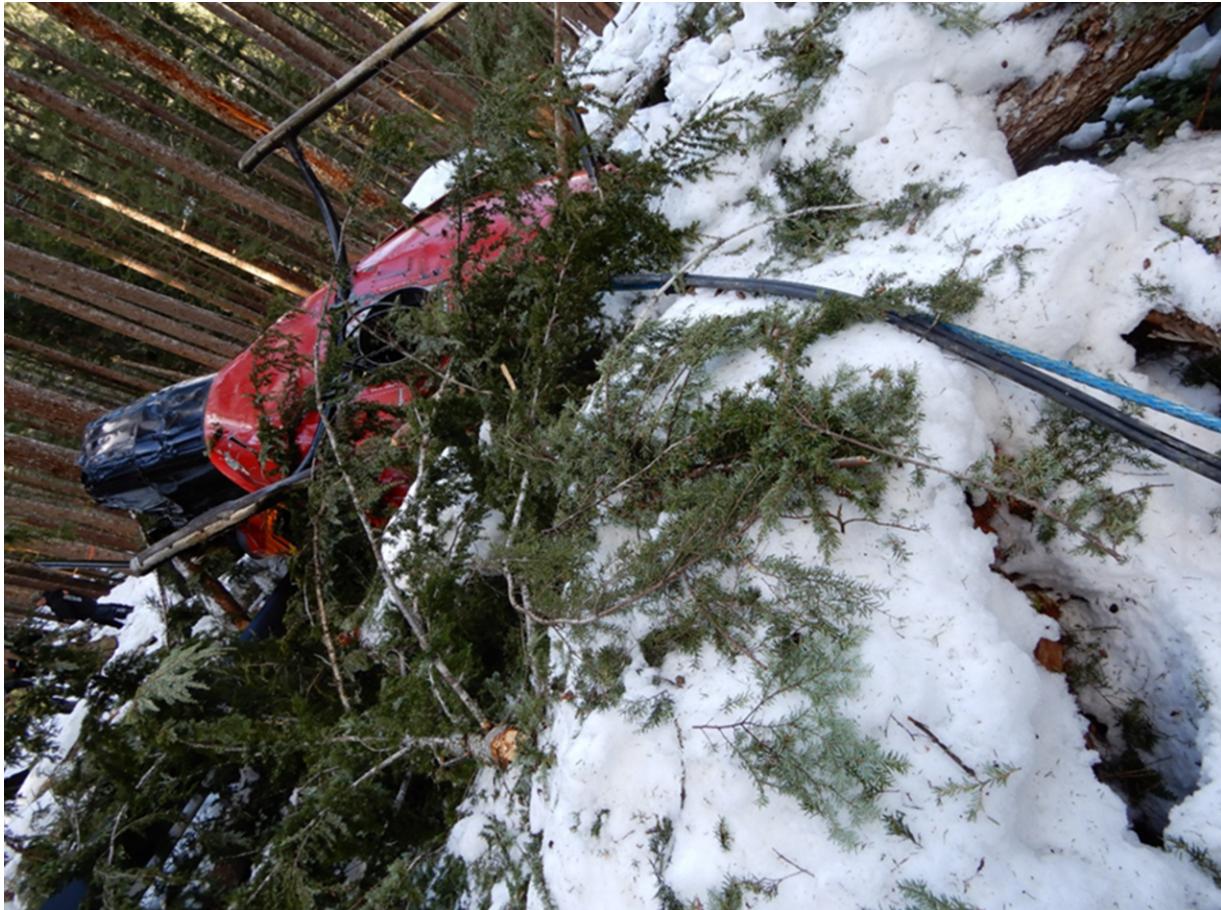
Figure 1. The helicopter at the accident site. A blue cargo line and two black hydraulic hoses can be seen running uphill to the grapple hook.

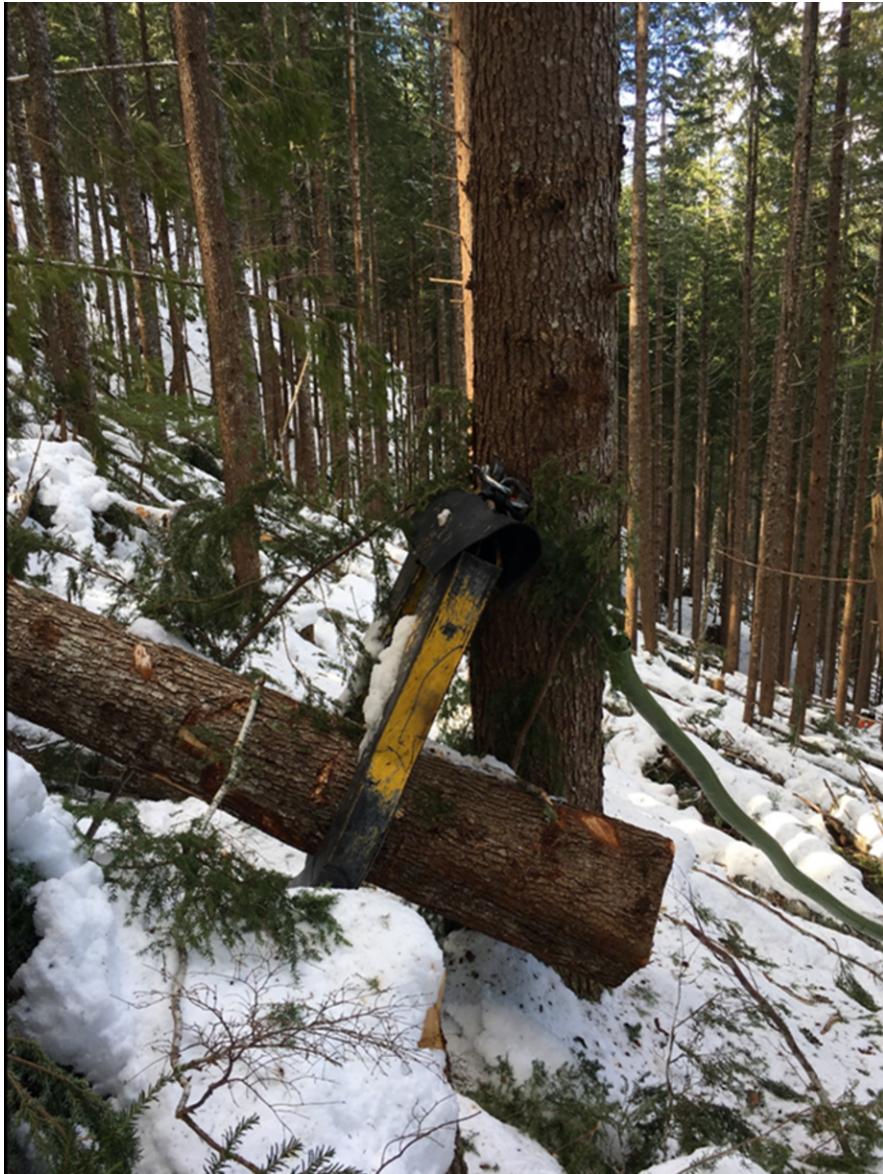
The helicopter came to rest on steep, mountainous terrain about 1/4 mile from the company's staging area. The area was covered with felled and standing trees. All major structural components of the helicopter were located within a very small debris field around the helicopter. There was no post-crash fire. A cargo line remained attached to the cargo hook and extended uphill 180 feet to a hydraulic grapple hook. Two hydraulic fluid hoses extended from the belly of the helicopter and followed the cargo line uphill and were attached to the grapple. The grapple was resting against a standing tree and held a log in its jaws. (See figure 2.) Visual examination of the area around the grappled log revealed the grappled log rested perpendicular to the cargo line running downhill to the helicopter, and a portion of the grapple had caught the standing tree consistent with establishing an anchor point.

Figure 2. The grapple hook, attached to a log, and learning against a standing tree. The cargo line and two hydraulic lines are contained in a green protective sheath and run downhill to the helicopter.

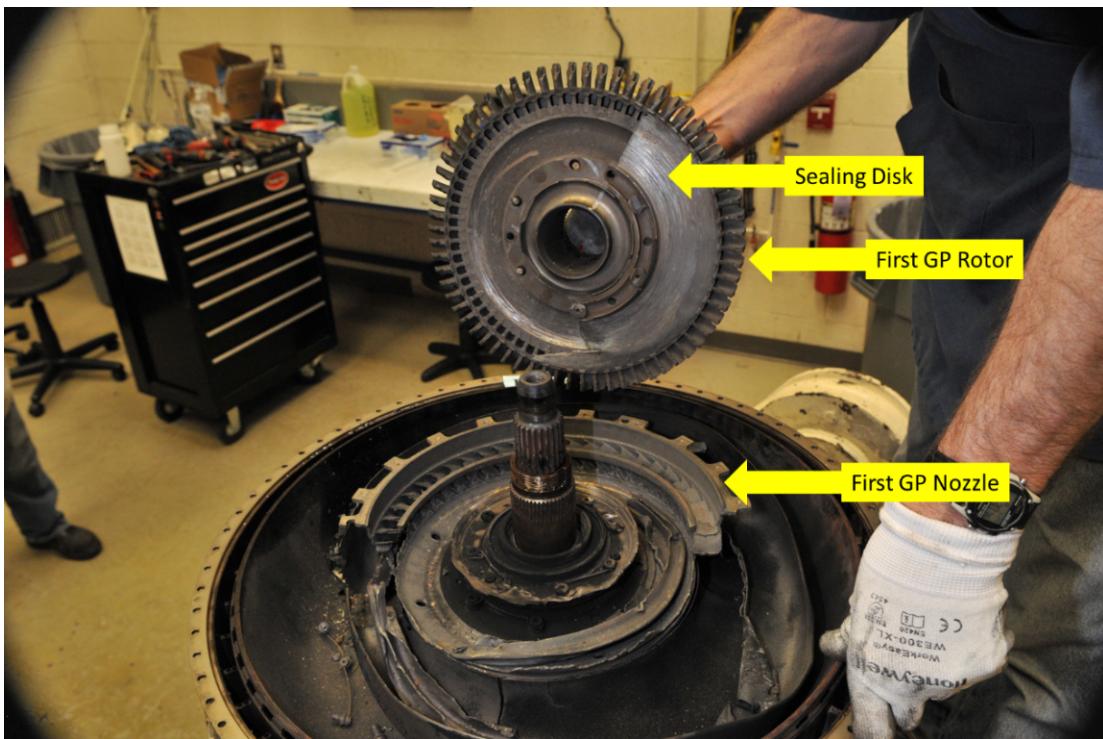
The engine was examined at Honeywell Aerospace on April 24, 2019; the following findings were noted. The first stage sealing disk mounted in front of the first stage gas producer turbine wheel had fragmented into three pieces and separated. Cracks were observed at all six cooling holes on the sealing disk. Damage was found on the four turbine wheels and other components downstream from the sealing disk. Magnified examination of the fracture surfaces on the sealing disk revealed multiple arc-shaped "beach mark" striations.

Figure 3. Engine showing first stage gas producer (GP) turbine rotor with sealing disk fragment attached.

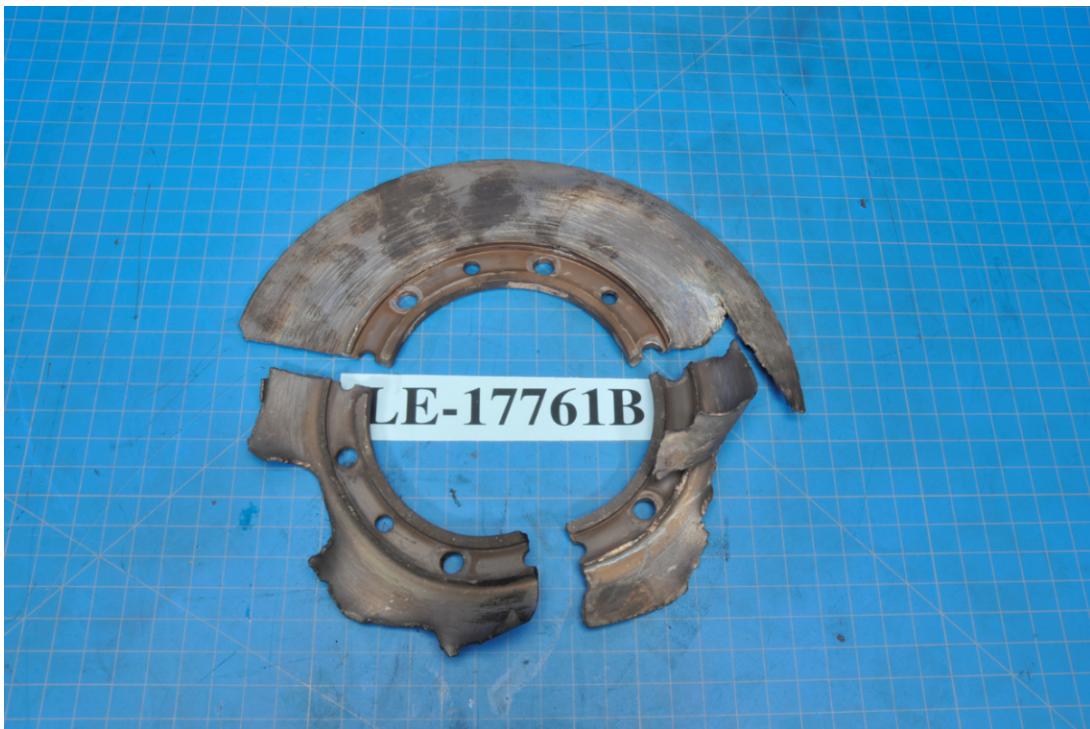
Figure 4. First Stage Sealing Disk. Photo courtesy of Honeywell Aerospace.

Examination of the engine revealed that the gas generator first stage sealing disk had fractured and separated into three major pieces. Multiple internal components of the engine were subsequently damaged as a result, including all four turbine rotors and nozzles. An examination of the first stage sealing disk revealed fracture features consistent with low cycle fatigue.

A total loss of engine power due to the failure of the gas generator sealing disk as a result of the operator's exceedance of the sealing disk life limits at too low an altitude for the pilot to accomplish a successful autorotation which resulted in the collision with terrain.

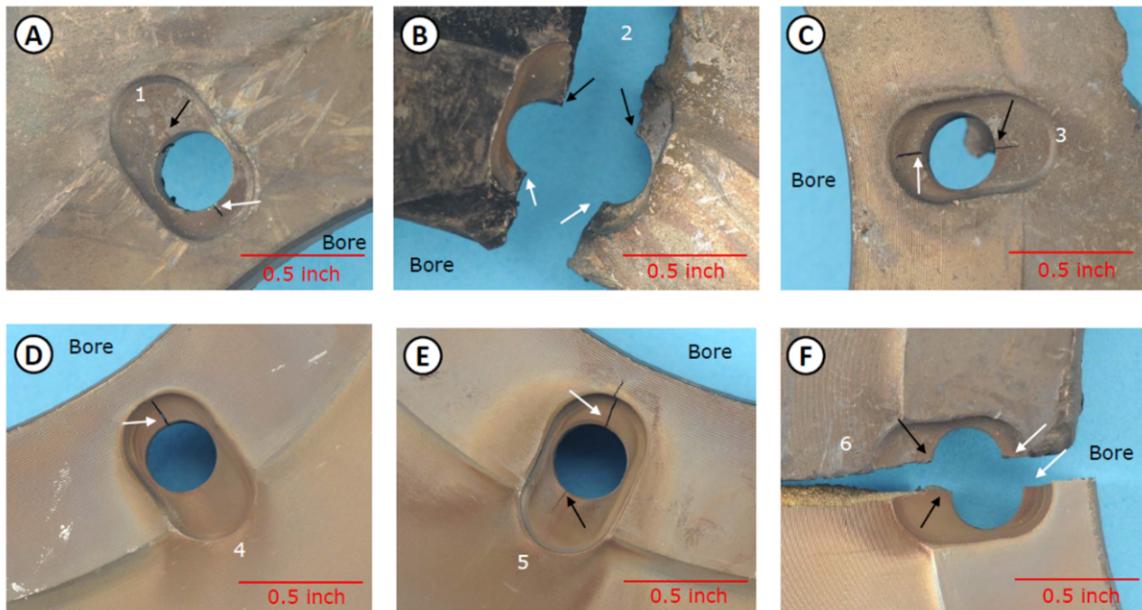
Figure 5. First stage sealing disk showing the six cooling holes, each with cracks formed. Photo courtesy of Honeywell Aerospace.

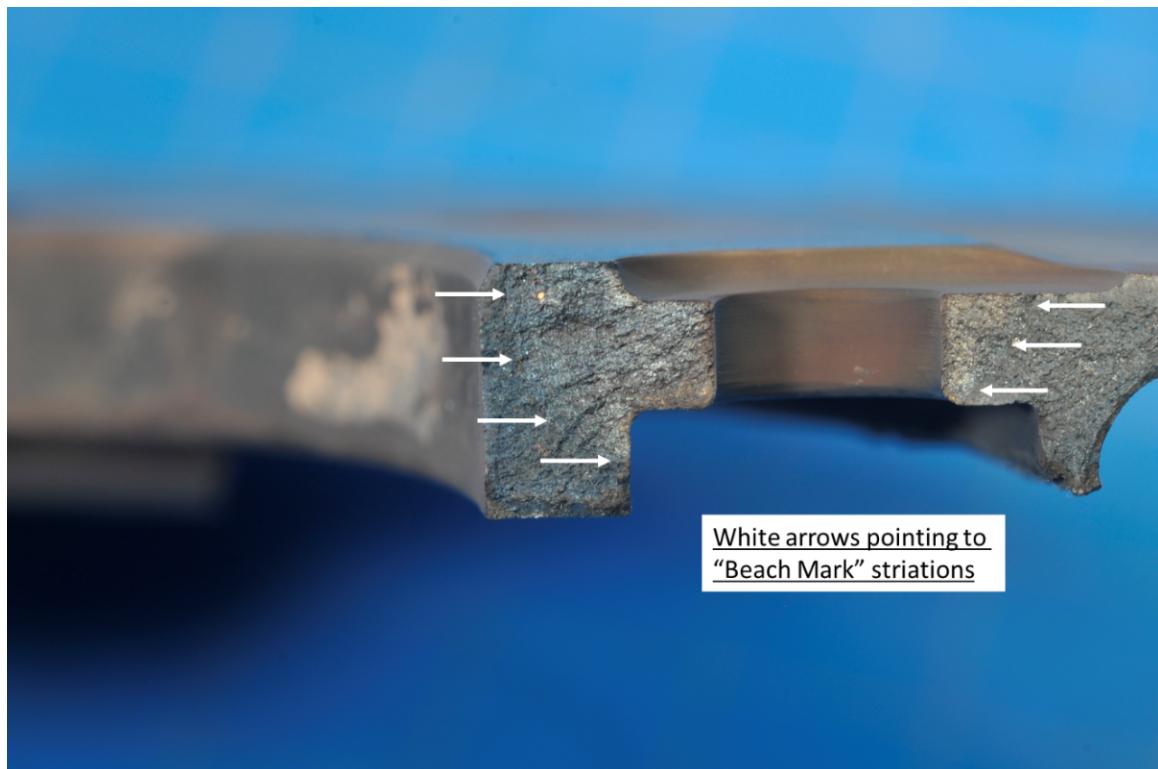
Figure 6. First Stage sealing disk, side view, showing beach mark striations. Photo curtesy of Honeywell Aerospace.

The sealing disk was further examined by Honeywell Aerospace. Microscopic examination revealed that the sealing disk separated in low-cycle fatigue. Both major and minor cycles were present on the fracture surface of the disk.
