Aviation Investigation Final Report

| Location: | Livingston, Texas | Accident Number: | CEN22FA086 |
| Date & Time: | December 30, 2021, 11:41 Local | Registration: | N8AU |
| Aircraft: | Bell 206B | Aircraft Damage: | Substantial |

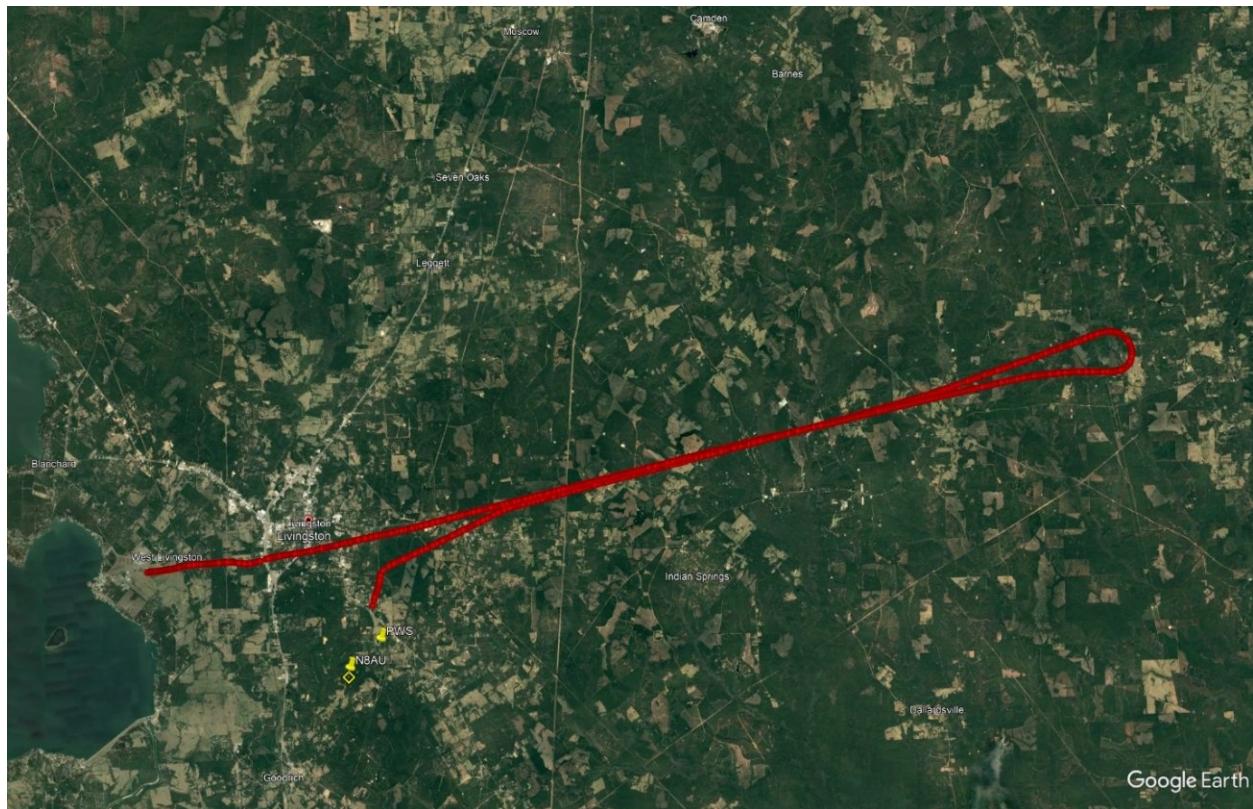
Figure 1. ADS-B Flight Path Depiction

Automatic dependent surveillance - broadcast data for the flight showed that the helicopter departed the Livingston Municipal Airport (00R) about 1107 and headed east-northeast for about 25 nautical miles (nm) before reversing course to a west-southwest direction. The helicopter then turned further south before the end of the data at 1138. The final recorded location was 1.8 nm northeast of the accident site.

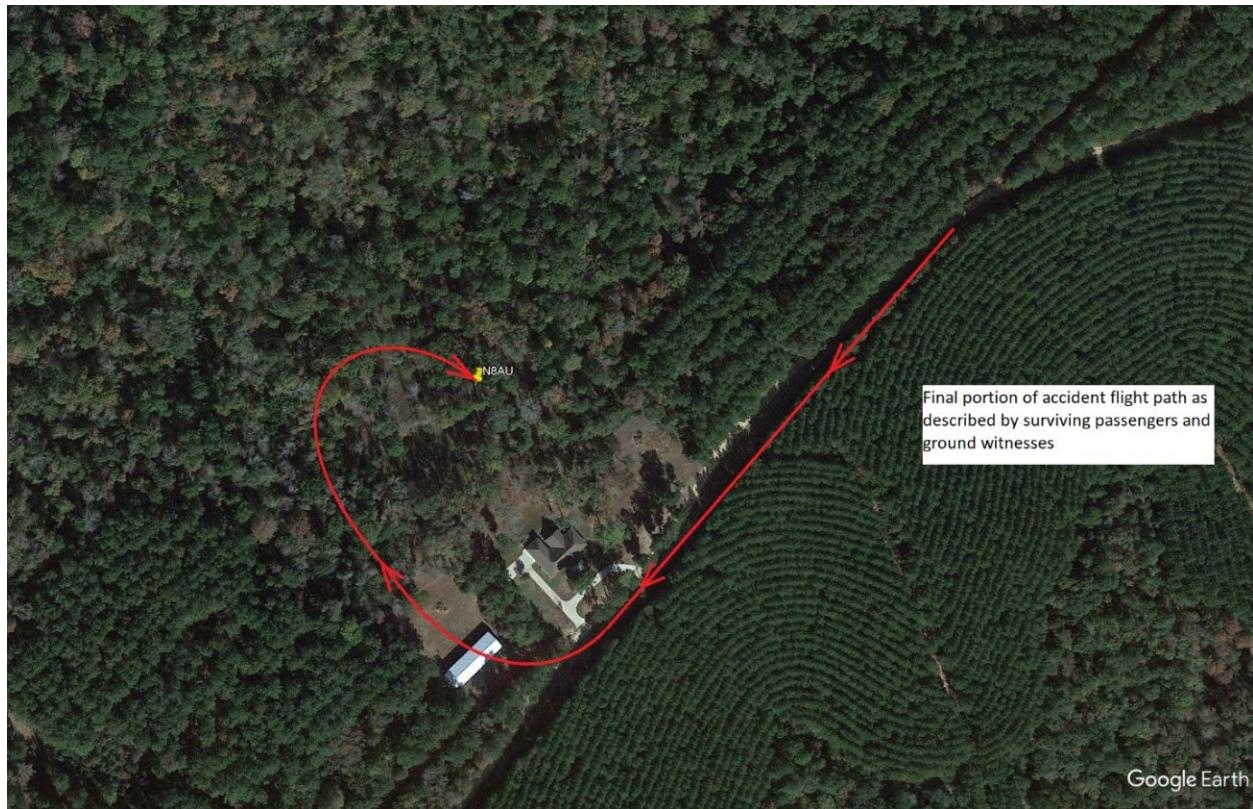
Figure 2. Depiction of the Flight Final Path to the Accident Site

According to the surviving passengers, the flight was a sightseeing flight that the deceased front-seat passenger had won at a local charity auction. On the day of the accident, the passengers met the pilot at 00R. The original intent was to fly over the deceased passenger's childhood home near Woodville, TX. While on course toward Woodville, it became evident that the flight could not be continued due to low clouds and the helicopter was then maneuvered to the passenger's current residence near Livingston, TX. The rear-seat passengers stated that the helicopter flew down the road where the residence was located and then around the house making a level right turn at low speed. The helicopter then flew over a pond on the property and toward the house. As the helicopter approached the house it was facing a south direction and came to a hover above the trees where the accident occurred. The passengers stated that the helicopter was either motionless in the hover or slightly drifting.

Once in the hover, the helicopter began to rotate to the right, which one passenger initially thought was the pilot intentionally maneuvering the helicopter. The helicopter continued to rotate, and the passenger realized the rotation was not intentional. The helicopter rotated about two full revolutions before striking a tree with the rotor blades and descending to the ground. It came to rest on its left side on top of a wood pile that had been created due to land clearing. One passenger noticed, after attending to the pilot and front-seat passenger, that the helicopter's engine was still running. He started moving any switch he could find to the "off" position until the helicopter's engine stopped.

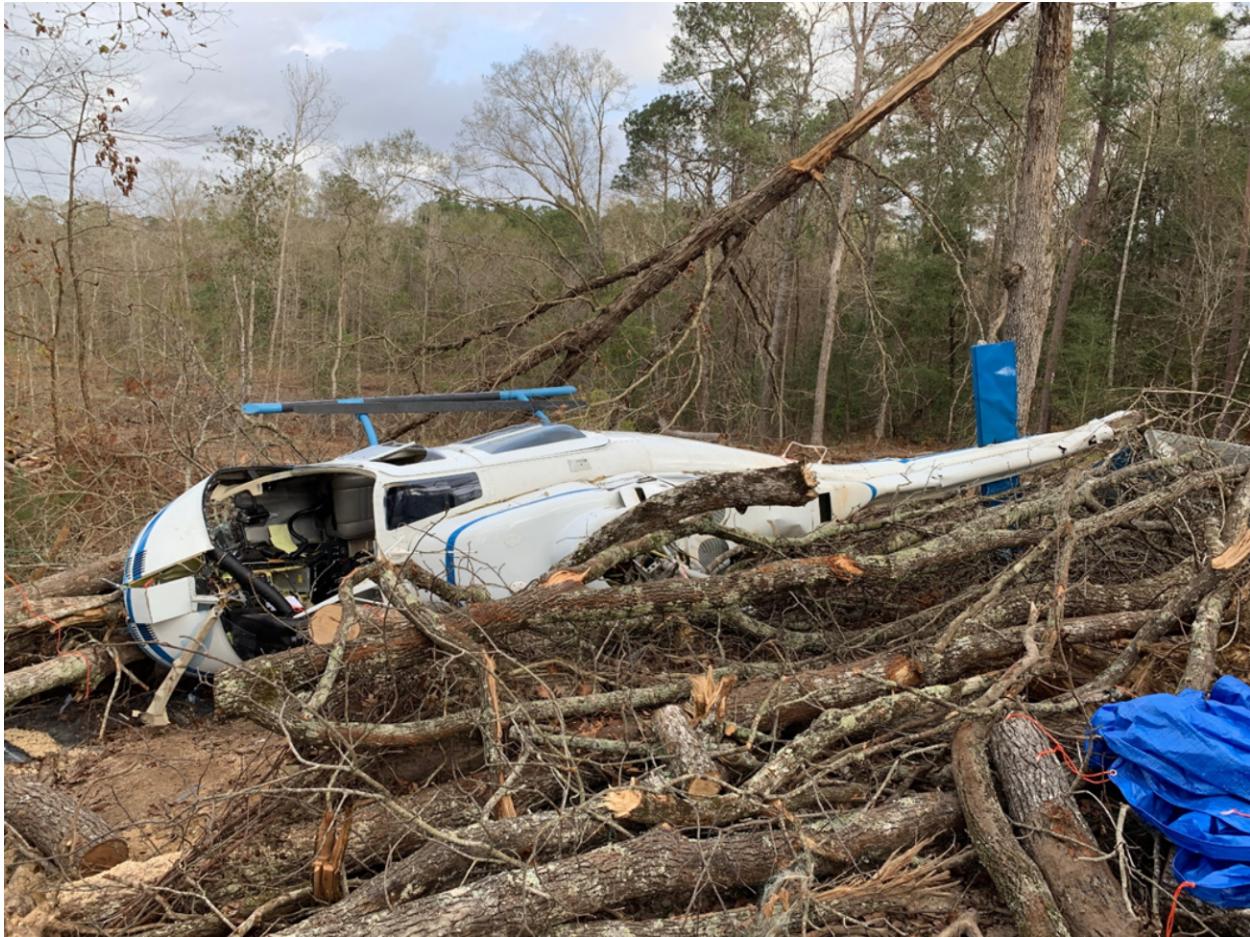
Figure 3. Helicopter as viewed during on-scene examination (NTSB Photo)

The helicopter impacted terrain and rolled over onto its left side coming to rest on a pile of logs. The forward fuselage and left side fuselage and tail boom sustained substantial damage. The main and tail rotors were separated. The elevation at the accident site was about 250 ft above mean sea level.

Postaccident examination of the helicopter did not reveal any preimpact failures or malfunctions with the airframe, rotor systems, engine, or flight controls that would have precluded normal operations.
