Redmi Note9 4G version is normally used without starting up, and the charging current is small

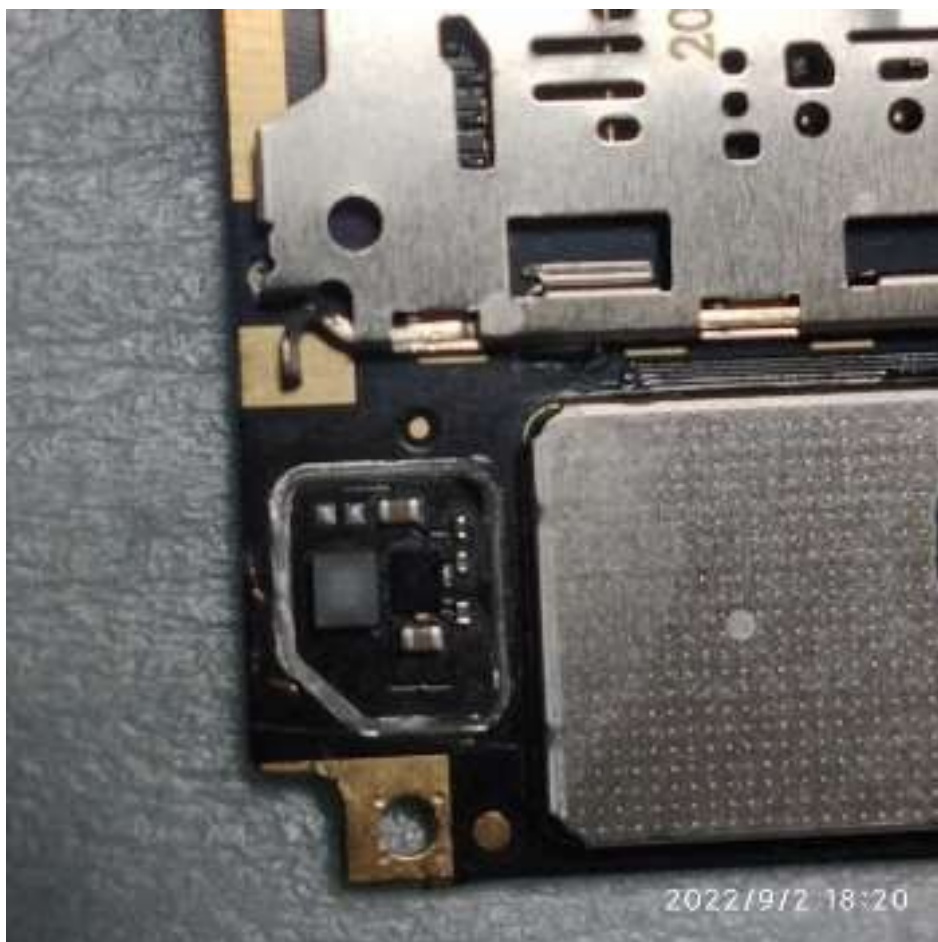
Failure description: The customer's mobile phone is in normal use, charged at night, and cannot be turned on the next day. Connect the charger + charge display adapter shows about 0.02 a, and it cannot be turned on. Several sets have been repaired in front. It should still be the power amplifier power supply IC problem.

Maintenance process: Shut down, remove the motherboard,

remove the power amplifier power supply IC shield with a hot

**air gun at 355 degrees, blow for a few seconds, and add welding oil to return the chip.**

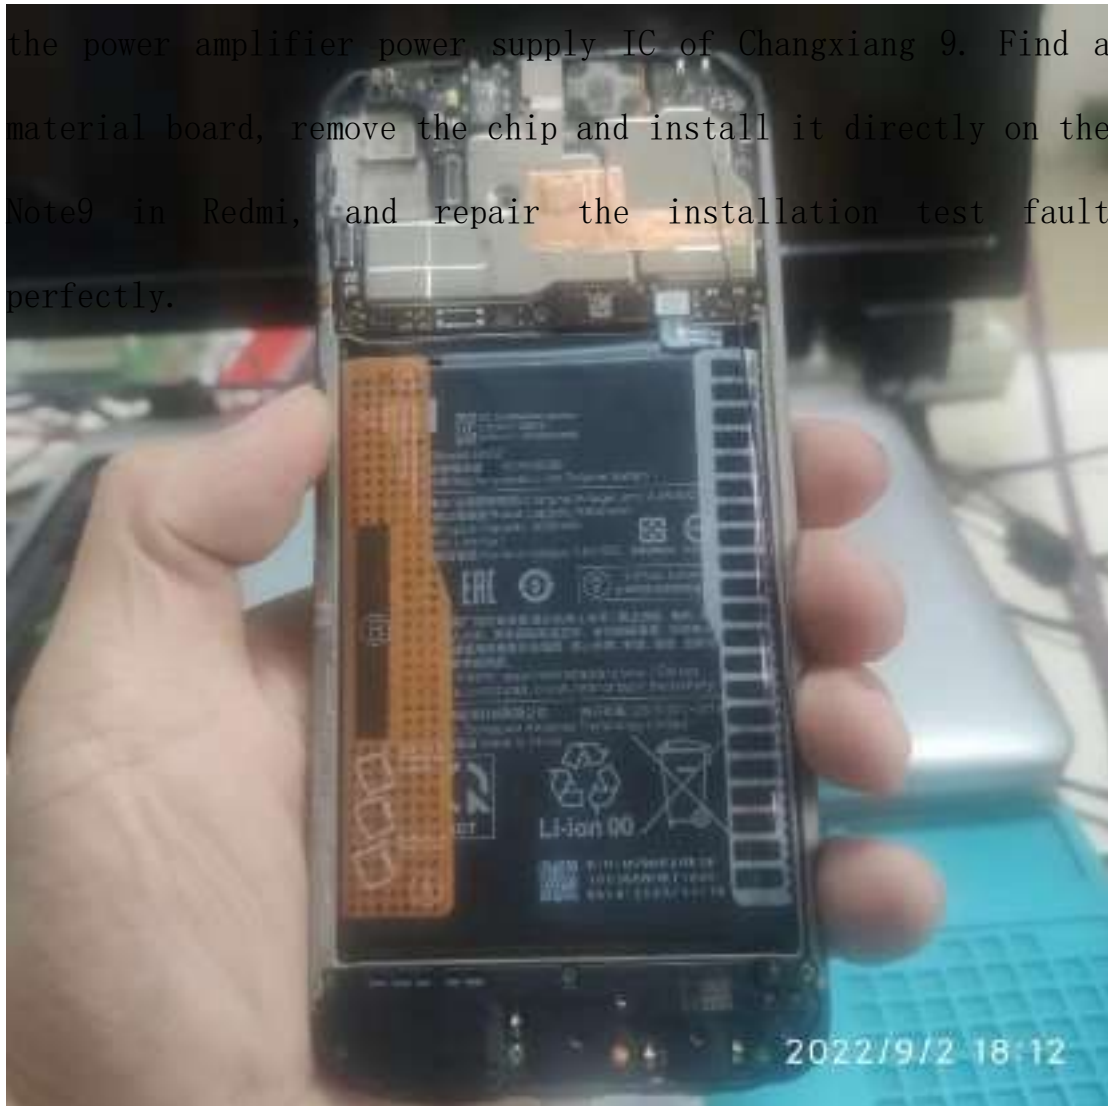
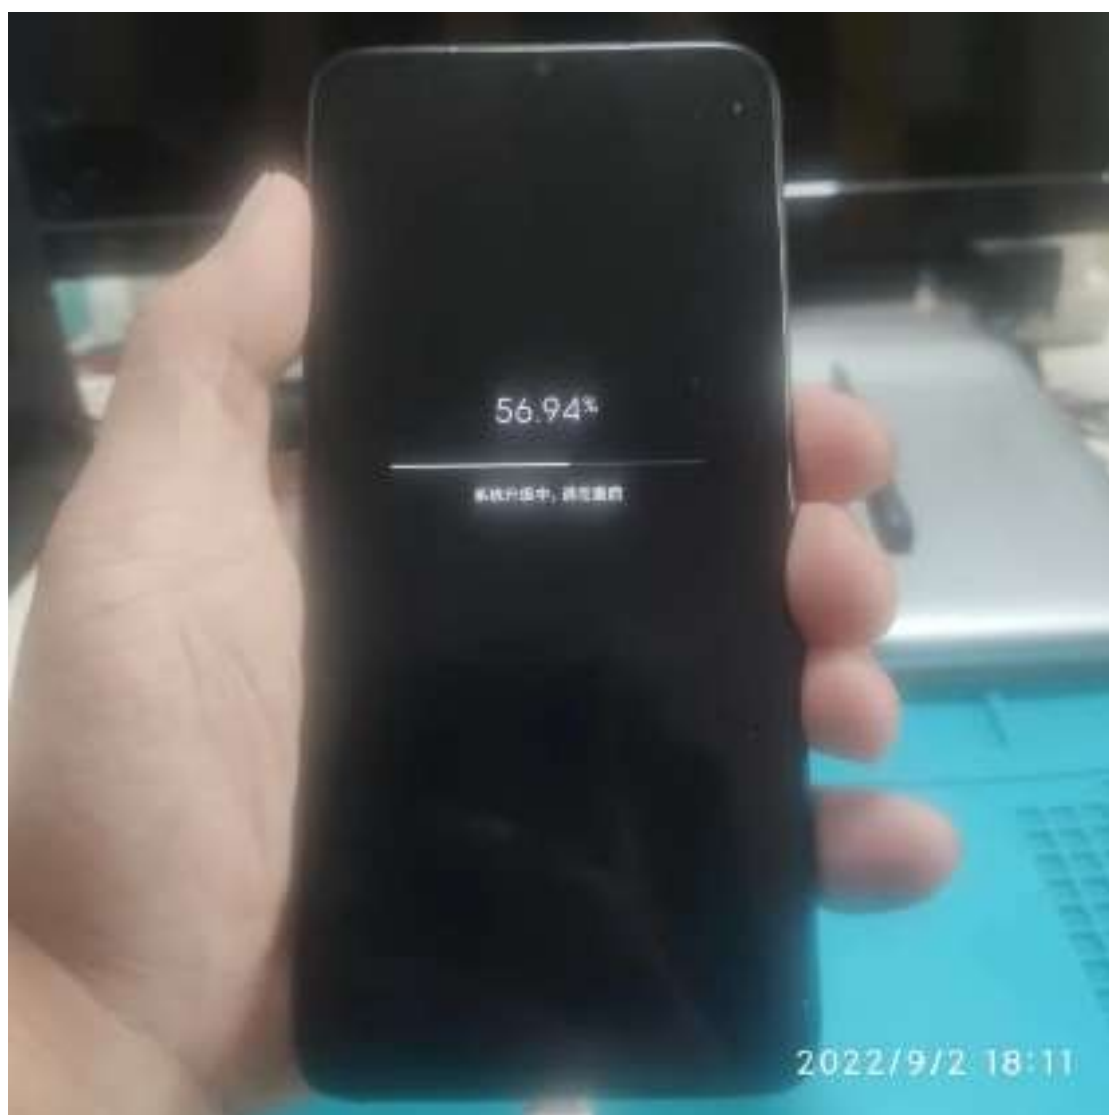
Install the motherboard back, plug in the data cable to show that the current is normal, and the charging icon is displayed on the bright screen of the machine. Press the boot button, the mobile phone starts normally and enters the upgrade interface. It seems that the customer's mobile phone should be upgraded automatically in the middle of the night, waiting for the upgrade to be completed and successfully entering the system. Test the function of the mobile phone, and find that there is no signal when inserting the mobile phone Dial key input \* # 06 #, send the data normally. Remove the master

Board, remove the power amplifier power supply IC and replant it back to the fault. The resistance of each pin of IC is normal. Check the IC model and find that it can be used with the power amplifier power supply IC of Changxiang 9. Find a material board, remove the chip and install it directly on the Note9 in Redmi, and repair the installation test fault perfectly.
