# Redmi NOTE9 does not charge or turn on

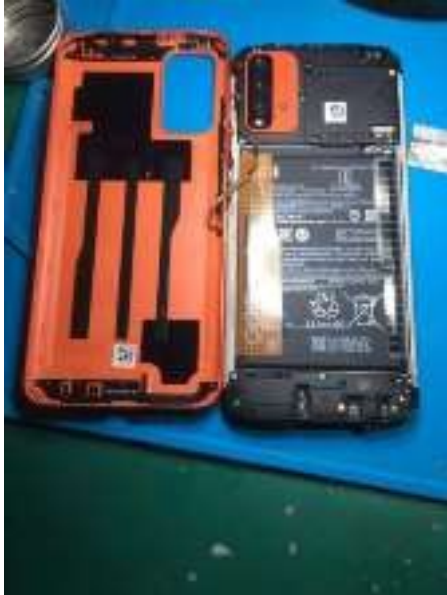
NOTE9 today does not charge, do not start, connected to the charger, charging current 0.002, sometimes no. Access computer, 9008 mode. You can be sure that there is nothing wrong with the CPU.

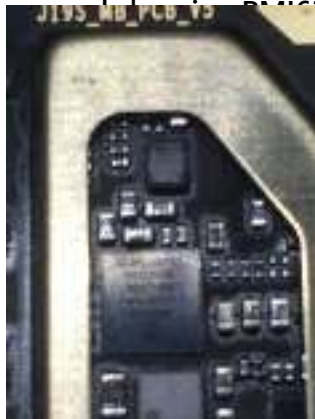
Connect the charger, measure the charging interface, and have 5V. Measuring with 5V, but no output.
