Red riceNota9 5GNo charging, no power on (caused by damage to the inline seat)

[Machine Model]Red riceNota9 5G

[Failure phenomenon]No charging, no power

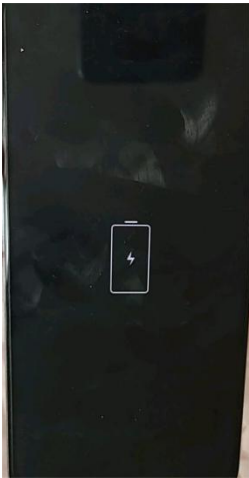
Red riceNota9 5GNo charging, no powerFigure 1

[Maintenance process]Receive a red riceNota9 4G version of the machine, the fault is described as not charging.

We took out the machine to detect and found that the fault of the mobile phone actually turned on the charging mark when plugging in the charger, but pressing the power-on button did not turn on.

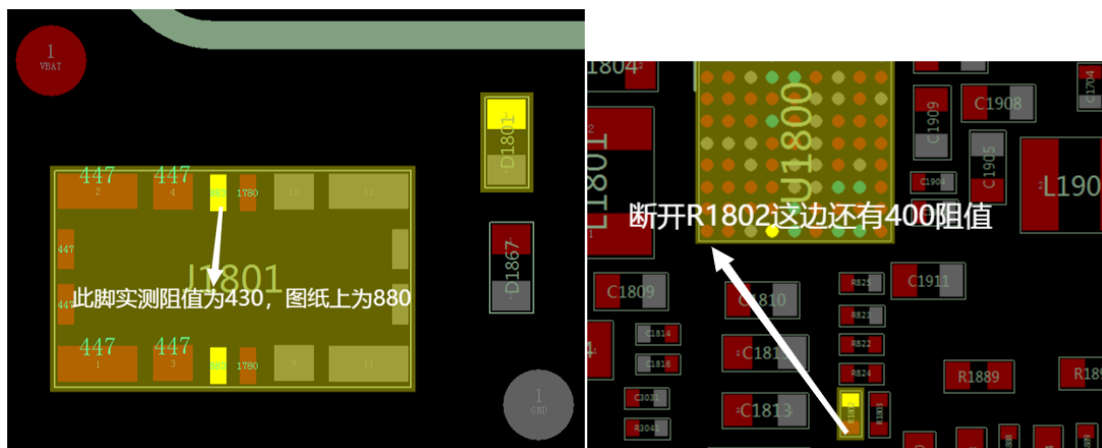
Red riceNota9 5GNo charging, no powerFigure 2

After communicating with the customer, we will continue to repair and remove the motherboard. The bright lightning logo generally does not recognize the battery, or the tail plug-in board. There is a problem with the wiring. We first test whether the tail plug 5V has been sent to the motherboard. Plug in the charger and wiring. The measurement tail plug 5V has been sent to the motherboard, and Although the resistance value of BAT\_ID is different from that in the drawings, it is not very big, so we give priority to the BAT\_THERM line.

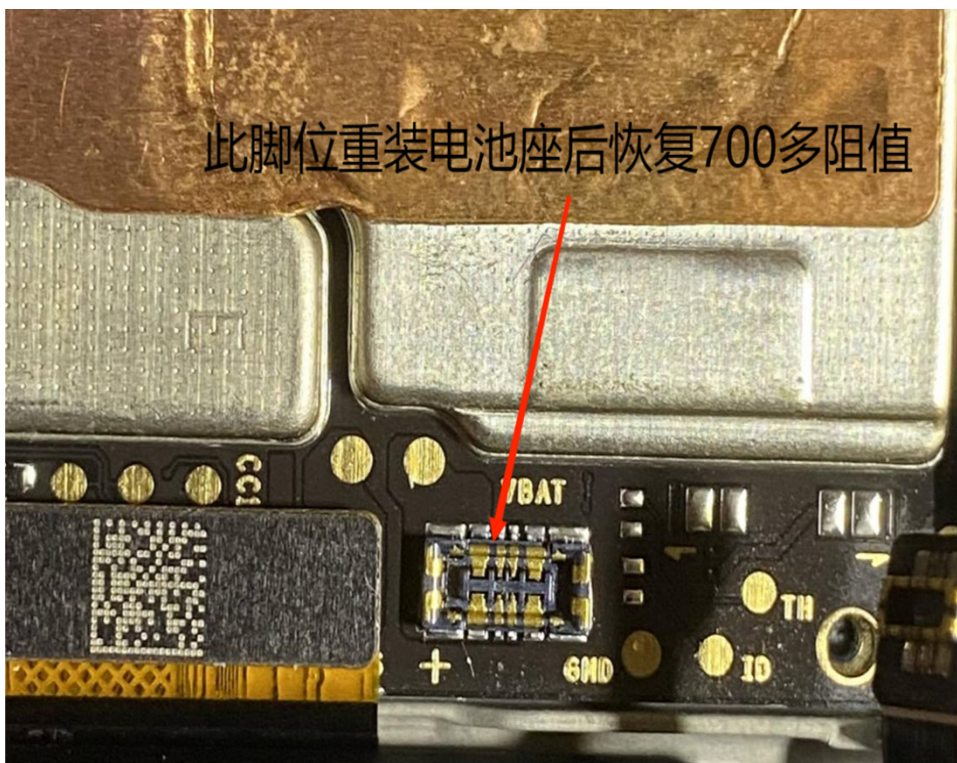
Red riceNota9 5GNo charging, no powerFigure 3

According to the point run diagram, this signal is directly sent to the charging IC after passing through a resistance R1802. There is only one grounded protective diode in the middle line, so we directly deduct this diode, and the measured resistance value is still more than 400. The resistance value of the measured resistance R1802 through the battery seat is 400, but the resistance value of the charging IC is more than 500. This resistance value is obviously wrong, because the battery seat itself certainly has no resistance value, and This is obviously unreasonable. We disconnected this resistance and measured it again. After removing the

resistance R1802, the resistance value on the side of the battery seat is still more than 400, and the charging IC side is still more than 500. Then the problem arises. The battery seat will certainly not produce a resistance value. There is a resistance value indicating that there is a problem with the

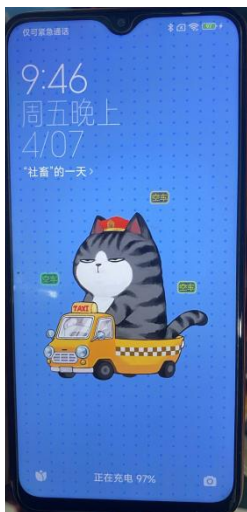
Red riceNota9 5GNo charging, no powerFigure 4

At this time, you can press the power-on button to enter the system, and the charging current is normal.

[Repair Results] Install the motherboard into the mobile phone, turn it on and test it. The mobile phone is turned on normally into the system, measuring charging, WiFi, sound, Compass, vibration, Telephone And other functions Normally, the repair is over here.
