Xiaomi Note3 water damage no booting, the light is not on.

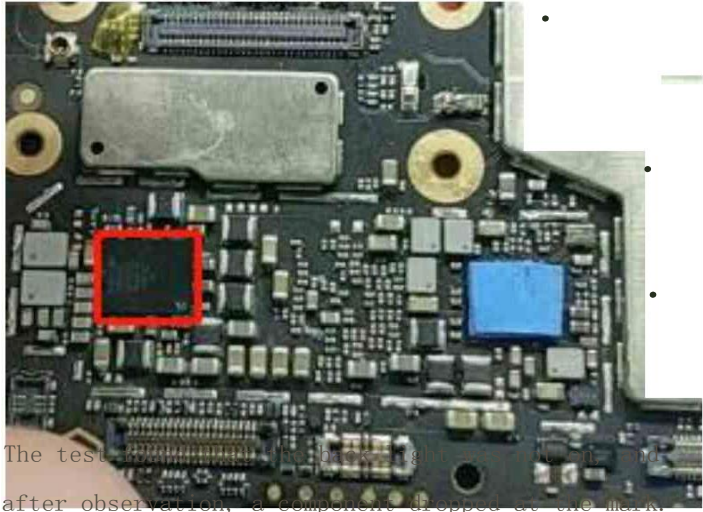
Maintenance process: after removing shielding cover, it is found that the marked power supply pm660L has traces of corrode. after cleaning, replace the pm660L, and test that the startup current is normal.

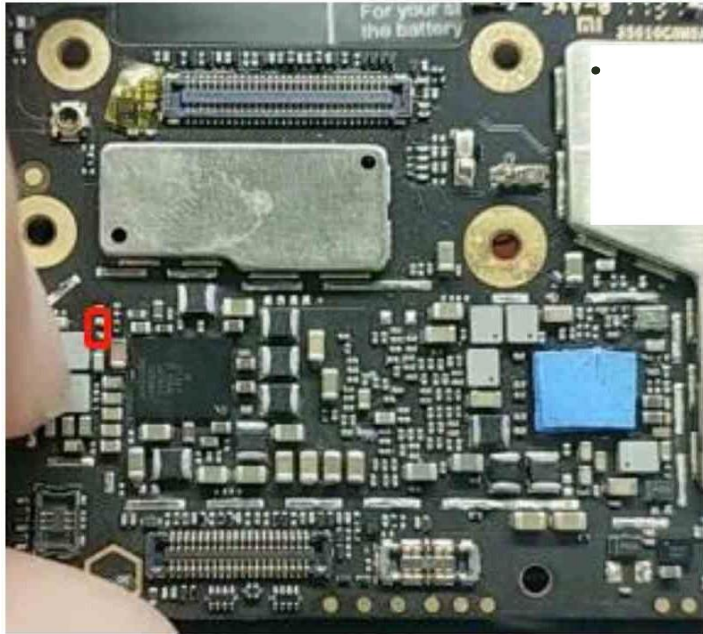
Drop diode position diagram

The test shows that the backlight was not on, and after observation, a component dropped at the mark. Through the drawing, it was known that the drop was the booster diode on the backlight circuit, which must be replaced, and it cannot be installed in the reverse position. Find the diode on the circuit with the same principle to replace it. The test shows that it is normal, and the fault is solved!
