# Xiaomi Note3 Level 3 Maintenance Guide V01

Technical support internal document control: TSIMMPC8 Xiaomi Note3 Level 3 Maintenance Guidance V01

First edition 2017/11/7

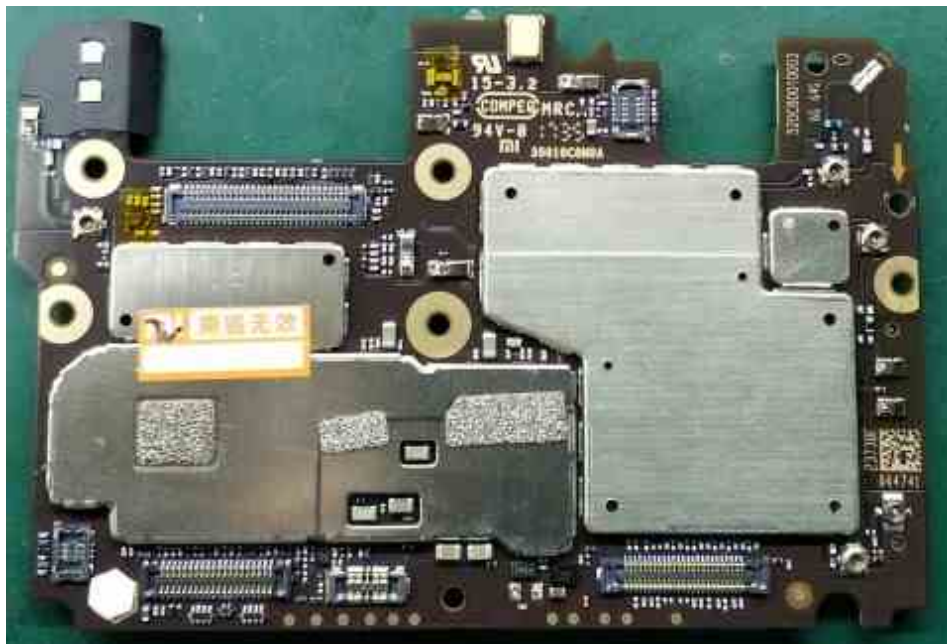
Repair label: 12mm\*5mm

Paste position: Paste on SH500 and SH600 shields.

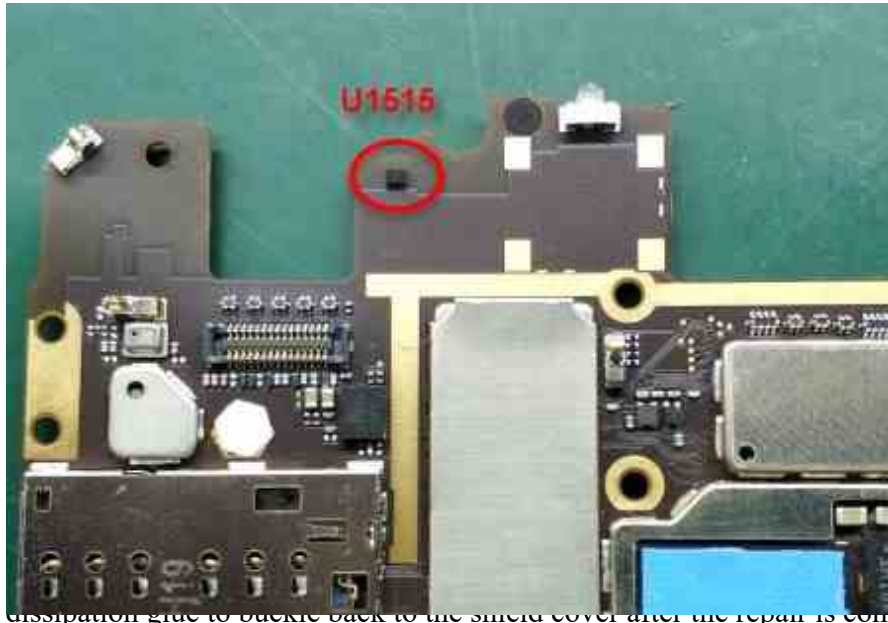
1. The TOP surface U1515 of the motherboard is fragile, so pay attention to protection during maintenance.

Apply the heat dissipation glue on the shield cover and the chip first, and then reapply the heat dissipation glue to buckle back to the shield cover after the repair is completed.
