## Samsung A8S camera cannot be opened and crashes

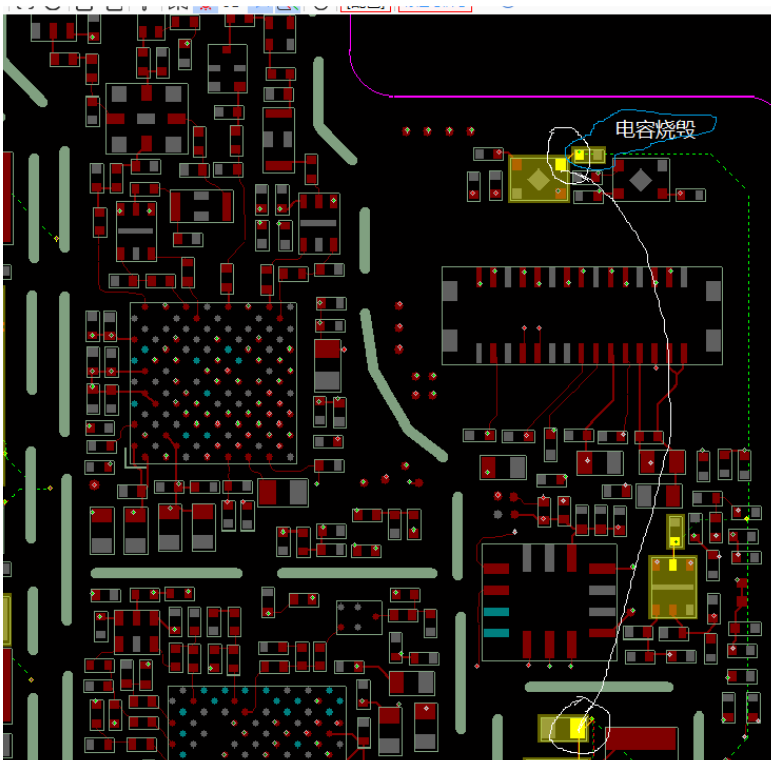
**Repair process:** After taking the phone apart, it was found that there were traces of water entering the front camera position of the motherboard, and the capacitors were burnt and carbonized. The tweezers broke when touched. Carefully clean the water inlet parts with washing water. Use a razor blade and washing water to scrape clean the electrolyte in the burnt area. Open the Xinzhi Manufacturing drawings, and there happens to be a bitmap for reference. The burned location should be the power supply line. Use a multimeter to measure the voltage, which is around 4v. I happened to have an A8S mobile phone on hand. I replaced the faulty camera with a confirmed machine and found that everything was normal with the camera. Judging from the current situation, the fault is most likely caused by circuit problems related to the front camera. According to the position of the point map,

fly the burned line area to restore the five-pin input to normal. After the installation test, it was found that the camera function returned to normal and the fault was perfectly repaired.
