# Apple mobile phone general disease repair experience

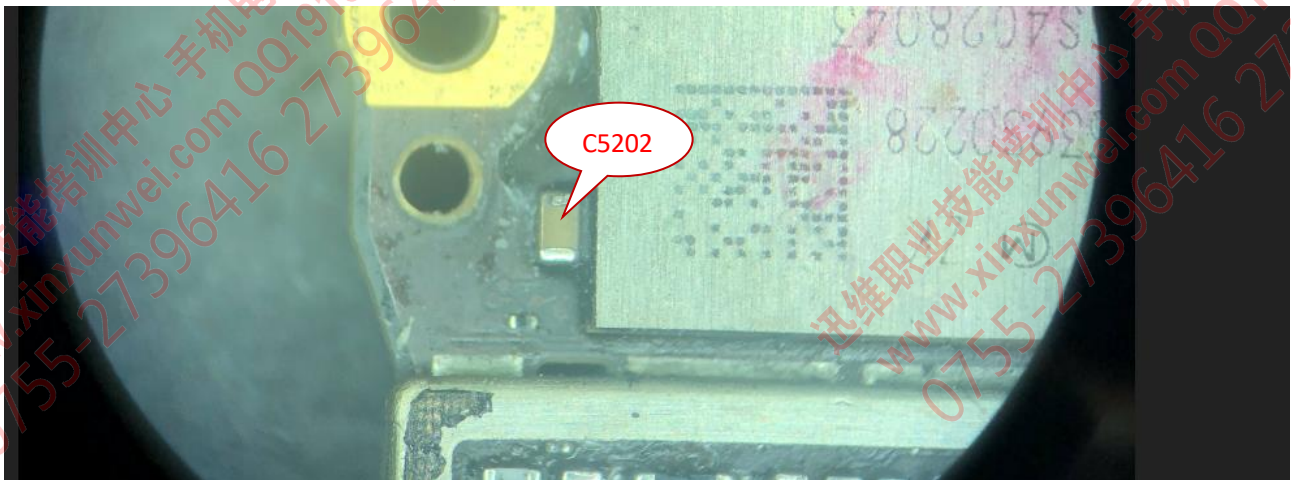
Short circuit of main supply: c5202\_RF

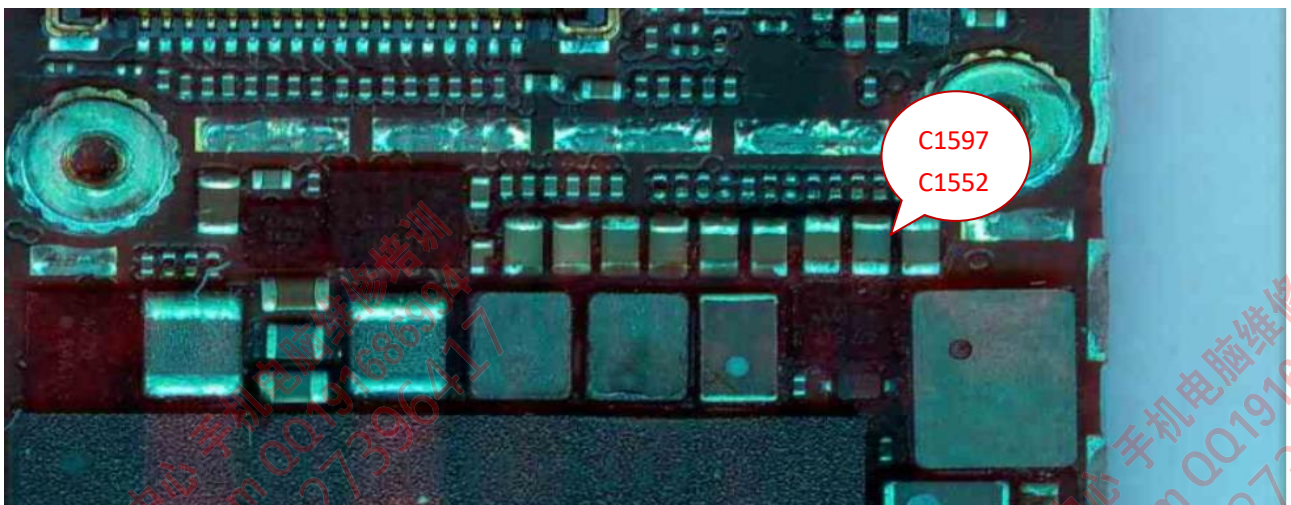
Main supply short circuit c1597 c1552

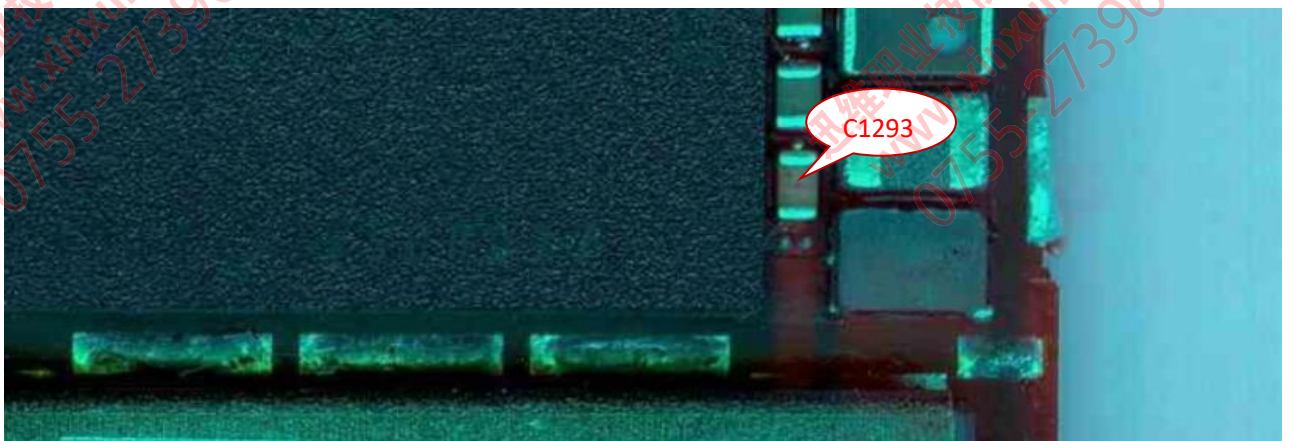
C1293

### 2、 1.8SDRAM powering short circuit:

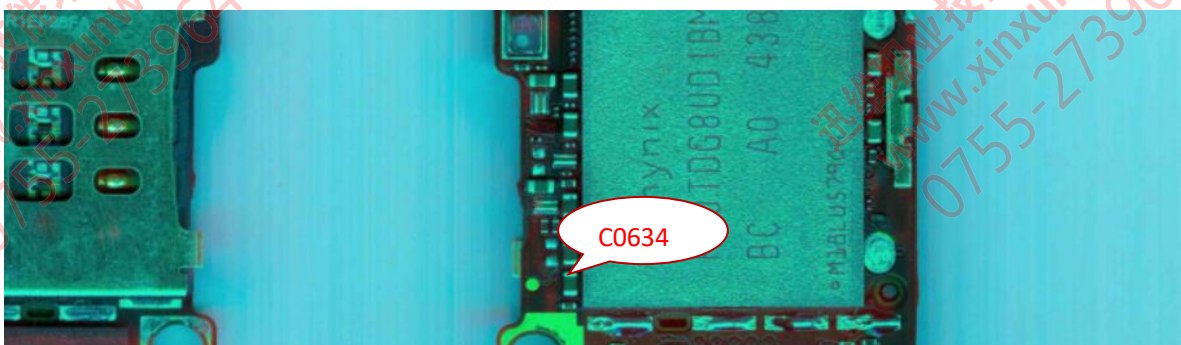
C0634

### 3、Short circuit in hard disk 3V supply:

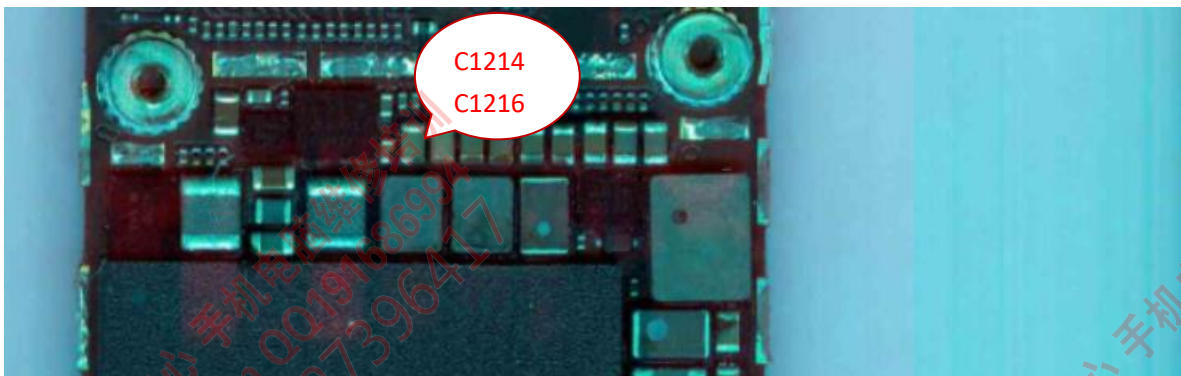
C1214 C1216

### 4、1.2SDRAM short circuit:

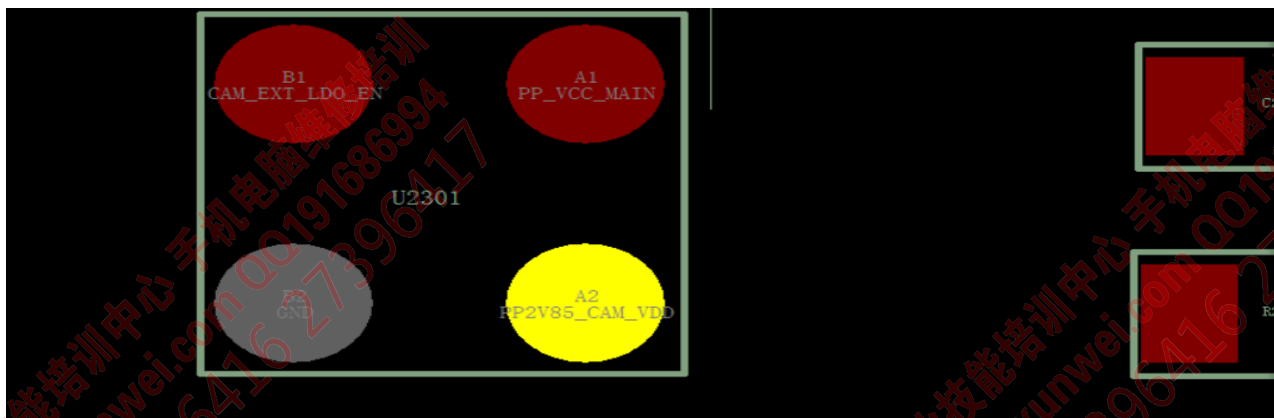
1. Post not taken: 2.85 conversion tube is in problem, can fly main supply to test is not a conversion tube problem.

Normal use can only fly hard disk 3V. Fly main supply will cause taking a dark place where the flower screen has a vertical bar.

U2301] [PP2V85\_CAM\_VDD] [阻值(502)] [电压(2.85V (相机打开时))]

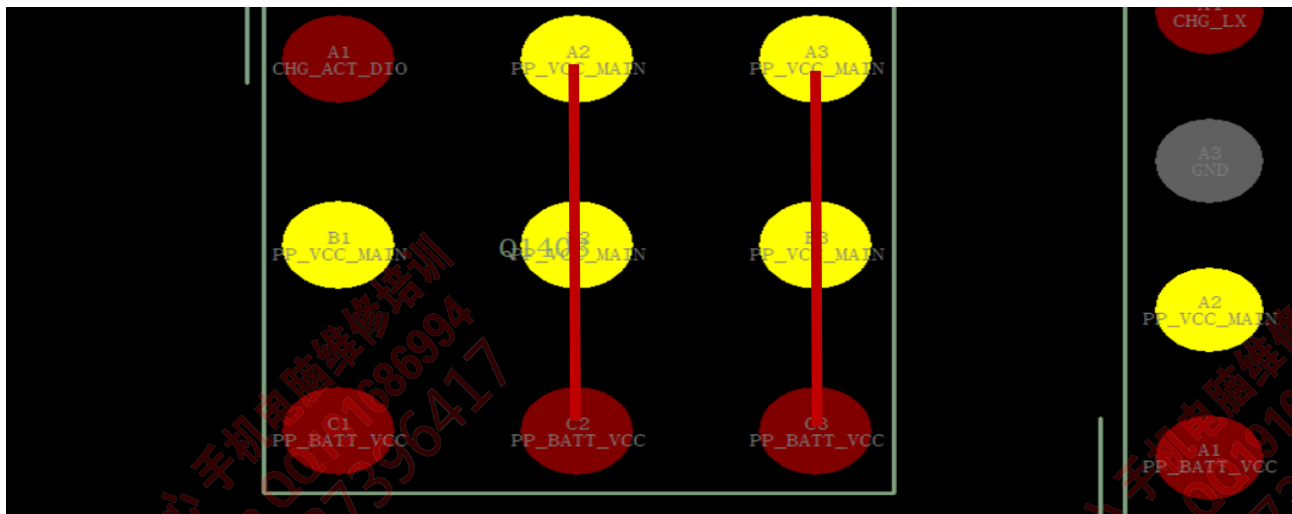
3. No service no signal: after the band break line problem is excluded, most of them are the radio-frequency has a problem replacing the radio-frequency chip. 4, no charge: a shortcharge tube, no change replacing the chip, USB chip. Exchange discharge capacitance, charge inductor.

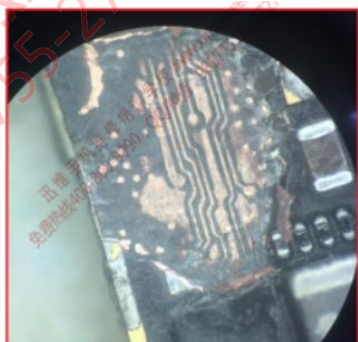
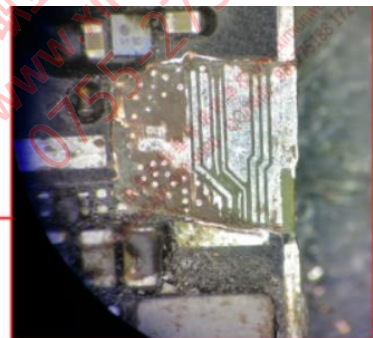
5. 6 generation left screw post wringing causes the no display, 6p is the right screw post wringing no display also galvanizes around 80mA.

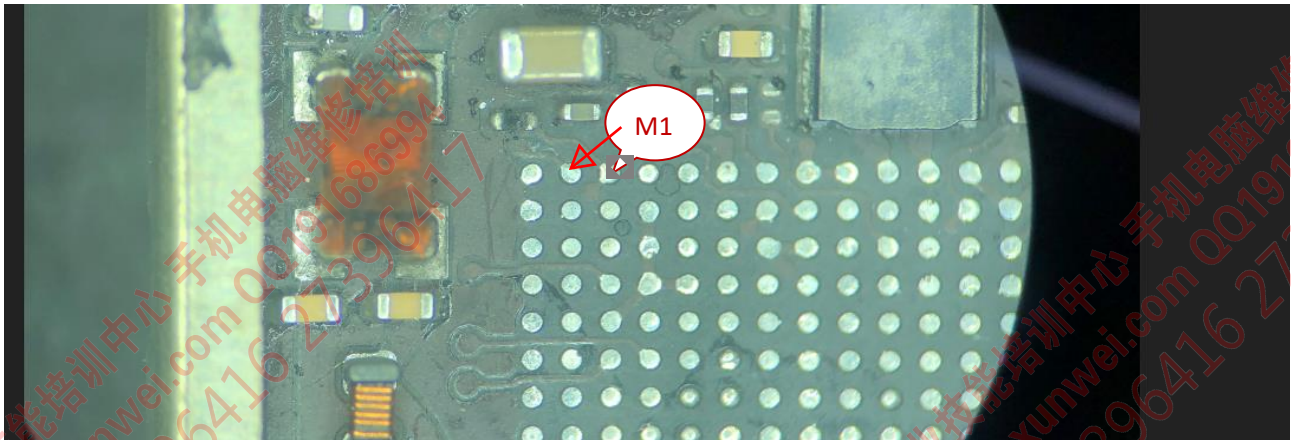
6. 6p general disease is more than 6 one M1 corner broken wire other failure repair same, no touch M1 corner broken

wire, fly wire

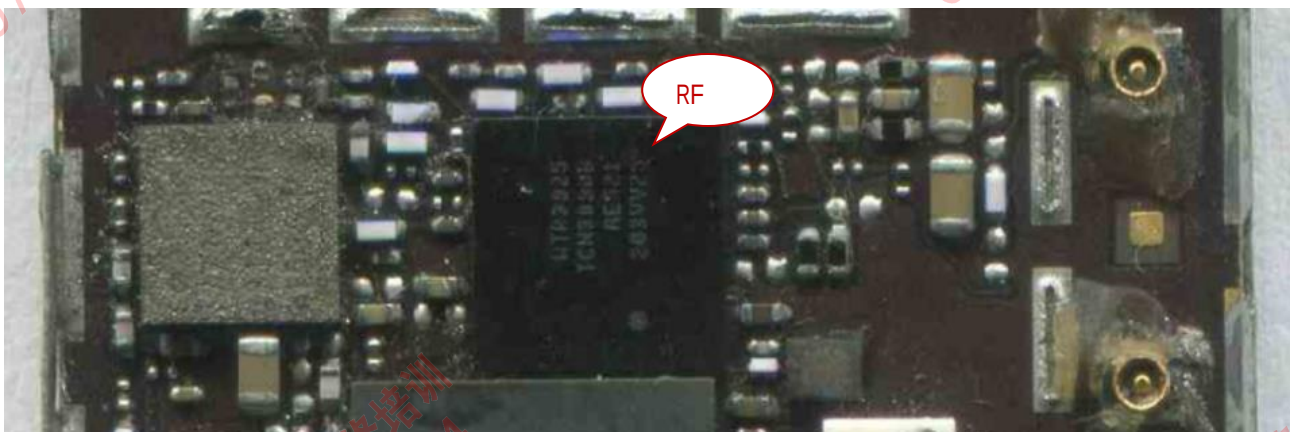
1. Sometimes nil when no service signal, problems with RF

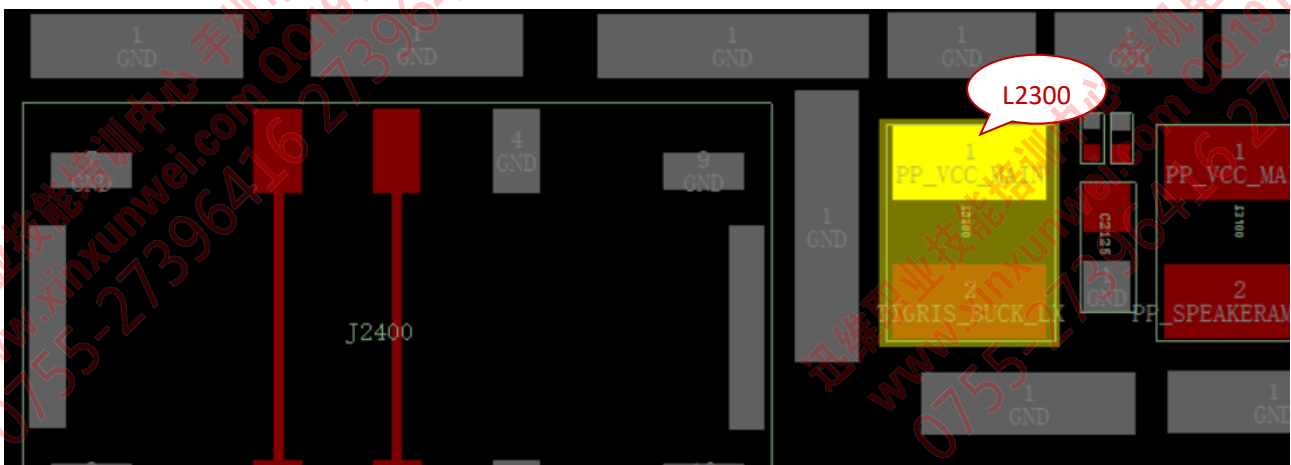
2. Not charged: charge induces bad

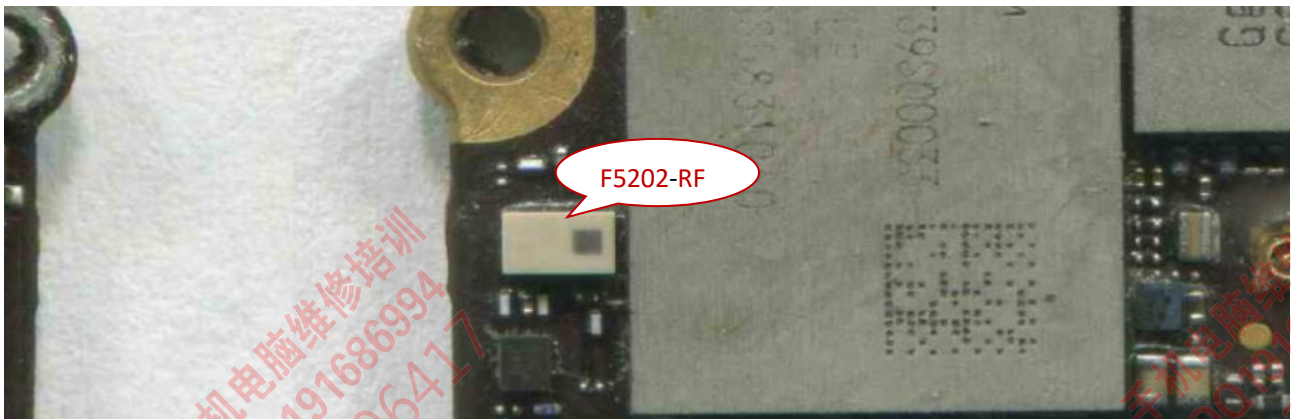
3. WiFi signal difference: there is a problem with the filter next to WiFi.

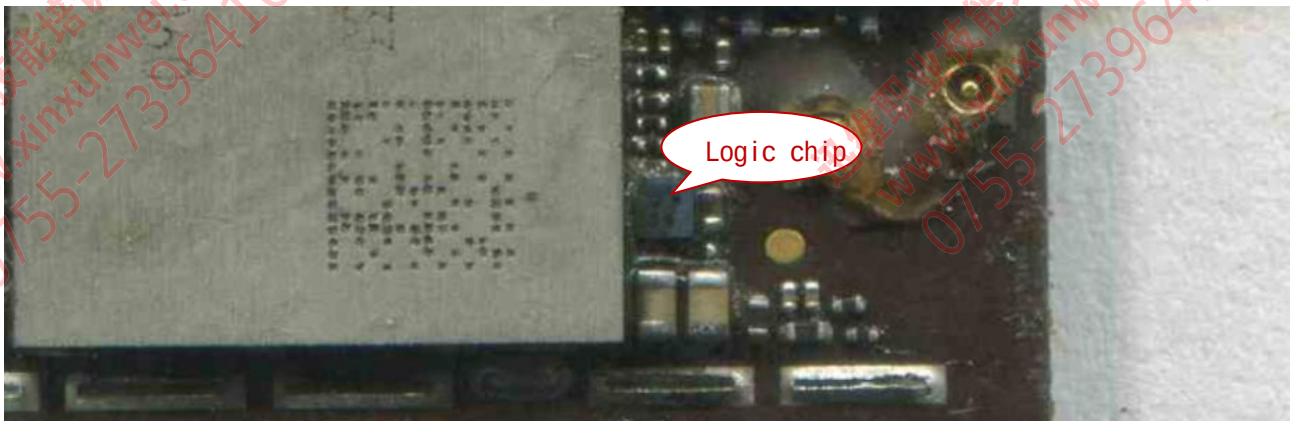
4. Removing WiFi requires hard disk unbinding, and removing WiFi can also easily cause problems with white apple restart from logical patch empty welding, most if it is the WiFi that causes white apple restart, mostly by blowing the logical patch empty welding.

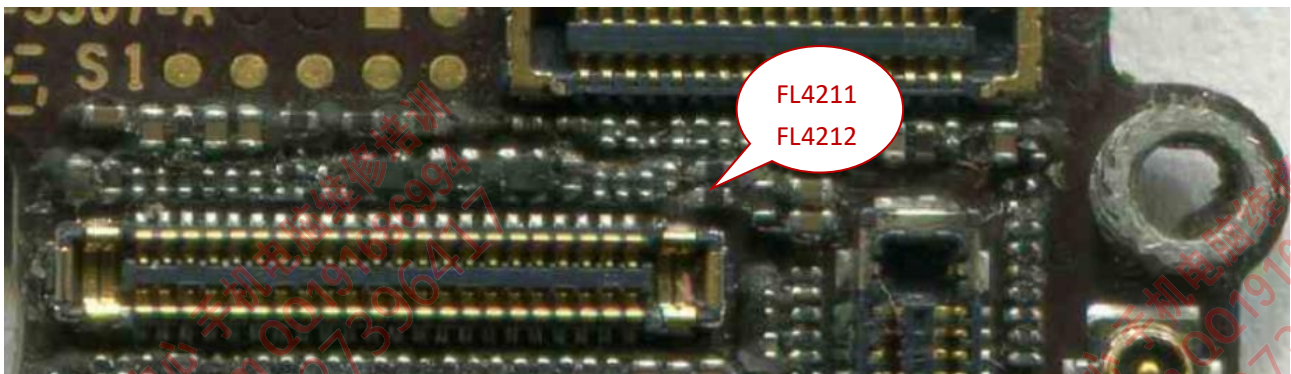
5. The unlit or yin-yang screen of the 6S mostly resulted from damage to the feedback inductor fl4211 fl4212.

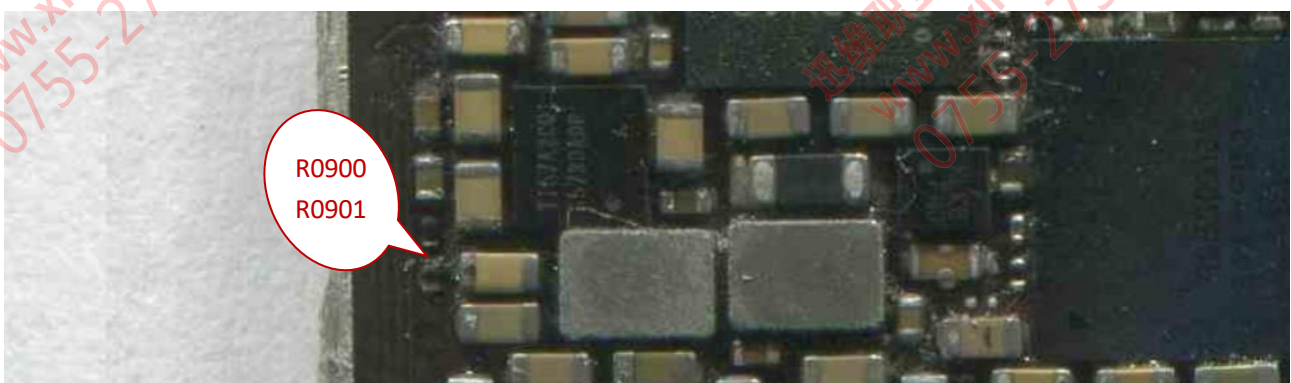
6. 6S water intake easily shows chip damage, i2c0 bus pull resistance corrosion r0900r0901, bus pull corrosion also causes power on 60mA or 100mA zeroing cycles, and does not recognize the cover current is almost the same with direct replacement.

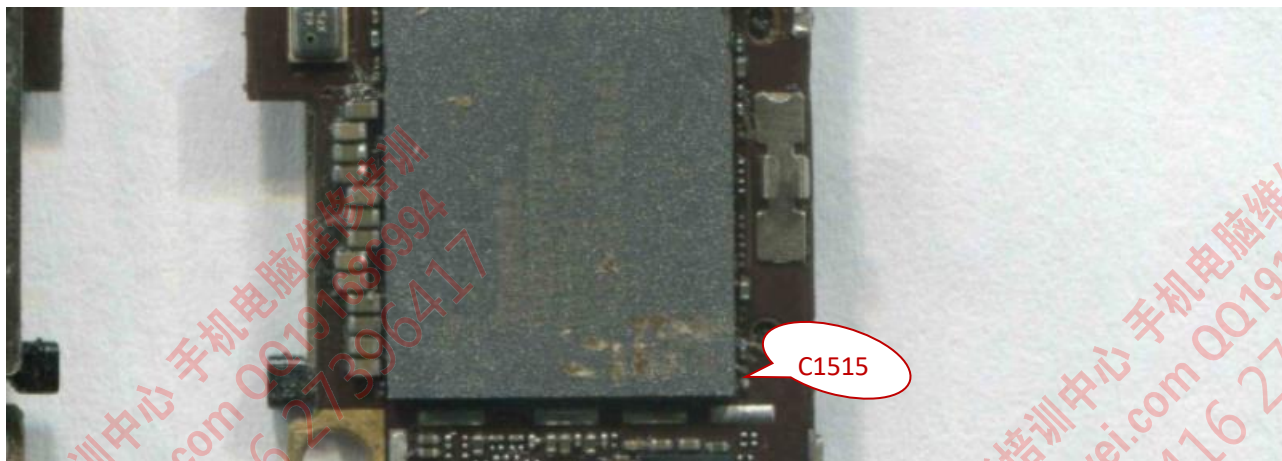
7. 3V short circuiting of 6S hard disks generally results from c1515 damage at the lower right corner of hard disks.

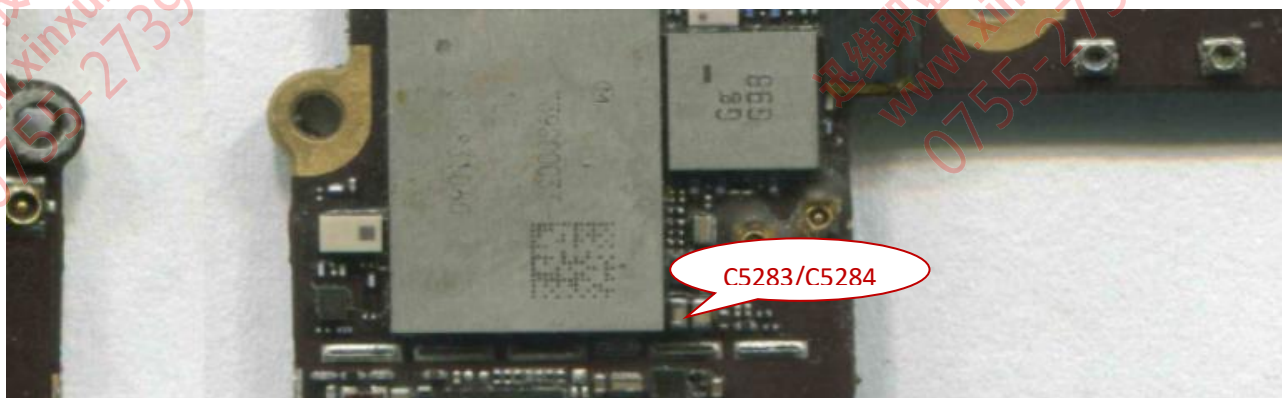
8. The short main supply is generally bad two capacitances c5283 ÷ RF c5284 ÷ RF on WiFi edge.

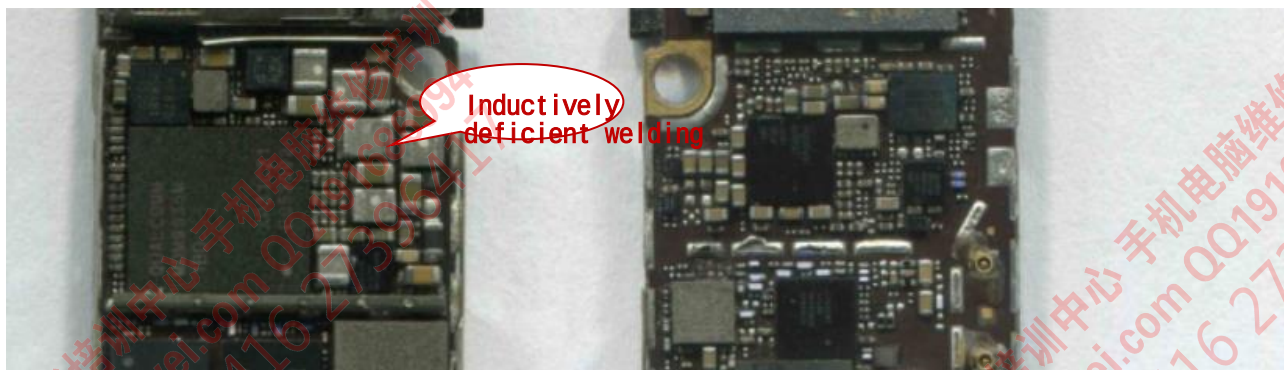
9. After a 6S fall, there will be brush report error 4013 or - 1 mostly with a fall back weld, or S1 S2 S3 S4 with a power supply inductor fall to weld the fall off angle

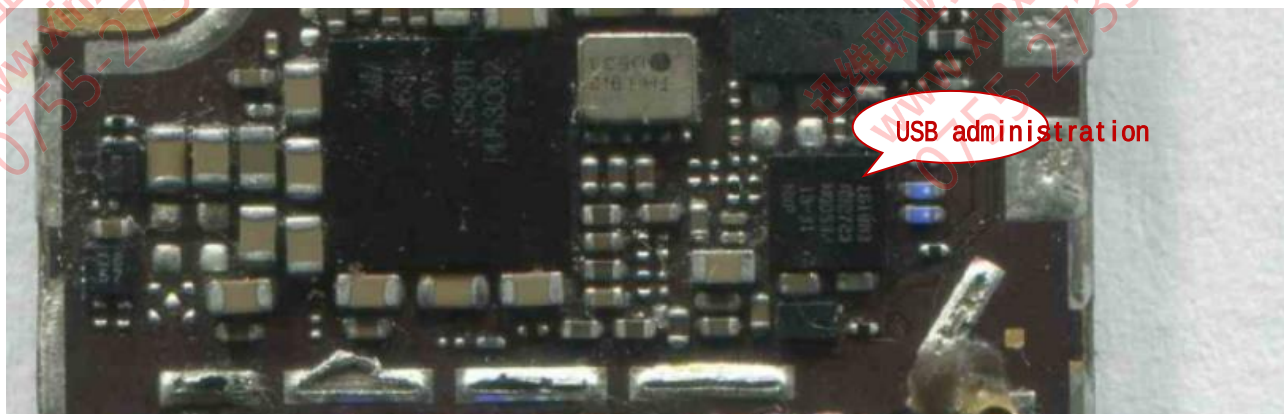
10. Most of the 6S leakage was the USB management chip's bad.

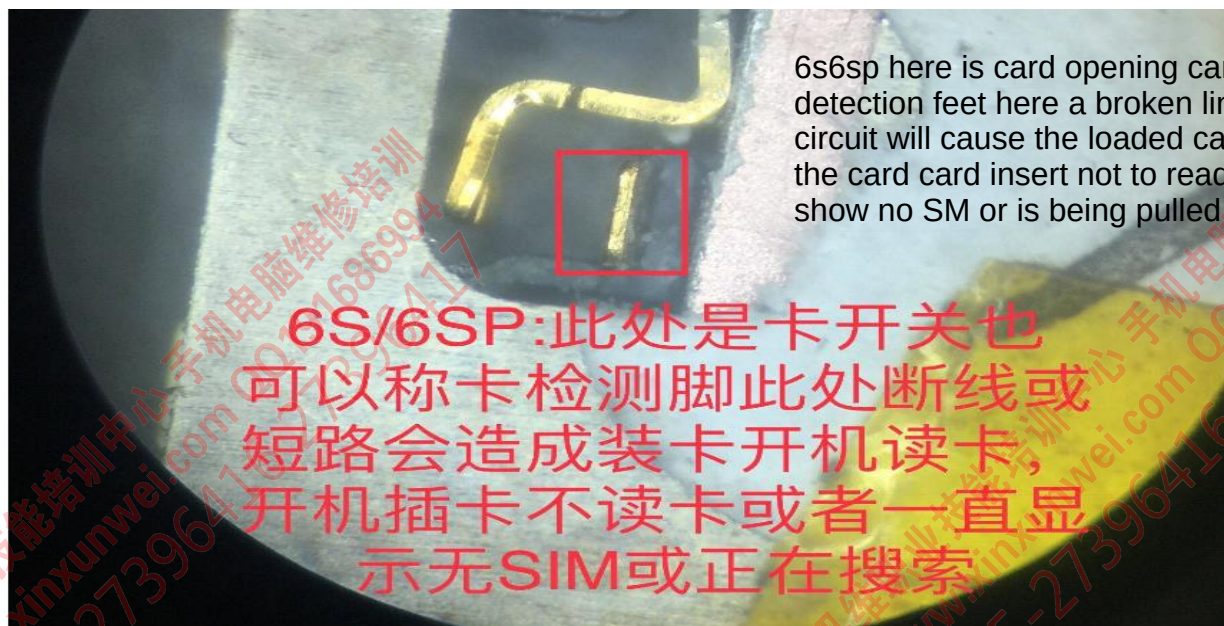
11. No card reading

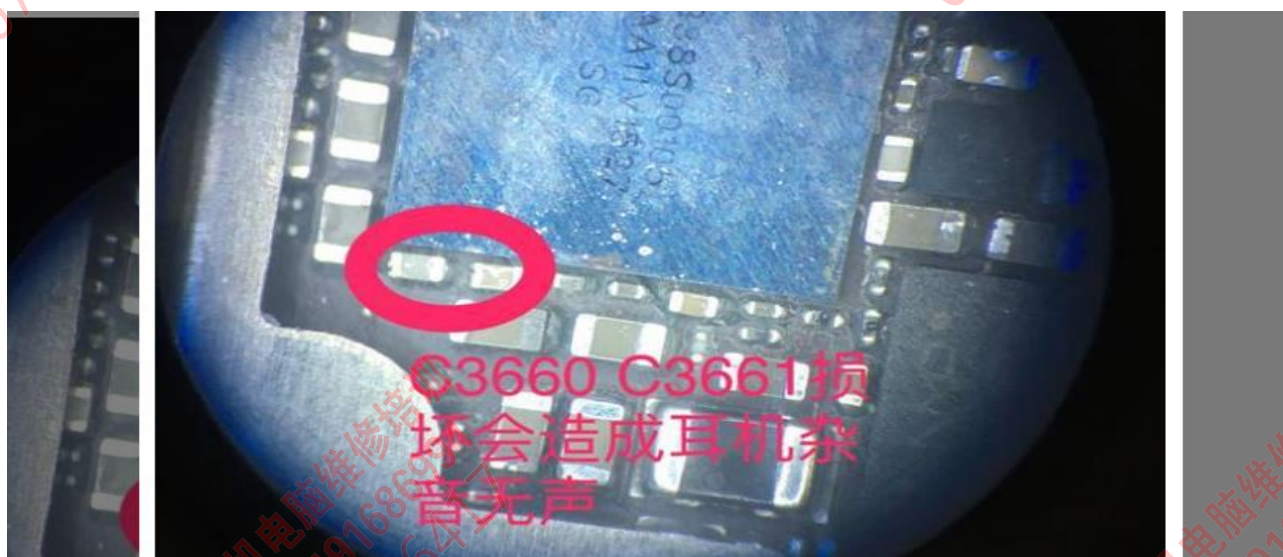
12. 6S, 6sp headphone with murmur silent:

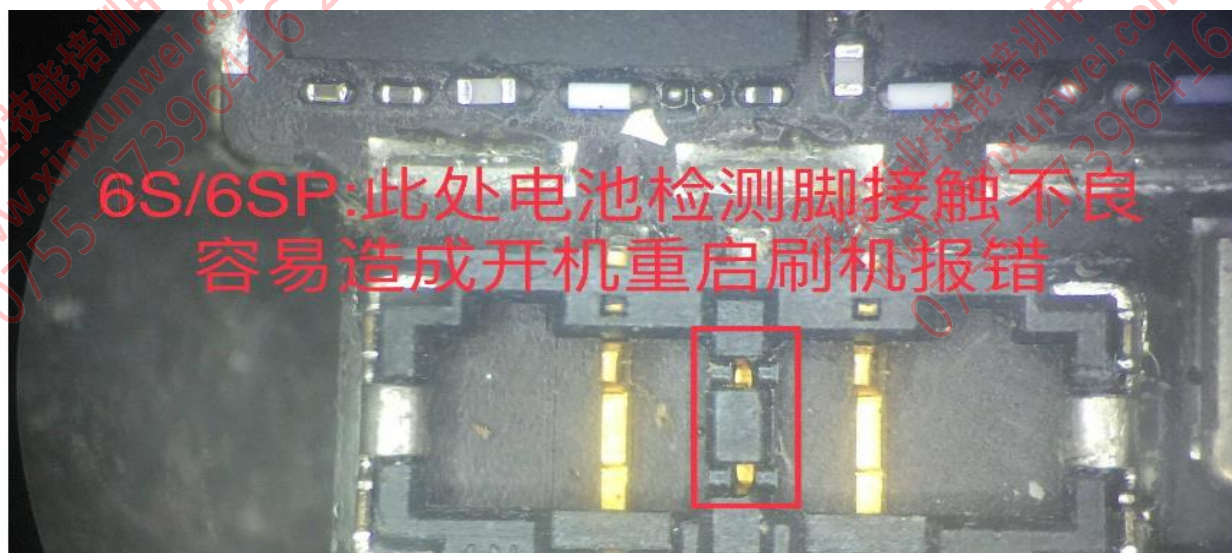
13. 6S, 6sp battery detects bad feet boot restart brush error:

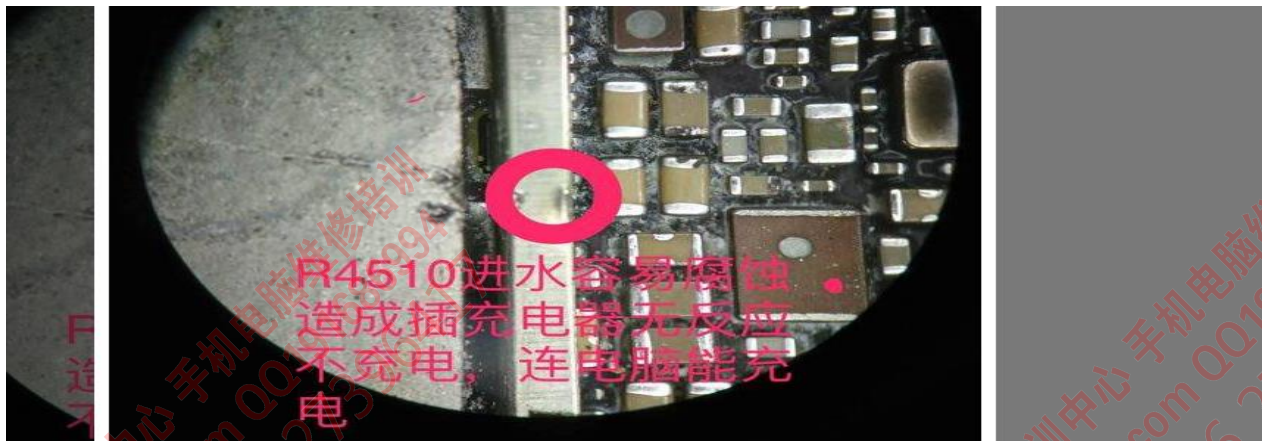
14. 6S, 6sp connected PCs were able to charge and play charger was unreactive

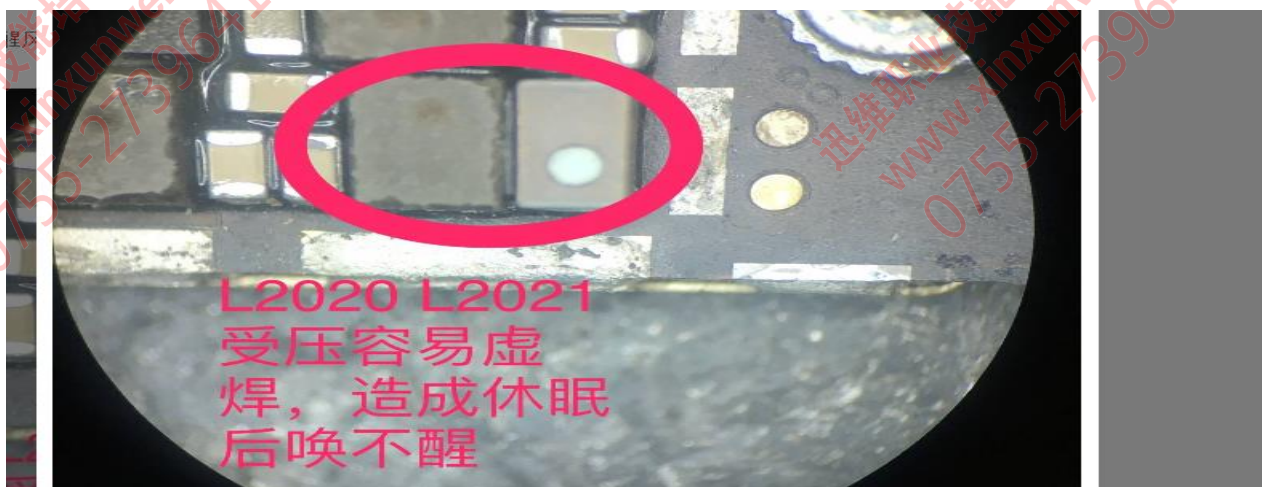
15. 6S, 6sp dormant change not wake shotgun blow l2020, l2021

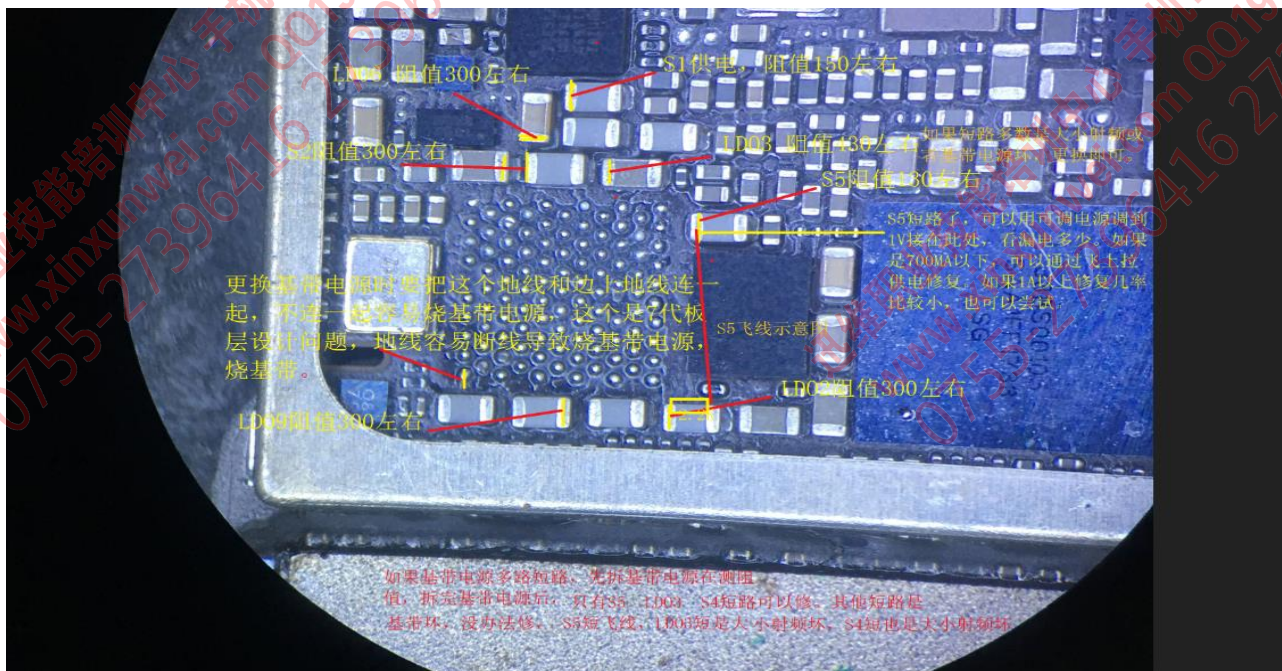
1. 7 generation three network band is easy to be bad, S1 S2 S3 S4 S5 is easy to short circuit. Like this case, the band power can be removed first, if also the short basic band is bad, the band is bad and cannot brush, not enter and not go to the table. The ldo3 short circuit is generally the size of the RF chip is bad, the general situation is the size RF band power supply is replaced together, the band power 83 8893 98 to be connected and grounded.

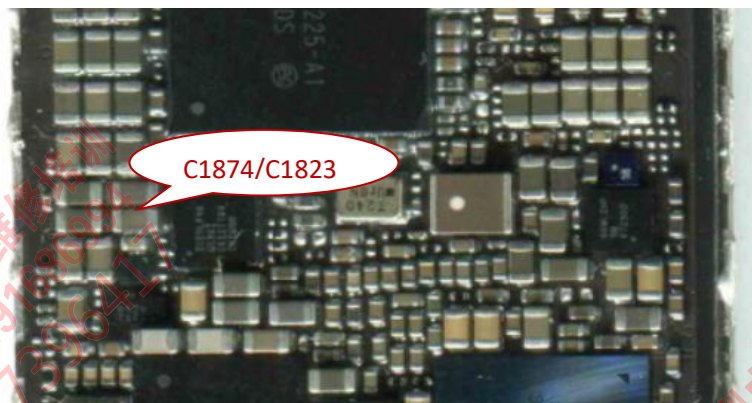
2. The broken machine in 7 generations, easy to cover short circuit. The c1874c1823 upper cover supply resistance value was measured to judge.

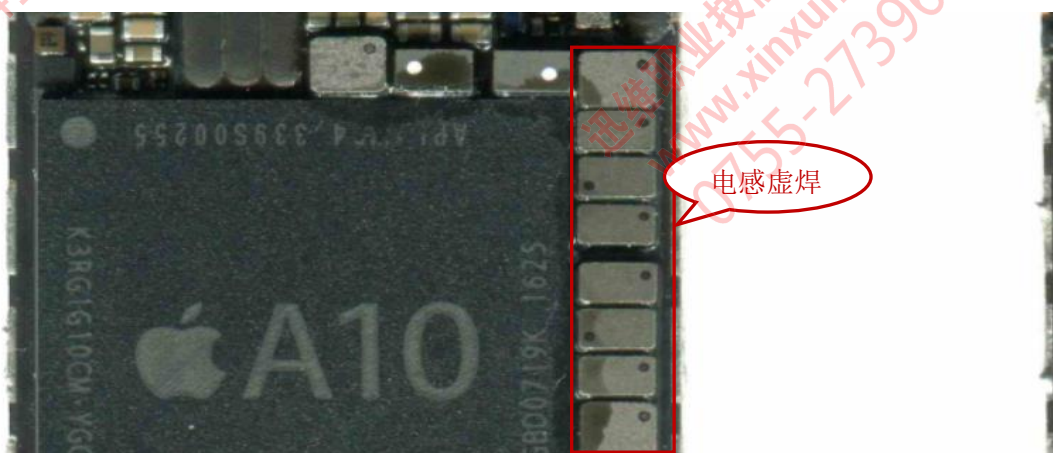
3. Broken machine white apple restart, inductively empty welding near CPU

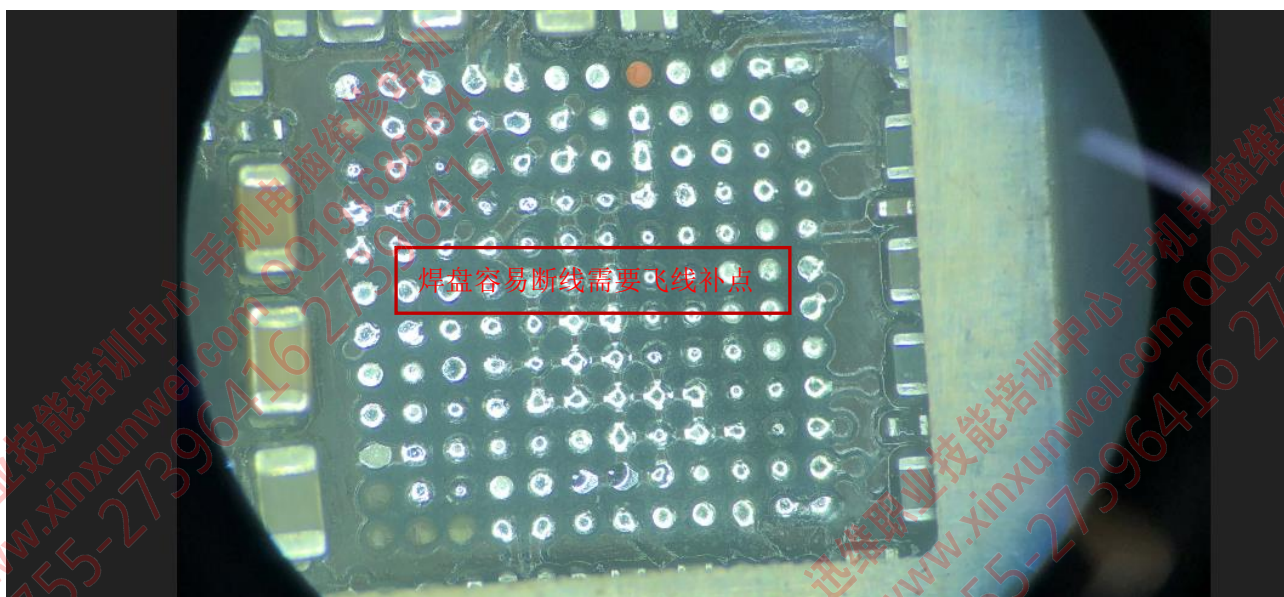
4. Audio disconnection

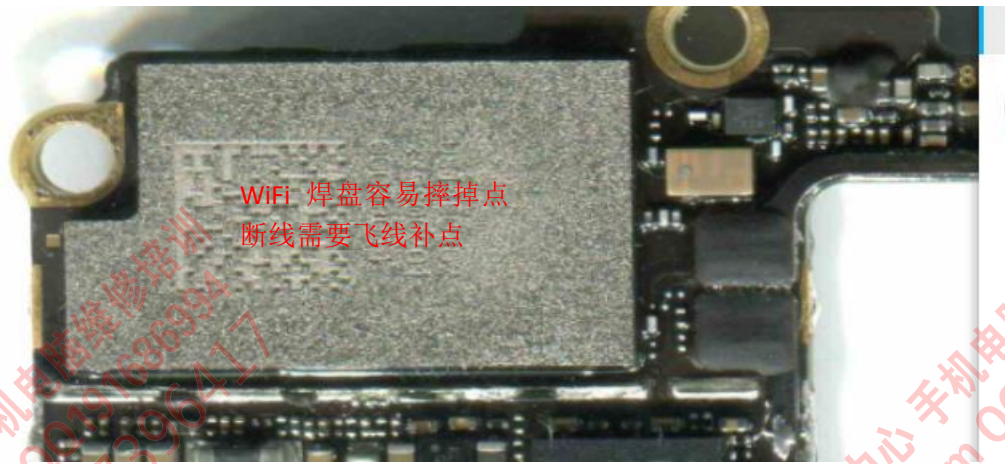
5. Broken machines WiFi easily chips or pads fall away.wifi sometimes does not.

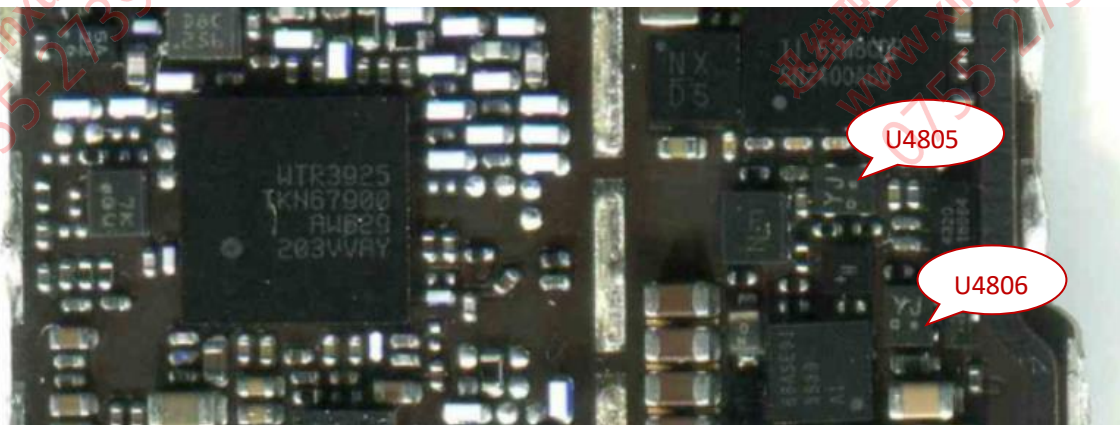
1. Vibration free / no external release / most are chip I2S bus has a problem or bus control tube has a question u4805 u4806

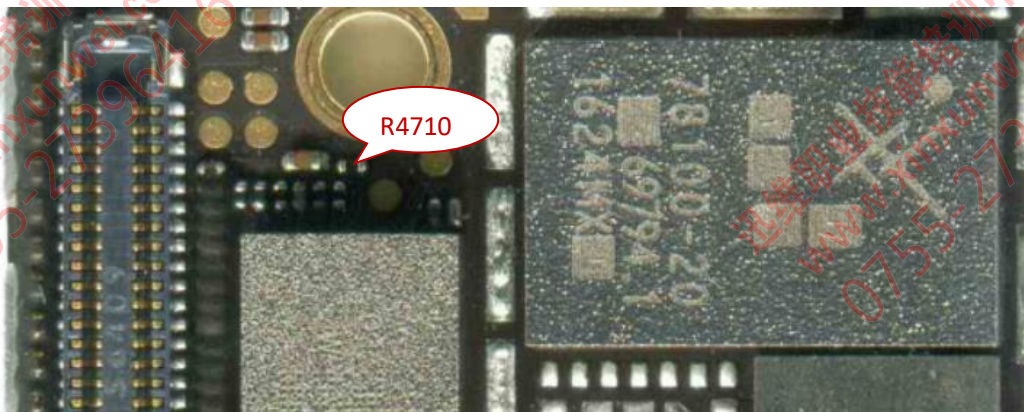
3. Unassembly induced restart, mostly by pulling the resistance off the I2C bus or touching r4710 when removing the screws that insert near

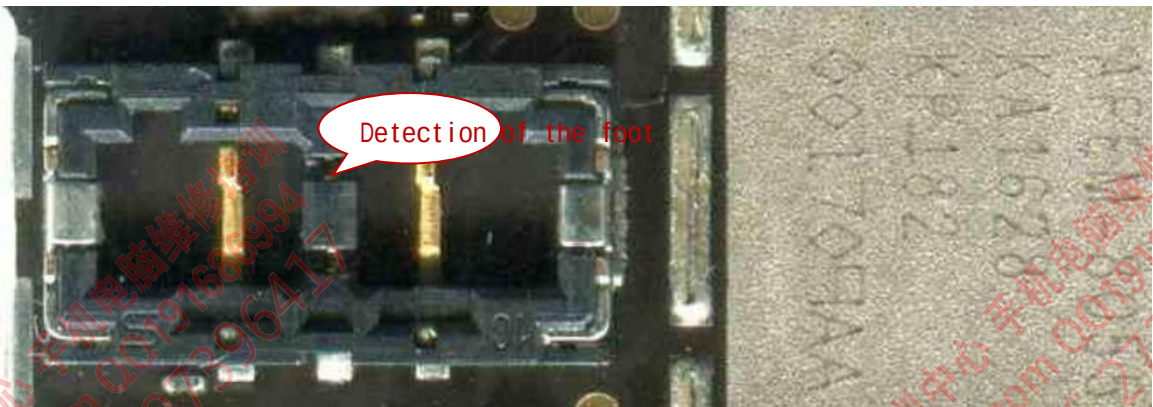
3. 7 the poor easy contact of the battery holders above will also cause a reboot, not charging the motherboard battery holders in the middle

Detect corners to challenge externally.

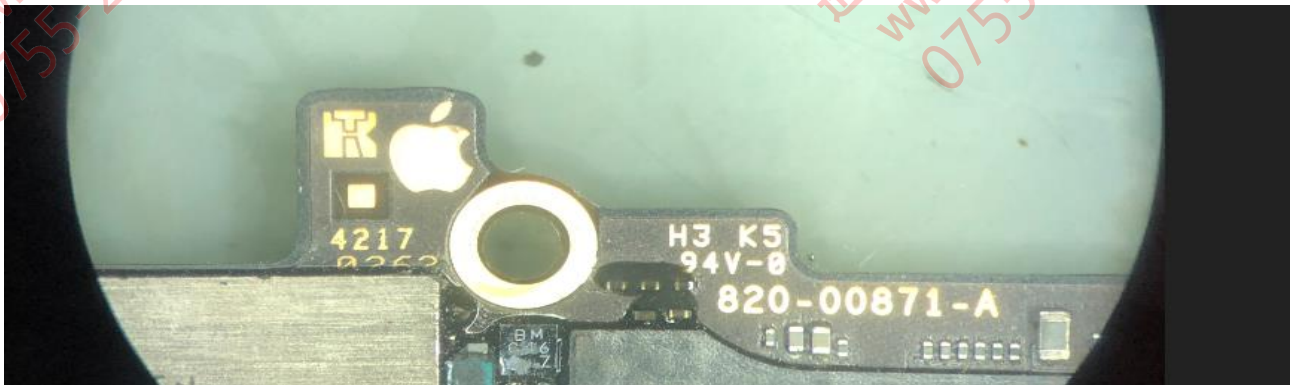
5. Easy low current identified by H3 K5 on generation 5 and 8 boards bottom, problems on boards bottom require moving boards

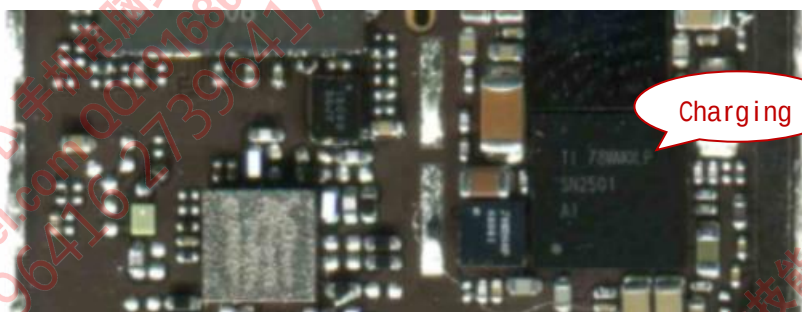
7, 8 8P without charging Most of them are directly replaced by bad charging chips without replacing the USB at first.

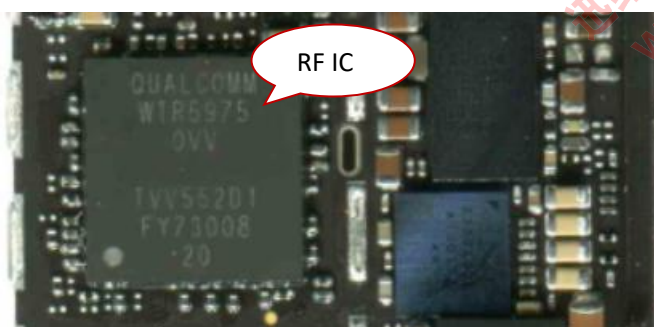
8, 8, and 8P radio frequencies break down easily resulting in no service

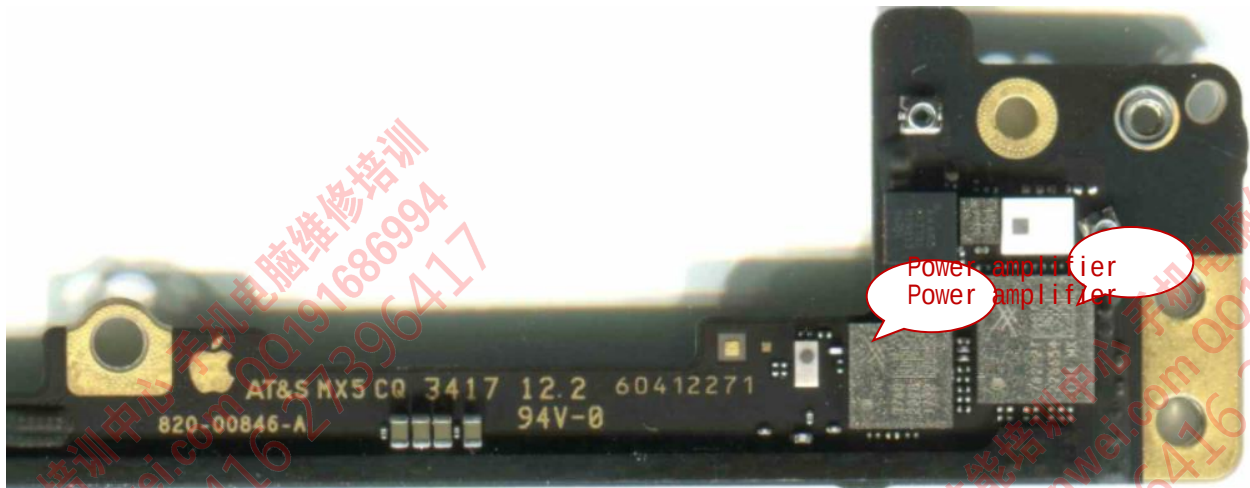
9, 8, and 8P amplifiers are prone to line breakage, virtual solder dropouts causing no service card skipping

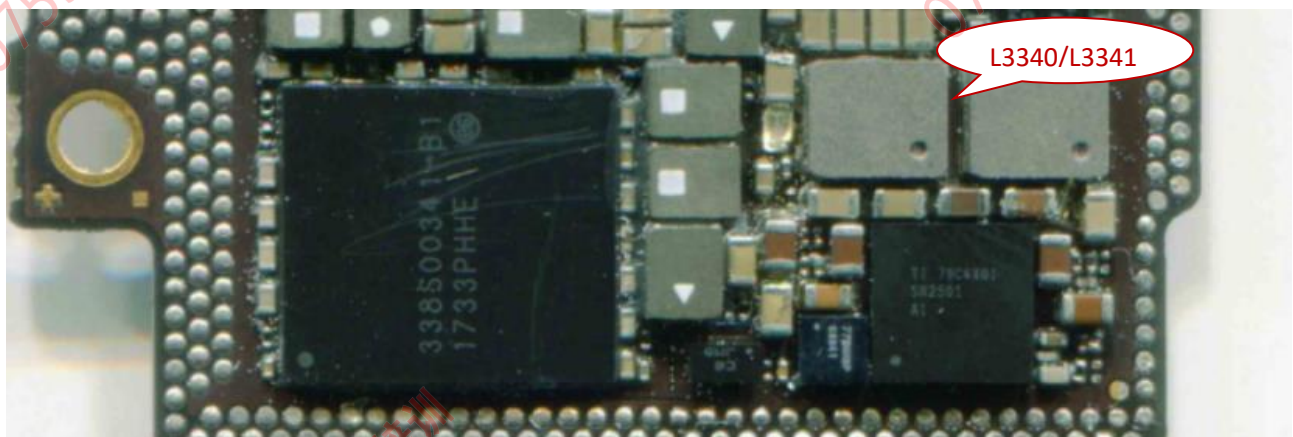
10. X is liable to break mid-level lines when it falls. To layered flying lines, it is also liable to cause no face. The face ID lens is liable to break and cannot be repaired.11.X does not charge, most of which is caused by damage to the charging inductance.L3340 L3341

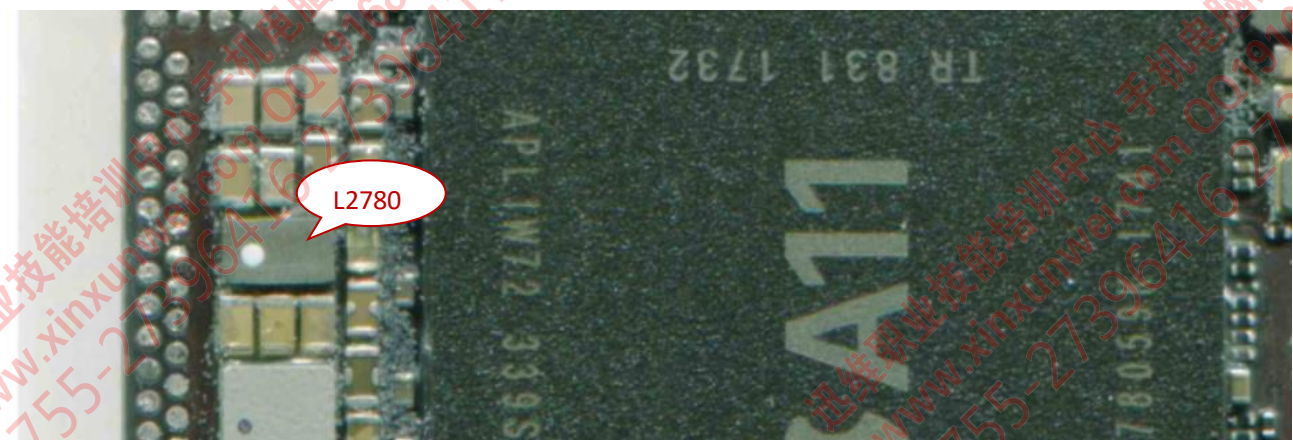
12. X-screen restart is a GPU temporary power supply inductance problem L2780.

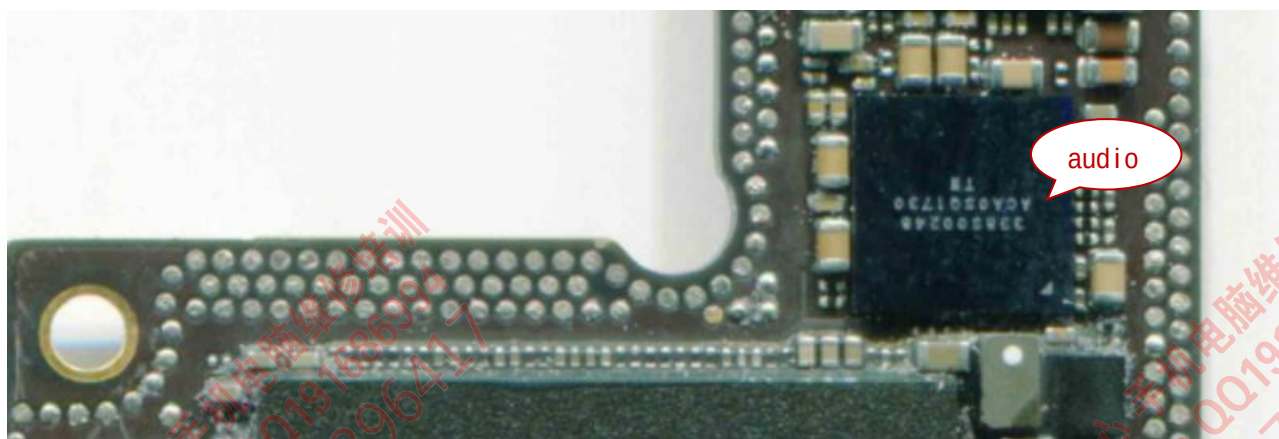
13. X-handset with ringtone and no handset is a direct replacement for big audio problems.
