Redmi note10 starts to display the battery icon (battery detection line is disconnected)

Faulty model: Redmi note10

Fault phenomenon: boot to display the battery icon

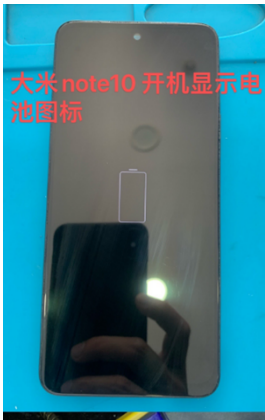
Redmi Note 10 Power-on Display Battery Icon Figure 1

Repair process: Receive a machine sent by a customer for repair, the model is Redmi note10, the fault isThe boot shows that the battery icon does not enter the system.。

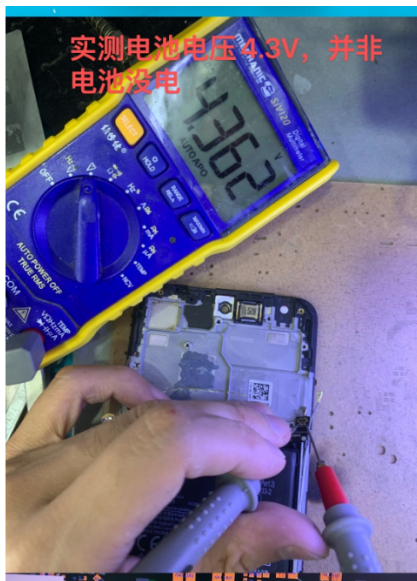
Redmi note10 power-on display battery icon Figure 2

First of all, we thought of the battery loss. We plugged the mobile phone into the charger and charged it for a long time, so we removed the motherboard for detection and measured the battery voltage of 4.36V, indicating that there is no problem with the battery.

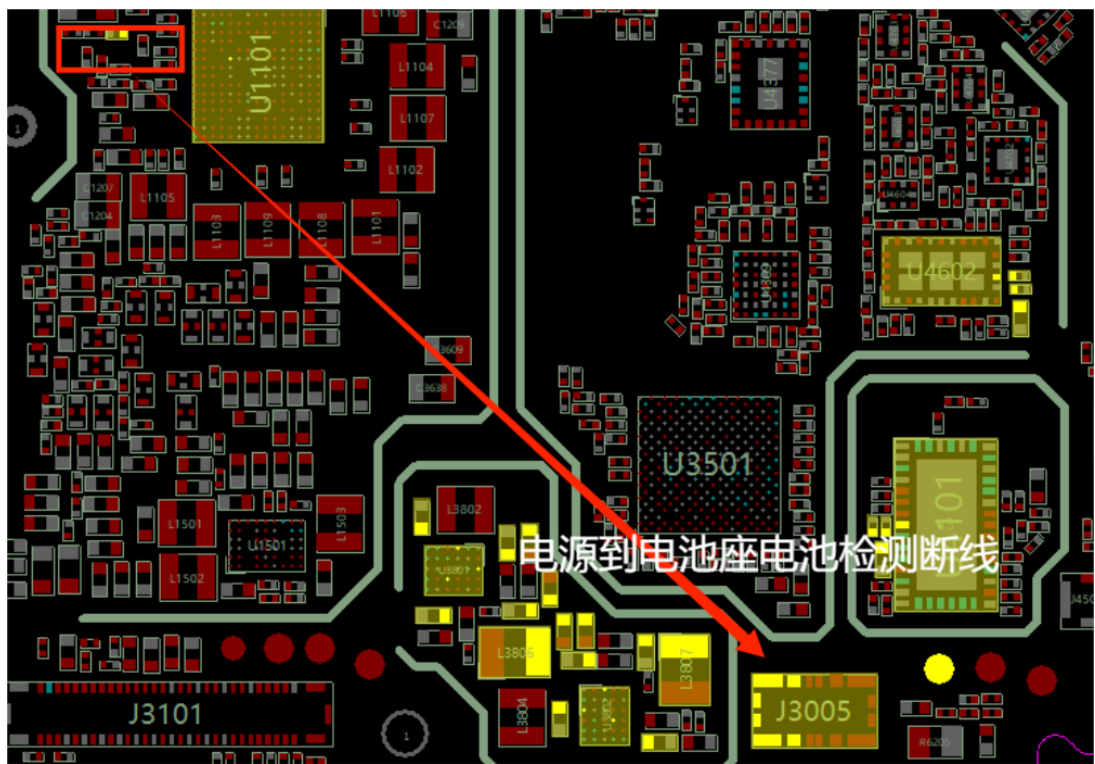
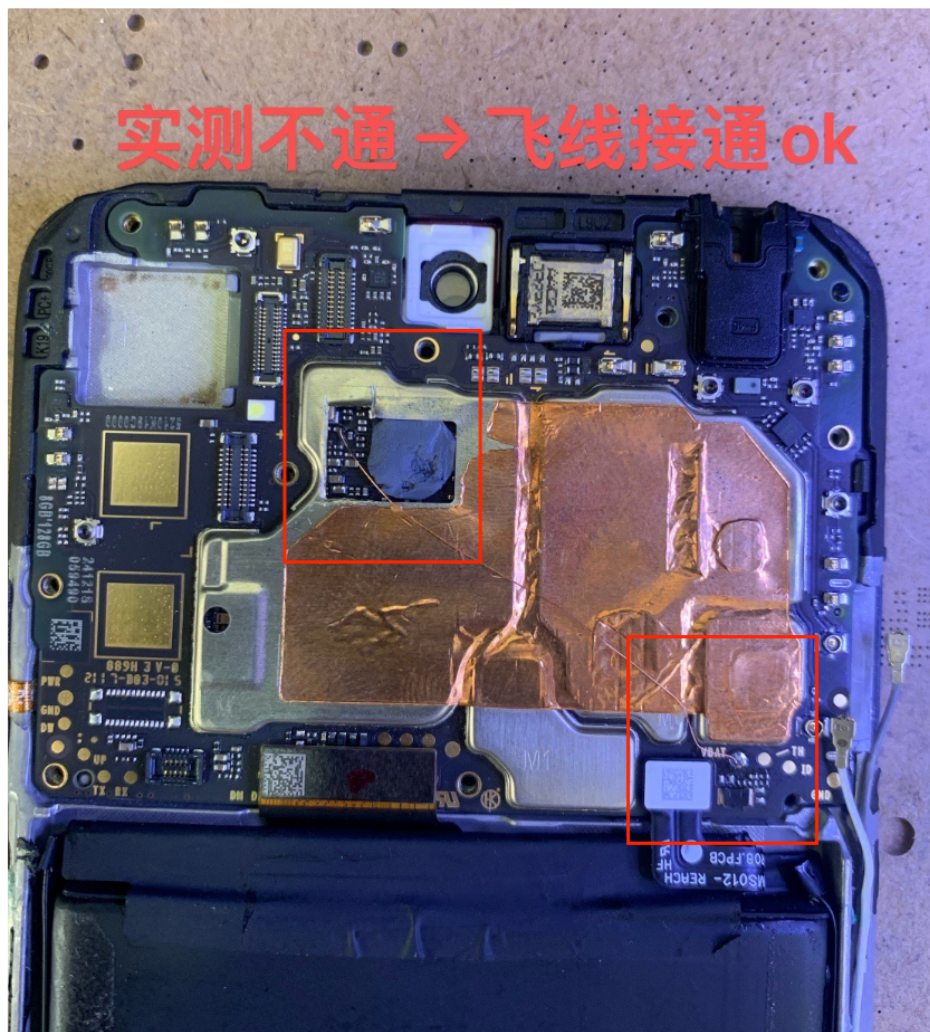
Redmi note10 boot display battery icon Figure 3

Open the drawing to find the battery seat, measure the battery detection foot, and find that the resistance value of the battery detection foot is normal, but the positive electrode of the battery is sent to the power supply for testing. The measured capacitor c1302 to the positive electrode of the battery is not connected, indicating that the line is disconnected, fly the root line directly to this capacitor, and

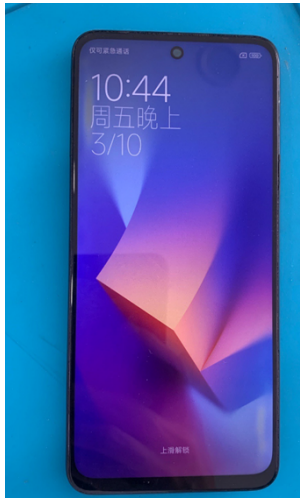
Redmi note10 boot display battery icon Figure 4

Repair results: The motherboard is installed in the shell, and the mobile phone can be turned on normally. The WiFi Bluetooth, sound, charging, fingerprint, photography, phone calls and other functions of the mobile phone are normal. The repair is over.
