# ZS551KL

## EE Troubleshooting Guide

Introduction & Training  
2017/8/9

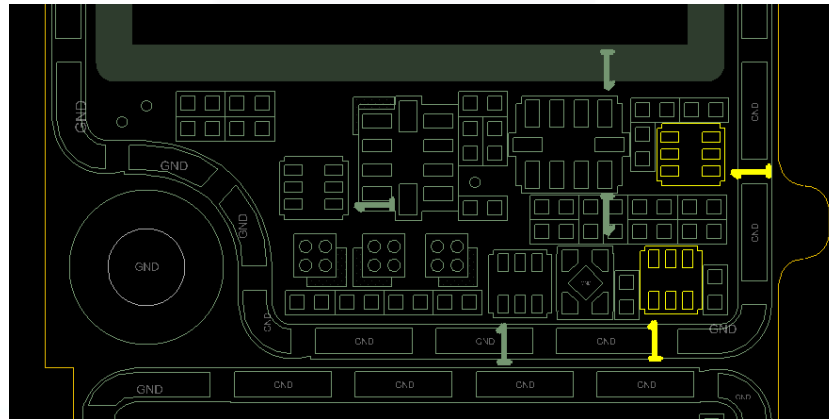
# 996 LID test fail-BMMI

LID apk passed, but LID test fail.

1. Use x-ray to confirm all components in the picture are mounted, or demount the shielding (the one with CPU & UFS) and check are there any lost components.
2. Demount the shielding and check the appearance of PQ8004, PQ8005 and their surrounding components (wrong polarity, IC cracks, short circuits)
3. Check the impedance of net LID\_EN 、USBCON\_LID (with key parts), and compare with normal PCB.
4. If the impedance seems normal, please connect the SUB board and USB cable to power on and check the net voltage of LID\_EN 、USBCON\_LID. If both nets are high level(1.8V), please change PQ8004.

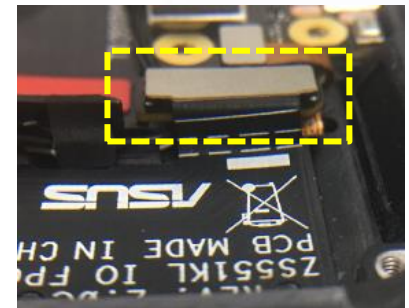
FPC w deformation

1. Make sure the **battery FPC** contacts well with the connector CON9601. Also check if there are any SMT issues.
2. Please check the battery voltage ( $> 3.7\text{ V}$ ) by probing T9603 or T9602. Also remember probe C3304.1 if a USB cable is connected to check the 5V input.
3. Check the **KEY FPC** and **LCM FPC** contact. Also check CON2501, CON1602 if there are any defects or SMT issues (sunken pins, cracks, foreign matters)
4. Both Rear CAM and Front CAM FPC contact with there connector firmly. Please remove the FPC to check
5. Make sure if the **IOFPC** connectors are contacts firmly with no deformation. If it looks fine, please remove the FPC and check both sides of the connector if there are any defects or SMT issues. You can swap IOFPC or SUB board to compare the results.
6. Make sure your image and modem image are correct.

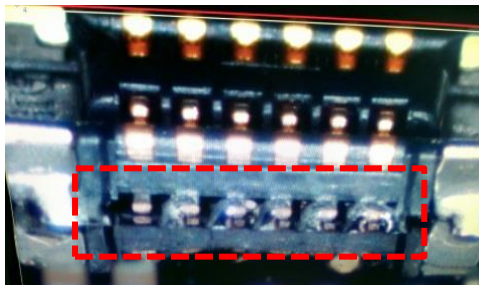
CON3303 SMT issues

1. Check the FPC if there are any ripped area.
2. Make sure CON3303 and FGP FPC contact well.
3. Check CON3303 and make sure there are no defects (sunken pins, cracks, SMT issues).
4. Probe C3319.1 or C3317.1 to make sure FGP power VDD\_2P85 has a stable 2.85V.
5. Swap a new FGP to assure the part is functional.

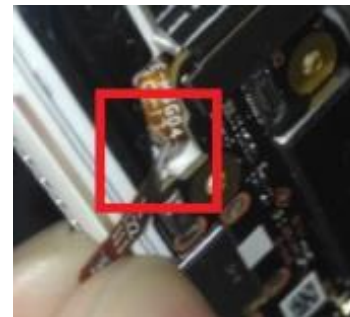
FGP FPC ripped apart

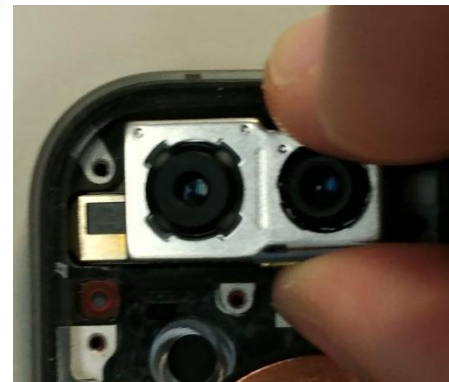
CAM assembly

1. Pre-bend the FPC.
2. Slip in the module on the left side first.
3. Only slightly press in the right side of the module.

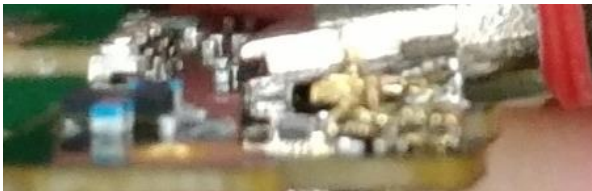
Fault USB connector

1. Swap IOFPC, SUB board to narrow down fault parts.
2. TYPE C CONN should be horizontal instead of rising on one side. Also check any SMT problems ( pin shift, short circuits, solder skip)
3. Check PQ9001, PQ9002, PQ9003, PU9502 using X-ray for SMT problems (IC shift, short circuits, solder skip)

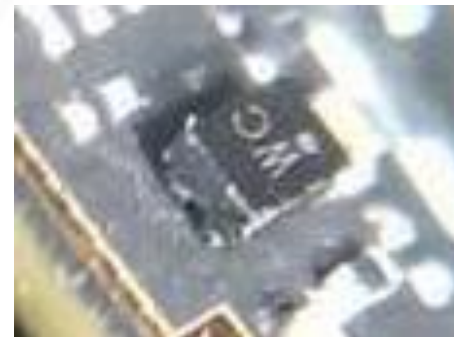
Crack on U2201

1. Probe SD\_CARD\_DET (R2212.2) to check if it pulls high (1.8V) when tray is inserted.
2. Check U2201 for cracks, short circuits, SMT problems. Also check:  
**SD card:** CON2206, CON2202, **SIM card:** CON2204, CON2203, for any squeezed and bending pins.
3. X-ray to check all RLC components inside shielding U3002. If not, reheat the shielding, and retry.

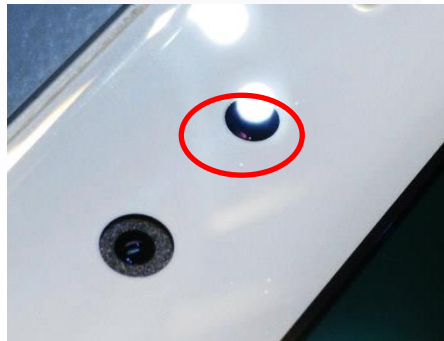
P-sensor under the window

1. Check if there is a possibility to pass under stress test (5~10 times).
2. Observe the window to see any obstacles blocking the sensor (sensor rubber, dust, fingerprints).
3. Reassemble and calibrate again to make sure if it is functional.
4. Probe the voltage on R1816.1 (1.8V) and C1807.1 (3V). If unusual, please swap the sensor.
