# ZE500KL Assembly Analysis

# 2/3/4G Quality Unhealthy **Assembly Analysis** of the Main Antenna

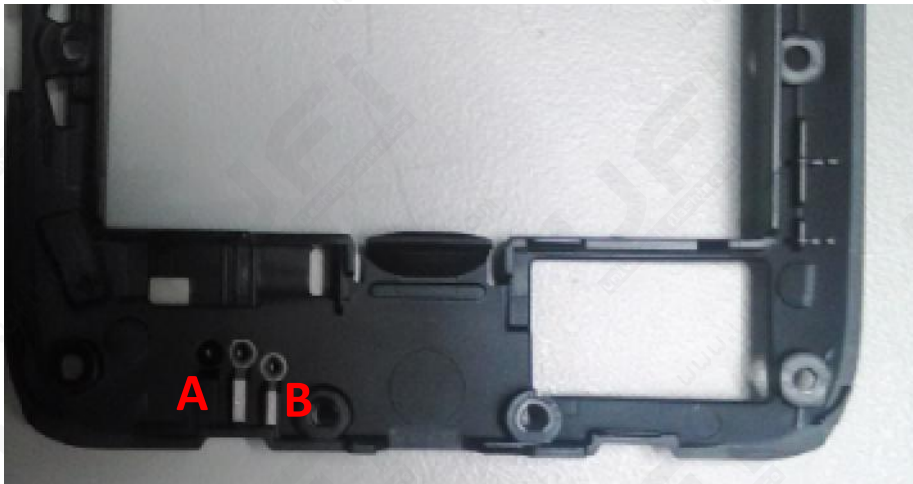
## A. 2/3/4G Bad Signal (LDS):

If the measured value (signal strength) have a very greatly impact, Use a voltmeter, measure each antenna at the A & B, if turn on voltage, LDS will not cut off ; If not turn on voltage, LDS will cut off  
(But the probability of this happening is very low probability)

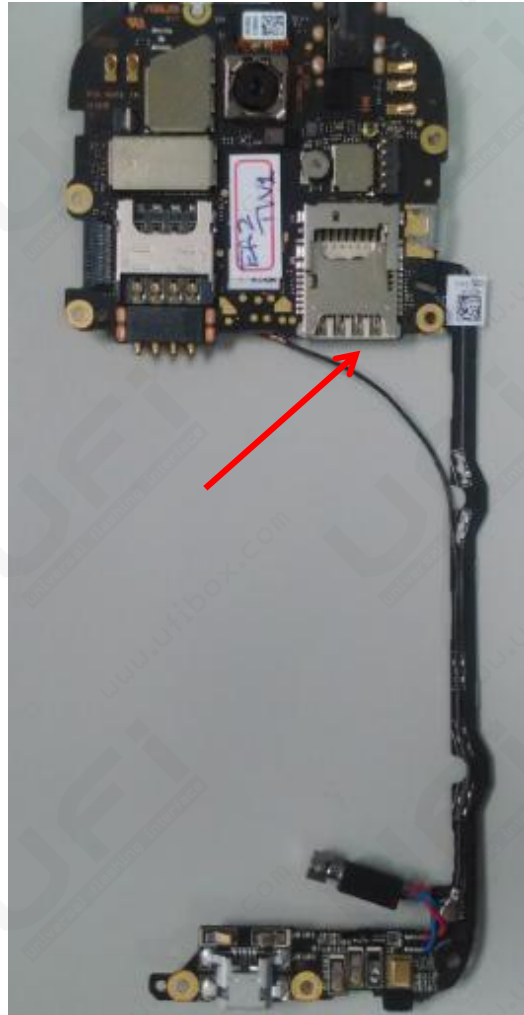
## D. 2/3/4G Bad Signal (RF Cable):

If found power values a great change, measured values varied widely, or only half the normal, check the RF cable as shown, That should be a cable break or damage caused by the assembly.

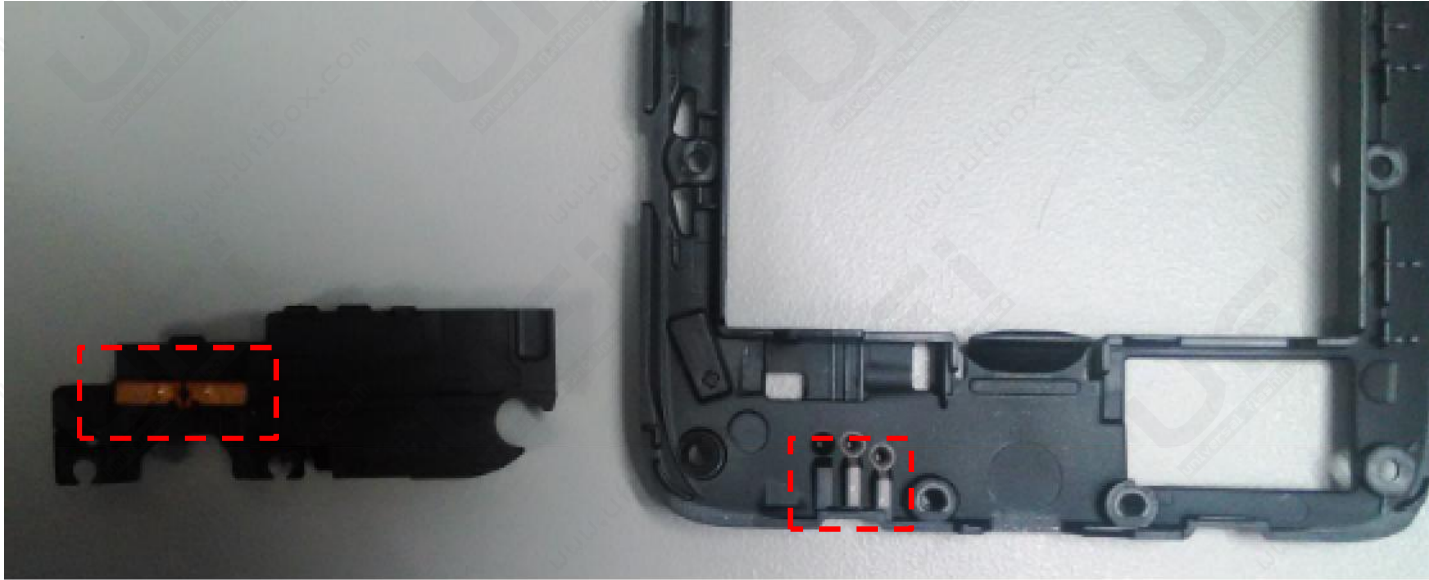
## F. 2/3/4G Bad Signal (4/4):

When the machine disassembly, you can check the SPK and antennas has no trace with top of the spring, if not, it may be at risk of the contact, the impact of Power value.
