## iPhoneX Facial Failure Classification

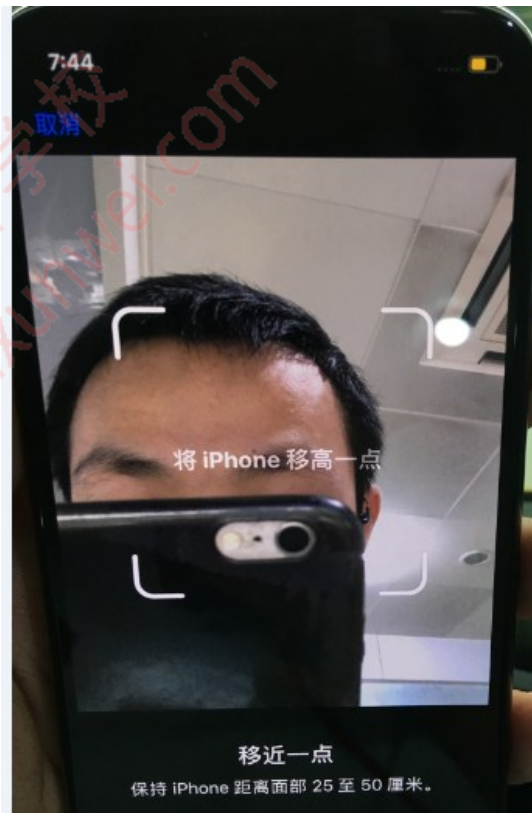
1: Blocking the dot matrix will prompt IPHONE to move a little higher. Figure

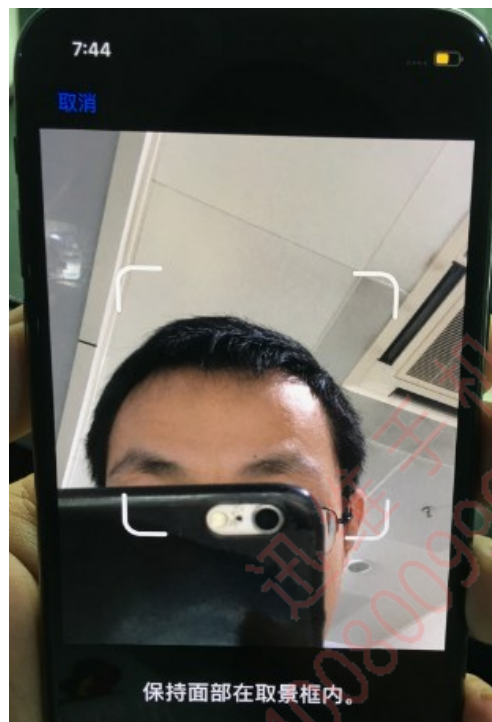
2: Block floodlight as well as infrared camera failure. Not prompted as shown

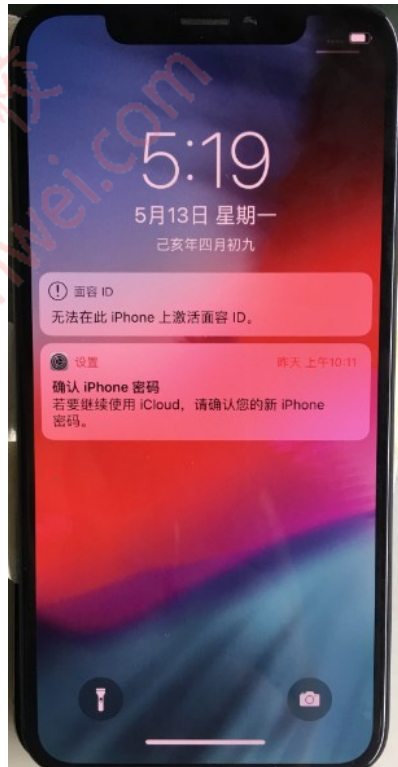
3: According to the workflow: First out 1.8V 3.3V power supply. Infrared camera without 1.8V 3.3V power supply can not directly self-check the device prompt that the face ID can not be used. Figure

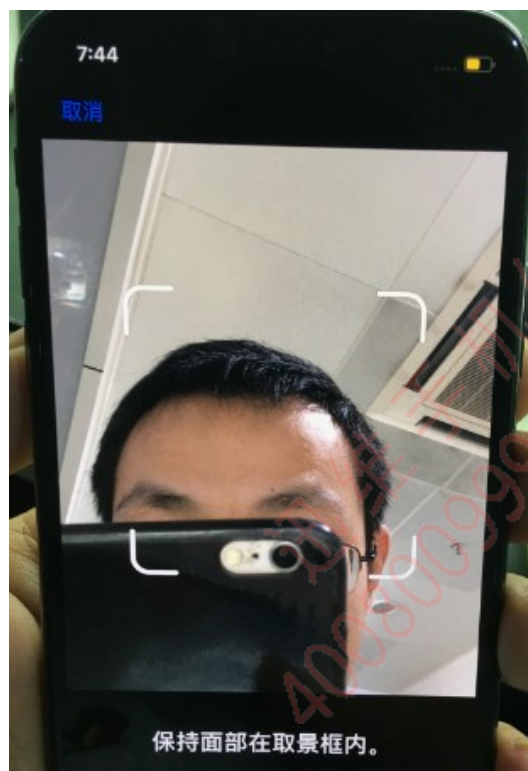
5: Disconnect the FL4650 floodlight status signal. No error will be reported. It will be prompted as shown in the diagram

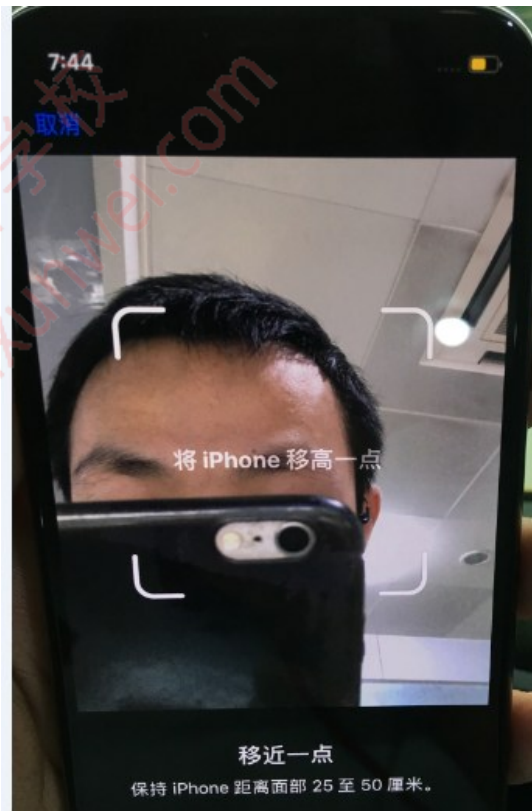
6: Disconnected dot matrix status signal FL4556 face is recognizable and can be turned on. You will be prompted to move higher and farther. Figure

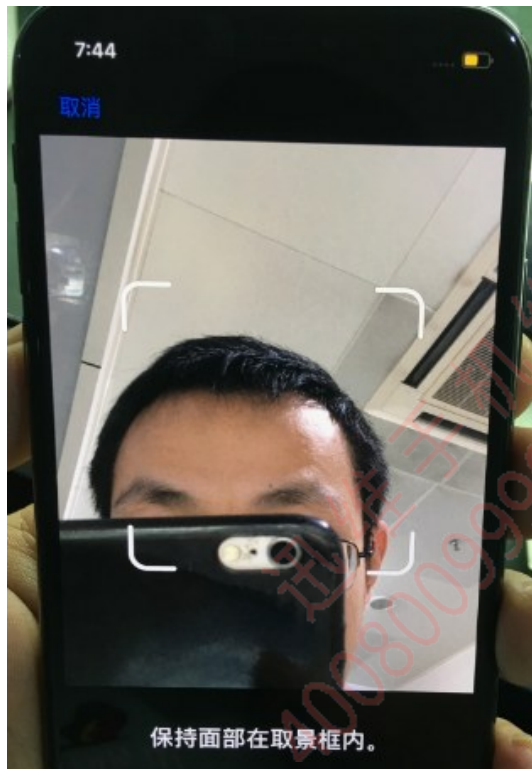
7: Disconnect the flash signal R4563, no error will be prompted. But the input interface cannot record. Figure

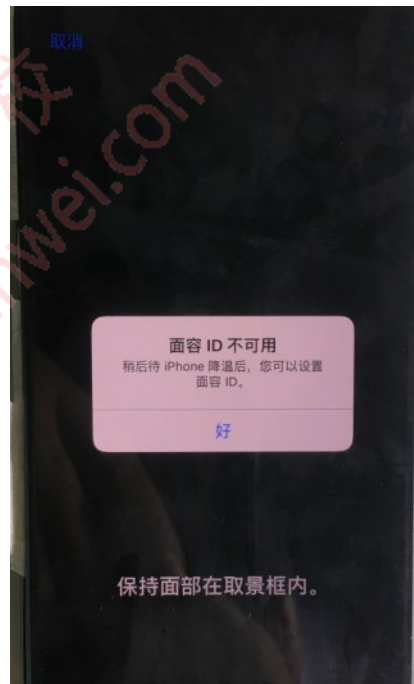
8: After the dot matrix temperature control FL4555 is removed, it is grounded by 2.2K resistance. Power on will not prompt for error. The input interface will indicate a high temperature. Figure
