Millet Tablet MI PAD1 does not show troubleshooting

The millet tablet computer sent for repair by the customer describes that the fault is not displayed when starting up. After taking over the machine, use the adjustable power supply to supply power, observe that the current has normal jump, and suspect that the display circuit is caused by failure. Quick folding machine visual inspection motherboard looks good, with motherboard pictures attached:

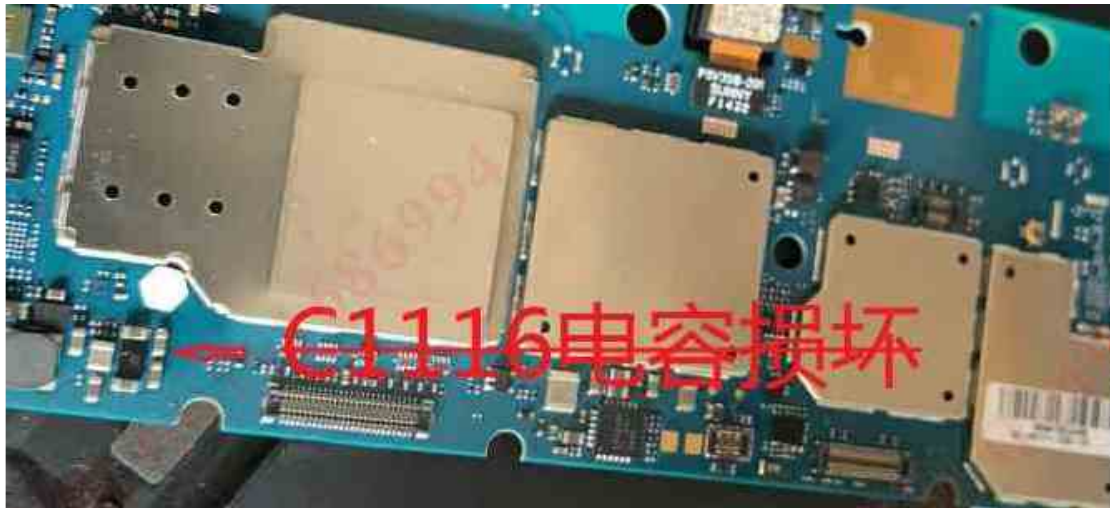
After the main board is powered on again, the value of the C1116 capacitor is only over 50 ohms, and the resistance value is small. After the soldering iron is turned on, the C1116 capacitor is disconnected.

It turned out that this capacitor was damaged by leakage,

Find the capacitor with the same capacity value in the material box and replace it. After the motherboard is turned on again, the measurement screen shows that the positive and negative pressures are about +4.6 V/-4.6V, and the on-screen test shows that it is normal. This machine has been successfully repaired. Attached with bright machine diagram:
