# **Moto X Force/DROID Turbo 2 BASEBAND TROUBLESHOOTING GUIDE V1.0**

Moto X Force/DROID Turbo 2  
BASEBAND TROUBLESHOOTING GUIDES

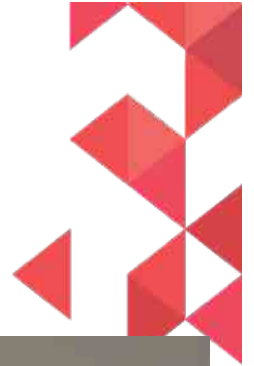
# Blemish Example #1

Blemish failure due to FM. This FM is most likely beneath the lens.

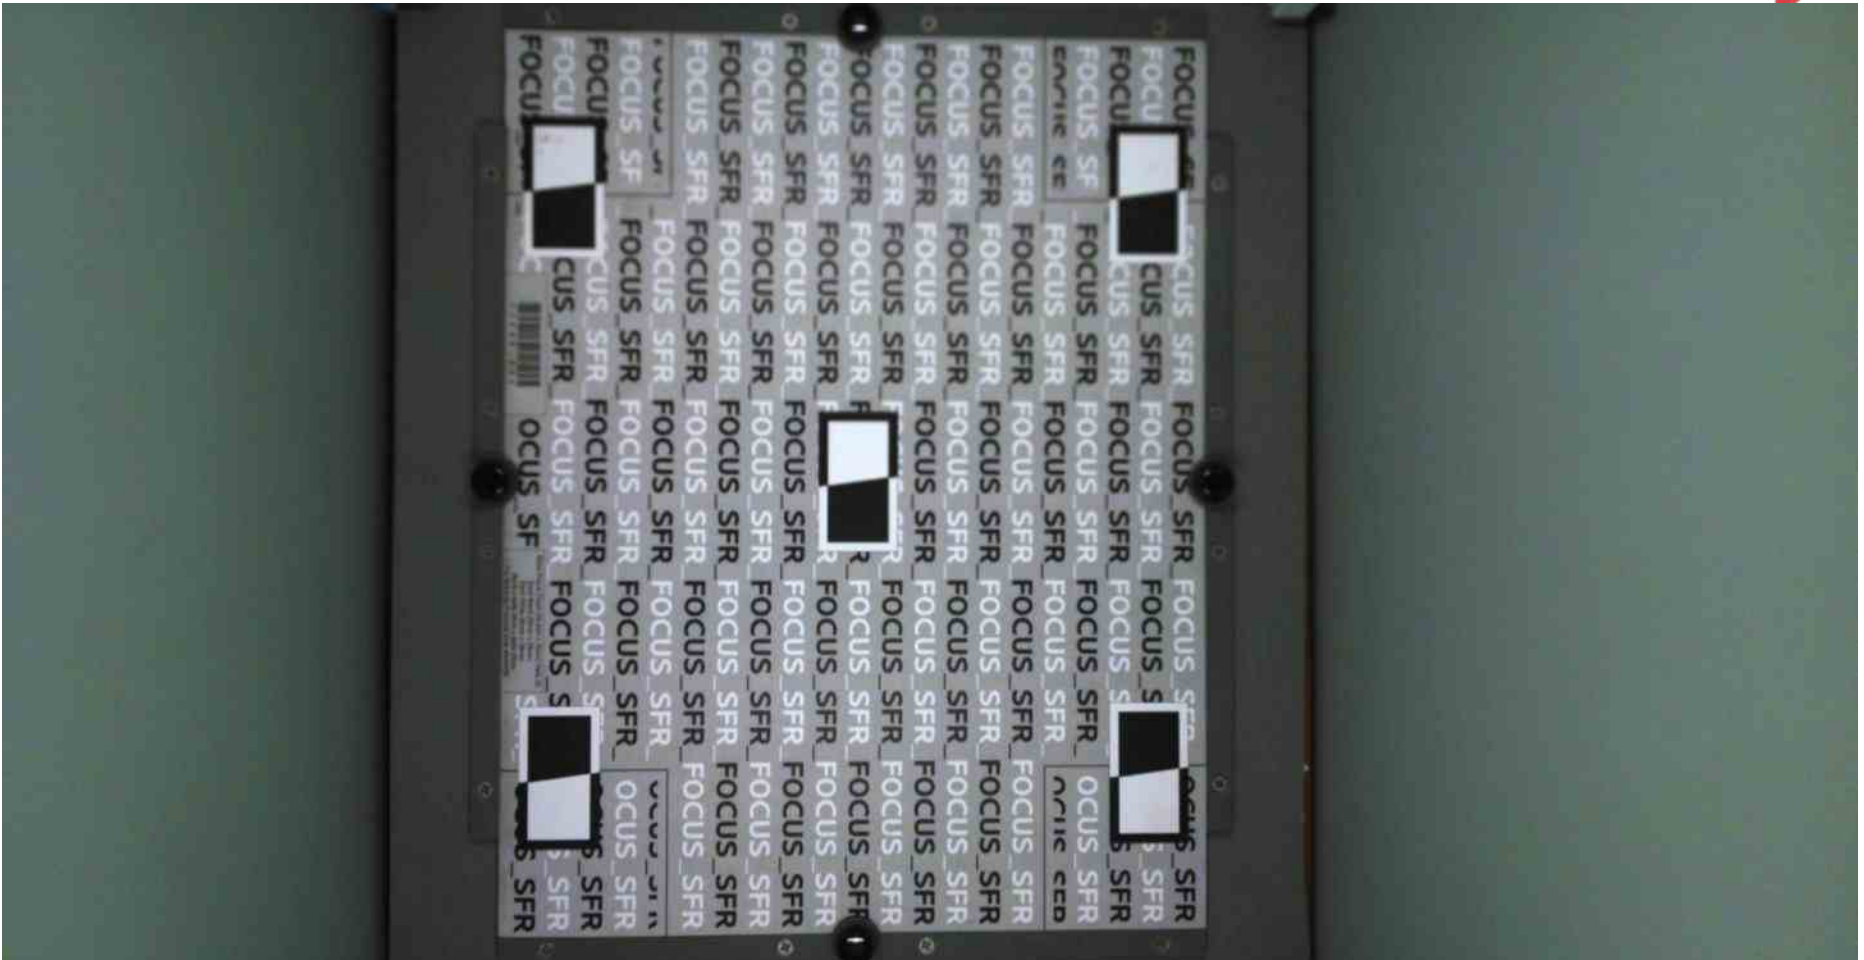
# Focus Error Example

The top side of this image is blurry. This will most likely be a problem with the lens placement inside the module.
