# Redmi 6 & Redmi 6A Grade III Maintenance Guide V01

Technical support internal document control: TSMHNC3C & C3D Redmi 6 & Redmi 6A three-level maintenance guidance V01

Analysis center, mainboard and whole machine maintenance factory

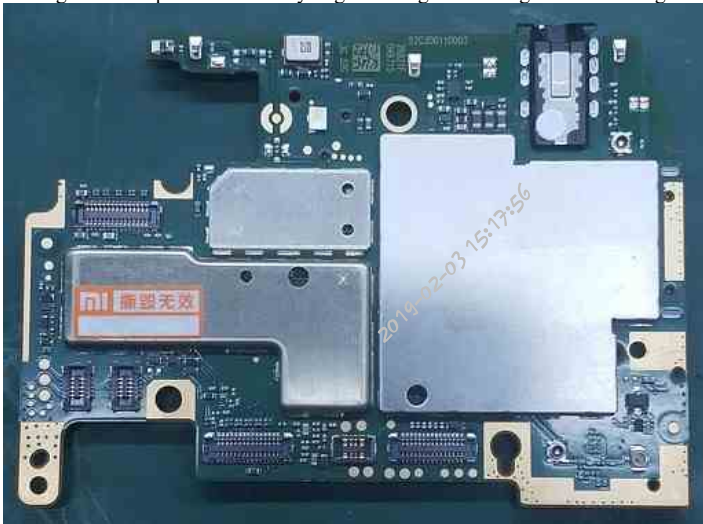
#### 1.4 Pasting position and specification of maintenance label

Sticking position of maintenance label: Stick on the shielding shell of auxiliary power supply.

Pasting standard: paste transversely aligned along the left edge and lower edge of the secondary power shield.
