Redmi 5 & Redmi 5 Plus First Sample

Analysis and sharing

Special training

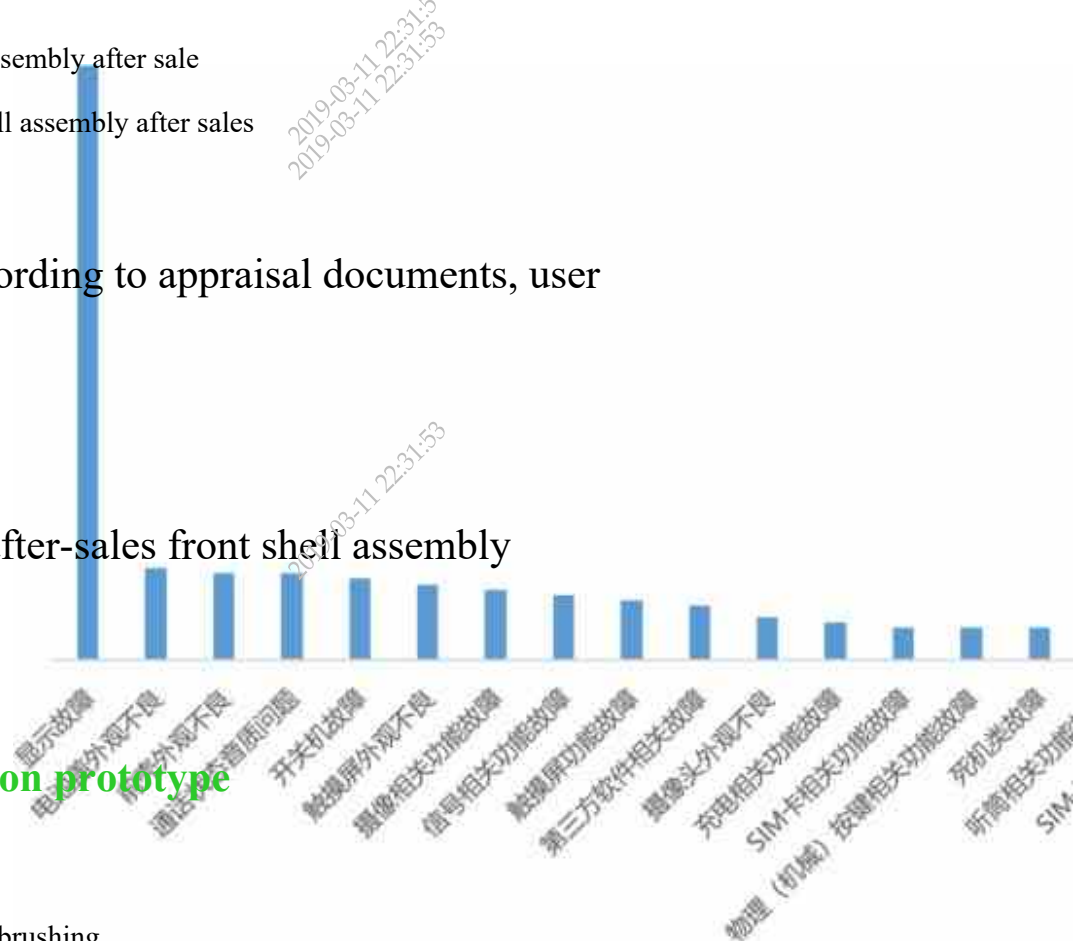
- Do not boot: Motherboard bad more; Some users brush Redmi 5 Plus, which is solved after deep brushing
- Automatic shutdown/non-startup (Kabaimi): There are many defects in the motherboard

- Camera or photo can't focus/camera photo screen: replace camera assembly

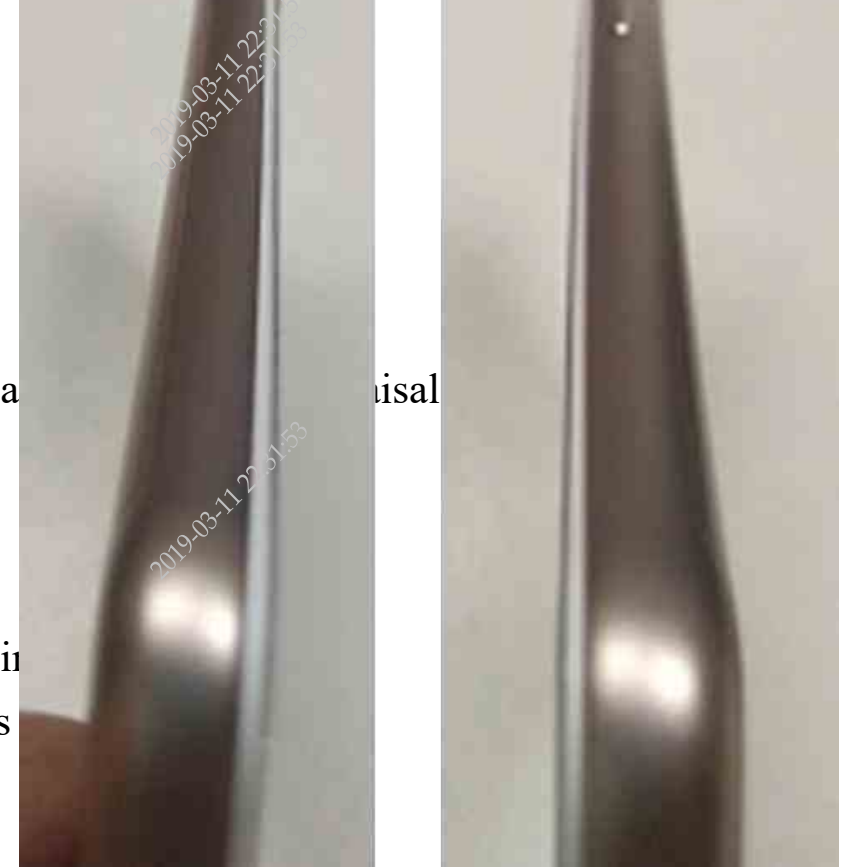
- Do not charge: The main board charging IC is damaged, replace the main board to solve the problem

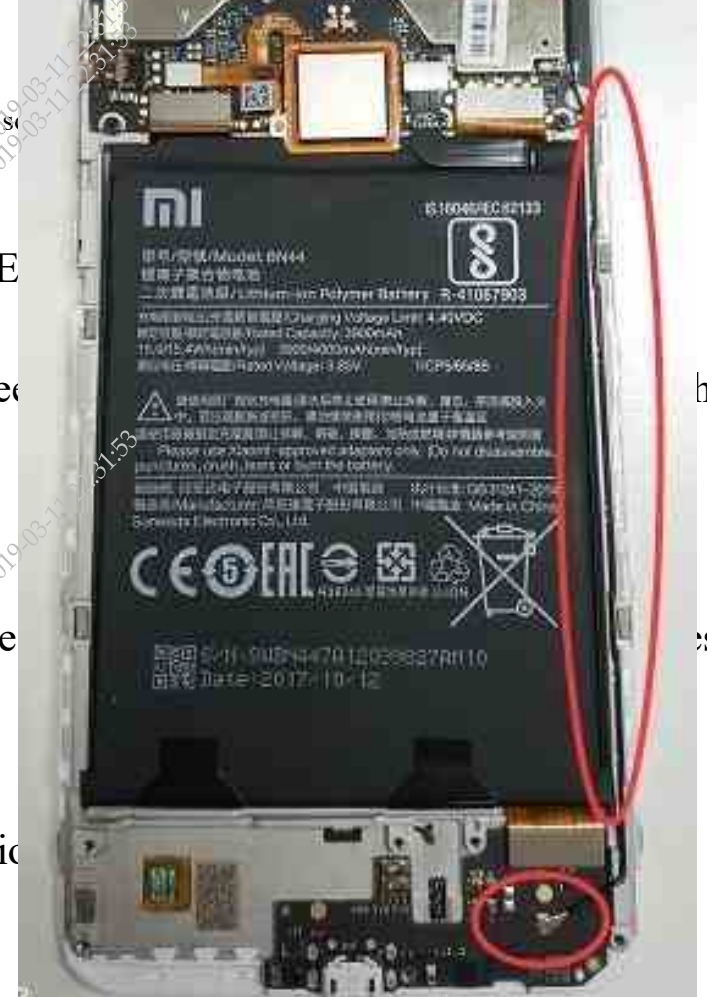
- Weak 4G signal: caused by coaxial line damage, replace and repair
- 4G No Signal: There are many bad motherboards, so replace the after-sales motherboard components

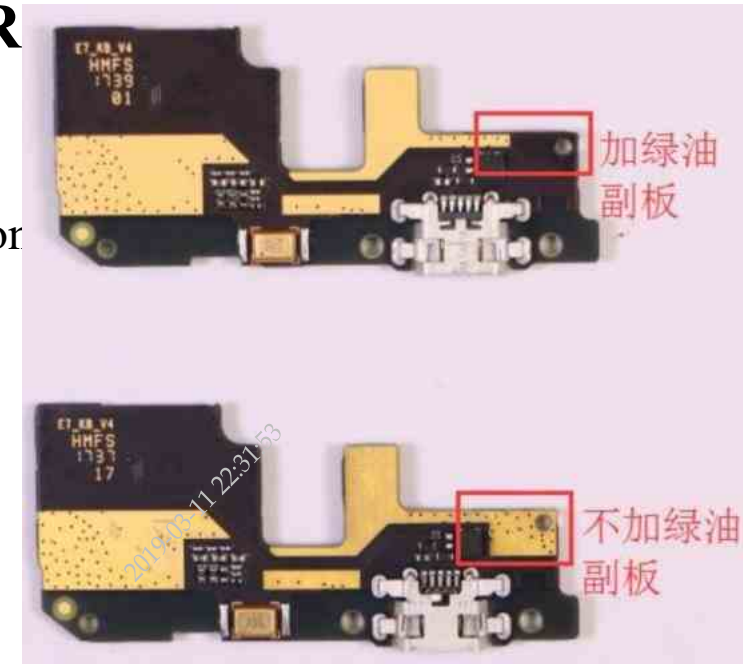
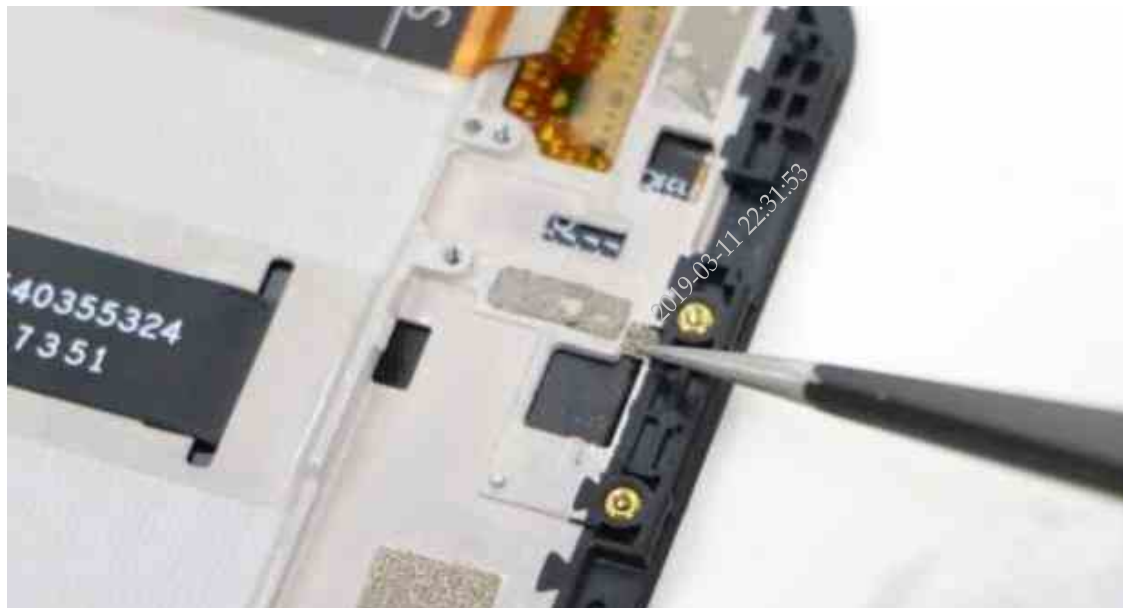
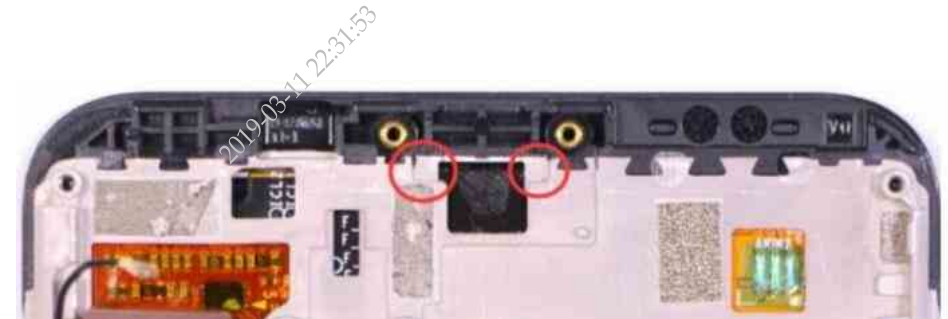
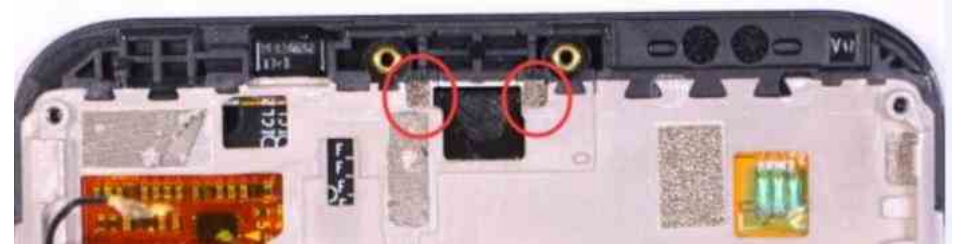
- When replacing the front shell assembly, you should pay attention to the type of auxiliary plate. If you use a green oil auxiliary, you should pay attention to the type of auxiliary plate  
Plate, need to add 2 conductive foam in the USB contact point position of the new front housing assembly.

- Conductive foam material number: 320509700031.
- Note: This foam must be pasted, otherwise it will cause signal problems.

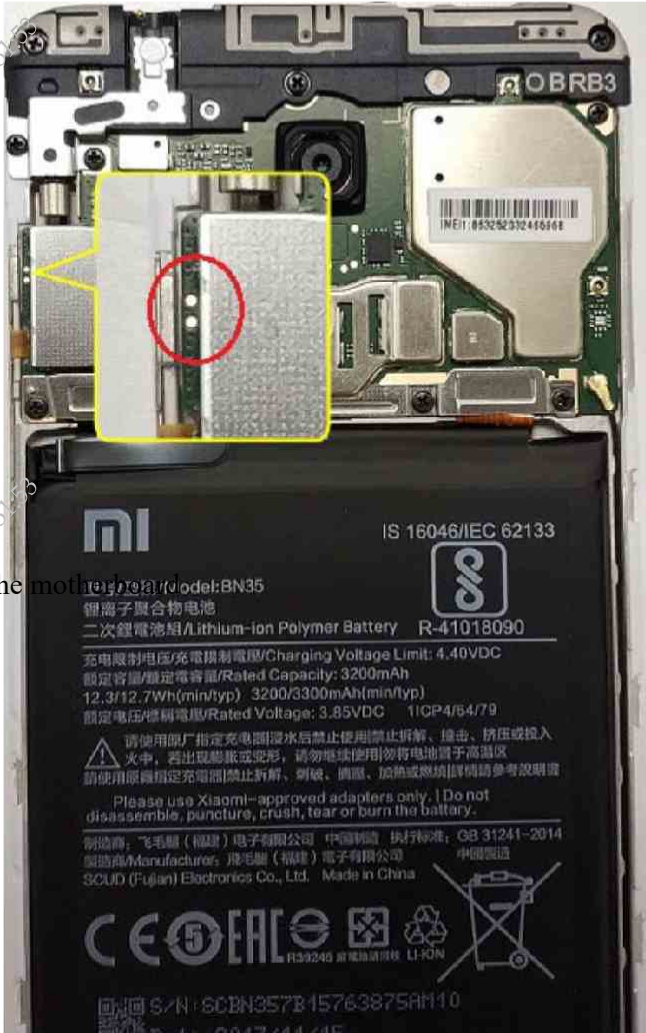
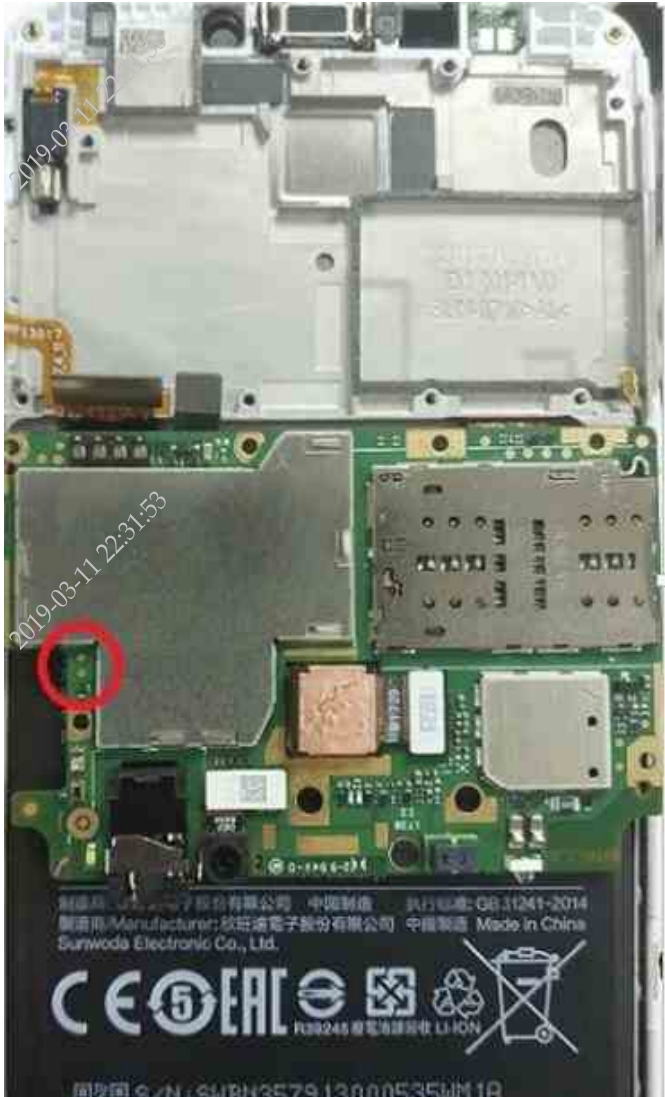
## Improvement of Deep Brush Point-Redmi 5

● Before improvement: The motherboard must be disassembled before deep brushing can be carried out.

● After improvement: it can pass through deep without disassembling the motherboard.
