## Maintenance of Redmi note5 Restart repeatedly no Baseband Version no serviecs

[fault model]Redmi note5

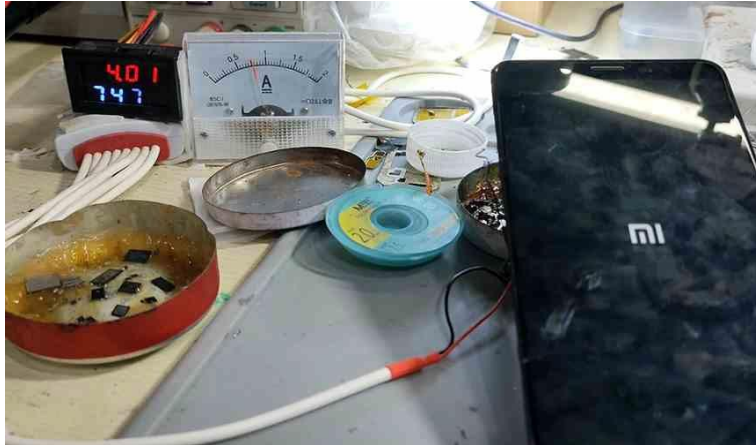
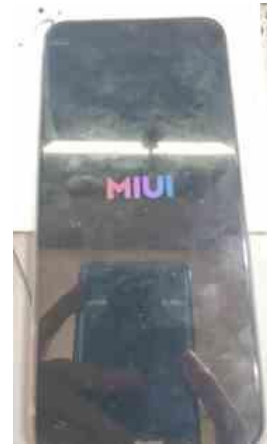
When this machine comes, it starts Restart repeatedly. If it doesn't enter the second interface, the current can reach 700mA, which means that the kit and chip are basically self checked. Don't be silly to see Xiaomi and Restart repeatedly to dry the

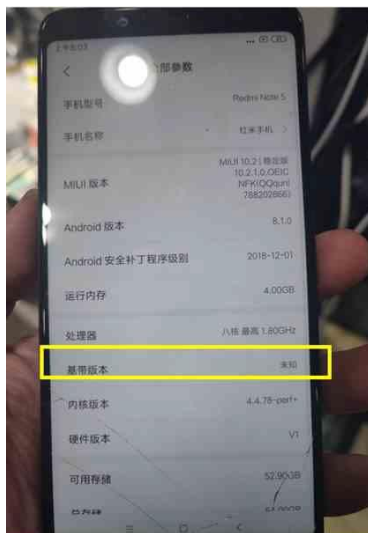
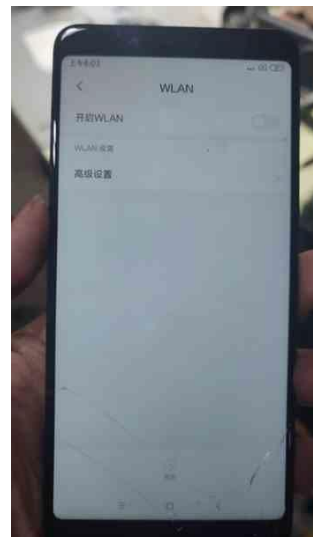
After brushing a functional system, we found that no Baseband Version has no WiFi

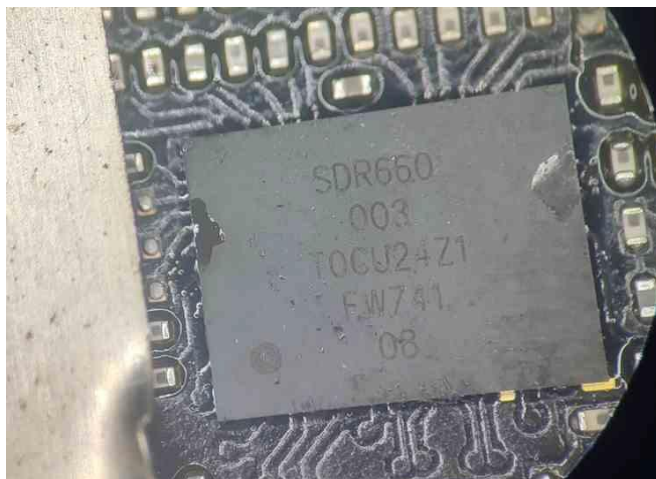
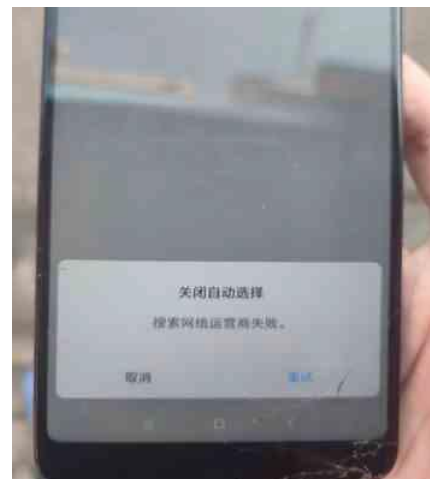
Baseband wifi is available after IF is changed.

Card insertion found that the card can be read,no serviecs, manual operator failed.

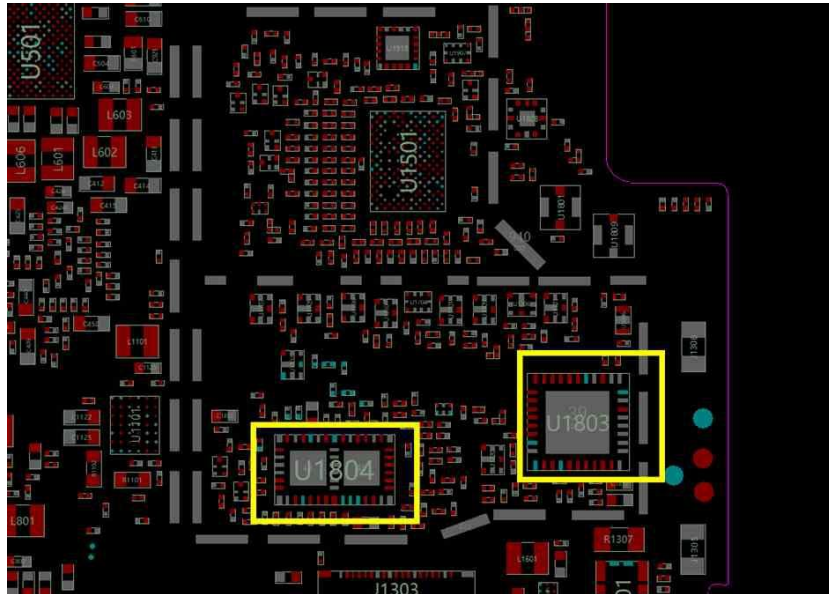
The search operator of Qualcomm model failed, or the call prompted to turn off the flight mode and open ANT, all of which resulted in the chip on RFFE Related circuit being damaged or not working properly.

At first, we measured power amplifier and ANT Switch VCC, and they were all normal. Redo the two chips

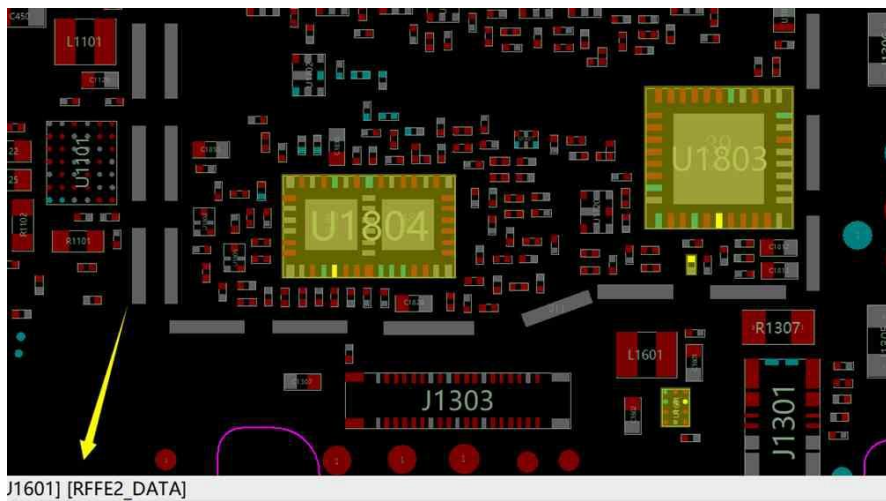
J1601] [RFFE2\_DATA]

and the fault remains the same.

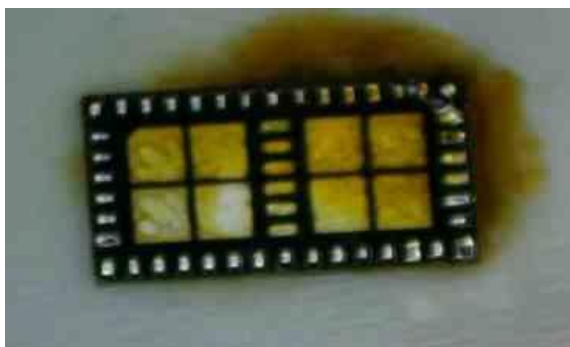
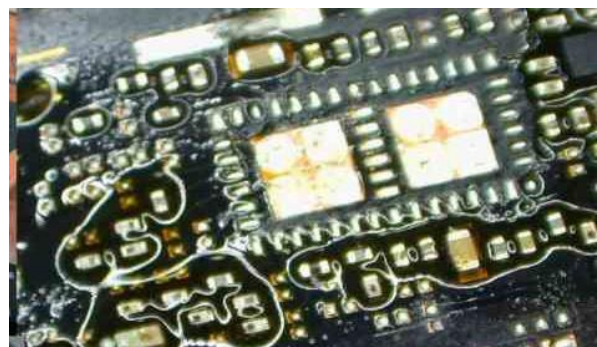
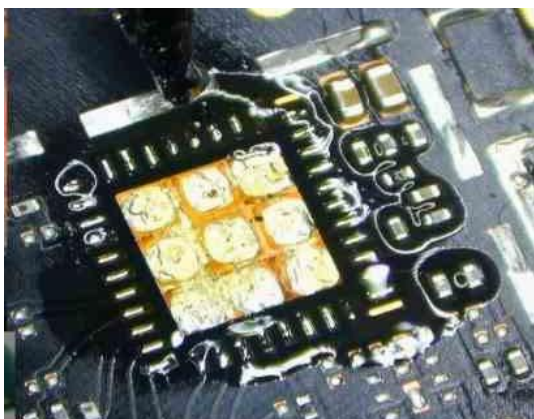
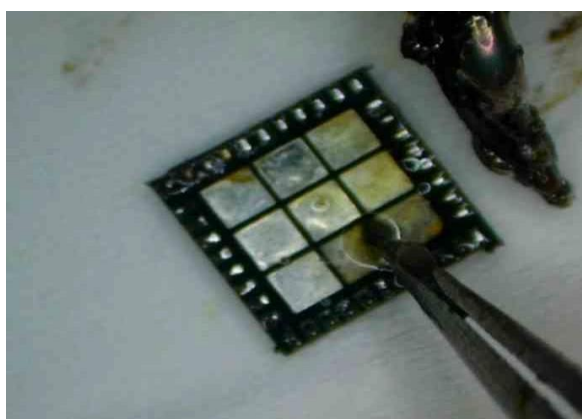
This RFFE2 bus involves three chips, including power amplifier power supply, which have been dismantled and redone.

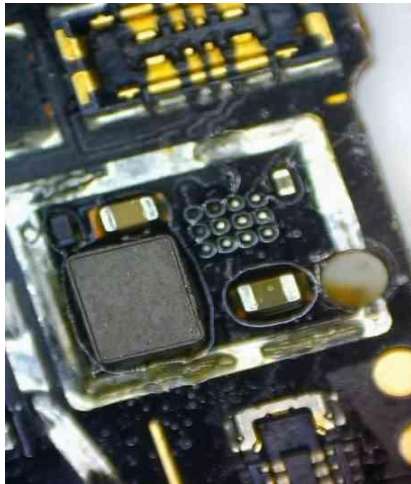
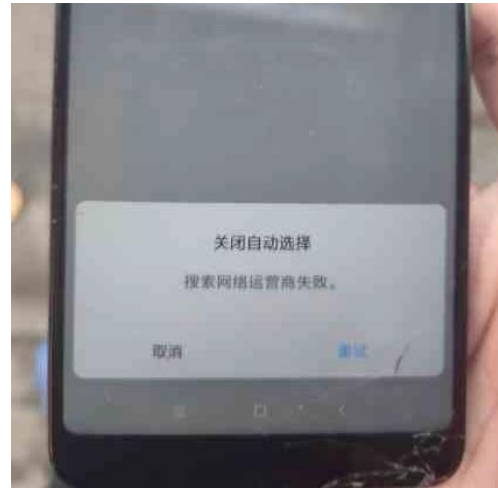
The traditional Hand solder dragging PAD and chip pin always feel that the tin dots are not

uniform.

Or the failure of searching operators manually, so the failure of replacing all signal chips is still the same.

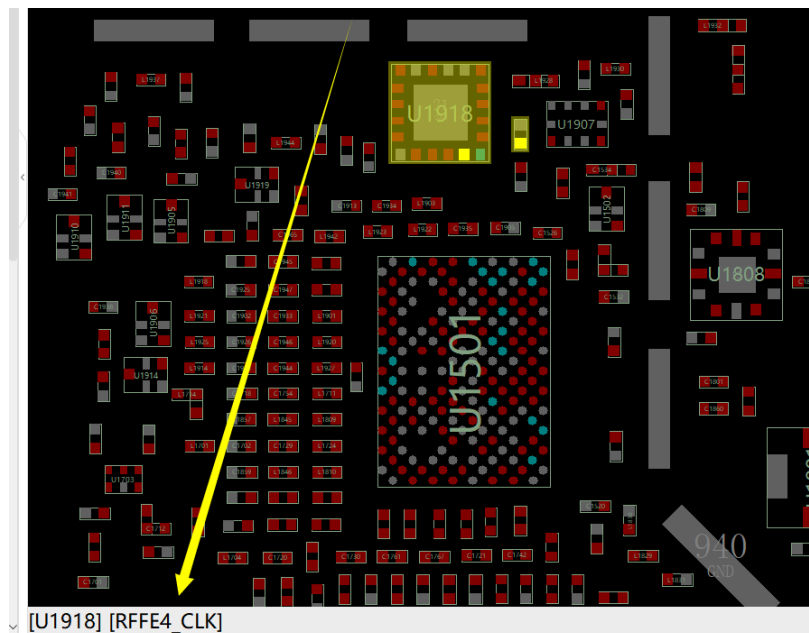
Looking at the drawings, it is found that the bottom pin of DRX diversity receiver on IF is equipped with RFFE4 bus, which will theoretically lead to the inability to search for operators, so it was dismantled and redone, and the bottom pin bus was tested to be normal.

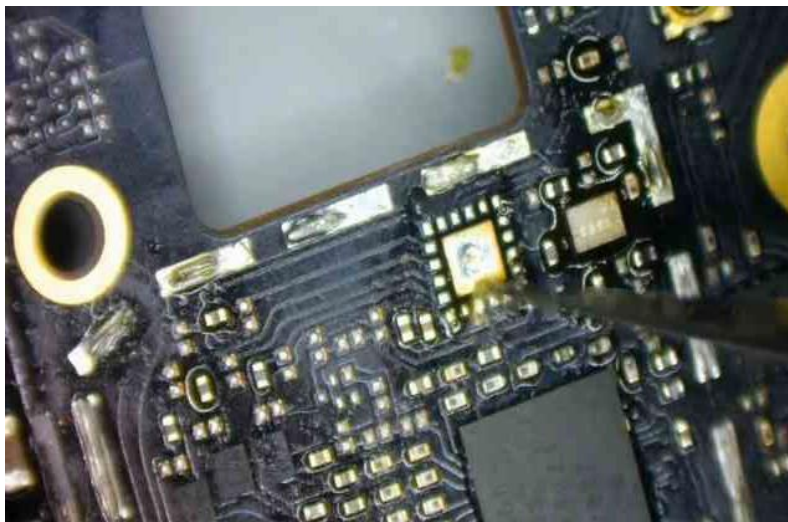
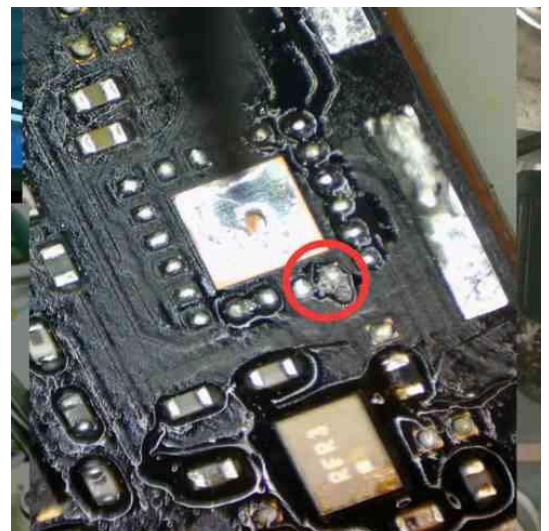
When reloading DRX, use the method of dialing tin to make every solder spot of pin full, and then observe whether ANT Switch is not installed properly, and some spots are Inveracious Soldering. I wish I could use the method of dialing tin to make Reballing work once, but I can't pull it down. This stupid machine only sells the whole fish for 199.

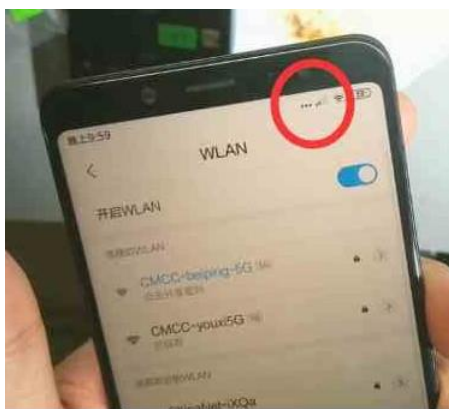
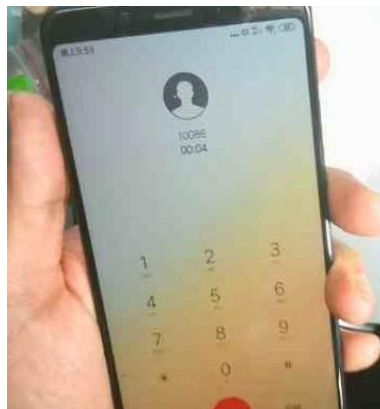
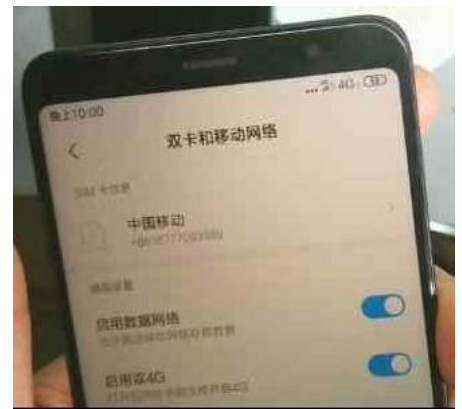
[Maintenance result] Boot test, perfect repair, because the back shell is not installed and the

signal in the house is weak.
