## Repeated restart of Redmi Note5 without baseband and service maintenance

[Failure Model] Redmi Note5

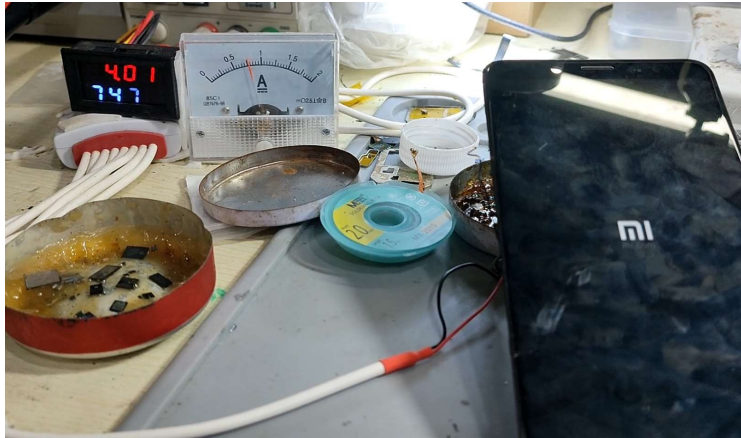
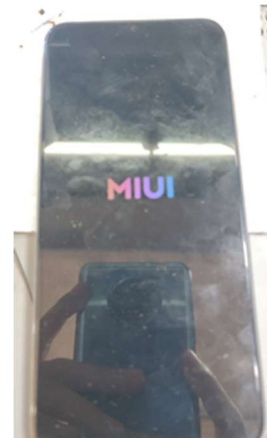
When this machine comes, it is turned on and restarted repeatedly. It does not enter the second interface. The current can reach 700ma, indicating that the kit and chip are basically self-tested. Don't be silly to see Xiaomi restart repeatedly and dry

the kit

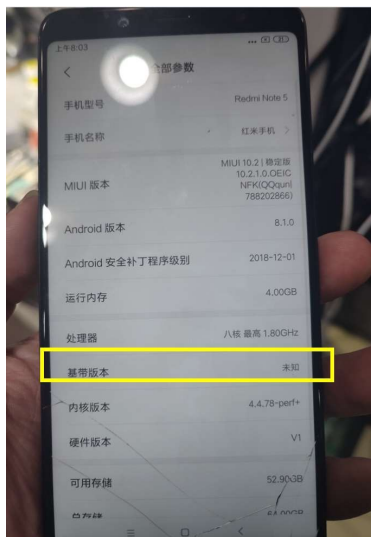
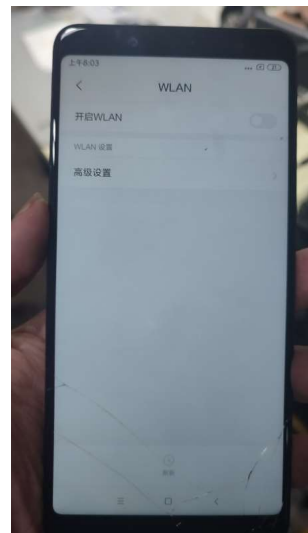
After brushing a function into the system, I found no baseband and no WiFi

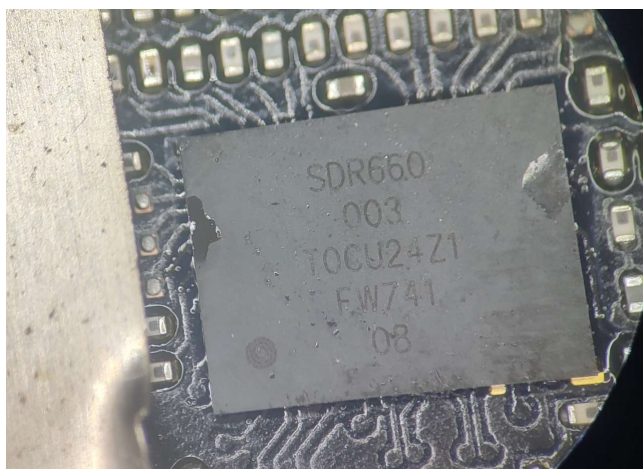
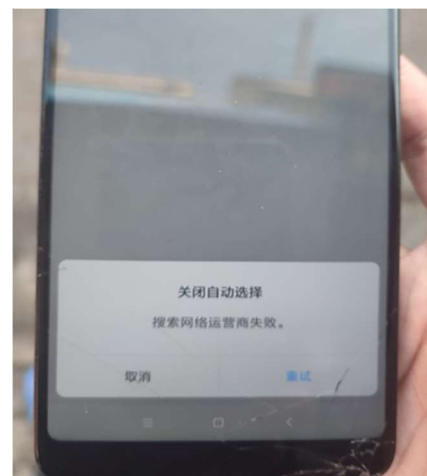
Card insertion found that card can be read, no service, manual operator failed

After changing the IF, the baseband WiFi is available

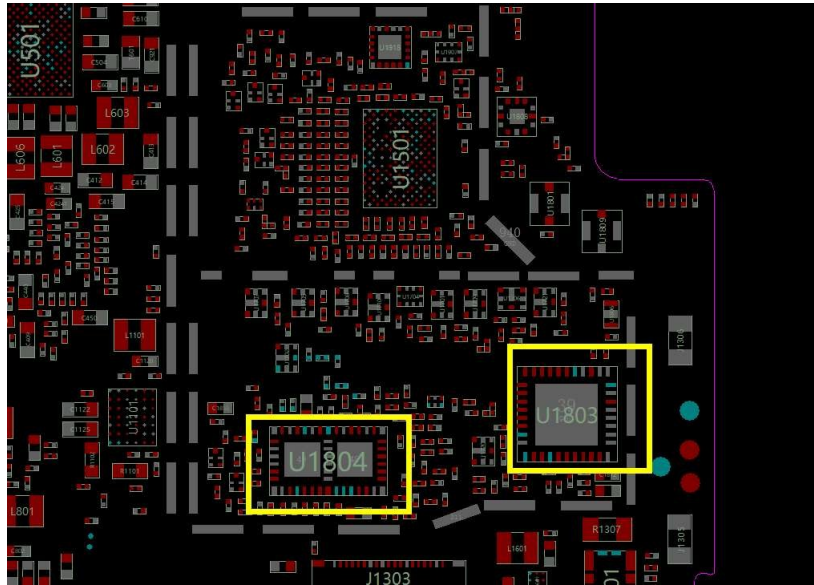
Qualcomm failed to search the operator, or called to prompt you to turn off the flight mode, and the antenna was being turned on, all of which were damaged or not working properly on the chip on the RFFE path

First, we measure the power supply of power amplifier and antenna switch, and they are all normal. Redo the two chips and

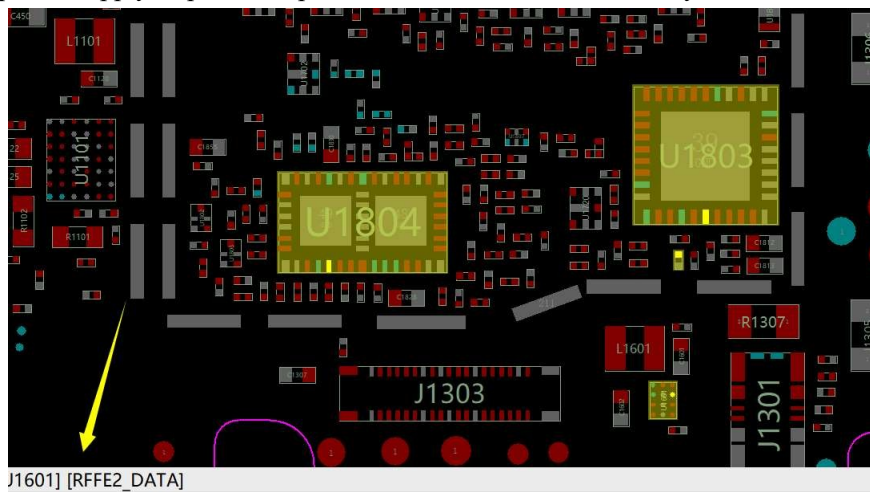
the failure remains the same

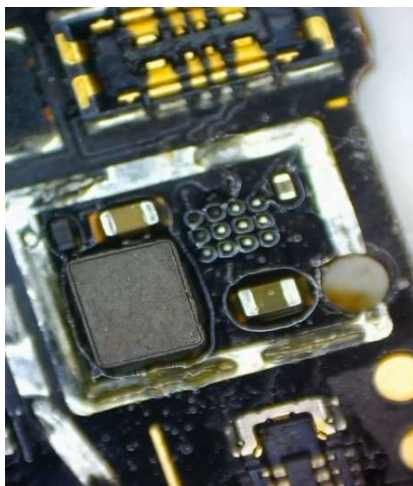
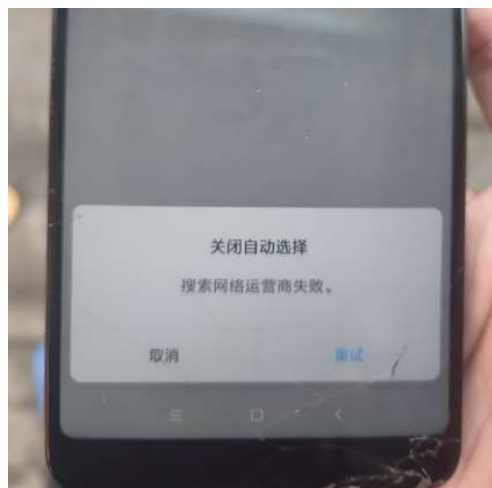
The traditional soldering iron drag pad and chip pin position always feel that the tin point is not

uniform when planting tin in the way of soldering iron drag pad and chip pin position

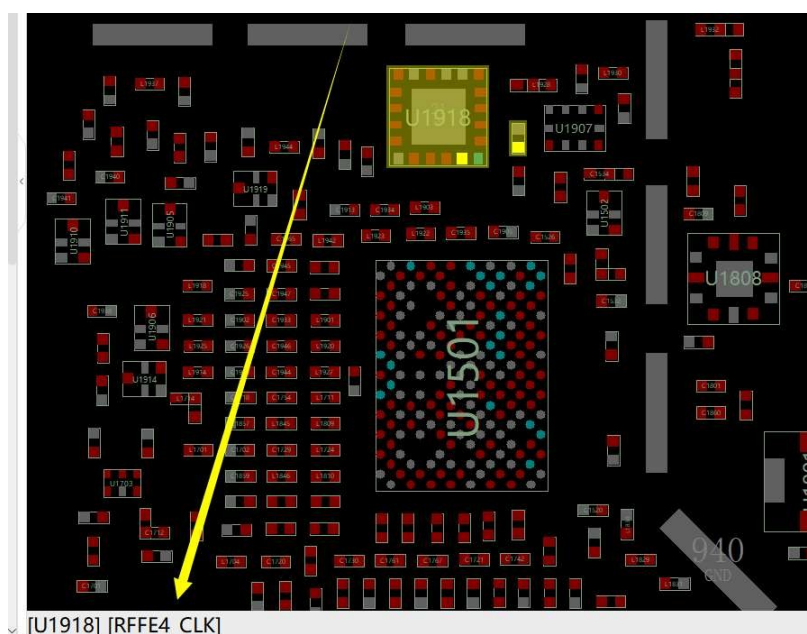
Or the failure of manually searching the operator and replacing all the signal chips is still the same

Looking at the drawing, it is found that the DRX diversity receiver on the intermediate frequency has RFFE4 bus on the foot, which will theoretically lead to the inability to search the operator, so it is disassembled and redone, and the foot bus is also normal after testing

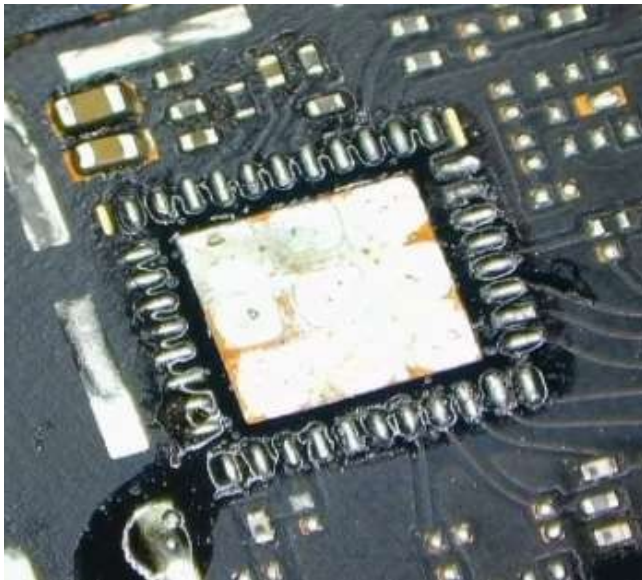
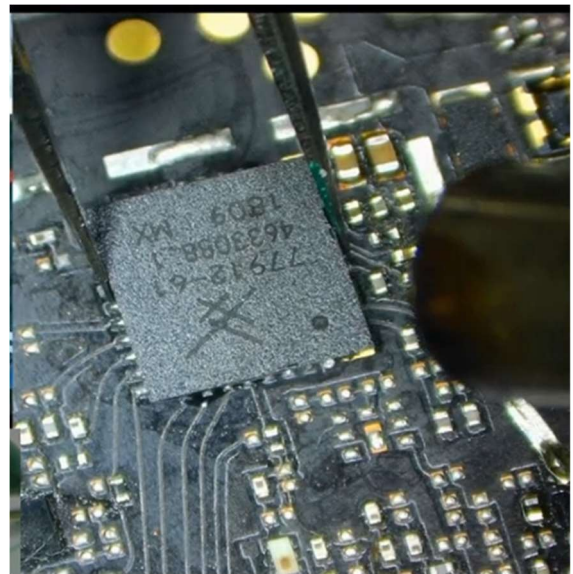
In the end, every point is much higher than the tin on the soldering iron. Win or lose in this shiver

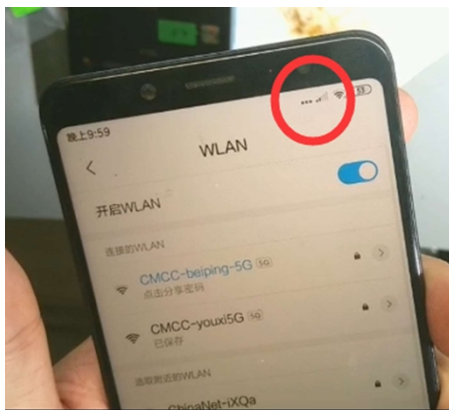
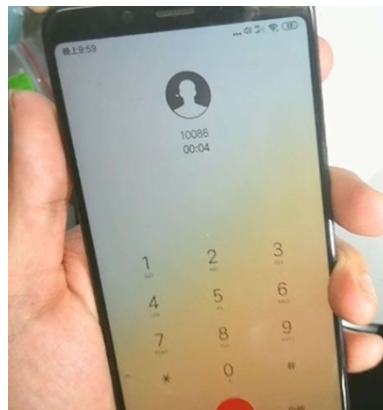
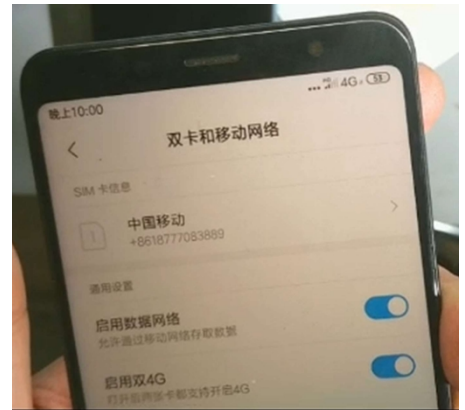
[Maintenance result] Start-up test, perfect repair, because there is no back shell and the signal in the house is weak
