# SIB (Service Information Bulletin)

| <b>Model</b> | <b>K4 2017 series</b> |
| <b>Revision</b> | <b>Revision 1.0</b> |

## No Power on Guide

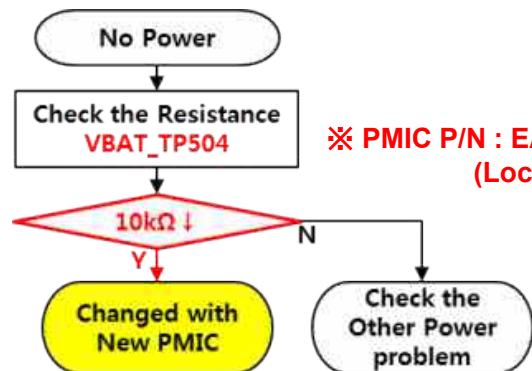
- Sometimes K4 2017 series Model has occurred from external electrical damage.

- If Phone is No Power-on (overcurrent),  
should add OVP circuit and replace with new PMIC.

| Location no | As-is | To-be |
| U901 | DNI | EAN64971401 (IC, OVP) |
| C930 | DNI | EAE65046201 (Capacitor) |
| C931 | DNI | EAE64621606 (Capacitor) |
| R913 | DNI | EBC64155608 (Resistor) |
| R910 / R910 | EBC64155605 | Remove |

※ PMIC P/N : EAN63748001  
(Location no : U401)
