INSPECTION REPORT BY AXIUM INSPECTIONS

8714 S Quemoy St
Aurora, CO 80016

Barry Poris
MAY 12, 2023

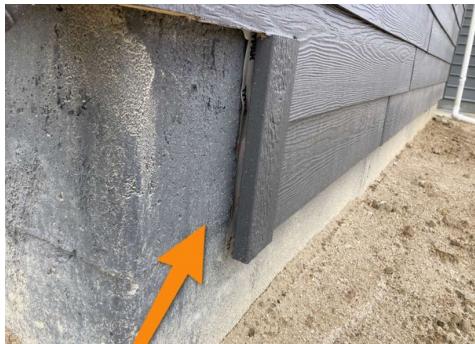
Back Right Corner

Gaps at intersections of the siding, trim, and door and window openings, as well as any other holes in the siding, should be sealed with an appropriate sealant to prevent water penetration into the wall system. A qualified contractor should evaluate and repair or replace as necessary.

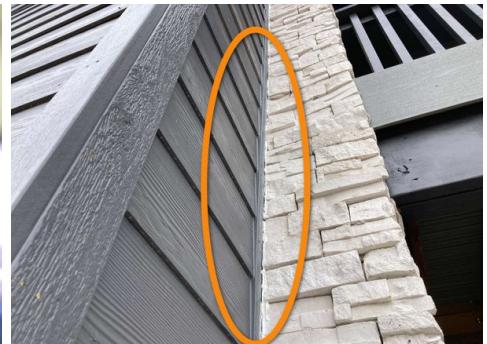
Back

4.10.1 Window Wells

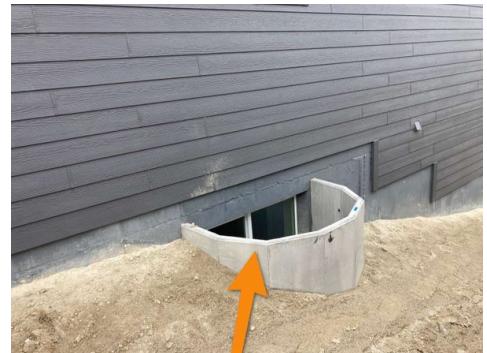
Window Well(s) lacked covers and may represent a danger to small children and may trap pests. A qualified contractor should evaluate and repair or replace as necessary.

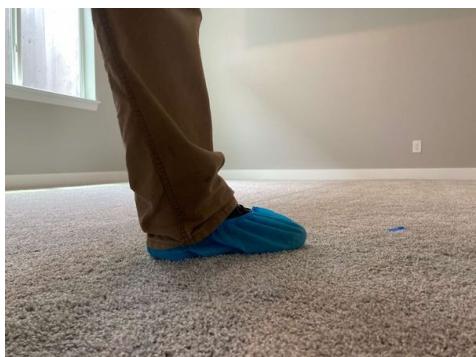
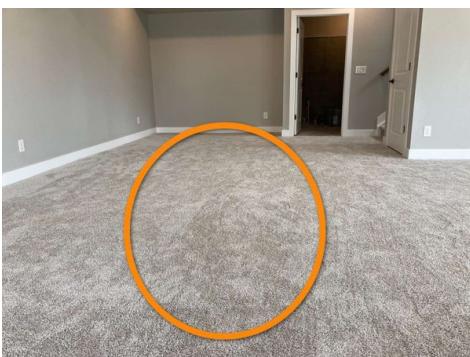
Front Basement Bedroom

The floor had a noticeable hump or rise. A qualified contractor should evaluate and repair or replace as necessary.

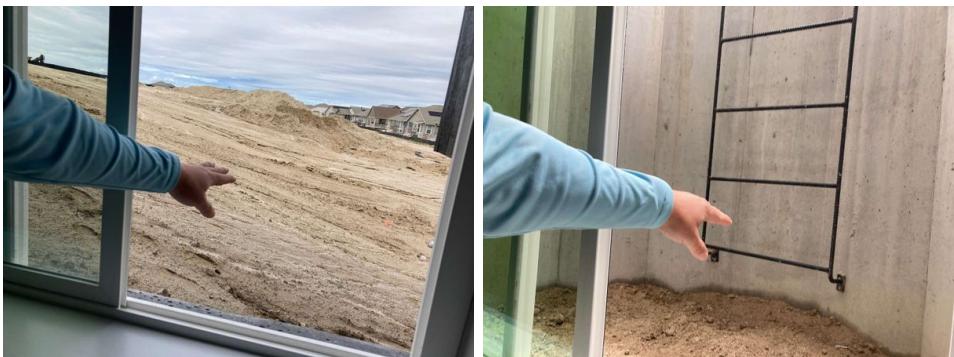
6.5.1 Windows

Some windows had damaged or missing screens. A qualified contractor should evaluate and repair or replace as necessary.

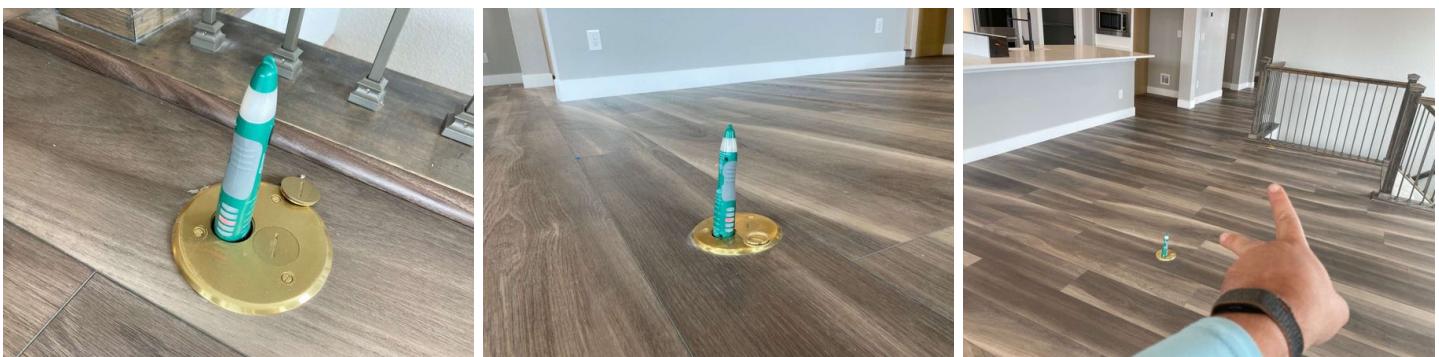
6.6.1 Electrical Outlets

One or more electrical outlet(s) were wired incorrectly with the hot and neutral wires being reversed. While the outlet still provides power to electronic equipment, a shock hazard has been created as there is still electricity running through the hot wire when the switch is off. A qualified contractor should evaluate and repair or replace as necessary according to current standards.

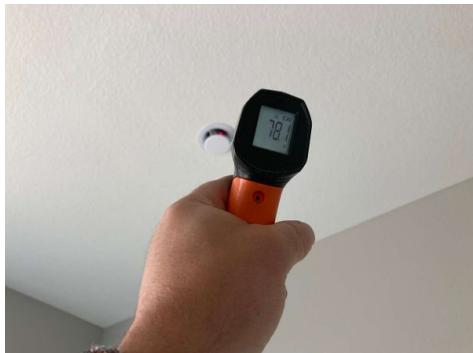
Basement Back Bedroom

The supply register supplied lower detectable heat temperatures than adjacent heat sources at the time of inspection. A qualified contractor should evaluate and repair or replace as necessary.

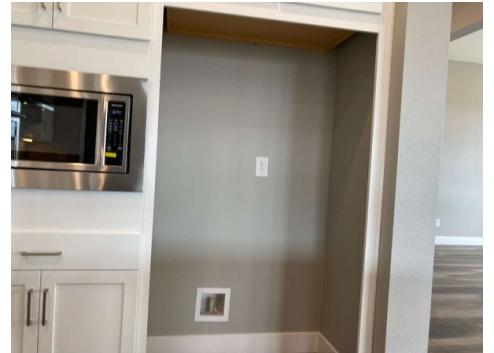
There was not a refrigerator installed at the time of inspection. A qualified contractor should evaluate and repair or replace as necessary.

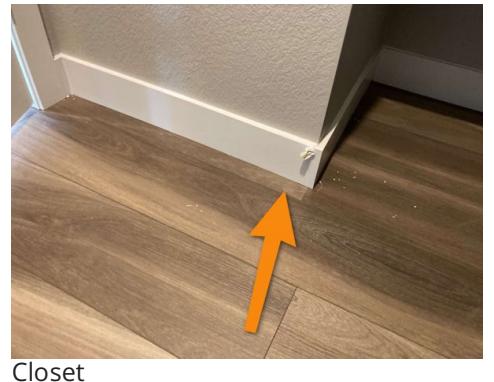
The door had a damaged or missing doorstop. A qualified contractor should evaluate and repair or replace as necessary.

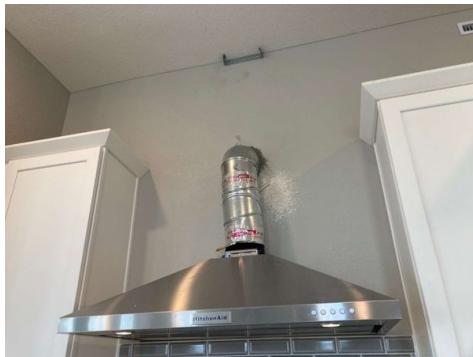
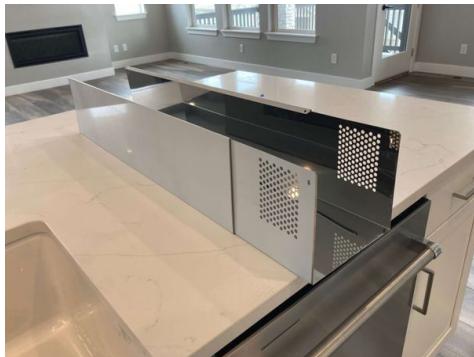
7.15.1 Range Hood

NOT FINISHED

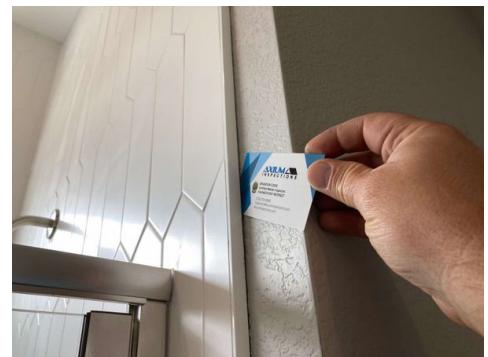
The drywall wall, ceiling, and/or trim was not finished properly. This may be one or more of the following: loose sections, missing pieces, missing caulking and/or paint, or poor application of any of the wall, ceiling, finishing components. A qualified contractor should evaluate and repair or replace as necessary.

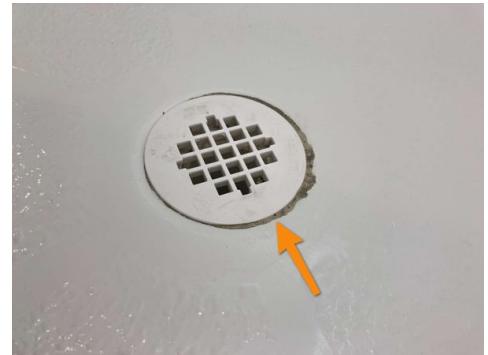
9.14.1 Tub, Shower Area

Some caulking in the tub shower area was loose, old, or poorly done. Recommend a qualified contractor evaluate and re-caulk as needed.

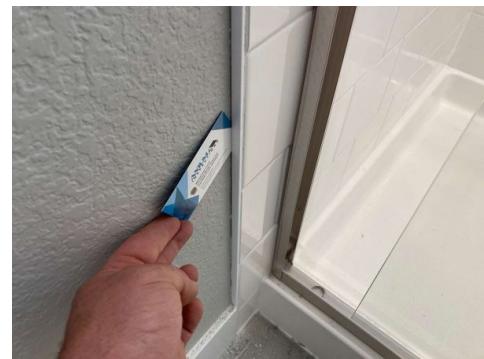
The drywall wall, ceiling, and/or trim was not finished properly. This may be one or more of the following: loose sections, missing pieces, missing caulking and/or paint, or poor application of any of the wall, ceiling, finishing components. A qualified contractor should evaluate and repair or replace as necessary.

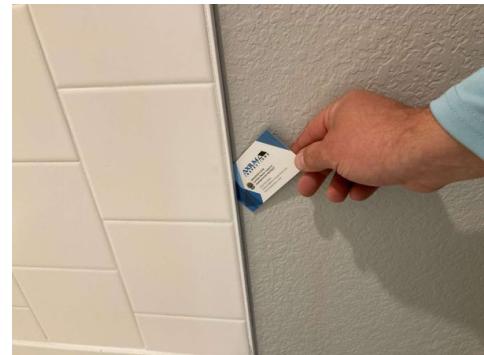
The drywall wall, ceiling, and/or trim was not finished properly. This may be one or more of the following: loose sections, missing pieces, missing caulking and/or paint, or poor application of any of the wall, ceiling, finishing components. A qualified contractor should evaluate and repair or replace as necessary.

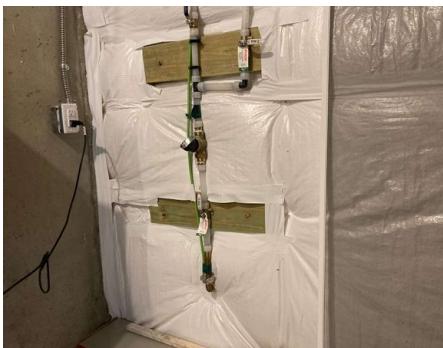
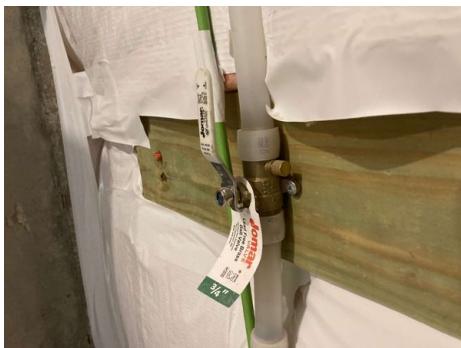
Main Water Shut-Off Valve: Inspected

The plumbing supply system had a shutoff valve installed. It appeared to be in serviceable condition but testing the operation of this valve is not within the scope of a property inspection.

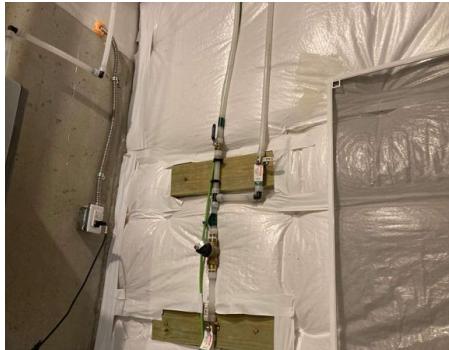
Water Supply & Distribution Systems: (P1) Inspected

The exposed and visible distribution piping running from the main source to each faucet or fixture was inspected for overall condition. Any notable deficiencies or exceptions will be listed in this report.

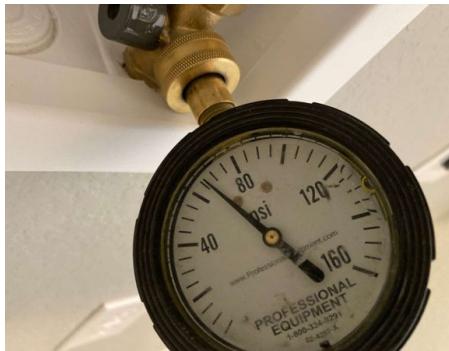
61-70 PSI

Water Pressure: (P1) Inspected

Water pressure was inspected to determine an acceptable range of 40 to 80 pounds per square inch (PSI) at the time of inspection. For rural properties supplied by well water, the acceptable pressure level can start at 30 PSI. Any notable deficiencies or exceptions will be listed in this report.

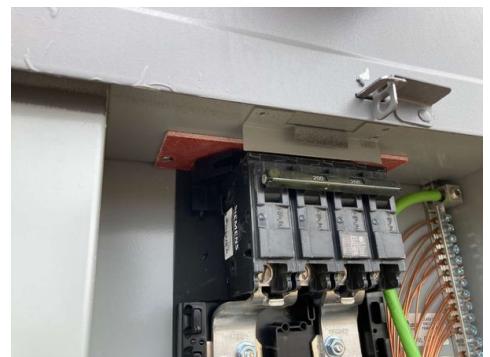
NOT VISIBLE

Service entrance conductors were not visible at the time of inspection. There was not adequate clearance between the meter cabinet and the main service shut off.

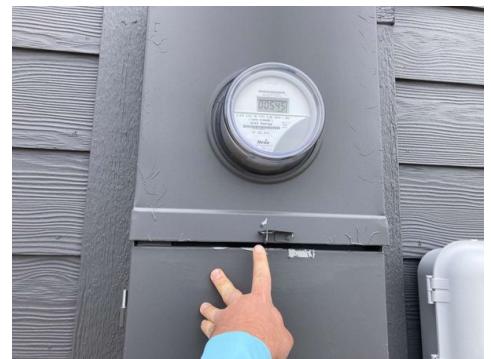
SECURITY TAG MISSING/CUT

The electric meter security tag was missing or damaged. A qualified contractor should evaluate and repair or replace as necessary.

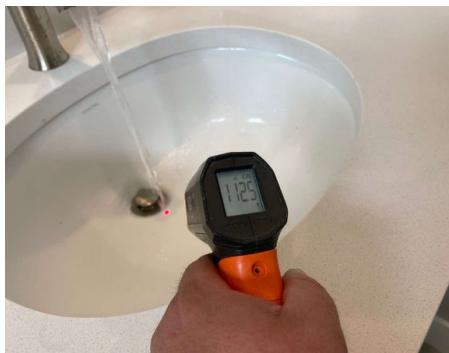
111-119 Degrees

WATER TEMPERATURE LOW

The water temperature was below the suggested range of 120-130 degrees. Recommend adjusting the water heater thermostat first. If water does not reach the acceptable range then a qualified contractor should evaluate and repair or replace as necessary.

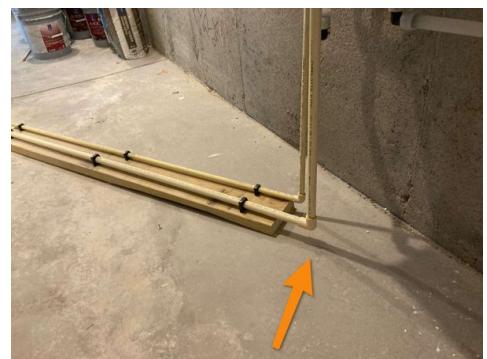
90 DEGREE ELBOW

There was a 90-degree elbow fitting installed on the TPR valve discharge pipe on the water heater. This pipe should terminate straight down within 6" of the floor and not have any threads or fittings prior to that point. Any fittings should be an approved material and configuration. A qualified contractor should evaluate and repair or replace as necessary and according to current standards.

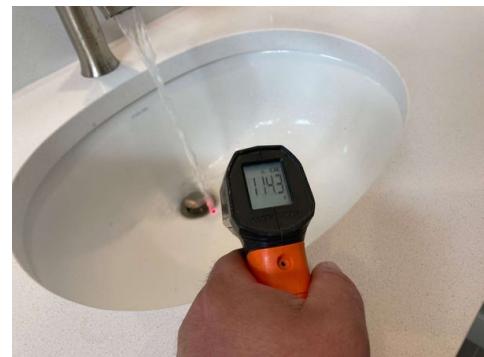
14.13.1 Water Temperature

- ⊖ 14.13.1 Water Heating Equipment - Water Temperature: Water Temperature Low
- ⊖ 15.10.1 Heating - Blower: Blower, Cabinet Dirty

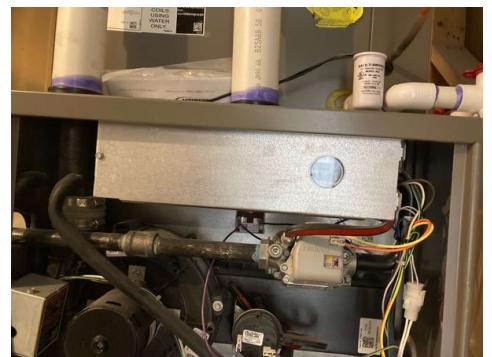
SEALED BURN CHAMBER

The burn chamber was a sealed design and not visible for inspection.

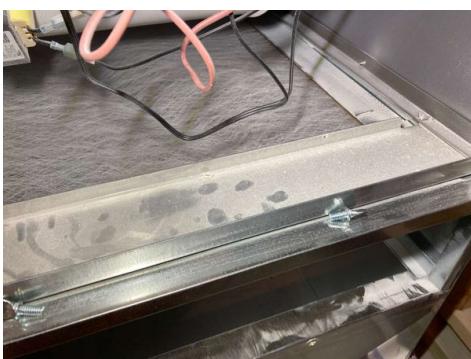
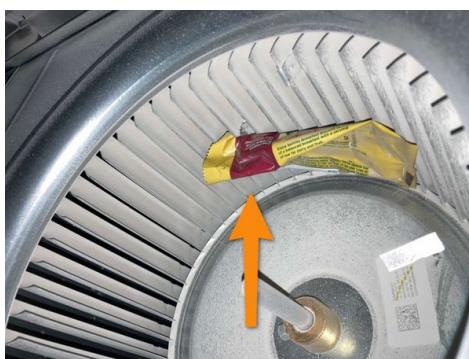
15.10.1 Blower

The blower motor, wheel, and/or cabinet appeared to be dirty at the time of inspection. Blower fans/wheels are subjected to constant dirt, dust, and lint and can become overly dirty when not cleaned on a regular basis and even faster if the air filters are not changed regularly.

A qualified contractor should evaluate, clean, and service as necessary, and certify the unit is in good working order.
