Figure 32-4. Skid Tube (BHT 205-050-400 and 412-050-023) Patch Repair

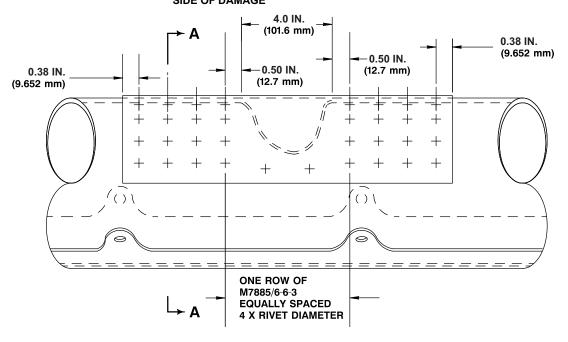
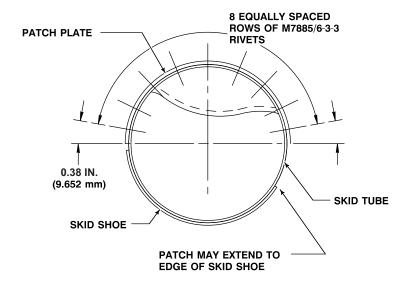
## TYPICAL PATCH REPAIR

SECTION A-A

## MINIMUM OF 4 ROWS OF M7885/6-6-3 RIVETS SPACED 0.72 IN. (18.288 mm) APART EACH SIDE OF DAMAGE
