Parveen Mohammed - Claim No. 100-0022886 - Country Financial

Project Number 23-12080527-0 - Donan Engineering Co., Inc.

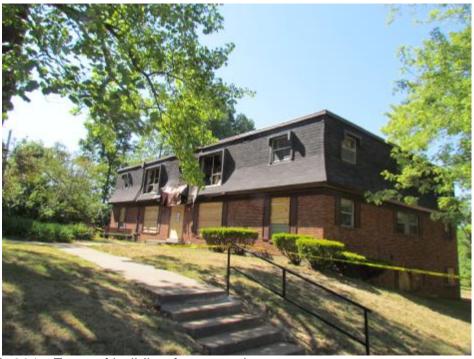
Photograph 001: Front of building faces north.

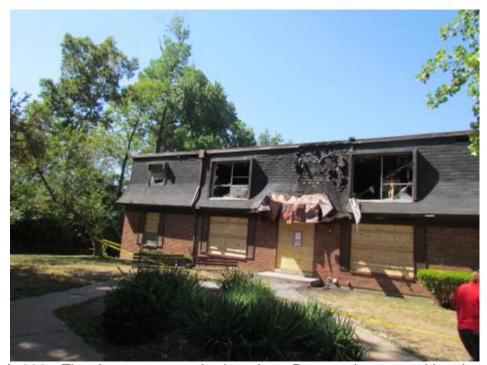
Photograph 002: Fire damage to north elevation. Door to the second level.

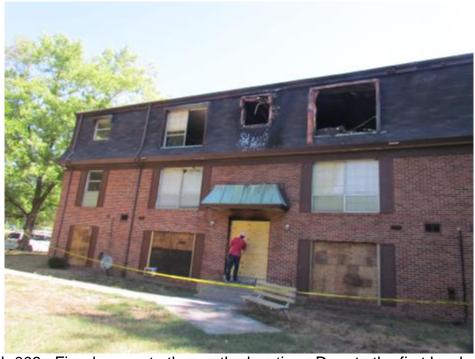
Photograph 003: Fire damage to the south elevation. Door to the first level.

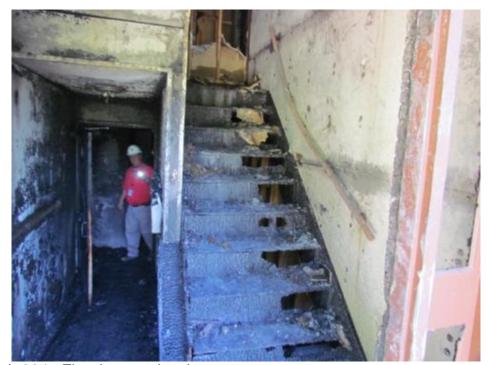
Photograph 004: Fire damaged staircase.

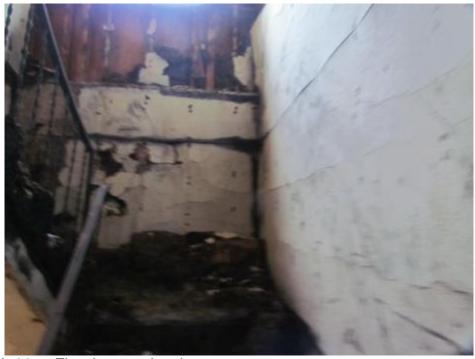
Photograph 005: Fire damaged staircase.

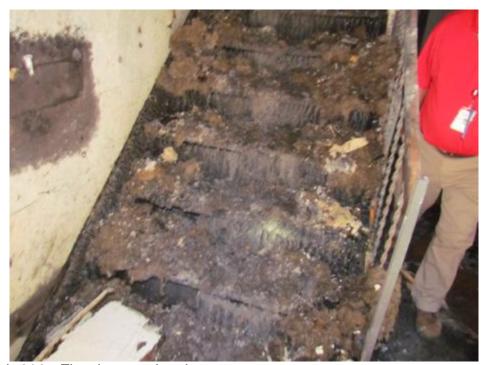
Photograph 006: Fire damaged staircase.

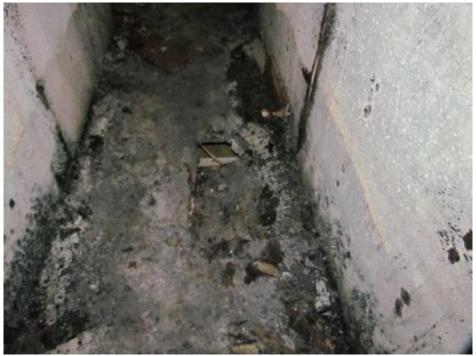
Photograph 007: Holes in the second level floor.
