# Analysis of an Uncrewed Mishap During Ground Test: A Case Study

On 16 November 2020, a MQ-8C Firescout was preparing for a form/fit/function ground test of a new battery. The ground test was considered low risk and therefore did not require extensive risk mitigation steps. The test points were simple: start the air vehicle, do a systems check, and shut down the air vehicle. On the morning of the test event, the MQ-8C was chained to the ground (as it was a maintenance ground turn), and a maintenance laptop was connected to interface with the air vehicle systems. A command and control communication link was not established with a ground station. The test team started the air system, and everything functioned as expected until test personnel initiated shutdown. Within 30 seconds, the air vehicle went to full power, the rotor disk shifted from parallel to the ground to full forward and full right, the shifted disk cut the only connection to the maintenance laptop, and the system ran for approximately 6 minutes until the transmission came apart causing over \$2,500,000 of damage. This paper summarizes the facts surrounding the mishap and offers conclusions and recommendations on how

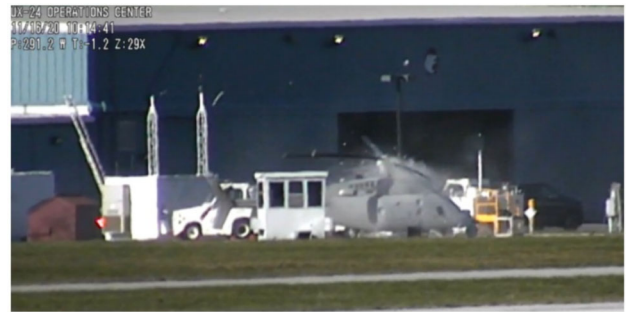
For approximately six minutes the rotor turned at 100% RPM with rotor tips contacting the ground and applying loads to the rotor hub for which the system was not designed. At 10:14:30 the gear system began to fail, and a substantial tail boom excitation began. At 10:14:35 the rotor head began to come apart. At 10:14:38 the tail boom broke off the mishap vehicle. At 10:14:41 the transmission appeared to fail and the main rotor blades were thrown. The engine continued to operate until ground test personnel initiated shutdown via the GCP at 10:16:10. Figure 4 is an image captured as the transmission appeared to fail. Figure 5 is an image depicting a ground test personnel initiated shutdown via the GCP.

**Fig. 4** Image of the Mishap Vehicle as the Transmission Failed, taken at 10:14:41 [4]

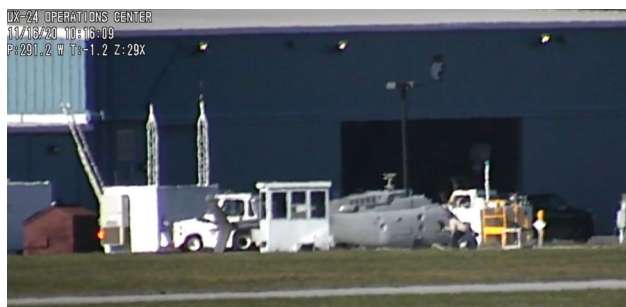
**Fig. 5** Image of ground test personnel shutting down the air vehicle via the GCP, taken at 10:16:09 [4]
