# Steinadler Pro Endurance Testing Summary

- **Company Name:** Jiangsu Yinguan Intelligence Technology Co., Ltd.
- **Project Name:** Steinadler Pro
- **Report Date:** September 2, 2025
- **Project Cycle:** April 2023 - July 2024

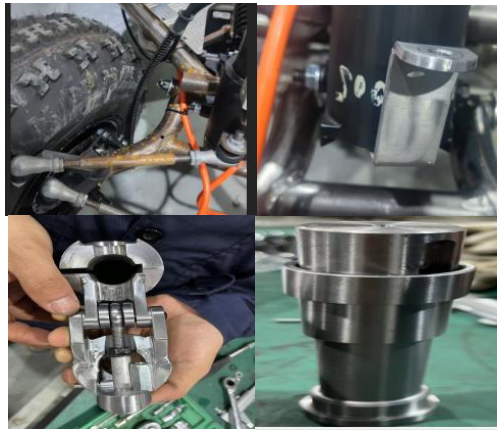
**Partial Issue  
Photos**

- **Test Period:** July 3, 2023 – August 3, 2023
- **Test Road Conditions:** Unpaved road conditions (professional racing venue)
- **Test Mileage:** 2,000 km
- **Test Results:** Issues detected during on-road testing are summarized below:
  1. Braking Force: The rear brake feels excessively soft with insufficient feedback force.
  2. Power Performance: Insufficient power output occurred during driving.
  3. Suspension & Chassis: Rear suspension crossbeam was concave; front suspension bearings and steering tie rods could not be fully locked.
  4. Steering System: Steering column displacement; inconsistent left and right steering angles.
- **Follow-up Actions:** all above issues were rectified in this phase. The 2nd prototyping verification was conducted on August 15, 2023.

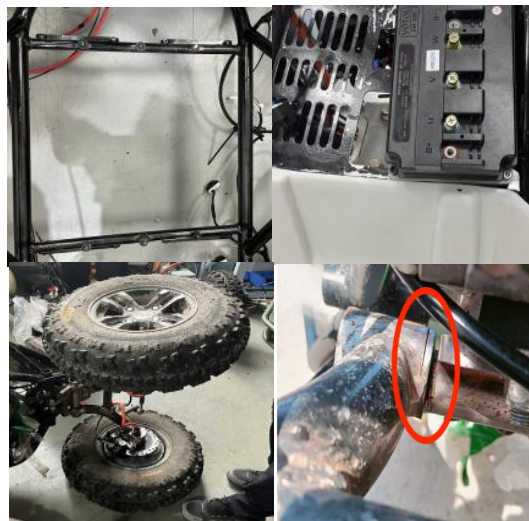
**Partial Issue Photos**

- **Test Period:** September 1, 2023 – October 1, 2023
- **Test Road Conditions:** Unpaved road conditions (professional racing venue)
- **Test Mileage:** 2,000 km
- **Test Results:** No obvious quality issues, but optimization opportunities remain:
  1. Braking Force: Uneven caliper braking force, causing vehicle body to shift right during emergency braking.
  2. Power Performance: Uneven power output.
  3. Suspension & Chassis: Slight sway in rear-wheel steering.
  4. Steering System: Steering structure is in good condition; it is recommended to increase steering angle.
- **Follow-up Actions:** all above issues were rectified in this phase. The 3rd phase verification was conducted on October 12, 2023.

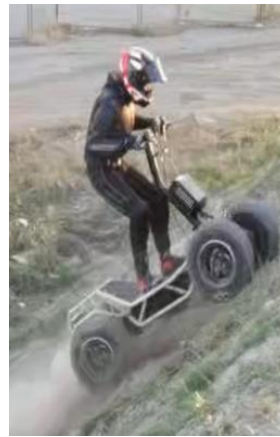
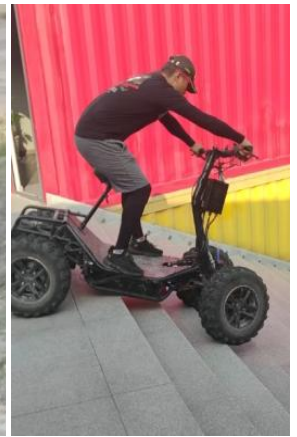
**Partial Road Test Photos**

- **Test Period:** November 22, 2023 – January 8, 2024
- **Test Road Conditions:** Unpaved road conditions (professional racing venue) + multi-terrain testing
- **Test Mileage:** 3,000 km
- **Test Results:** No obvious quality issues, but optimization opportunities remain:
  1. Braking Force: Good braking performance, no abnormalities.
  2. Power Performance: Rear-wheel power output can be appropriately increased.
  3. Suspension & Chassis: Good chassis performance, no abnormalities.
  4. Steering System: Understeering still exists; further improvement is needed by increasing steering angle.
- **Follow-up Actions:** all above issues were rectified in this phase. The pre-production phase verification was conducted on February 10, 2024.
