# Feasibility Nanni Weir and Maratakka Spillway Nickerie, Suriname

# INTERMEDIATE REPORT

Prepared by: Ravindra Patandin

Date: May 28<sup>th</sup>, 2018

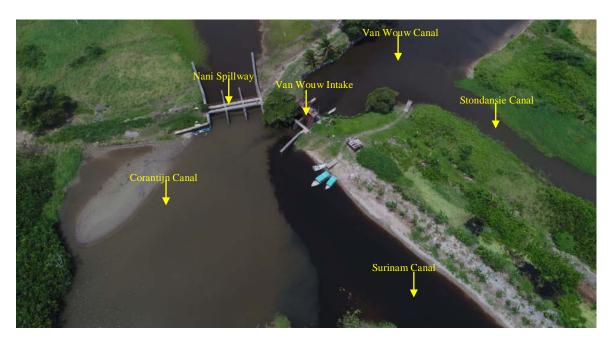
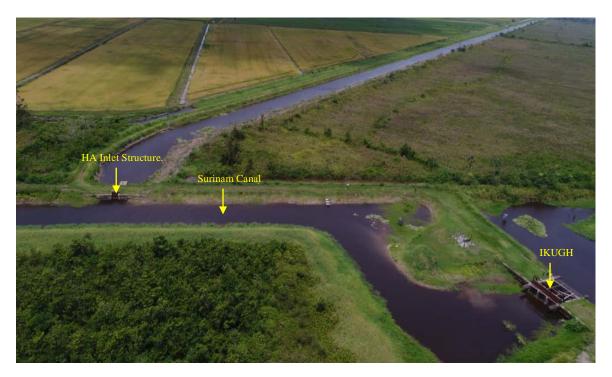
The project area consists of four hydraulic structures, namely the Van Wouw Intake, Nani Spillway, IKUGH (Integraal Kunstwerk Groot Henar) and HA Inlet Structure. Field survey occurred in March and April 2018. The structures have been assessed if they could be rehabilitated and used again as main structure. In addition some surveys and cross-sections have been carried out to assess the main dam and canal levels.

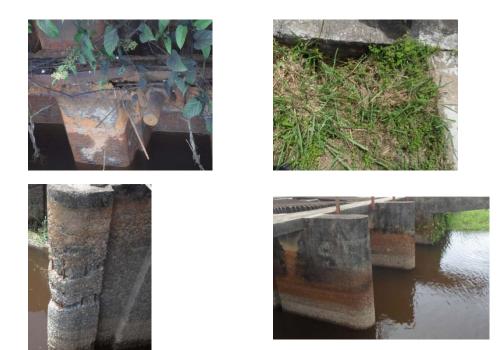
#### Inflow/Outflow side

The steel sheet piles and its anchoring show corrosion. At several locations at both inflow and outflow side concrete decay is shown. There is also erosion seen at the inflow side near the steel sheet piles.
