HISTORIC AMERICAN TIMBER-FRAMED STEEPLES

IV. Reproducing Burned or Destroyed Steeples

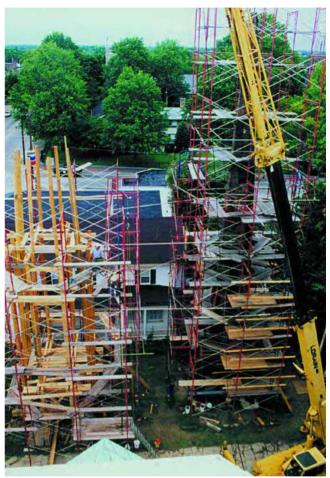
Jan Lewandoski Fig 1. Perfect original spire frame on right, totally replaced middle stages on left, awaiting lift onto Salem, N. J., Presbyterian Church, 1854, out of sight at right.

At the Salem, New Jersey, Presbyterian Church (1854), the middle stages rotted, requiring complete reframing, while the healthy spire required only recladding (Figs. 1-3). At Christ Church, Philadelphia, built 1753, the wood sills laid upon the lower brick portion of the tower, as well as the feet of some of the great octagon lantern posts, rotted alarmingly by 1771, and the church's builder and designer Robert Smith was called back to repair it. Given the immense size and good condition of the steeple above, it was left in place (somehow supported on jacks, probably in successive segments) while the rotted timber was removed and replaced by built-up plank. Smith scarfed on new bottoms to the belfry posts as needed, and replaced with plank several of what he

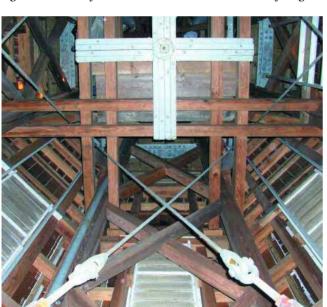
Fig. 3. Restored middle-stage framing (octagonal stage, Fig. 2) of steeple at Salem. Tall spire above is tied down via long central bolt terminating at laminated crossing that bears up against partners in middle stage.

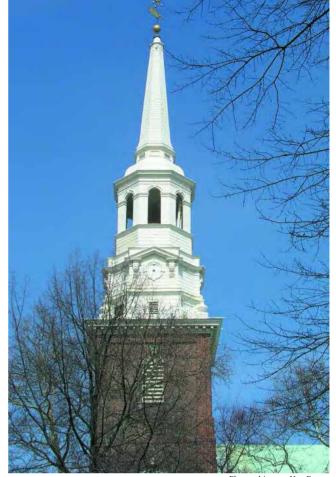
called hammer beams, cantilevered members designed to carry the upper posts within the perimeter of a lower square tower. The spire, the ultimate stage of this rescued steeple, escaped water and decay but was destroyed by fire and rebuilt in 1908 (Figs. 4–5).

Photos this page Ken Rower Fig. 4. Christ Church, Philadelphia, 1753, designed by Robert Smith.

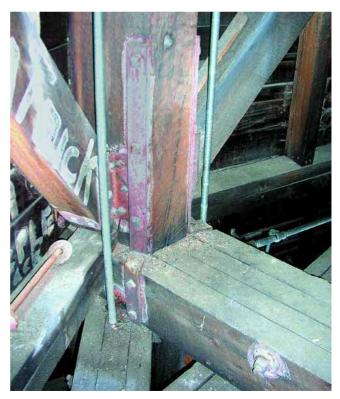
Fig. 5. Laminated beams replaced rotted material at Christ Church in 1771. Iron straps appear to be original, rods 20th-century.

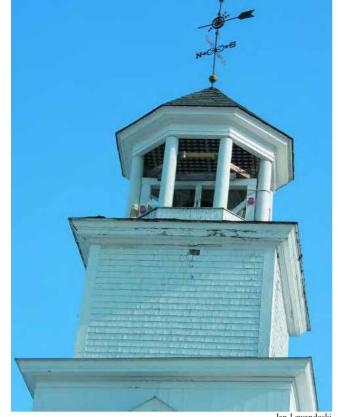
Fig. 6. Decay in posts and supporting beams led to significant distortion of steeple at the South Woodstock, Vt., Community Church, 1836.

At the South Woodstock, Vermont, Community Church (1836), the combination of rotted sleepers and tower posts and a rotted and deflected first truss chord caused the modest steeple to tilt out of plumb 7 in. on one axis and 5 in. on the other (Fig. 6). The steeple was restored by dismantling its conveniently telescoped and lodged stages (see TF 85).

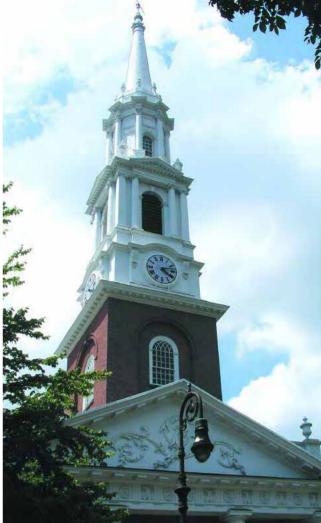
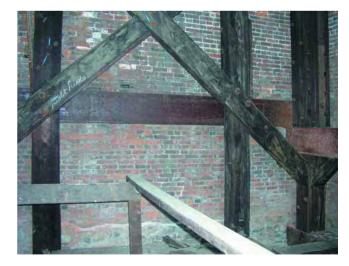
The deep telescoping discussed in previous articles in this series, while offering no lightning protection, is a method of avoiding the tearing off of successive stages by high wind. Telescoping is very different from platform framing. At Ithiel Town's great Center Church (1811) on New Haven Green in Connecticut, for example, the framing of one stage may penetrate as much as 38 ft. into the stage below (Figs. 7–8).

Figs. 7–8. Center Church, New Haven, Conn., 1811. Deep penetration of stages to those below successfully resists effects of wind. Below, lowest wood-framed stage is deeply lodged in brick tower.

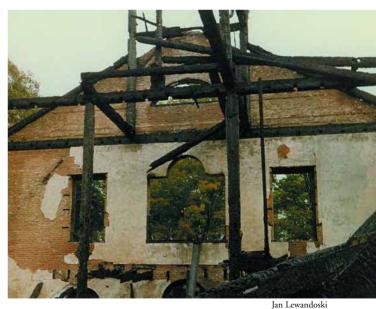
▼HE WEATHERSFIELD MEETINGHOUSE. In 1985 a fire destroyed all the timber portions of the 1826 Weathersfield, Vermont, Meetinghouse, leaving the brick walls standing (Fig. 16). The church's insurance company was quick to offer a check for the insured value, but the policy also promised to replace the building in kind. A determined church committee waved away the first offer and decided to discover what "in kind"

Fig. 16. Weathersfield standing timber remains included three tower posts, inset front plate, sleepers, first truss tie beam and vestibule posts.

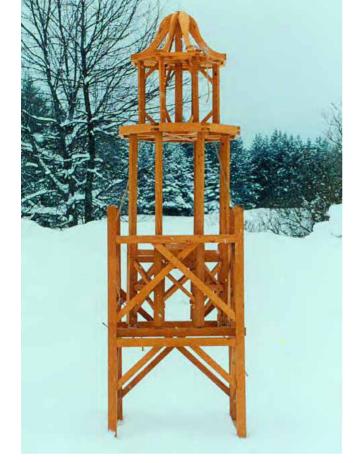
Fig. 17. One-inch-scale Weathersfield steeple model in spruce and with correct joinery, built by Ted Ingraham. Model stands 70 in. high.

steeple was designed to be erected in discrete, lodged, telescoping stages, and how we would accomplish this task (Fig. 17).

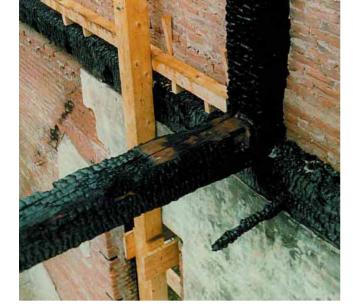
Framing the steeple. The original Weathersfield steeple was lodged at the bottom upon two 12x12x28-ft. spruce sleepers, one fortunately still in position after the fire. The sleepers began at the

Fig. 20. Charred remains of inset plate, front tower post and long sleeper to carry steeple. New material is part of front-wall shoring.

inset plate on the interior of the front brick wall and ran back to span two kingpost roof trusses (Fig. 20). Two 10x10 vestibule posts rose from the ground to the underside of the first interior truss to help carry the rear steeple load. The plate, sleepers and vestibule posts were all replaced in dimension, species and joinery.

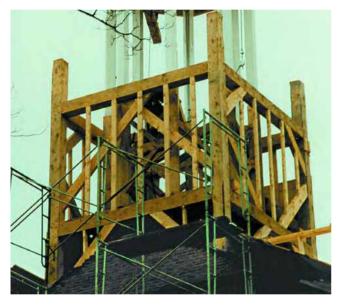
Fig. 21. Weathersfield tower frame in place, well braced and studded for exterior finish. Posts descend to long sleepers in attic and carry short sleepers halfway up to foot belfry posts. See also Fig. 17.

The first stage, the square tower, 14 ft. on a side and 25 ft. tall, had abundant crossing bracing and a square of short sleepers lodged halfway up to accept the bottoms of the eight telescoping belfry posts. The sleepers lodged on girts tenoned into the 10x10 tower posts, and the two girts that carried the four extended ends of the 12-ft. belfry crib were reinforced by mortised 4x6 studs that dropped to the long sleepers below. The tower frame made itself

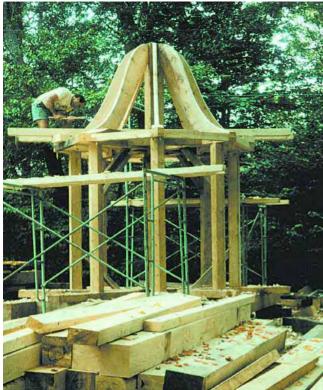
Fig. 23. Mike Cotroneo fairing legs of lantern crab to cupola roof's ogee rafters. An adze in good hands remains unsurpassed for such work. Lantern posts will tenon to major crab atop belfry in Fig. 24.

The desired framing of the lantern, the top stage, was less obvious. We had the remains of a mast that anchored the weathervane and rose the full height of the lantern and its cupola roof. How it could pass through a crab was unclear, so for the lantern crab that would carry its cupola roof we altered the typical design of the period by turning its main axis into partners, parallel timbers spaced apart, to accommodate the mast we knew to be original. The ogee rafters of the lantern's cupola roof were cut from solid 2½x18 white pine plank, and careful adzing continued their curve onto the supporting crab legs (Fig. 23 overleaf).

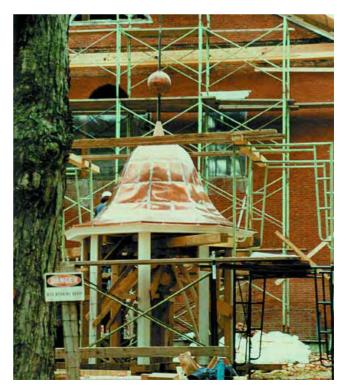
Fig. 25. Lantern covered by soldered copper cupola roof, topped by mast with orb (weathervane unseen above), awaits lift to top of belfry. Timbers just under cornice will be strapped to lift the stage.
