Inspection Pros

**757 Santa Ray Avenue
Oakland CA 94610**

Inspection Date: 7/21/2025

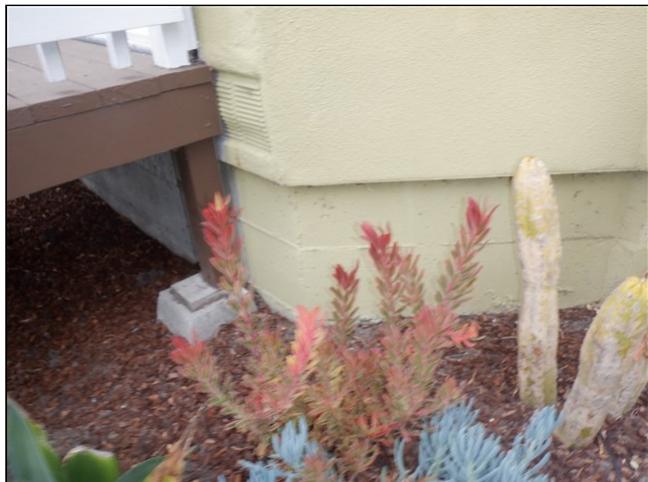
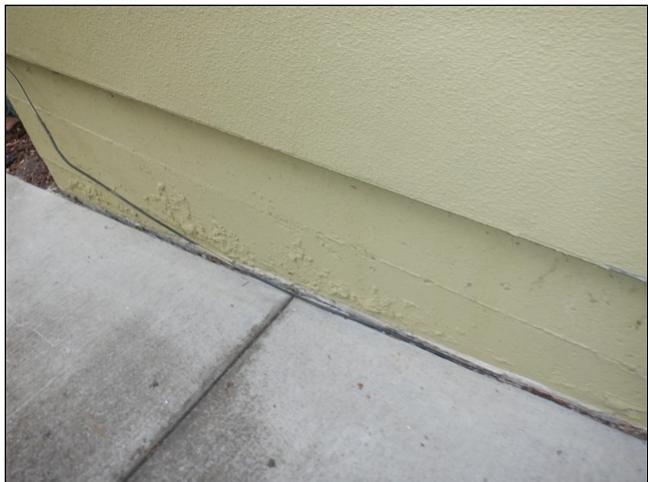
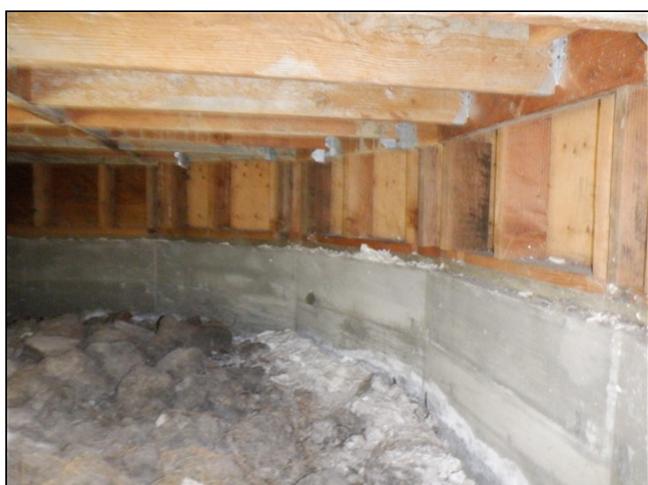
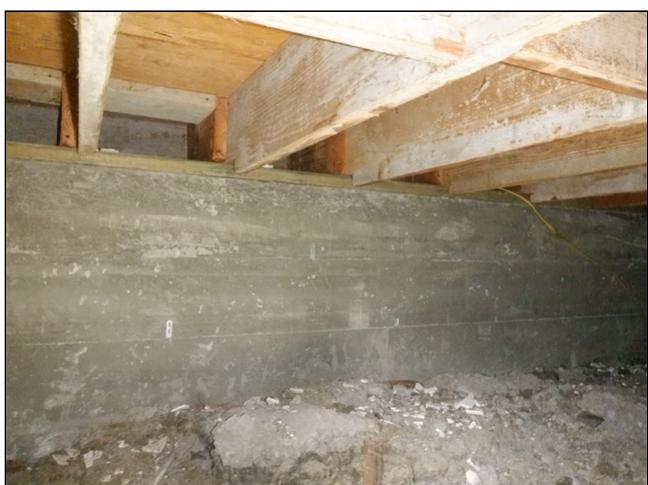
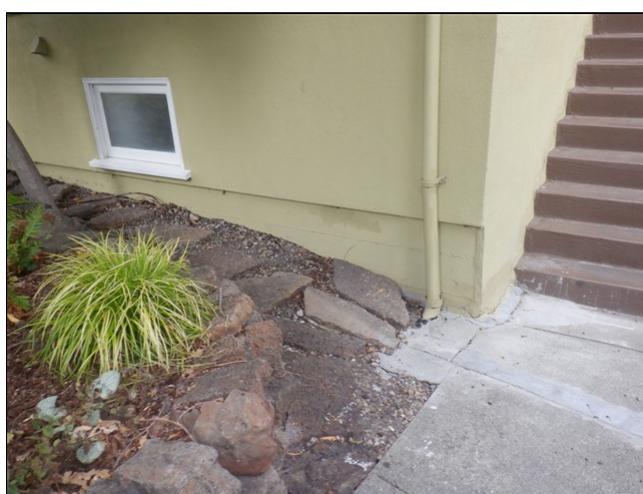
- ◆ The foundation and related components were in generally serviceable condition, however the foundation showed typical wear as well as some minor cracks and/or surface spalling. No significant damage, settlement or other deficiencies were noted at this time. We recommend attention to grading and drainage, and periodic monitoring.

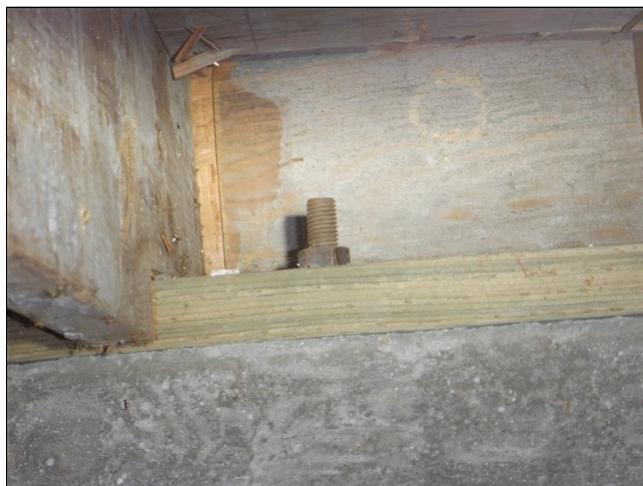
- ◆ The original foundation for this property has been removed and replaced. It appeared to be properly installed and in serviceable condition. If more information is desired, we recommend referral with the seller, the foundation contractor and/or the permit history.
- ◆ Foundation anchor bolts are fasteners that connect the wood framing to the concrete foundation, and limit the ability of the framing to move independently of the foundation in the event of seismic activity. Anchor bolts are in place as would be typical for the age of the structure, and appear to be in serviceable condition.

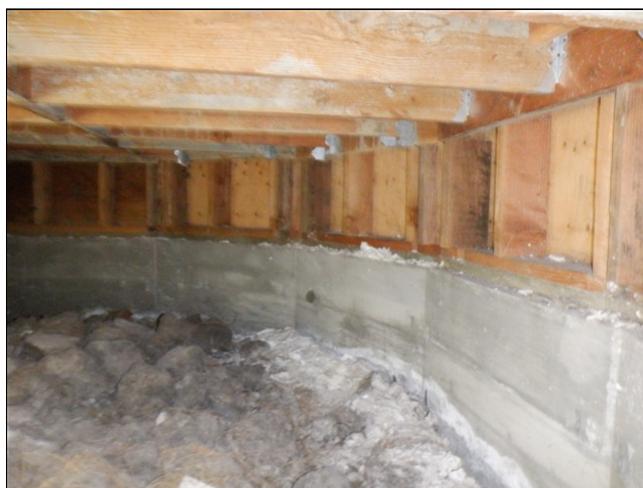
- ◆ Plywood bracing or "shear" panels were observed, and are beneficial to help prevent lateral movement or "racking" during an earthquake. They appear to be in generally serviceable condition, however they are nailed from the exterior, and the nail pattern, size and frequency was not visible.

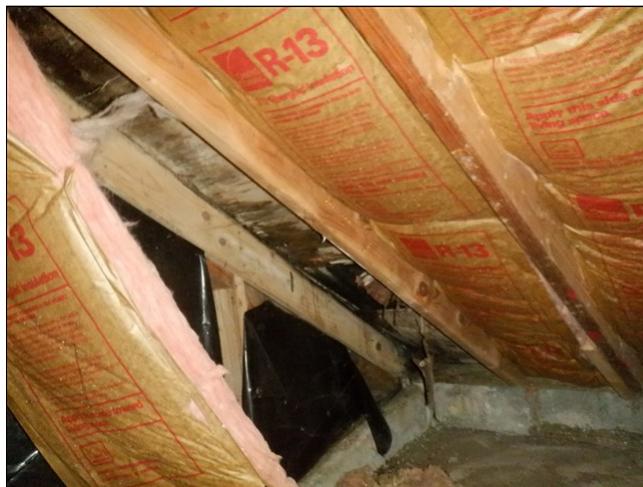
- 1. We observed damaged or deteriorated wood members, and what appeared to be some type of infestation and/or wood-destroying organism activity in the crawl space below the front porch/stairs. We recommend review of a current pest control report for information and repair recommendations. If not available, we recommend a licensed pest control inspector be retained to inspect the property.
- 2. There was no access found to the subarea at the rear wall and left rear. We recommend that modifications be made, or an additional access hatch installed, and the entire subarea inspected at that time.

- ♦ We observed damaged or deteriorated wood members, and what appeared to be some type of infestation and/or wood-destroying organism activity in the crawl space below the front porch/stairs. We recommend review of a current pest control report for information and repair recommendations. If not available, we recommend a licensed pest control inspector be retained to inspect the property.

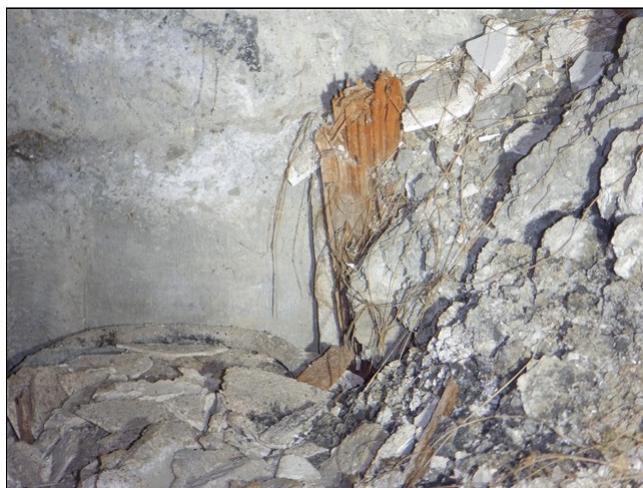
- ♦ There was no access found to the subarea at the rear wall and left rear. We recommend that modifications be made, or an additional access hatch installed, and the entire subarea inspected at that time.
- ♦ Miscellaneous scrap or stored wood, or "cellulose" debris was observed in the crawl space. This is conducive to infestation and damage from wood destroying organisms. As preventative maintenance, we recommend all cellulose debris be removed.
- ♦ Embedded form wood was observed in the crawl space at the front wall. This is conducive to infestation and damage from wood destroying organisms. As preventative maintenance, we recommend that the form wood be removed or treated. We also recommend referral to a current pest report for more information.

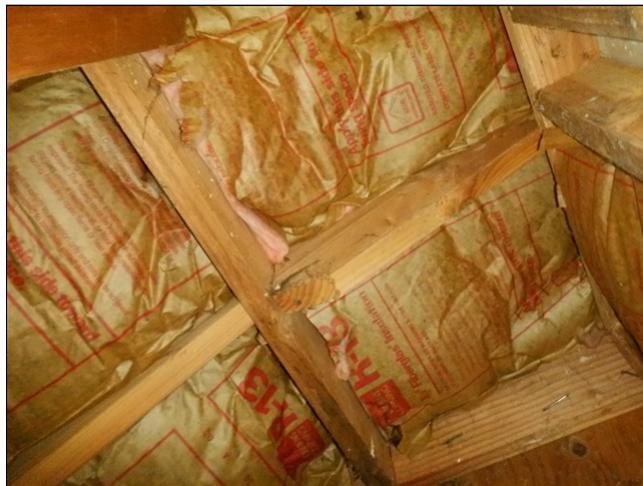
- 39. The subfloor insulation has been installed with the foil or plastic vapor barrier reversed (facing the soil, not the subfloor) in conflict with manufacturers' specifications. With dry soil, this condition is not likely to cause difficulties or loss of efficiency and action would be considered optional. However, if the soil under the house is moist or damp, we recommend that the insulation batts be re-installed with the vapor barrier against the subflooring.

- ☒ ◆ The subfloor insulation has been installed with the foil or plastic vapor barrier reversed (facing the soil, not the subfloor) in conflict with manufacturers' specifications. With dry soil, this condition is not likely to cause difficulties or loss of efficiency and action would be considered optional. However, if the soil under the house is moist or damp, we recommend that the insulation batts be re-installed with the vapor barrier against the subflooring.

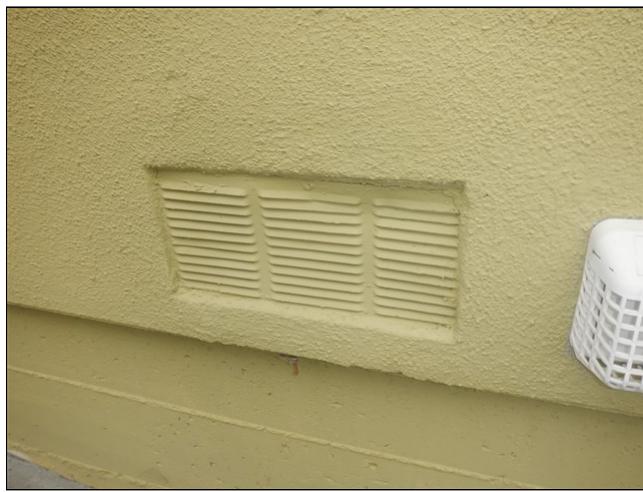
- 40. Some of the crawl space ventilation openings had louvered vents installed. Louvered vents restrict air circulation more than screened vents, and are more likely to be clogged with weeds or debris. We recommend that replacement with screened vents be considered for improved air flow.

- ☒ ◆ Some of the crawl space ventilation openings had louvered vents installed. Louvered vents restrict air circulation more than screened vents, and are more likely to be clogged with weeds or debris. We recommend that replacement with screened vents be considered for improved air flow.

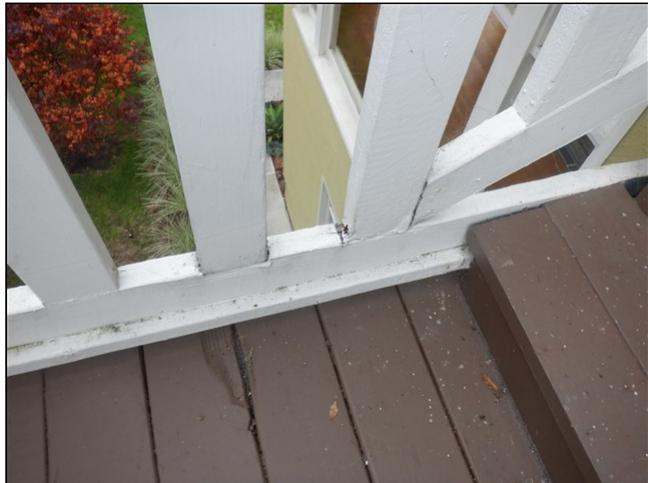
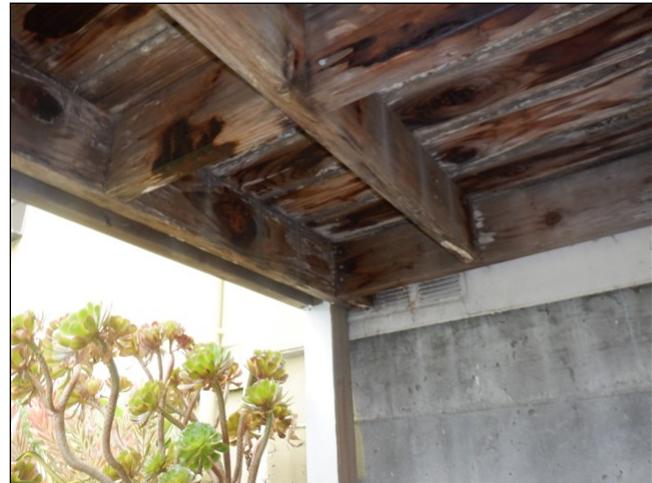
- 3. Damage or deterioration was observed in some of the deck boards and/or framing members at the left rear deck and left side deck and stairs and/or railing. We recommend referral with a general contractor and/or to a current pest report for specific recommendations, and repair or replacement of all damaged material as necessary.

- ☒ ◆ Damage or deterioration was observed in some of the deck boards and/or framing members at the left rear deck and left side deck and stairs and/or railing. We recommend referral with a general contractor and/or to a current pest report for specific recommendations, and repair or replacement of all damaged material as necessary.

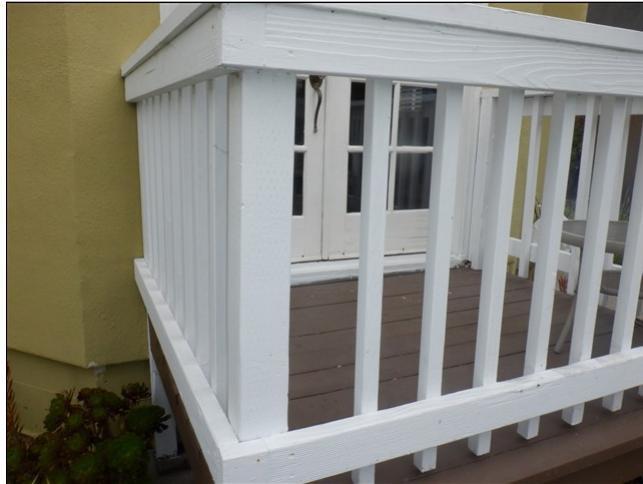
- ☒ ◆ The railings at the rear were spaced more than 4 inches apart, possibly allowing a child to pass through or become trapped. This installation is no longer approved, and upgrading or installing barriers should be considered, particularly if small children will be present.

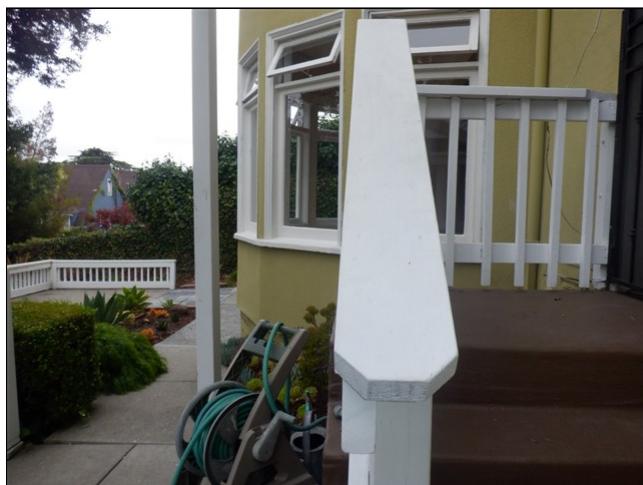
- ☒ ◆ The stair handrails at the rear were not "grippable" by present standards. We recommend they be upgraded for maximum safety.

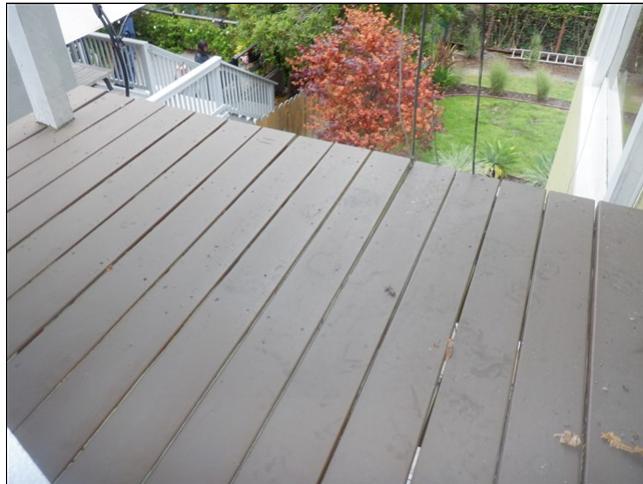
- ☒ ◆ There were no railings installed around the perimeter of the porch/deck at the left side. This should be considered a potential falling hazard, and we recommend that railings or other barricades be installed for maximum safety.

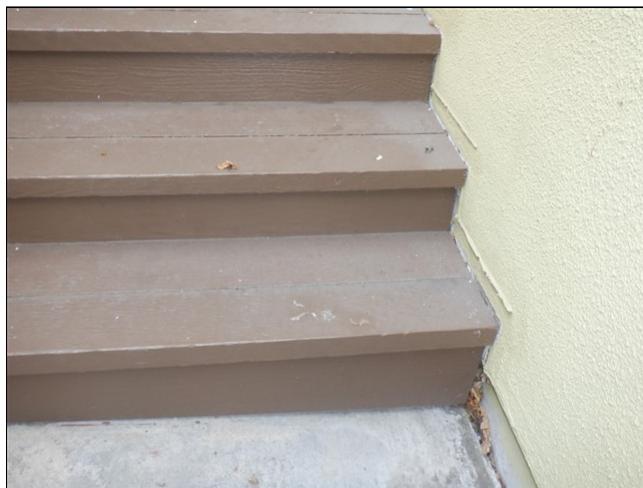
- ☒ ◆ The stairs at the left front are nonconforming by current standards. Upgrades or modifications should be considered for improved safety. We recommend referral with a licensed general contractor for more information and recommendations.

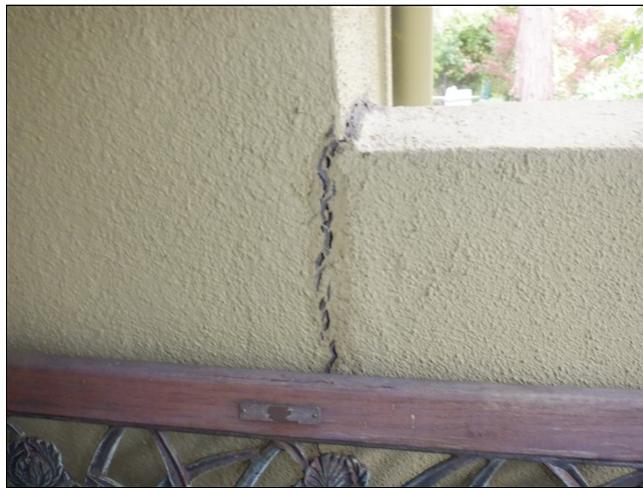
- ☒ ◆ The wall at the rear of the front porch have shifted as a result of moisture and soil settlement and it's performance may be affected. We recommend further review by a qualified contractor/general contractor.

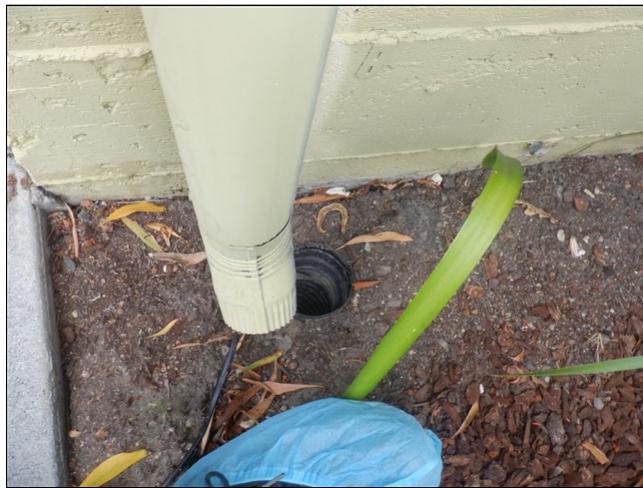
- ◆ One of the downspouts was loose or has slipped out of place at its connection to the underground drain at the right rear. We recommend that it be reconnected, repaired or replaced as necessary to restore proper function, and to ensure that water is routed away from the structure.

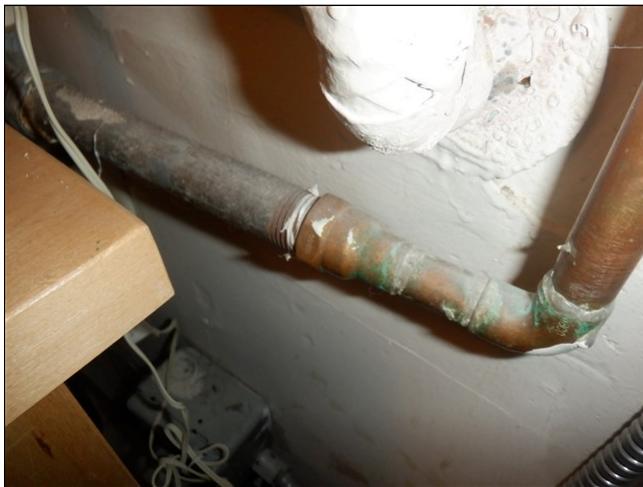
- 4. We observed copper and galvanized steel water piping connected directly together in the subarea below the upper unit laundry area. This installation is not approved because of the electrolysis and corrosion caused by connecting the dissimilar metals. We recommend that approved dielectric unions (insulated couplings) be installed by a licensed plumber.

- ◆ We observed copper and galvanized steel water piping connected directly together in the subarea below the upper unit laundry area. This installation is not approved because of the electrolysis and corrosion caused by connecting the dissimilar metals. We recommend that approved dielectric unions (insulated couplings) be installed by a licensed plumber.

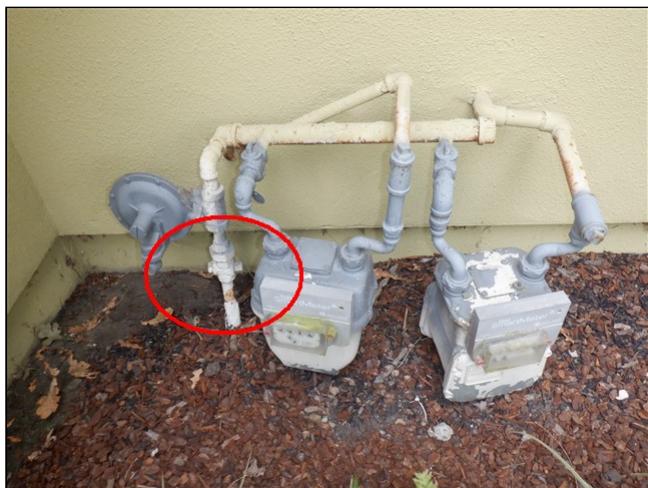
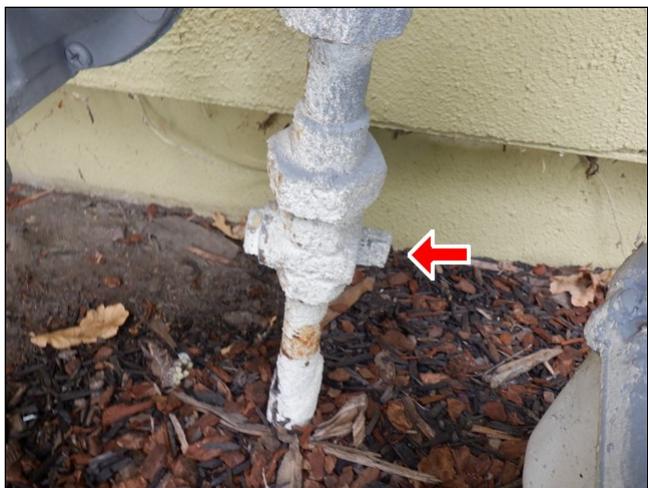
- ♦ There was no gas valve shut off wrench observed near the gas meter. We recommend that a wrench be attached to, or stored near the meter so the gas can be shut off in the event of an emergency. An automatic seismic shut off valve should also be considered for maximum safety in the event of an earthquake.

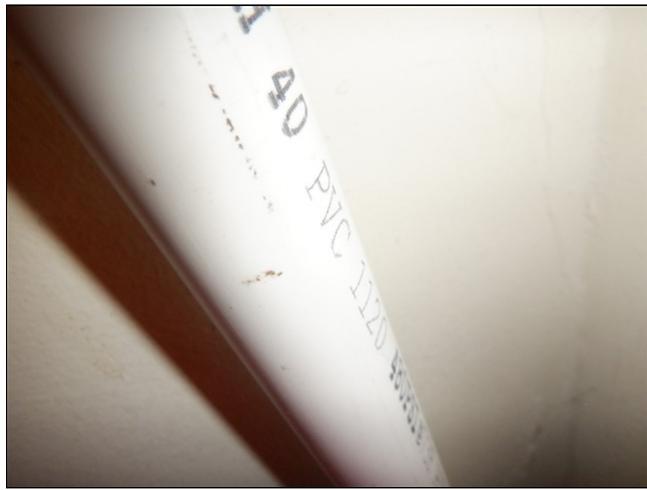
- ♦ NOTE: We do not test water heater temperature/pressure relief valves as they often leak after being operated. If the valve fails to reset and leaks, replacement is necessary. We recommend either the valve be tested annually with an expectation of possible replacement or simply replaced every three years.
- ♦ The upper unit water heater temperature/pressure relief valve discharge pipe material is not approved. We recommend replacement with either copper, galvanized steel or CPVC. Contact a licensed plumber or water heater specialist for more information and recommendations.

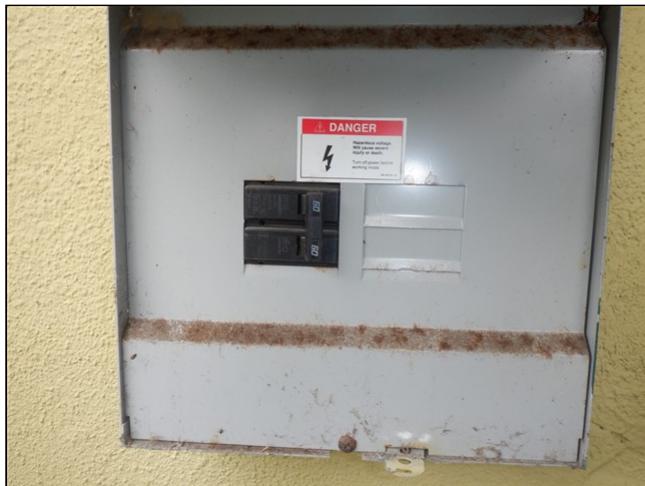
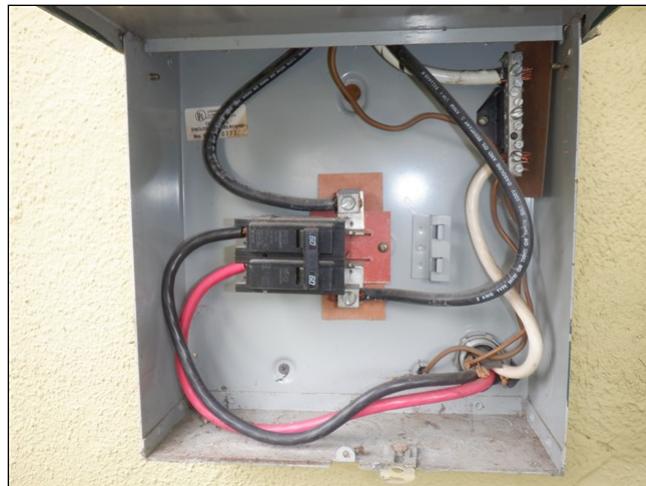
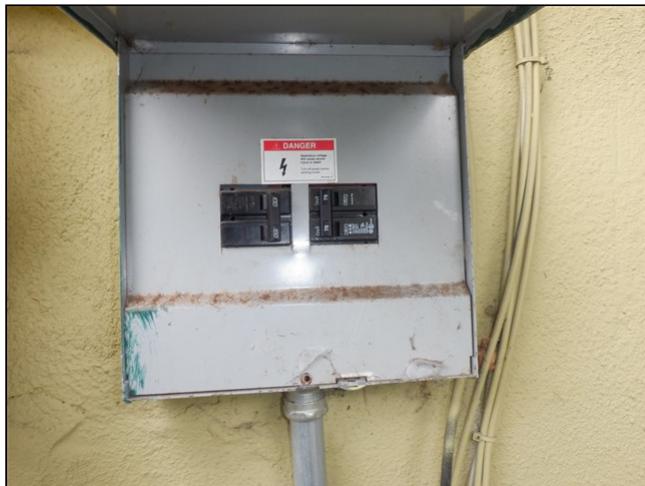
- ◆ The circuitry in the main electrical panels was not labeled. We recommend that each circuit be identified and labeled for added convenience and safety.

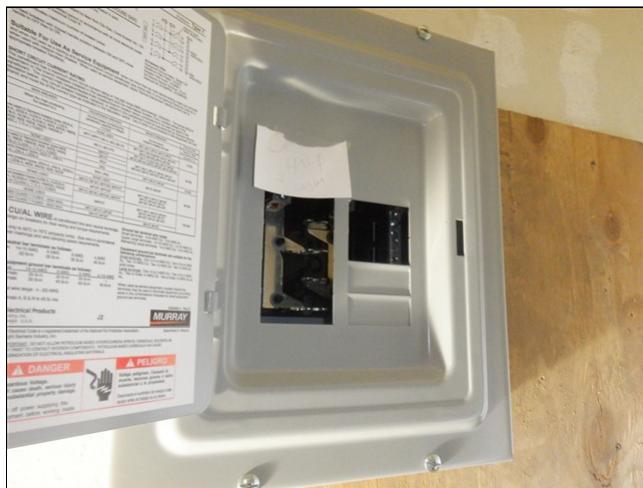
- ♦ We observed several openings in the abandoned lower unit in-law closet electrical subpanel cover plate where "twistouts" have been removed and left open (no circuit breakers were installed). This is a potential safety issue, and we recommend that approved snap-in filler plates be installed.

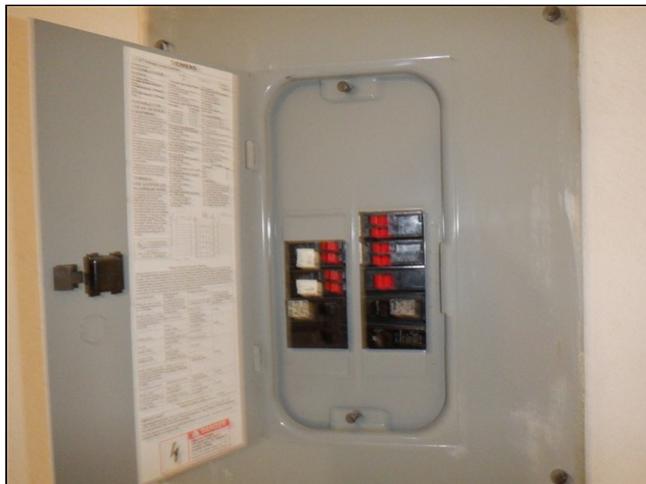
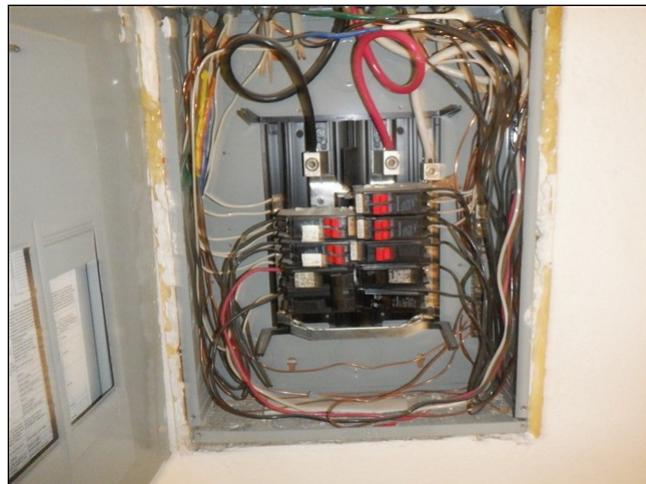
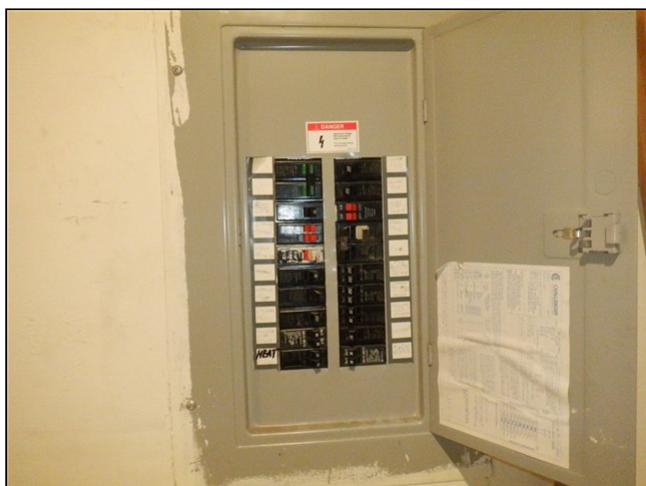
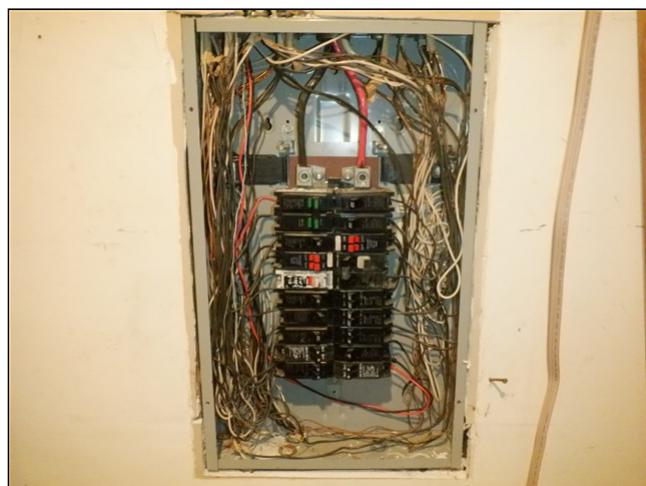
- ♦ Note: The electrical subpanels are older, and they were not designed or intended to have an indefinite working lifespan. No particular deficiencies were noted, however older equipment should be considered potentially unreliable, and replacement of the breakers and/or the entire panels may be necessary, and should be anticipated. We recommend periodic inspection by a licensed electrician to ensure safe and proper function.

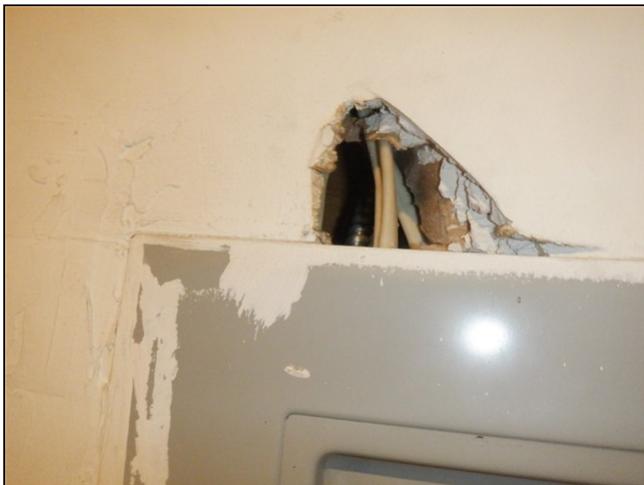
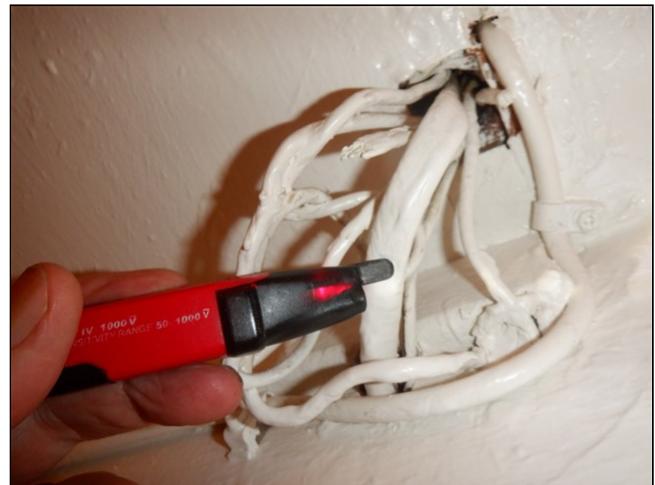
- ♦ We observed exposed and unprotected electrical wiring (NX - non metallic sheathed cable) in the utility room lower floor behind voids in the wall and in the stairwell. This installation is not approved as the wiring is subject to physical damage. We recommend referral with an electrician and all unprotected wiring be replaced with "BX" armored cable, "MC" metal clad or physically protected.

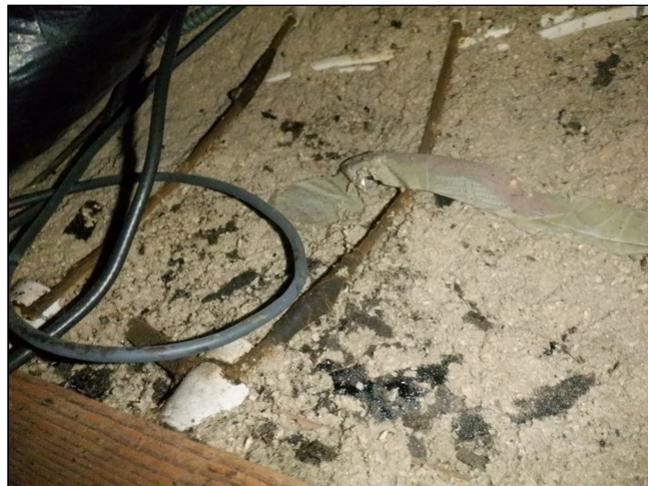
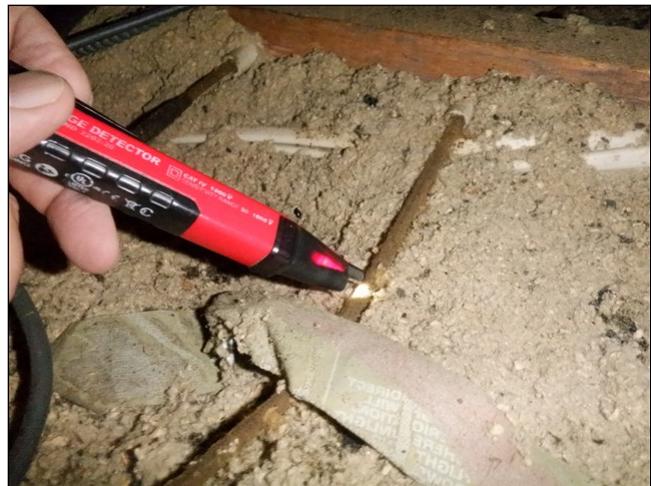
- ♦ There appears to be knob & tube wiring buried under the attic insulation that is not visible. Since 1991 California Code allows ceilings containing knob and tube wiring to be insulated, provided certain conditions are met. These include the certification that the wiring is safe, and posting signs stating that there is knob and tube wiring under the insulation. No particular deficiencies were noted, however if more information or further evaluation is desired, we recommend referral with a licensed electrician.

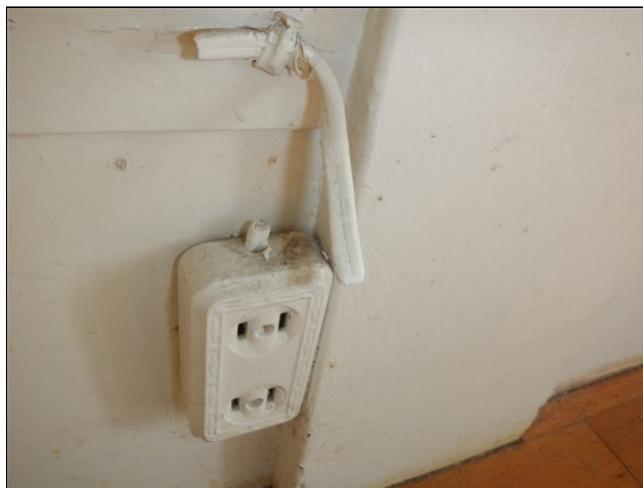
- ☒ ◆ We observed loose, unsecured and abandoned wiring in the lower unit upper left rear bedroom (and abandoned two pronged receptacle). The wiring is disconnected and not live, however we recommend it be removed in the course of ongoing maintenance.

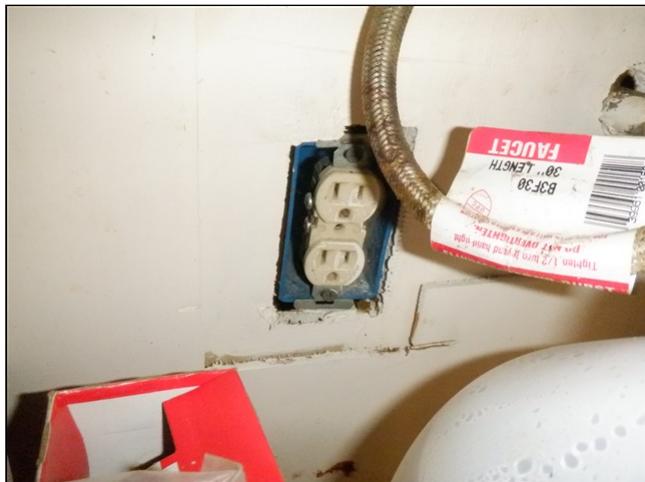
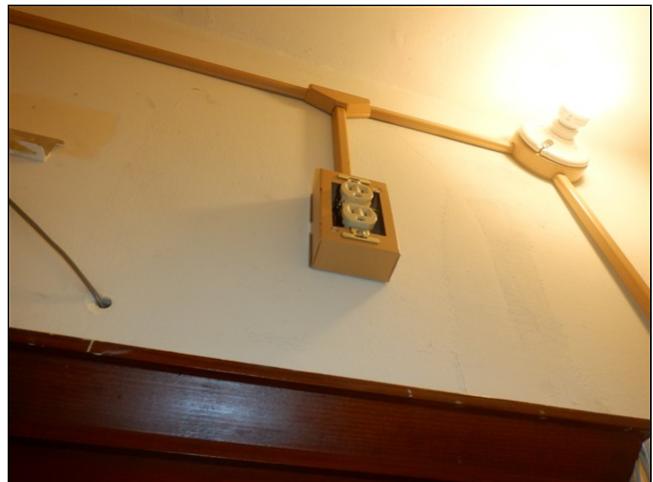
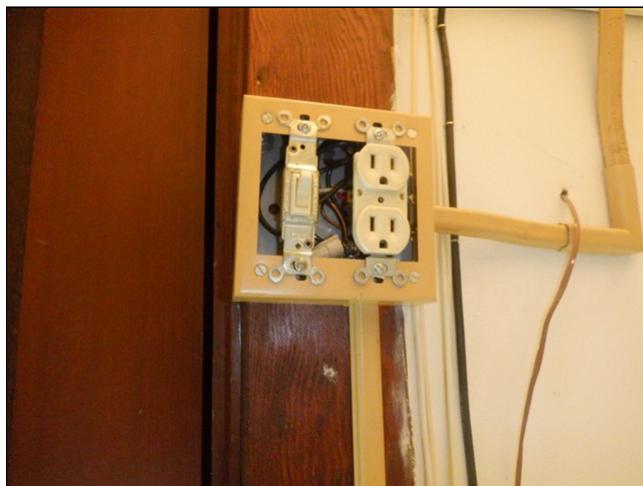
- ☒ ◆ The cover plates was missing from one of the receptacles in the upper unit kitchen sink cabinet and few of the receptacles in the lower unit right rear bedroom closet. We recommend they be replaced to ensure proper function and safety.

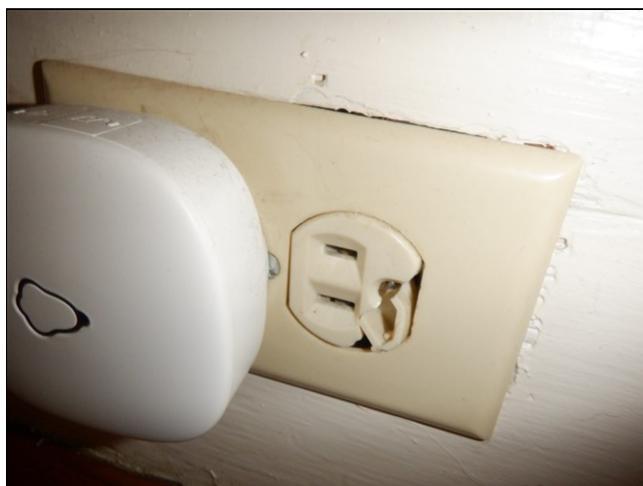
- ♦ We observed a damaged receptacle in the upper unit dining room. A damaged plug may not function properly and should be considered a potential safety hazard. We recommend it be replaced by a licensed electrician.

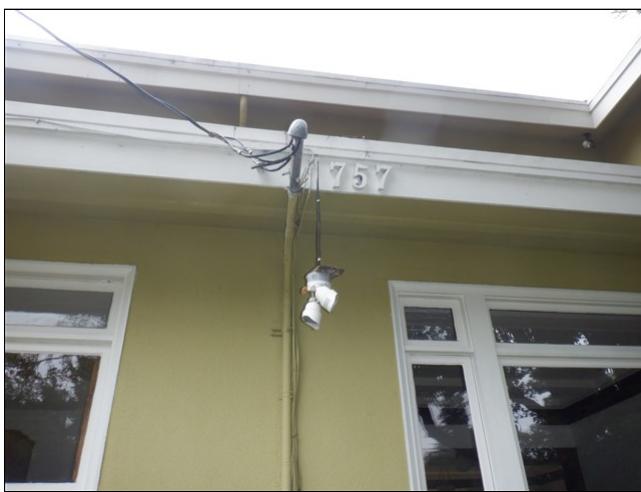
- ♦ NOTE: One or more of the exterior light fixtures are controlled by sensors. The sensors typically work by motion and/or by photo cells that come on at dusk. Testing of these devices is difficult during the daytime, and is beyond the scope of this inspection. We recommend testing them for proper function at night.
- ♦ The exterior light fixture at the front was loose. We recommend that the fixture be resecured or replaced to ensure a water tight seal, proper function and safety.

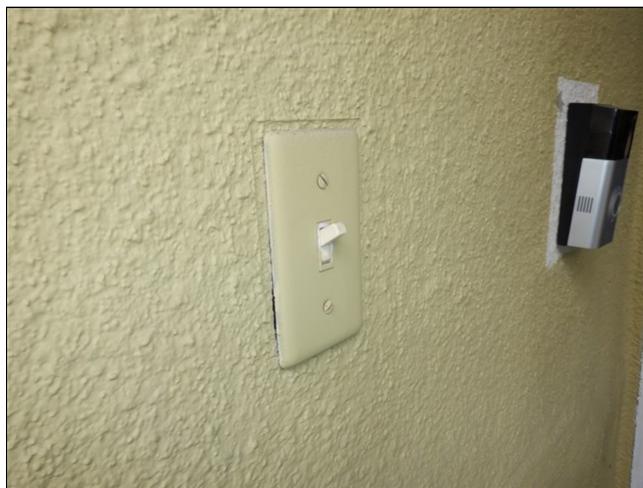
- ♦ Some of the switches at the exterior front and in the upper unit front entry appeared to be without an obvious function. We recommend referral with the owner, testing the switches at night or if necessary referral with an electrician.
- ♦ The light switch at the front is not rated for exterior use. We recommend it be replaced with an approved exterior rated switch for maximum safety and to ensure a watertight seal.

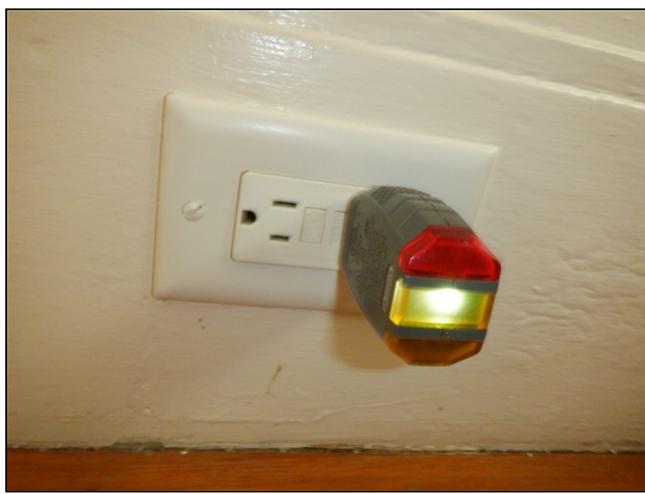
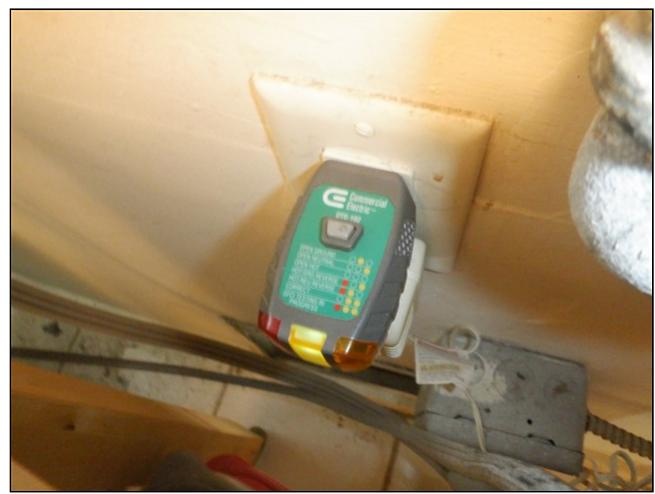
- ◆ NOTE: A number of the three prong electrical receptacles in the house were ungrounded. Some of the devices were replaced with GFCI's which are an approved replacement for ungrounded three prong receptacles. The ungrounded GFCI devices should be labeled as being ungrounded to avoid confusion and to comply with current standards. We recommend that the ungrounded receptacles be retrofitted back to their original two prong configuration, properly labeled as ungrounded GFCI's, or be properly grounded by a licensed electrician.

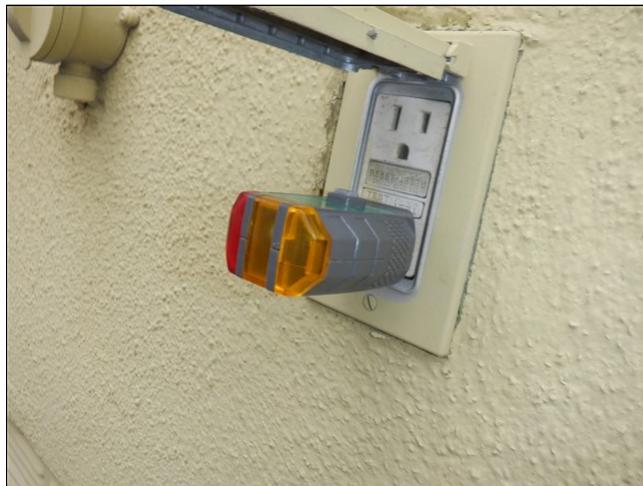
- ◆ NOTE: An arc-fault circuit interrupter (AFCI) is an electrical device designed to provide protection from the effects of electrical arc faults and de-energize the circuit when an arc fault is detected. There is a difference between AFCIs and GFCIs. AFCIs are intended to reduce the likelihood of fire caused by electrical arcing faults; whereas, GFCIs are personnel protection intended to reduce the likelihood of electric shock hazard.
- ☒ ◆ The GFCI receptacle at the rear failed to trip when overloaded, or when its test button was pressed. We recommend they be replaced by the appropriate contactor, and proper operation verified.

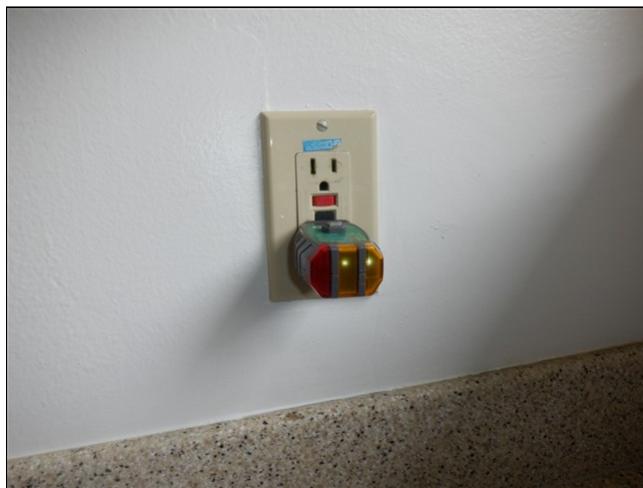
- ♦ The GFCI receptacle in the lower unit kitchen tripped when its test button was pressed, however it remained live. This indicates improper wiring or a faulty device, and it should be considered a potential safety hazard. We recommend the receptacle be rewired or replaced by a licensed electrician.

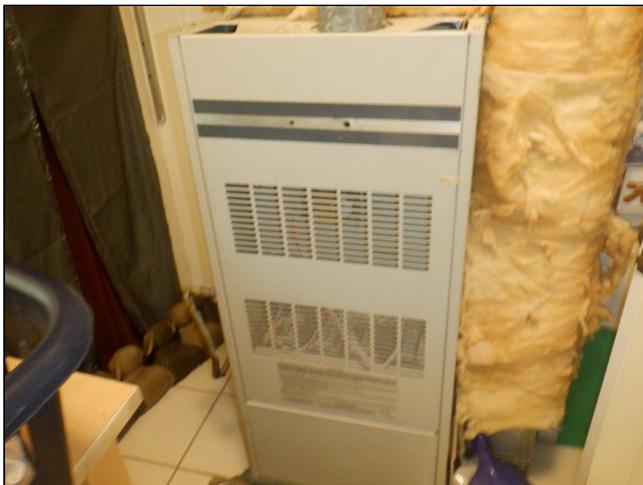
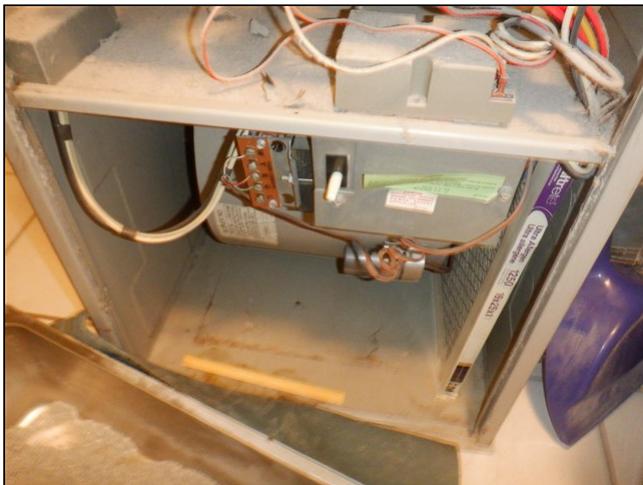
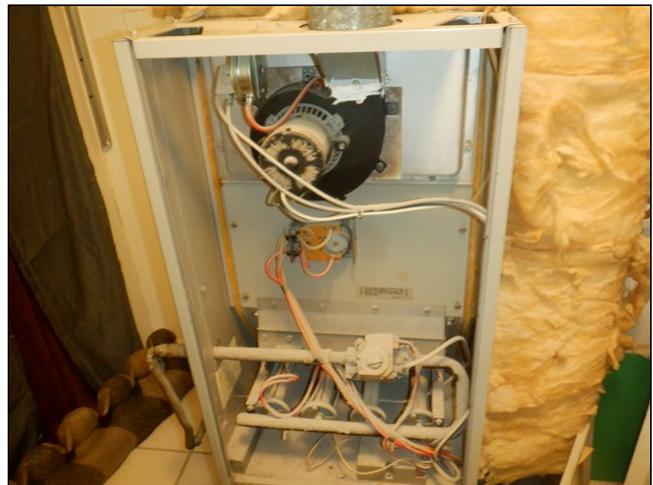
- ☒ ◆ The upper unit furnace is older, and base on age and/or condition is near the end of it's service life. Although it was functioning at the time of the inspection, replacement should be considered and anticipated.

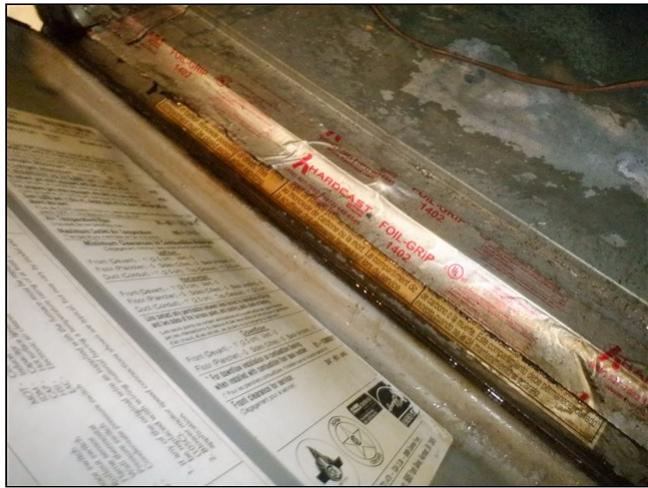
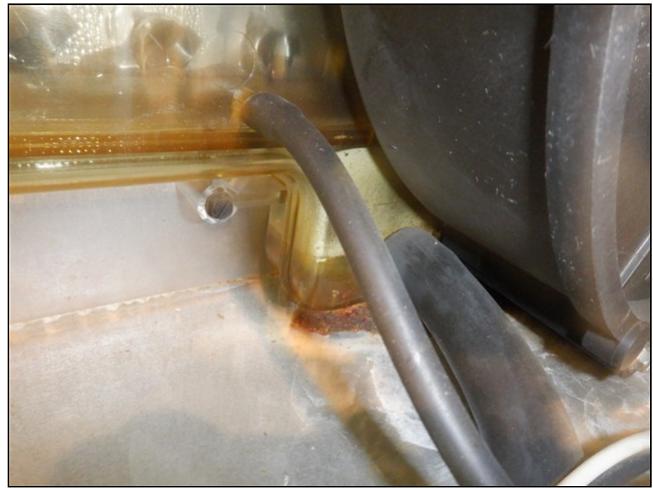
- 17. There was evidence of condensation leakage and corrosion at the lower unit in-law furnace vent connection. The condensate is considered to be corrosive and we recommend further evaluation and repair by a licensed HVAC contractor.

- ♦ There was evidence of condensation leakage and corrosion at the lower unit in-law furnace vent connection. The condensate is considered to be corrosive and we recommend further evaluation and repair by a licensed HVAC contractor.

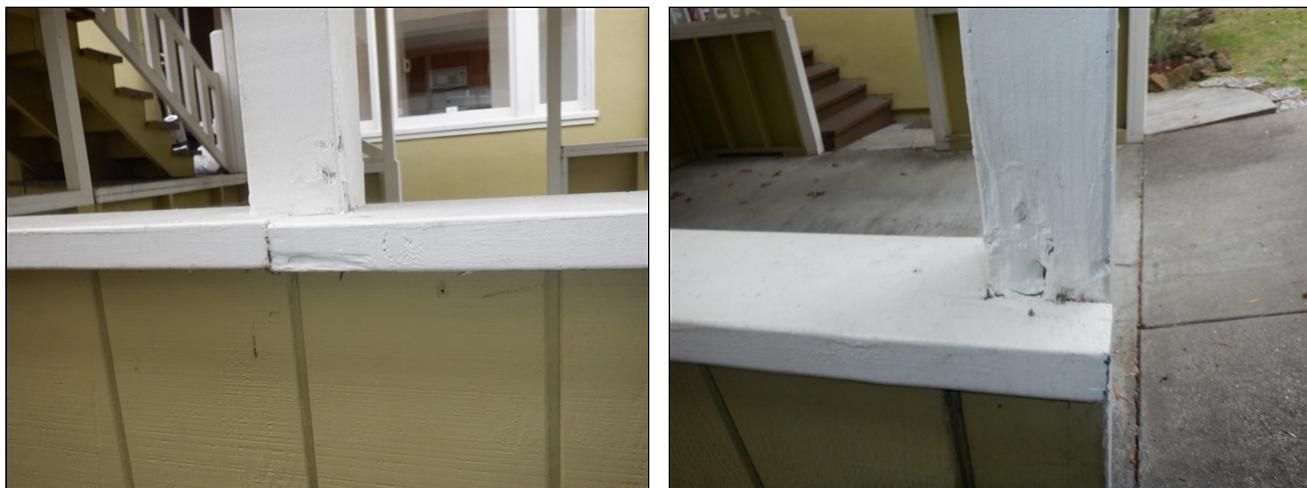
- 19. We observed what appears to be some type of infestation and/or wood-destroying organism activity in the carpent framing, trim, support post and plywood siding. We recommend referral to a current pest control report for more information concerning this condition. If not available, we recommend a licensed pest control inspector be retained to inspect the property.

- ◆ There were hairline to small cracks observed in the carport concrete slab. This type of cracking is typical and no action is indicated.
- ◆ We observed what appears to be some type of infestation and/or wood-destroying organism activity in the carport framing, trim, support post and plywood siding. We recommend referral to a current pest control report for more information concerning this condition. If not available, we recommend a licensed pest control inspector be retained to inspect the property.

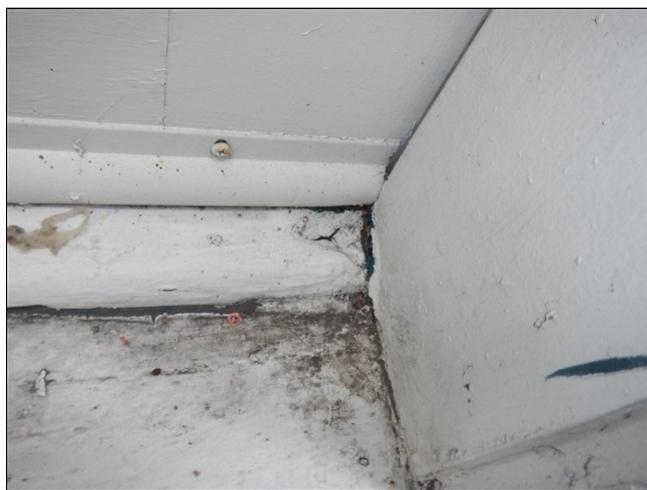
- 21. Damage or deterioration was observed in the exterior doors and/or door jamb/frame at the left rear and right rear. We recommend referral with a general contractor and/or to a current pest report, and the door be repaired if possible, or replaced if necessary.

- ◆ Some of the doors lacked door stops, which can allow the handles to hit the walls. We recommend that all of the doors be equipped with door stops to help prevent damage to the interior walls.
- ◆ Damage or deterioration was observed in the exterior doors and/or door jamb/frame at the left rear and right rear. We recommend referral with a general contractor and/or to a current pest report, and the door be repaired if possible, or replaced if necessary.
- ◆ The threshold was sloped inward and deteriorated at the right rear exterior door. We recommend referral with a general contractor and/or to a current pest report, and all damaged material repaired or replaced as necessary.

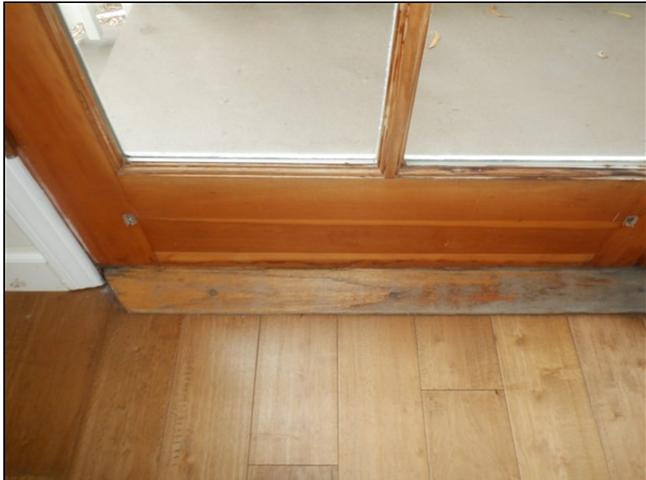
- 23. There was evidence of past moisture intrusion through the in-law primary bedroom and living room exterior doors. We recommend referral with a general contractor or door specialist, and door and/or threshold modified or resealed as recommended, and the interior surfaces repaired or refinished if necessary. We also recommend referral to a current pest report if available, and monitoring during rainy periods.

- ◆ There was evidence of past moisture intrusion through the in-law primary bedroom and living room exterior doors. We recommend referral with a general contractor or door specialist, and door and/or threshold modified or resealed as recommended, and the interior surfaces repaired or refinished if necessary. We also recommend referral to a current pest report if available, and monitoring during rainy periods.

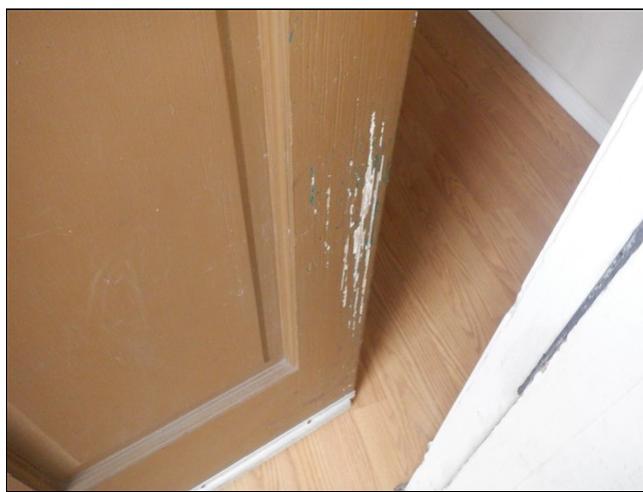
- ☒ ◆ The left side entry door was blemished or surface damaged. This is primarily a cosmetic consideration, however repair or replacement should be considered for a better appearance.
