Inspection Pros

**757 Santa Ray Avenue
Oakland CA 94610**

Inspection Date: 7/21/2025

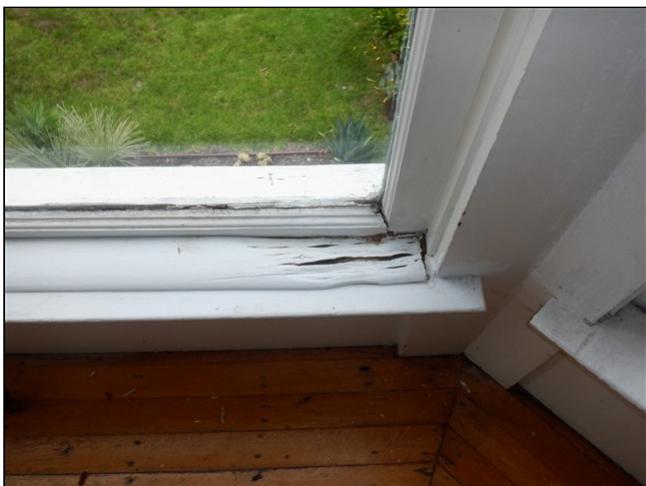
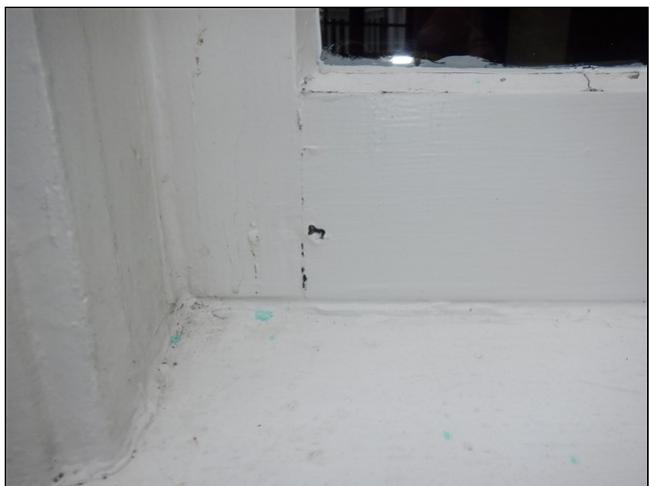
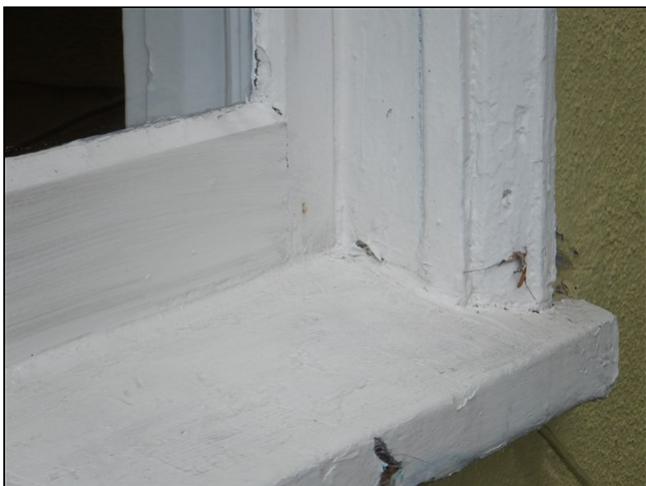
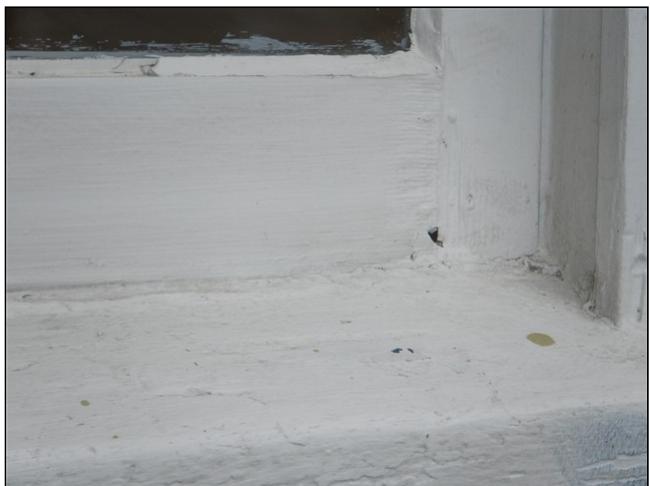
- 24. Damage or deterioration was noted to several of the window frames, sills and/or trim. We recommend referral with a licensed general contractor and/or to a current pest report, and all damaged frames be repaired or replaced as necessary.

- ☒ ◆ Damage or deterioration was noted to several of the window frames, sills and/or trim. We recommend referral with a licensed general contractor and/or to a current pest report, and all damaged frames be repaired or replaced as necessary.

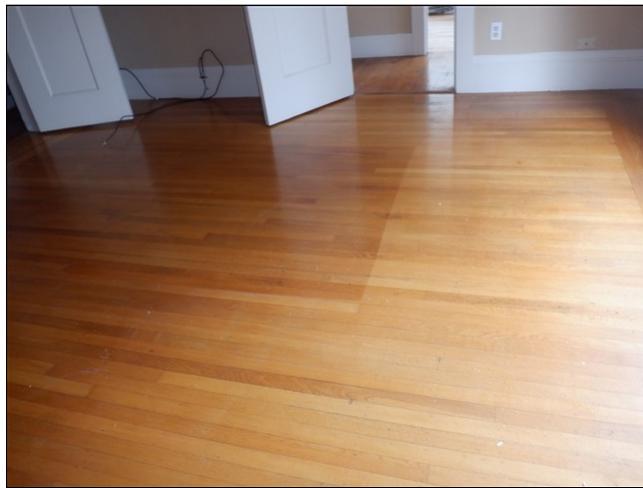
- ☒ ◆ The wood flooring was sun faded in the lower unit right rear bedroom. This is primarily a cosmetic consideration, however if this is a concern we recommend refinishing or replacement for a better appearance.

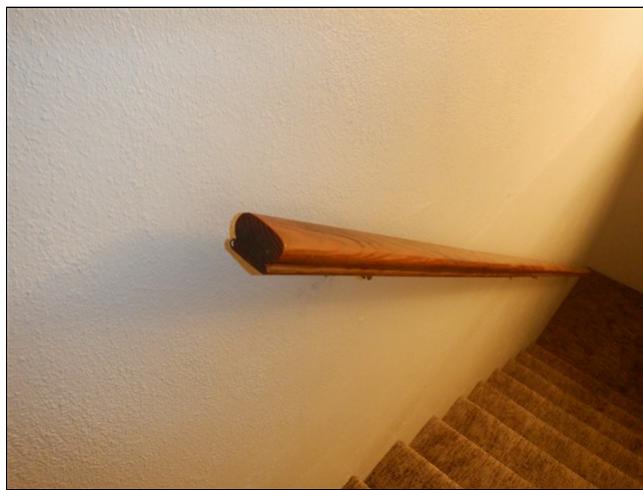
- ☒ ◆ Note: The lower unit stair handrail ends do not return to the walls, as is now required. This should be considered a potential safety concern as purse straps, long sleeves, etc. can get caught on the ends of the handrails. We recommend that upgrading be considered for maximum safety.

- ♦ The lower unit lower unit stairs are nonconforming by current standards. Ideally, modifications should be made to comply with current building standards, however this may not be practical. If more information is desired, we recommend referral with a general contractor or the local Building Department.

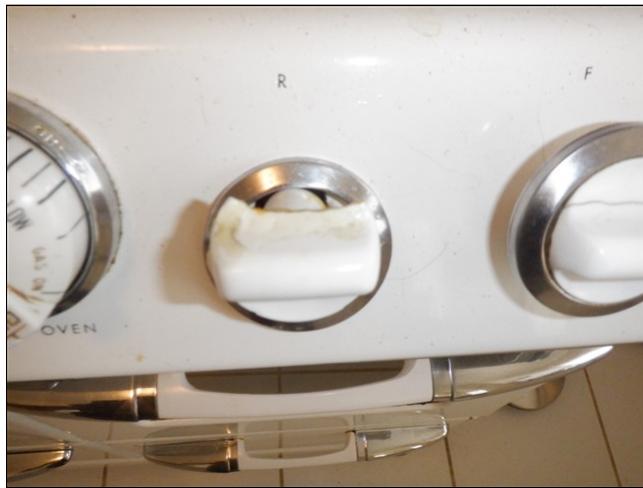
- ☒ ◆ One of the upper unit oven or cooktop control knobs were damaged. We recommend they be replaced to allow full use of the appliance.

- ☒ ◆ There was no anti-tip hardware installed for this range. This is a safety feature that prevents the oven from tipping if a child climbs on the open oven door. Although this feature may not have been available when the unit was manufactured or installed, we recommend the hardware be retrofitted for maximum safety.

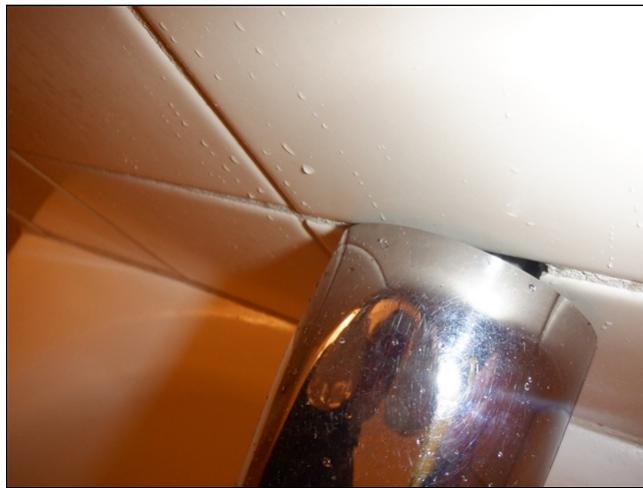
- ◆ Note: The in-law primary bathroom sink did not feature an overflow drain. Care should be taken to not leave the sink filling unattended.
- ☒ ◆ We observed missing drain stops at the upper unit bathroom wash basin and tub and in-law unit tub. We recommend they be replaced to restore proper function.
- ☒ ◆ There was a noticeable gap between the tub spout and the shower walls in the upper unit hall bathroom. We recommend modification, or the gap caulked or sealed to help prevent water entry behind the shower walls.

- ☒ ◆ The wash basin drain stop in the in-law bathroom was not functioning properly. We recommend adjustment or repair as necessary.
- ☒ ◆ The bathtub drain stop was not functioning properly in the in-law bathroom. We recommend adjustment or repair as necessary to restore proper function.
- ☒ ◆ The tub drain in the in-law bathroom was unusually slow. We recommend the trap be cleared or snaked as necessary.
- ☒ ◆ The surface of the in-law primary bathroom tub was blemished, scratched or marred. This condition is primarily cosmetic, and no action is indicated except for a better appearance.
- ☒ ◆ The wash basin in the in-law primary bathroom was unusually slow draining. We recommend adjustment of the stopper and/or snaking as necessary.

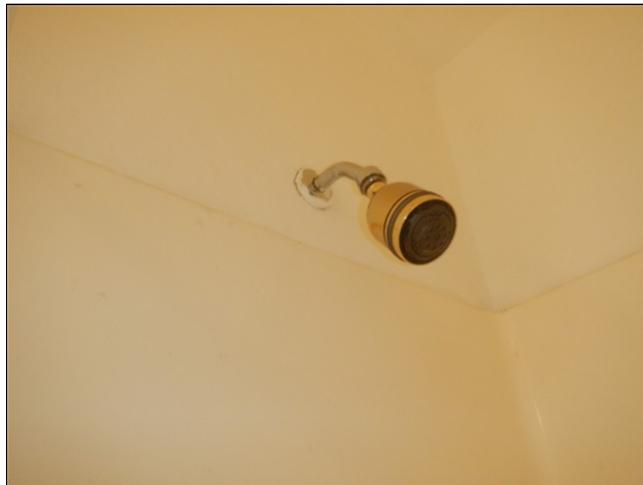
- ◆ Tiled shower pans are subject to water entry over time, either from grout failure, cracked tiles, improper installation, and/or physical damage. A definitive water test requires 1 to 2 inches of standing water for an extended period of time, which is well beyond the scope of a home inspection. There were no indications of leakage at this time, however we recommend referral to a current pest inspection if available, and periodic monitoring and inspection.
- ☒ ◆ The in-law primary bathroom shower wall material does not extend all the way to the top of the enclosure, creating the opportunity for moisture penetration. We recommend that the shower walls be kept well sealed, and upgraded with waterproof material above the shower head in the near future.
