WOOD DESTROYING PESTS AND ORGANISMS INSPECTION REPORT

Building No.	Street	City	Zip	Date of Inspection	Page:
757	Santa Ray Avenue	Oakland	94610	04/21/2025	1 of 18

GT INSPECTS <small>Book an inspection online at GTInspects.com</small> 4820 MacArthur Blvd. Oakland, CA 94619 Ph 510-530-0687 Fax 510-743-4259				Company Report #: G225415- Santa Ray Ave, 757	
Ordered by: Jim Turner c/o Chimene Pollard Red Oak Realty		Property Owner and/or Party of Interest: same as ordered by		Report sent to: Chimene@team510.com [REDACTED]

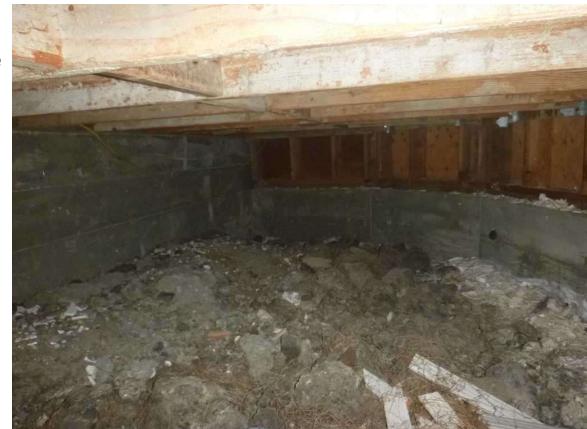
1C. FINDING: Fungus infected cellulose debris was found in the portion of the accessible subarea as indicated on the diagram. Cellulose debris can and does attract subterranean termite activity and is important to remove.

RECOMMENDATION: GT Inspects Inc. to remove all debris of a size that can be raked and/or larger and dispose of the same.

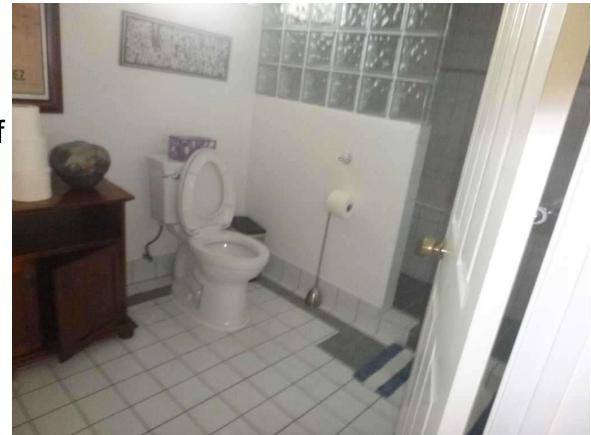
2A. FINDING: The lower insuite bathroom shower was not water tested due to it was over concrete slab. Water testing of the shower could cause water damage to the surrounding areas if the shower leaked. There was no outward signs of leakage at visible areas at the time of the inspection. There is no warranty that the stall shower would not leak if a water test was applied.

RECOMMENDATION: Owner or party of interest should maintain the stall shower in a well sealed and caulked manner at all times. At the request of the owner or party of interest and release of liability, GT Inspects Inc. would return and apply a standard water test. GT Inspects Inc. would issue a supplemental report outlining our findings and recommendations and price quote if any.

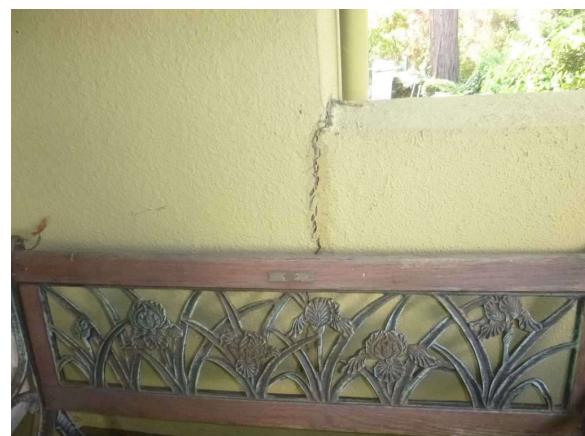
4B. FINDING: A stress crack was noted at the stucco buttress wall at the front porch area. This appears to be due to past settlement of the porch.

RECOMMENDATION: Owner should seal the crack. Further information desired regarding the settlement should be directed towards the appropriate contractor.

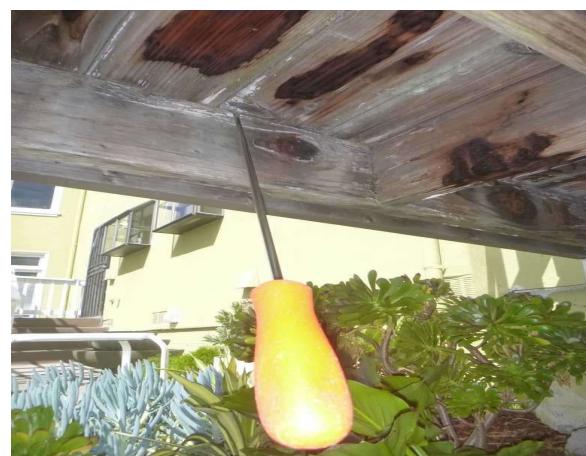
4F. FINDING: Fungus damage was found to the rear wooden porch as indicated on the diagram.

RECOMMENDATION: GT Inspects Inc. to repair the porch and framing as necessary to eliminate the fungus damage and decay. No painting or staining is included in our cost quote. Owner or party of interest must then maintain the porch in a well sealed and caulked manner at all times.

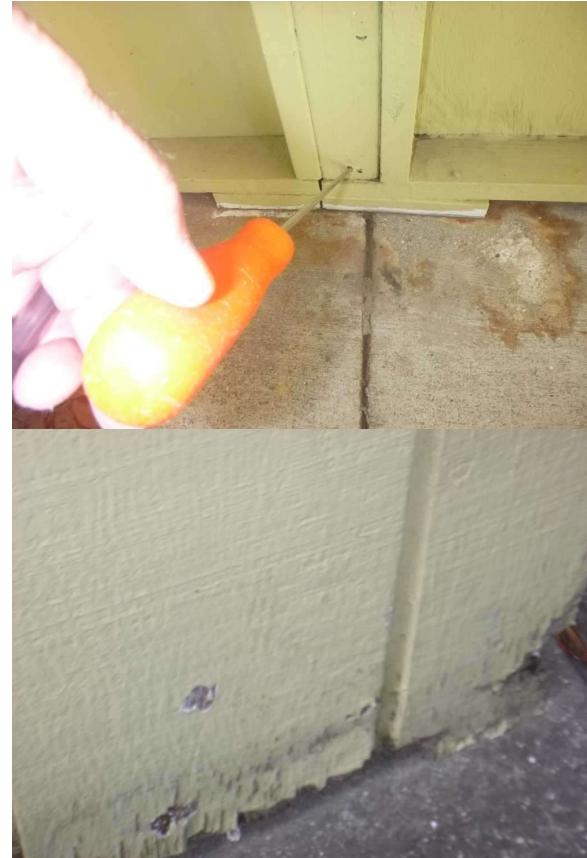
8B. FINDING: Fungus damage was found to the carport framing and T1-11 siding as indicated on the diagram.

RECOMMENDATION: GT Inspects Inc. to cut out all fungus damaged wood framing and sheathing and replace with new material to eliminate the fungus infection. Chemically treat adjacent area with a wood preservative. The wood preservative to be used is Tim-Bor.

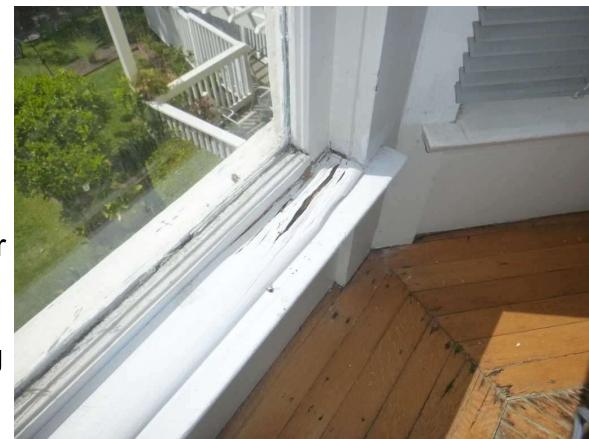
10H. FINDING: This large single lite fixed wood window sash, This single lite swing out wood window sash and the window sill and framing at the bedroom were found to be fungus damaged and decayed as indicated on the diagram.

RECOMMENDATION: GT Inspects Inc. to remove this fungus damaged wood window sashes and replace with new prime painted wood window sashes of like design. GT Inspects to repair the window sill and framing. No finish painting is included in our cost quote. Some minor damage may occur to the interior wood window trim in replacement of the wood window sashes. Existing hardware to be reused if possible.

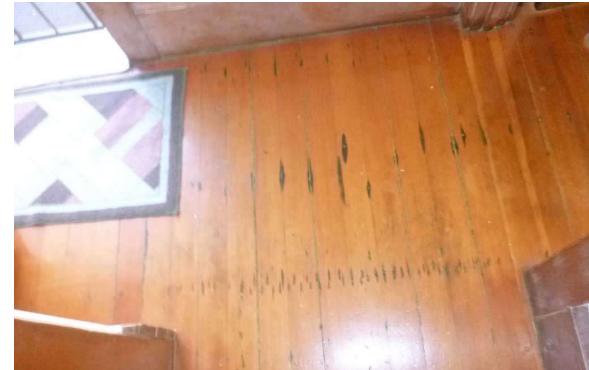
10I. FINDING: Water stains were noted to the hardwood floor covering in various locations. No signs of fungus damage or decay was observed. The cause of the staining is unknown.

RECOMMENDATION: Owner or party of interest should engage the services of an appropriate floor refinisher for recommendations and repairs as necessary. Further information as to the cause of the stains should be directed towards the appropriate contractor or current owner.

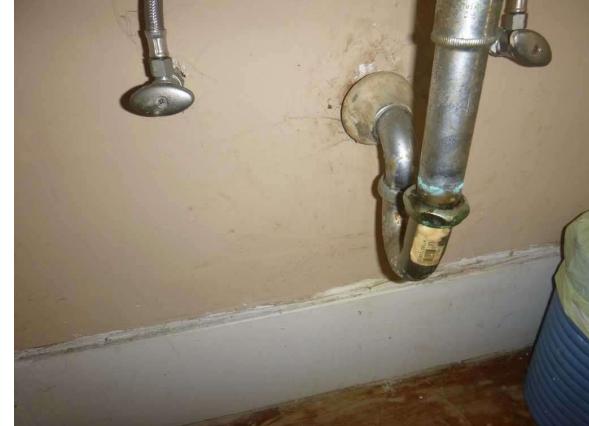
10J. FINDING: The 1/2 bathroom sink P-trap was noted to be rusted and near term replacement as indicated the diagram.

RECOMMENDATION: Owner or party of interest should engage the services of a licensed plumber to repair the sink plumbing as necessary to eliminate the leak.

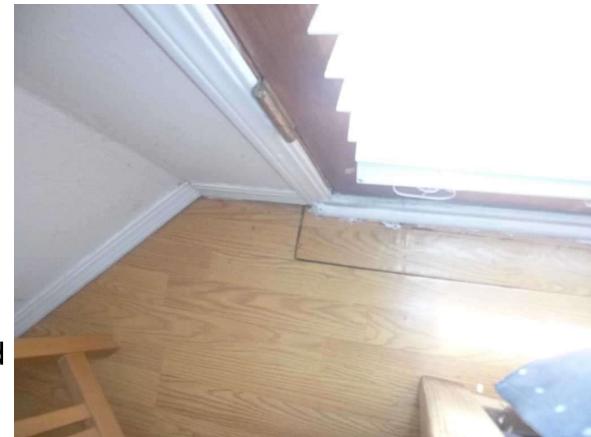
10L. FINDING: Fungus damage was found to the subfloor and framing adjacent to the lower french doors as indicated on the diagram.

RECOMMENDATION: GT Inspects Inc. to repair the fungus damage subflooring, and framing. No finish painting or replacement of the floor covering is included in our cost quote. These repairs to be done in conjunction with our finding 11H.

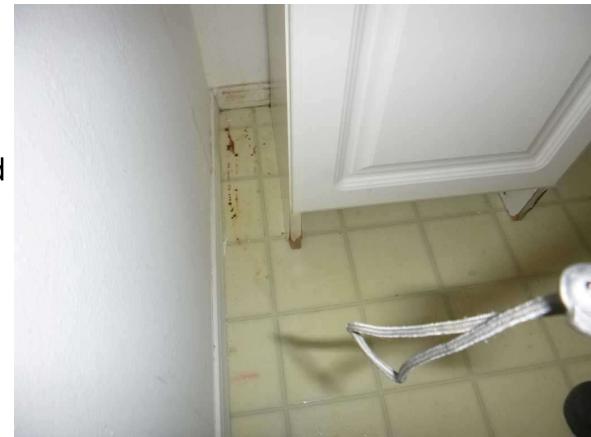
10P. FINDING: The vanity in the lower main bathroom was found to be deteriorated and water damaged. No signs of infestations were seen.

RECOMMENDATION: Owner should keep the vanity well sealed at all times and replace when no longer serviceable.

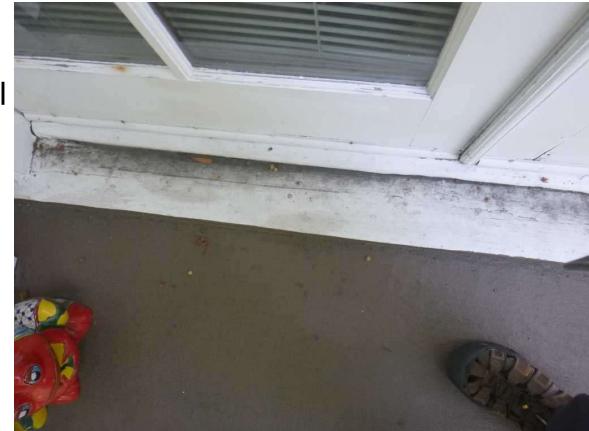
11E. FINDING: The side French doors were found to be fungus damaged and decayed as indicated on the diagram. The door sill was noted to slope inward.

RECOMMENDATION: GT Inspects Inc. to remove the fungus damaged doors/ framing and sill and replace with new prime painted wood doors, framing and sill of like design. No finish painting is included in our cost quote. **PLEASE NOTE:** Some minor damage may occur to the wood door trim/framing in replacement of the door. Existing hardware/lock set to be reused if possible.
