# WOOD DESTROYING PESTS AND ORGANISMS INSPECTION REPORT

| Building No.<br><b>757</b> | Street<br><b>Santa Ray Avenue</b> | City<br><b>Oakland</b> | Zip<br><b>94610</b> | Date of Inspection<br><b>04/21/2025</b> | Page:<br><b>1 of 18</b> |
| | | | | <b>G225415- Santa Ray Ave, 757</b> | |

| General Description:<br><b>A two story duplex with no garage</b> | Inspection Tag Posted:<br><b>Subarea</b><br>Other Tags Posted:<br><b>None Noted</b> |

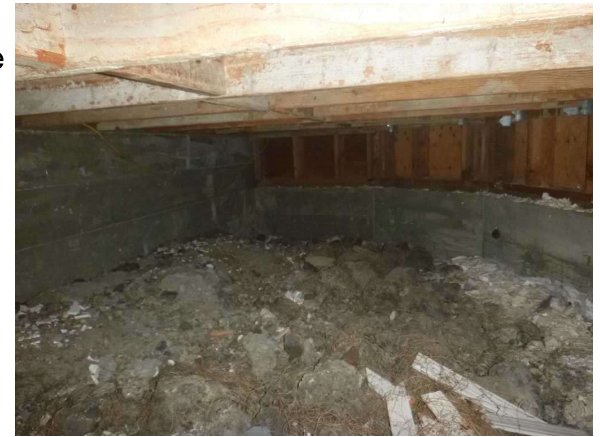
**1C. FINDING:** Fungus infected cellulose debris was found in the portion of the accessible subarea as indicated on the diagram. Cellulose debris can and does attract subterranean termite activity and is important to remove.

**RECOMMENDATION:** GT Inspects Inc. to remove all debris of a size that can be raked and/or larger and dispose of the same.

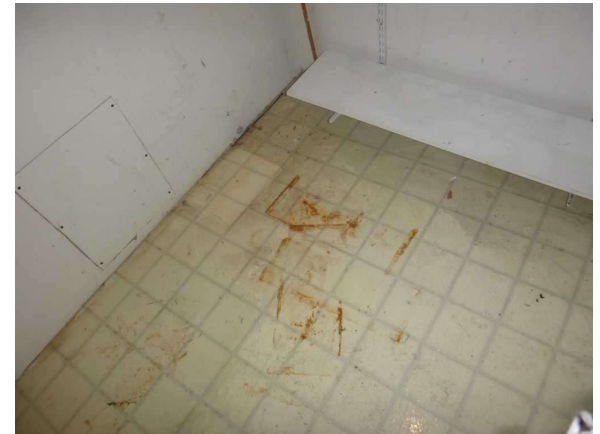
**1E. FINDING:** Signs of past moisture intrusion were noted to have occurred in the basement at the area indicated on the diagram. This is not uncommon to a structure in this area. The amount or cause of the moisture intrusion occurring was beyond the scope of this inspection.

**RECOMMENDATION:** Further information desired regarding the moisture intrusion should be directed towards an appropriate drainage contractor.

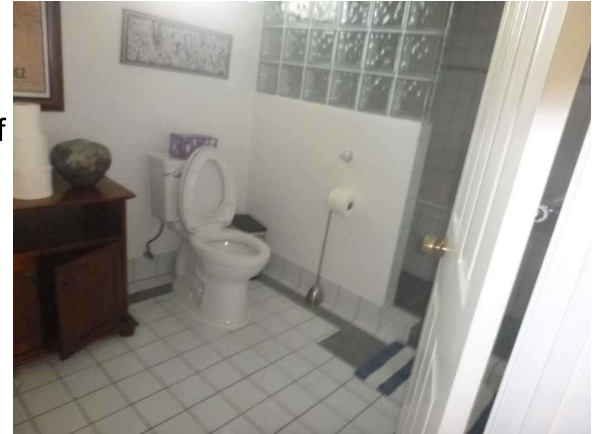
**2A. FINDING:** The lower insuite bathroom shower was not water tested due to it was over concrete slab. Water testing of the shower could cause water damage to the surrounding areas if the shower leaked. There was no outward signs of leakage at visible areas at the time of the inspection. There is no warranty that the stall shower would not leak if a water test was applied.

**RECOMMENDATION:** Owner or party of interest should maintain the stall shower in a well sealed and caulked manner at all times. At the request of the owner or party of interest and release of liability, GT Inspects Inc. would return and apply a standard water test. GT Inspects Inc. would issue a supplemental report outlining our findings and recommendations and price quote if any.

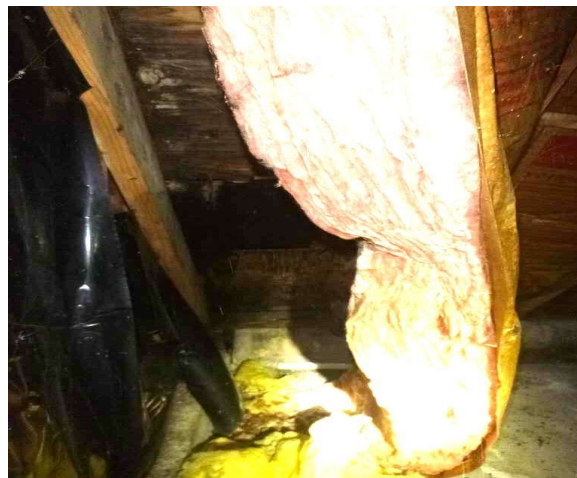
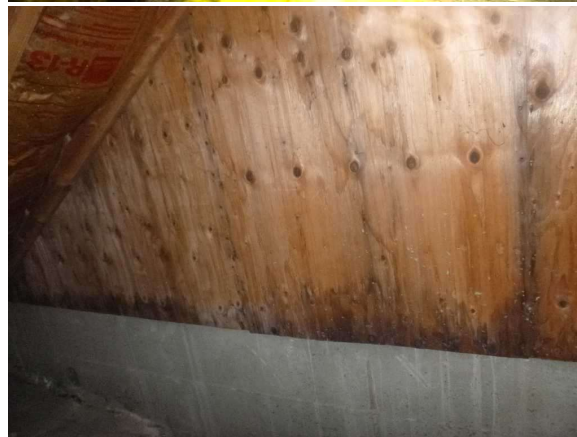
**4A. FINDING:** Fungus damage and decay was observed at the wood framing and sheathing beneath the concrete on wood framed front porch and stairs at the location as indicated on the diagram. The cause of the damage is due to moisture intrusion occurring at this area. The extent of the damage could not be determined due to the finished walls and insulation present. It was noted that the area beneath the porch has been converted to useful living space ( closet) and there were signs of past moisture intrusion.

**RECOMMENDATION:** GT Inspect Inc. to remove the insulation and the sheetrock. If additional damage is found additional costs may occur. GT Inspects Inc. to repair the fungus damaged framing and sheathing with new material to eliminate the fungus infection. The new material to be used will be pressure treated douglas fir framing as available. GT Inspects will treat this area with a registered fungicide. The fungicide to be used is Timbor (see chemical disclosure for active ingredients). GT Inspects Inc with then reinstall the sheetrock and insulation and tape texture to match exiting. At completion of repairs, owner or party of interest to engage the services of waterproofing contractor to seal the porch and stairs to prevent further moisture intrusion and decay. Failure to maintain the porch in a well sealed and caulked manner at all times will result in future moisture intrusion and decay.

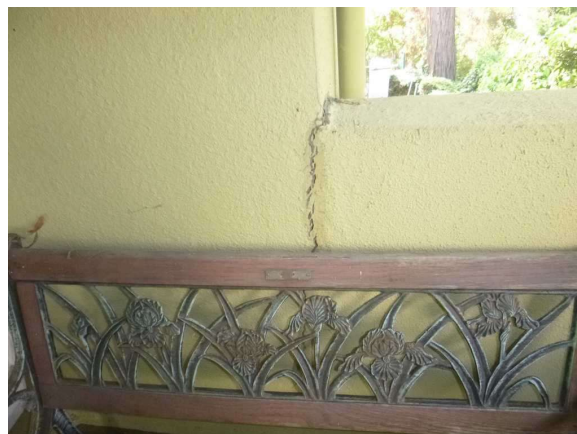
**4B. FINDING:** A stress crack was noted at the stucco buttress wall at the front porch area. This appears to be due to past settlement of the porch.

**RECOMMENDATION:** Owner should seal the crack. Further information desired regarding the settlement should be directed towards the appropriate contractor.

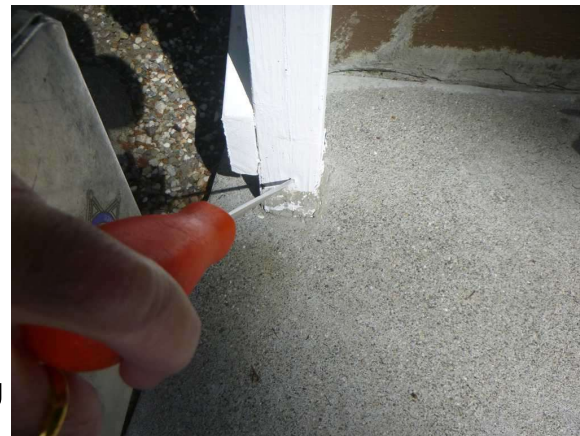
**4C. FINDING:** The side stairs handrail post was found to be fungus damaged and decayed. It appears that the existing handrail can be repaired.

**RECOMMENDATION:** GT Inspect Inc. to repair the existing handrail as necessary to eliminate the fungus damage. No painting is included in our cost quote. No code upgrades are included in this cost quote.

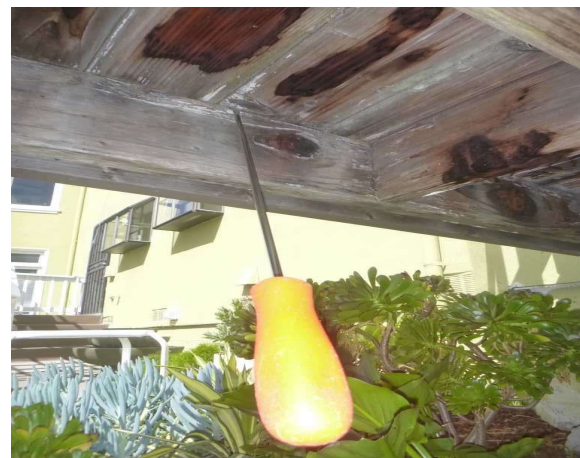
**4F. FINDING:** Fungus damage was found to the rear wooden porch as indicated on the diagram.

**RECOMMENDATION:** GT Inspects Inc. to repair the porch and framing as necessary to eliminate the fungus damage and decay. No painting or staining is included in our cost quote. Owner or party of interest must then maintain the porch in a well sealed and caulked manner at all times.

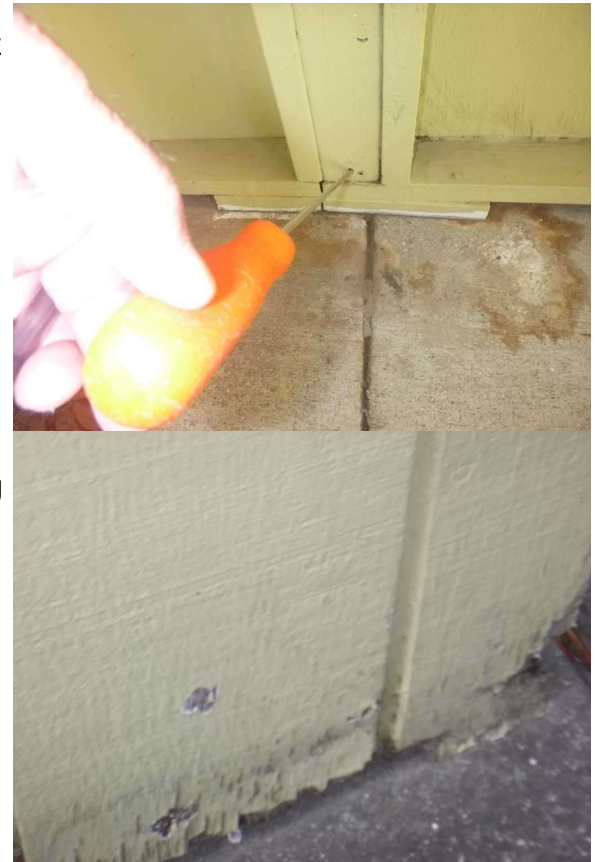
**8B. FINDING:** Fungus damage was found to the carport framing and T1-11 siding as indicated on the diagram.

**RECOMMENDATION:** GT Inspects Inc. to cut out all fungus damaged wood framing and sheathing and replace with new material to eliminate the fungus infection. Chemically treat adjacent area with a wood preservative. The wood preservative to be used is Tim-Bor.

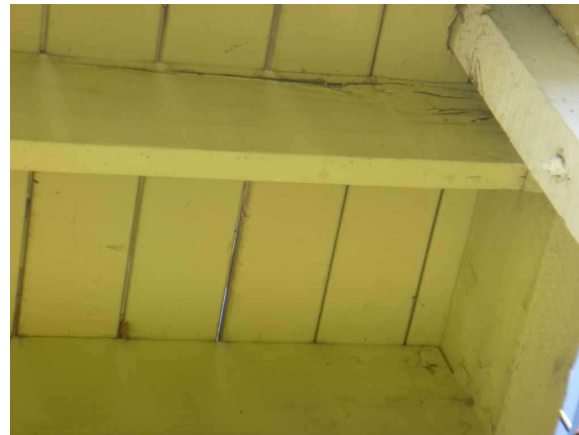
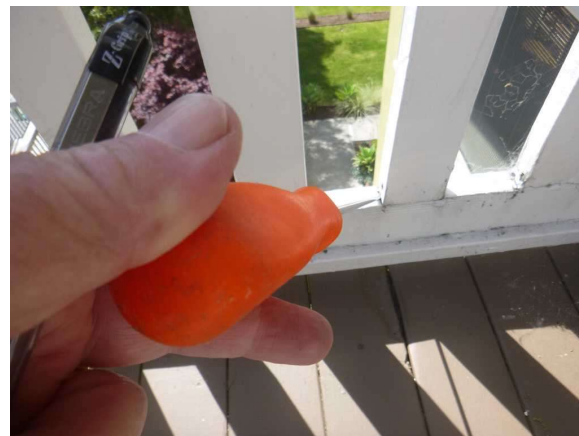
**9C. FINDING:** The detached patio cover at the rear was not inspected or included in this report.

**RECOMMENDATION:** Upon request and for an additional fee, GT Inspects Inc. would return to inspect the cover and issue a supplemental report outlining our findings, recommendations and repairs as necessary.

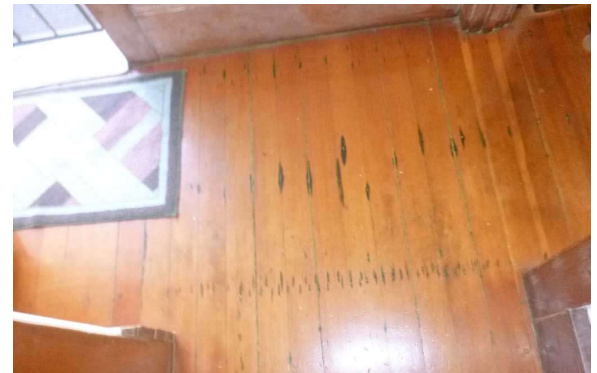
**10I. FINDING:** Water stains were noted to the hardwood floor covering in various locations. No signs of fungus damage or decay was observed. The cause of the staining is unknown.

**RECOMMENDATION:** Owner or party of interest should engage the services of an appropriate floor refinisher for recommendations and repairs as necessary. Further information as to the cause of the stains should be directed towards the appropriate contractor or current owner.

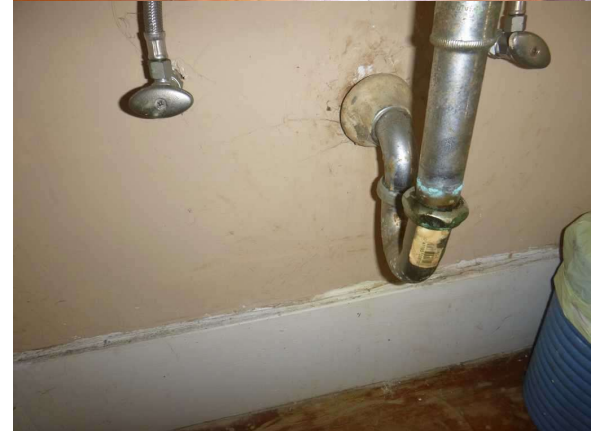
**10J. FINDING:** The 1/2 bathroom sink P-trap was noted to be rusted and near term replacement as indicated the diagram.

**RECOMMENDATION:** Owner or party of interest should engage the services of a licensed plumber to repair the sink plumbing as necessary to eliminate the leak.

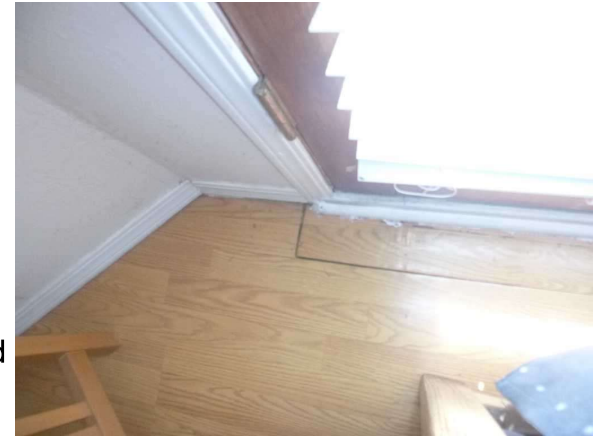
**10L. FINDING:** Fungus damage was found to the subfloor and framing adjacent to the lower french doors as indicated on the diagram.

**RECOMMENDATION:** GT Inspects Inc. to repair the fungus damage subflooring, and framing. No finish painting or replacement of the floor covering is included in our cost quote. These repairs to be done in conjunction with our finding 11H.

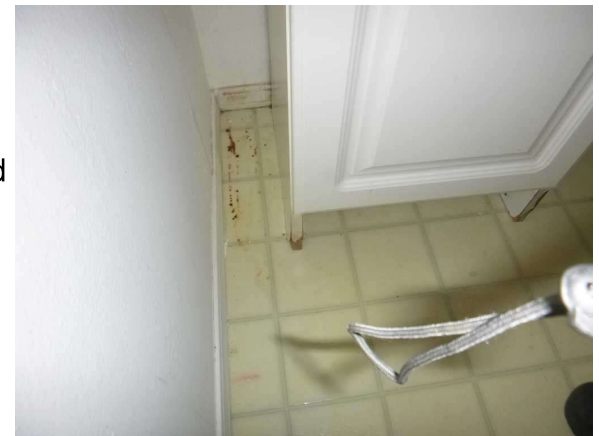
**10P. FINDING:** The vanity in the lower main bathroom was found to be deteriorated and water damaged. No signs of infestations were seen.

**RECOMMENDATION:** Owner should keep the vanity well sealed at all times and replace when no longer serviceable.

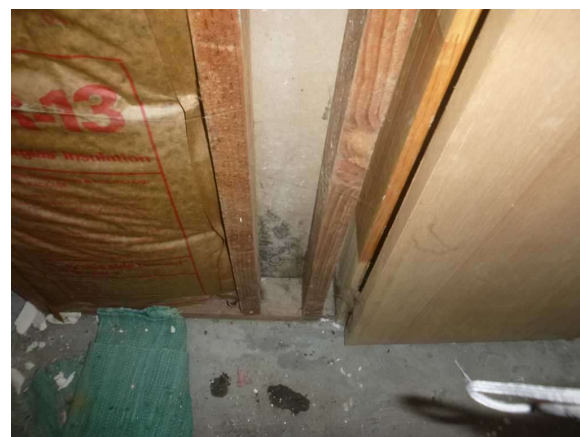
**10U. FINDING:** Moisture intrusion and decay was noted at the closet area beneath the front porch and the stair area.

**RECOMMENDATION:** See finding and recommendation 4A.

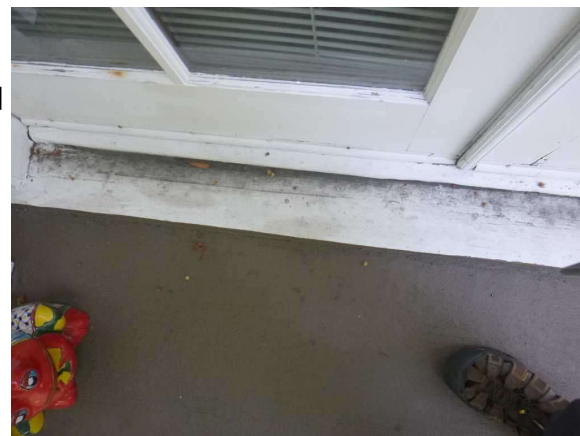
**11E. FINDING:** The side French doors were found to be fungus damaged and decayed as indicated on the diagram. The door sill was noted to slope inward.

**RECOMMENDATION:** GT Inspects Inc. to remove the fungus damaged doors/ framing and sill and replace with new prime painted wood doors, framing and sill of like design. No finish painting is included in our cost quote. **PLEASE NOTE:** Some minor damage may occur to the wood door trim/framing in replacement of the door. Existing hardware/lock set to be reused if possible.

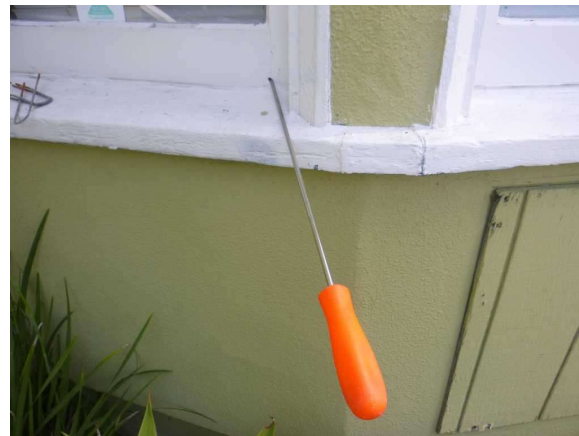
**11G. FINDING:** Deterioration was noted to the exterior subarea access.

**RECOMMENDATION:** GT Inspects Inc. to remove the fungus damaged doors/ framing and sill and replace with new prime painted wood doors, framing and sill of like design. No finish painting is included in our cost quote. **PLEASE NOTE:** Some minor damage may occur to the wood door trim/framing in replacement of the door. Existing hardware/lock set to be reused if possible.
