1. Visual Board Inspection & Photograph

2. Power System Evaluation

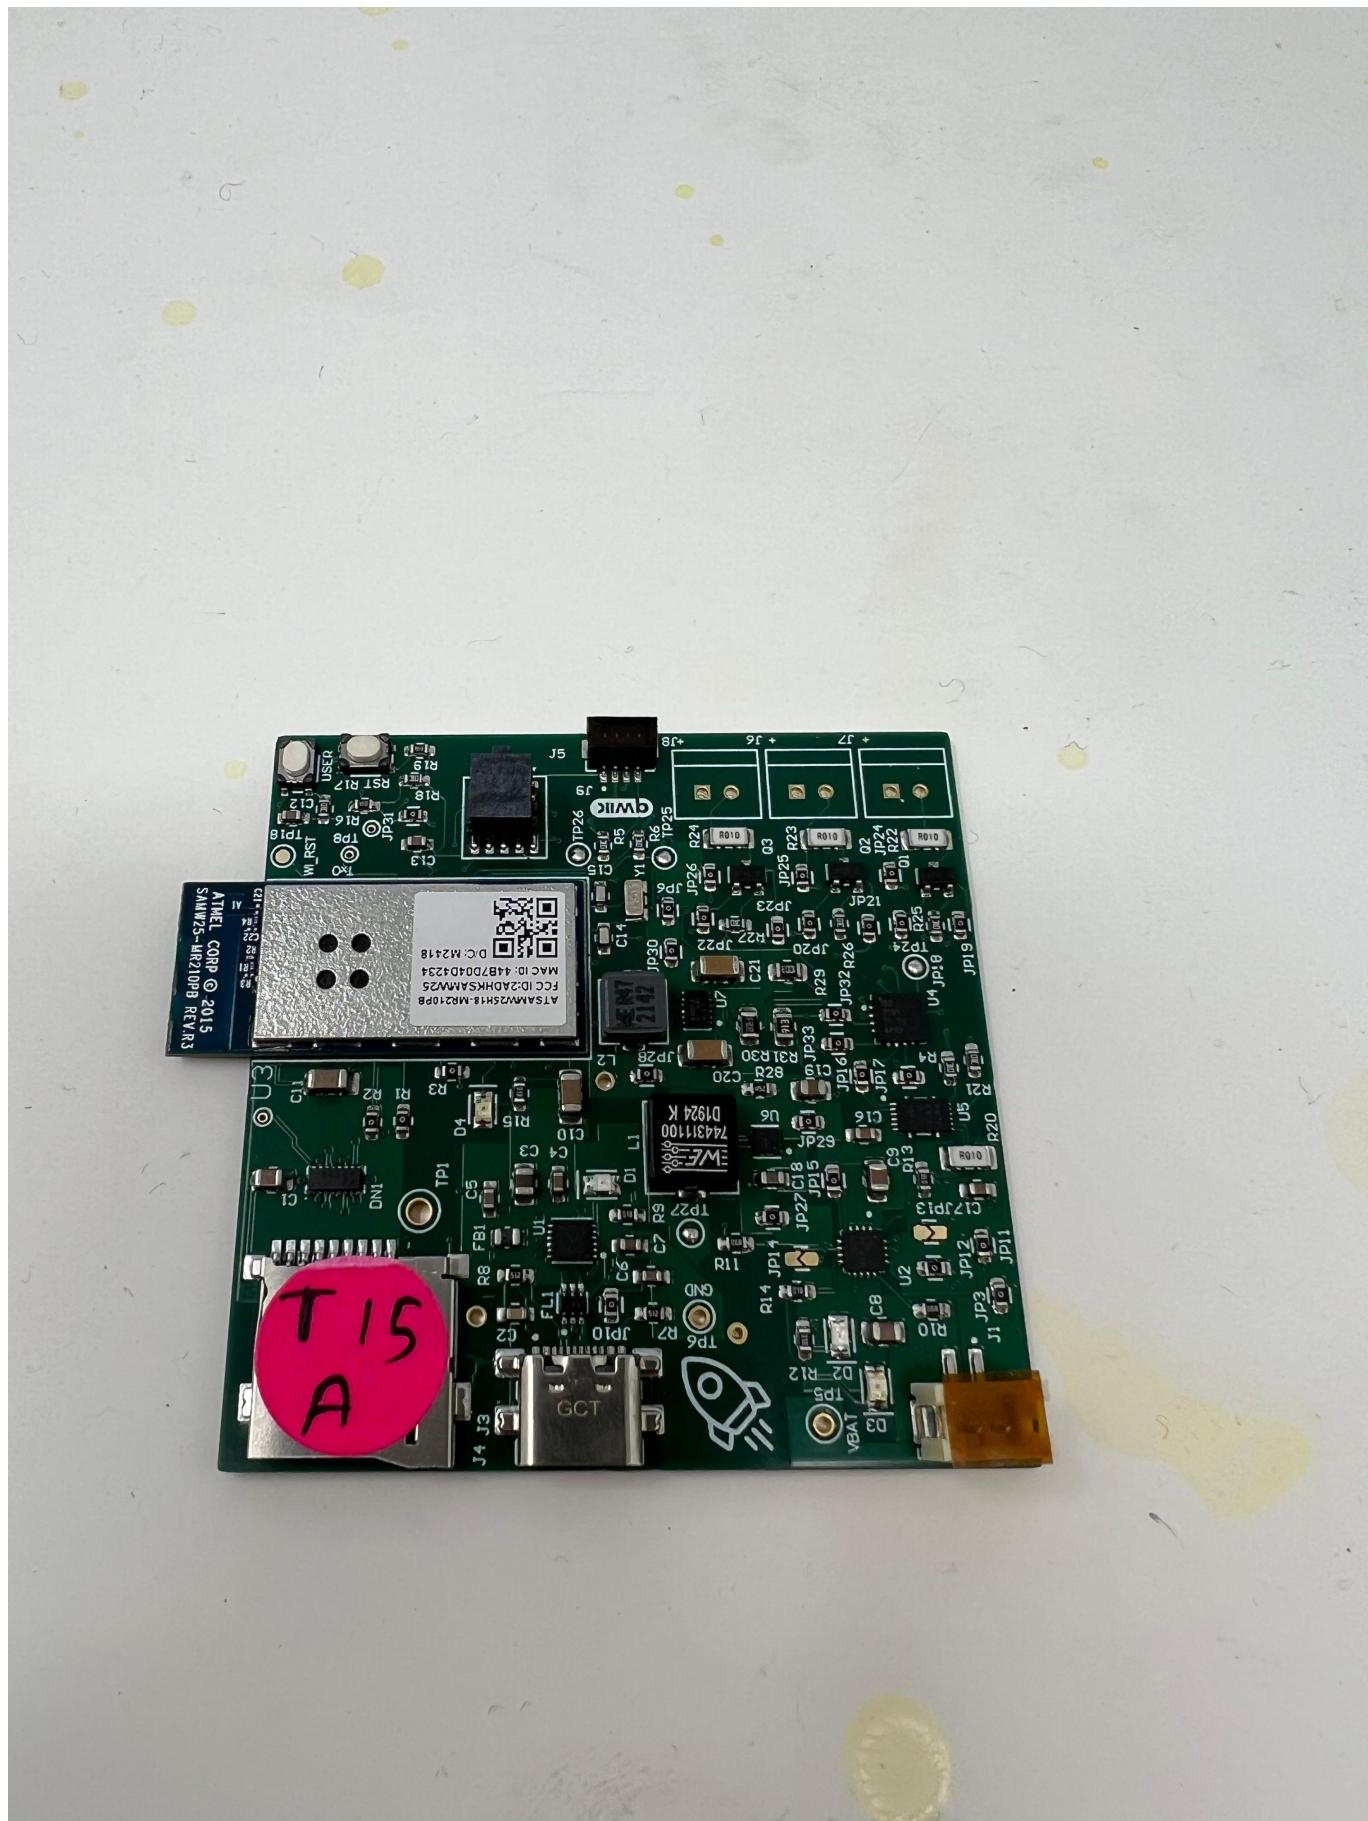
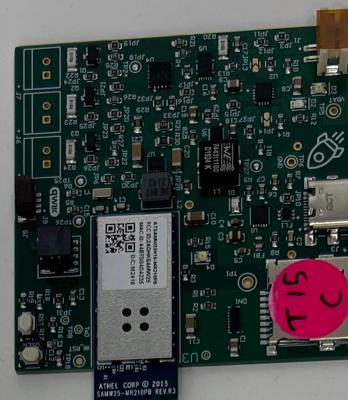
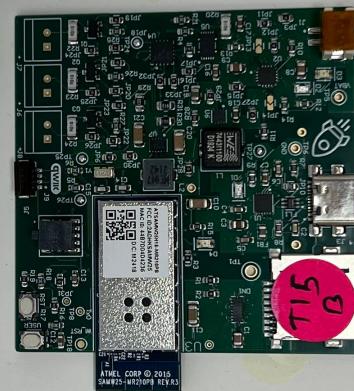
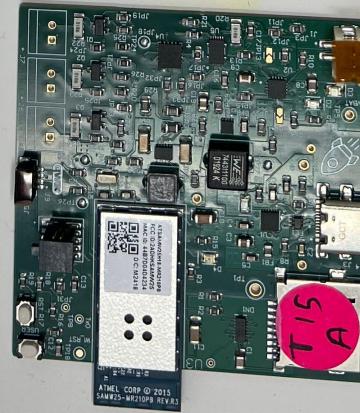
Noticed here that jumpers JP14 and JP13 are missing

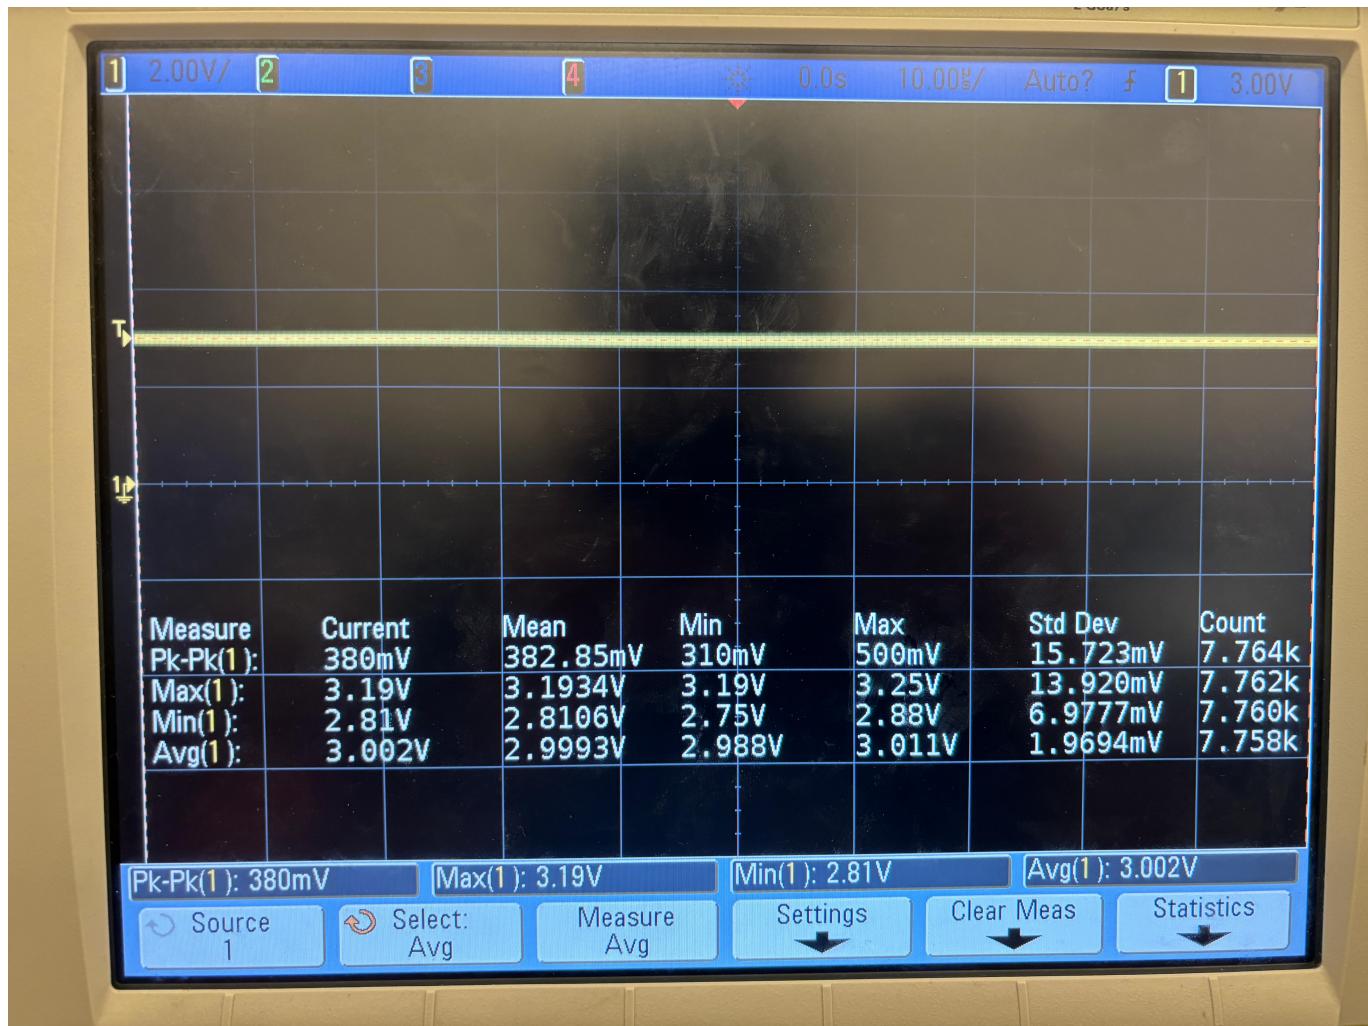
1. 3.3V :

- Average Voltage: 3.002 • Error: 0.3V • minimum Voltage: 2.81V • Maximum Voltage: 3.19V • DC offset: ~0.298 V → 9.0 % • Peak-to-peak ripple: 0.380 V → 11.5 % of 3.3 V (≈12.7 % of the measured average)

- 3.3V Rail: Within spec on average, but ripple may need optimization.
- 5V Rail: Functional, but transient spikes may pose a risk to sensitive components.

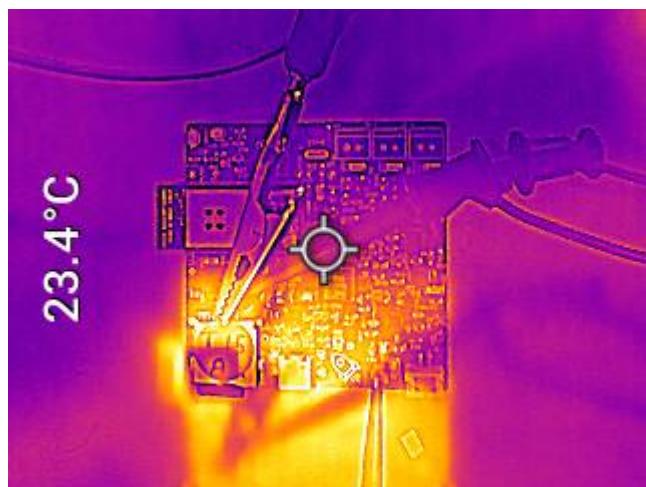
2.4 Thermal Image

The PCBA was running under 55% capacity, 0.6A
