MEMJET®

PRINT QUALITY ARTEFACTS *Reference Guide*

PRINT QUALITY ARTEFACTS REFERENCE GUIDE

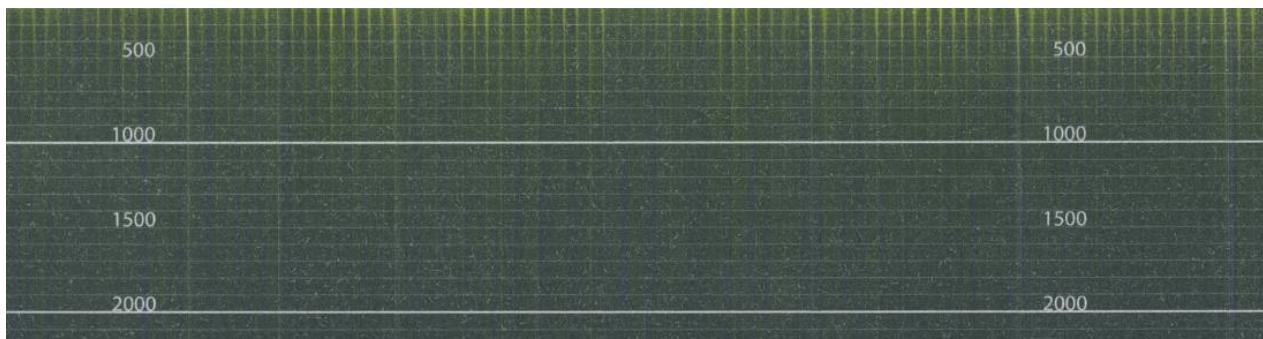
PQ ARTEFACT 8 – 1 MM INTERVAL COLOR CONTAMINATION

Fresh ink is feeding into the properly cleared areas, and the contaminated ink takes longer to clear in the eddies.

Description: Color contamination lines that continue at ~1 mm intervals after the majority of the color has cleared.

Cause: Ink mixing clears in this manner due to the location of the feed holes in the backchannel.

- a) Contaminants diffuse into the back channel.
- b) Artefacts such as those in PQ 6.

- a) PH surface must be cleaned
- b) Spit sufficient ink during maintenance
- c) Others as for PQ 6.

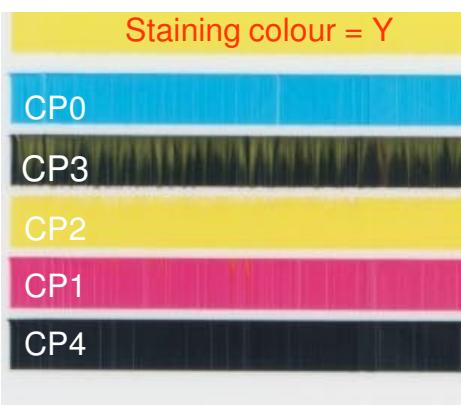
PQ ARTEFACT 10 – COLOR MIX AFTER HEAVY PRINTING

Description: After printing long area fills with a primary (or secondary) color, adjacent color rows that were not ejecting are stained with the ink that was printing.

Cause: Ink migration across the MEMS surface from heavily printing nozzles into nearest odd or even nozzle row that was not printing.

What to do: Check color profiles ink limits.

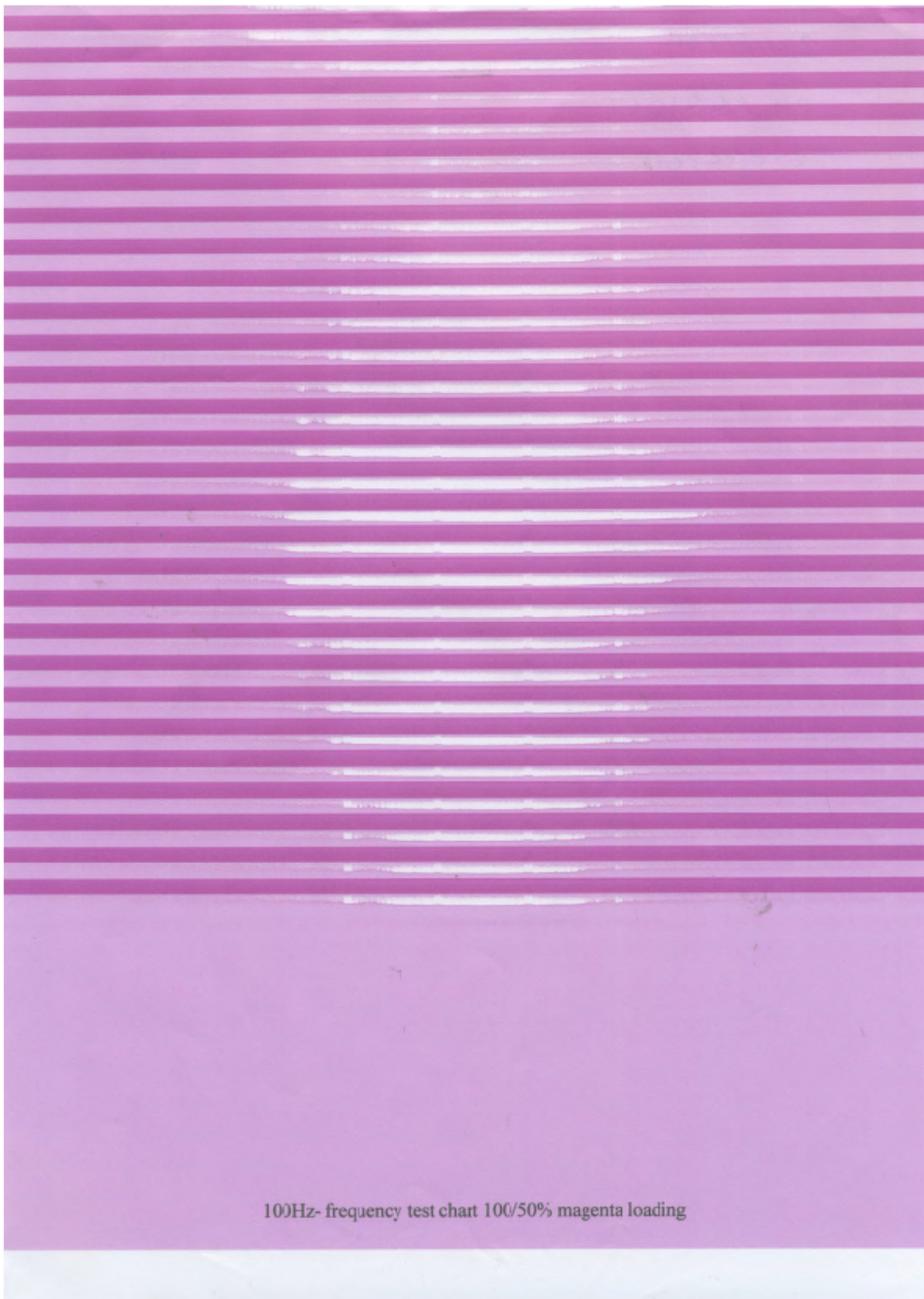
PQ ARTEFACT 11A – FLUIDIC RESONANCE FLOODING VOID AREAS

Description: When printing horizontal bars of alternating dark and light color bands void areas show in lighter color bands. Worse at higher temperatures.

- a) Repeating patterns excite resonance in the printhead (like an organ pipe) that eventually makes ink pressure go positive allowing ink to flood out onto PH surface. Nozzles are then not able to eject through flood until flood clears. Most obvious when firing reduced number of nozzles in light color areas.
- b) Ink in air boxes due to incorrect PH handling.

- a) Avoid resonance frequency OR add resonance damping elements to IDS or cartridge.

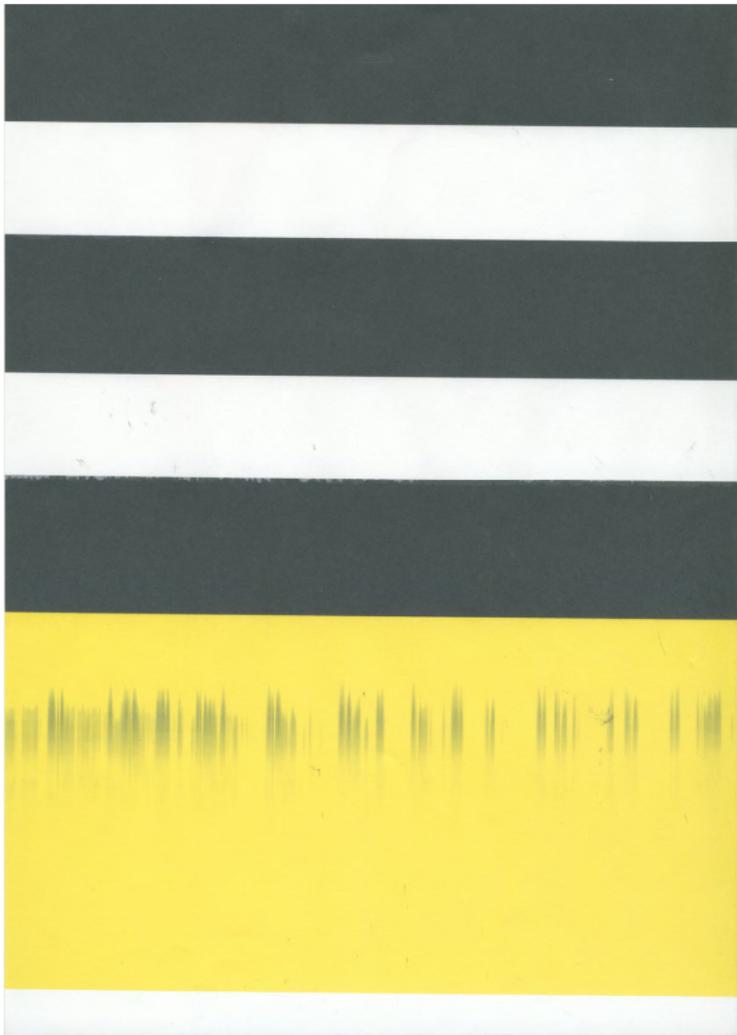
PQ ARTEFACT 11B – FLUIDIC RESONANCE FLOODING COLOR MIXING

Description: When printing horizontal bars or alternating color and no-color, brief color mixing sometimes seen a short distance after trailing edge of flooding color plane's printed bar.
Worse at higher temperatures.

- a) Repeating patterns excite resonance in the printhead (like an organ pipe) that eventually makes ink pressure go positive allowing ink to flood out onto PH surface. When the standing wave goes negative again, ink gets sucked back into the nozzles.
- b) Ink in air boxes due to incorrect PH handling.

- a) Avoid resonance frequency OR add resonance damping elements to IDS or cartridge.

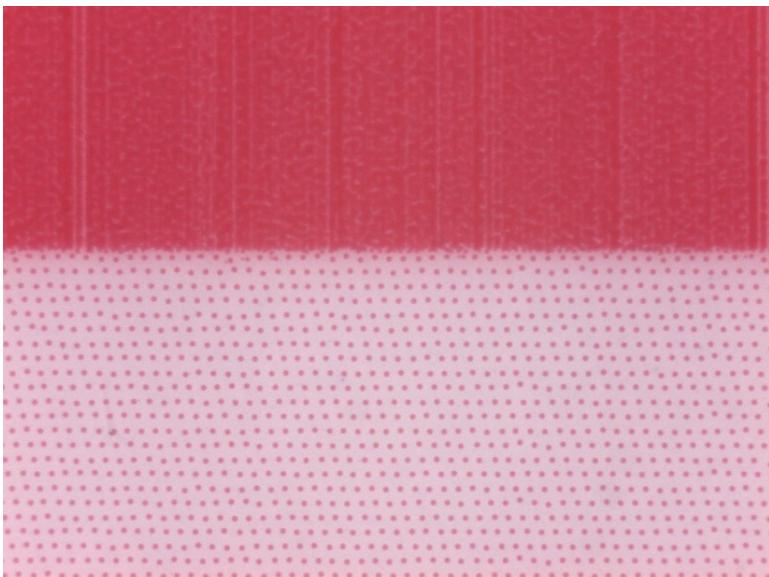
PQ ARTEFACT 13 – WANDERING HORIZONTAL LINES/EDGES

PPS = 1.45 mm

Description: Grainy patterns in area fills, wandering horizontal lines or horizontal edges.

Cause: Excessive pen-to-paper distance.

Same printhead with PPS = 0.80 mm

What to do: Move paper closer to nozzles.

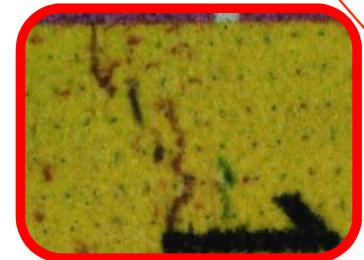
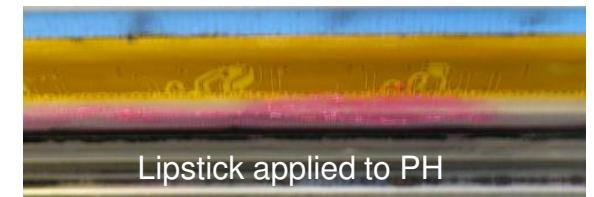
PQ ARTEFACT 15 – LINTY LOOKING PRINTS

Description: Looks like there is lint spread out down the page.

- a) Insufficient PPS or
- b) Wet curl of media under PH.

- (a) Check PPS
- (b) Check maintenance routines
- (c) Set color profile ink limits for the media.

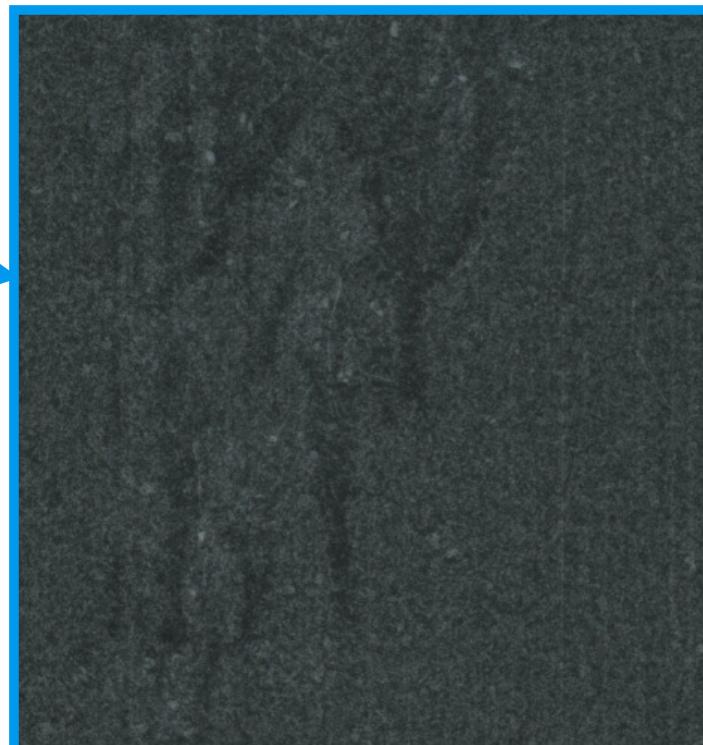
PQ ARTEFACT 19 – CONDENSATION ON PRINthead

Description: Mottled appearance on high density prints. Can happen while printing a single page with 100% ink coverage. Black and magenta seem to be worse.

Cause: Water vapour from the thermal inkjet droplet ejection process condenses on prnthead forming into beads of water as printing proceeds. These beads eventually grow large enough to touch the paper and smudge the print.

- a) Check color profiles
- b) Check maintenance routines.

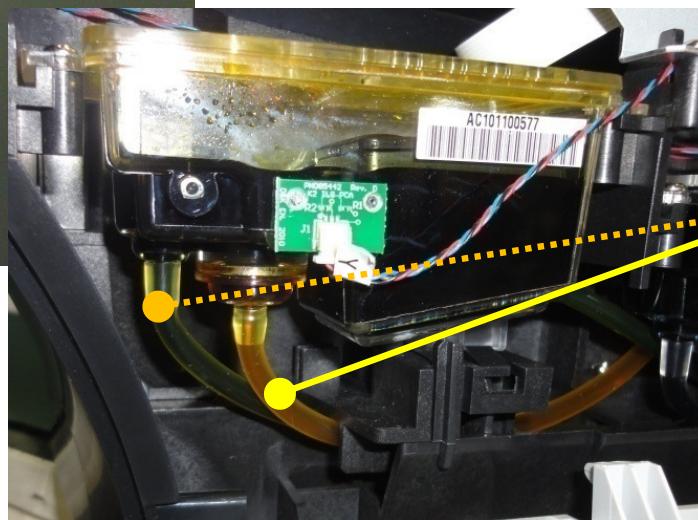
PQ ARTEFACT 25 – WRONG COLOR PRINTED

Description: The wrong color is printed

- a) The wrong color profile has been selected or
- b) A severe uniform color mixing failure has occurred.

Same image/profile printed on two different printers. The left one has severe uniform color mixing, as shown when compared with the internally generated document beneath.

Accumulator with tubes showing different colors: One tube is coming from the ink tank, the other is connected to the IDS and some color mixing has occurred.

- a) Check color profile
- b) Address cause of color mixing
- c) Check color management settings in OS / App.

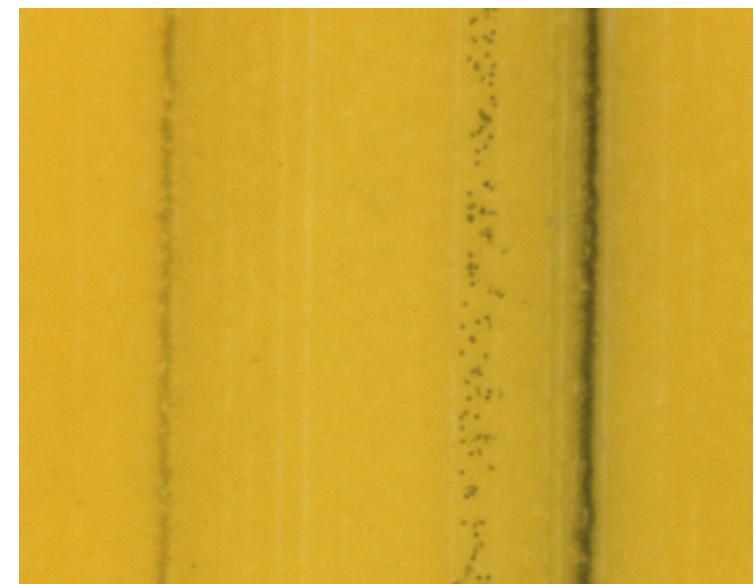
PQ ARTEFACT 28 – RAT TAILS

Rat tails in cyan, magenta and yellow

Description: Prints after a pause of a few ten's of seconds without keep wet have fine trails of mixed ink. Get longer and wider with more time idle & capped and with increasing differential pressure between ink colors. May be the same as Artefact #7.

- a) Surface fibre causes fluidic bridge between color
- b) Dehydrated nozzles not ejecting properly cause micro-flood on MEMS surface

Magnified view showing trails of discolored dots

- a) Repeat print
- b) Use Fixme button.

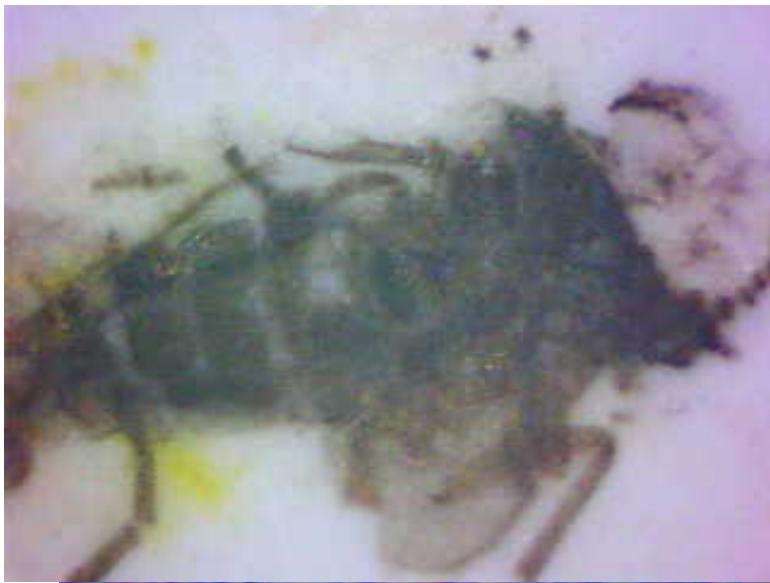
PQ ARTEFACT 30 – VOIDS AND BLEMISHES

Description: Small light or dark patches appear in the middle of printed areas. These are typically <1mm in diameter.

Cause: Media defect.

Hydrophobic particles embedded in the media prohibit ink being properly absorbed into the body of the paper. Instead the ink either migrates to the edges of the particles where the print appears slightly darker or produces very low dot gain drops.

What to do: If objectionable, then re-print only affected pages, since these are typically isolated artefacts.
