# Lil' Willy 001 Accident Report

E-Town Rocket Bureau

| <b>Flight Number:</b> Flight #1 |
| <b>Crash Date:</b> March 29, 2026 |

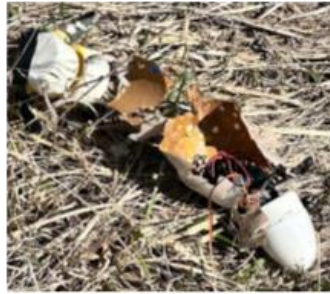
Lower Section with shattered Coupler and damaged fuselage

Although the Aft System and its fins survived, the engine sustainer was bent into multiple angles, the top part of the lower fuselage collapsed, and the coupler fragmented into multiple pieces with fault lines running through them. The heat-resistant lining was not visible, although the gas expansion nozzle was intact. The upper fuselage was completely destroyed, the remnants of the airbrake were ejected from the rocket and had melted parts. The egg was found disintegrated in its capsule, and a carbon fiber rod was found to have penetrated deep into the capsule. Additionally, the capsule also bore burn marks. The avionics bay was fragmented and

- I. Redesign of the coupler and parachute deployment system:
  - A. Removal of weight-reducing gaps to increase parachute deployment reliability (reduces risk of the parachute getting caught)

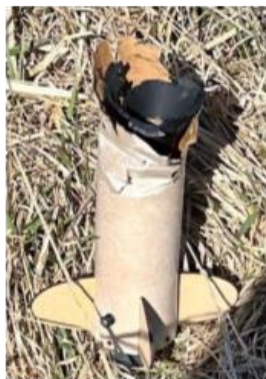
Undeployed parachute and airbrake piece

Excessive friction between the coupler and the upper stage caused by adhesive tape likely prevented separation upon deployment of the ejection charge.

- B. Parachute stored in the bottom section (as opposed to the current top-stored one which can get stuck)
  - C. Parachute grounded to the tether between the upper and lower sections

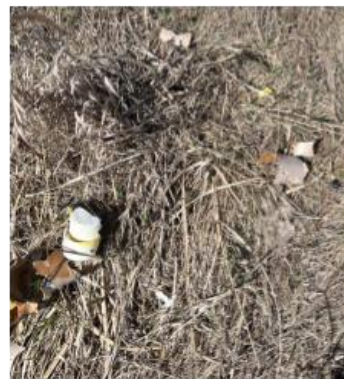
Another angle of the Lower Section
