# St James' Weir Assessment Report

Document: R10 Version: 2

South West Fish Passes

Environment Agency

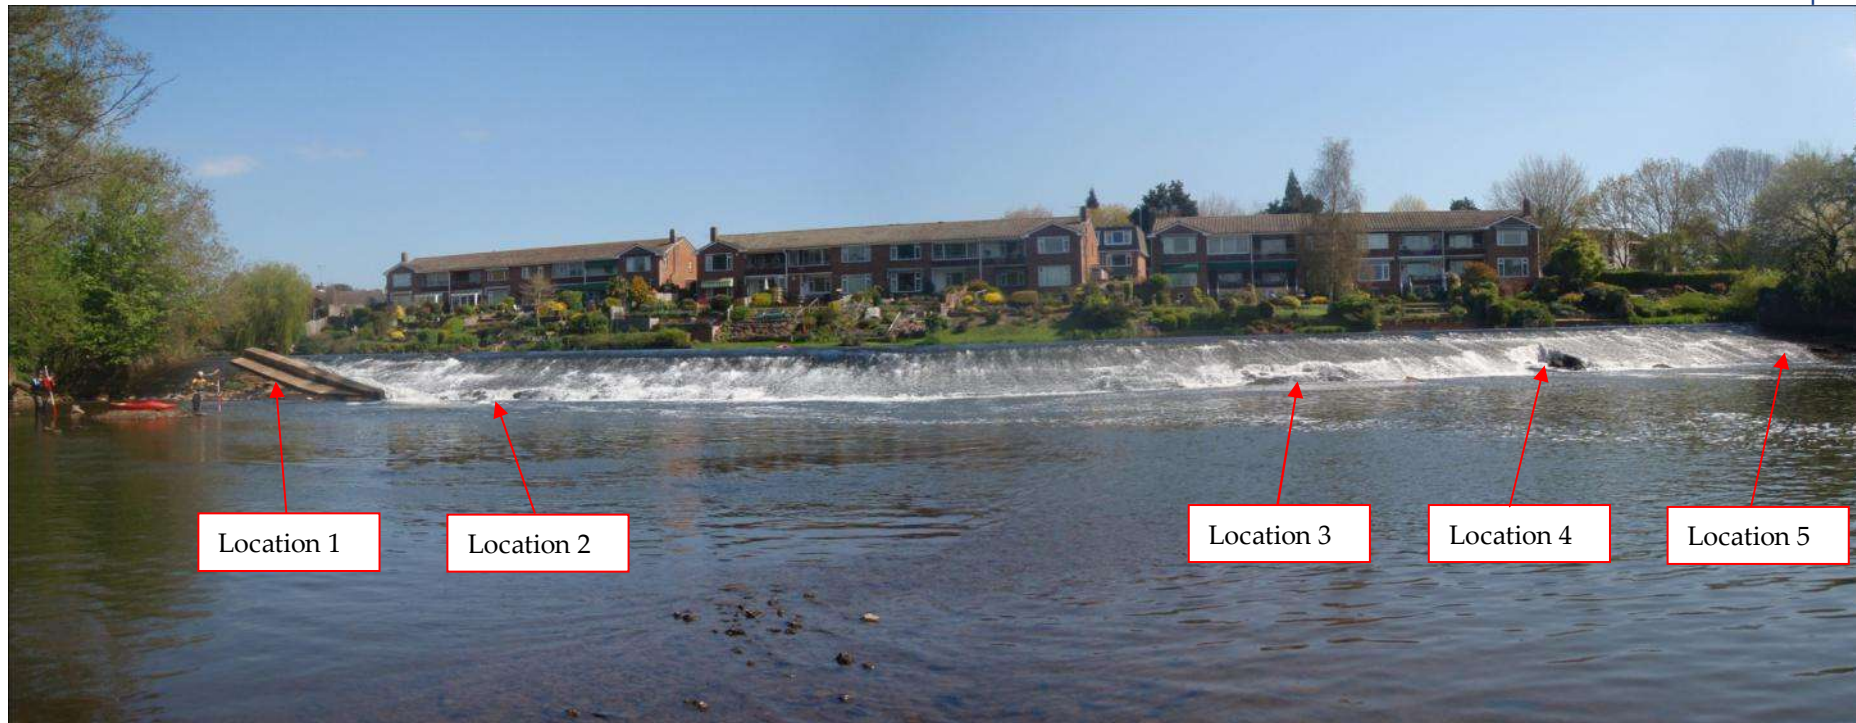
Areas where significant defects were identified are shown in Figure 2-6 and Figure 2-7 below and a detailed description of each defect is provided in section 2.4 below.

Figure 2-7: Defect locations

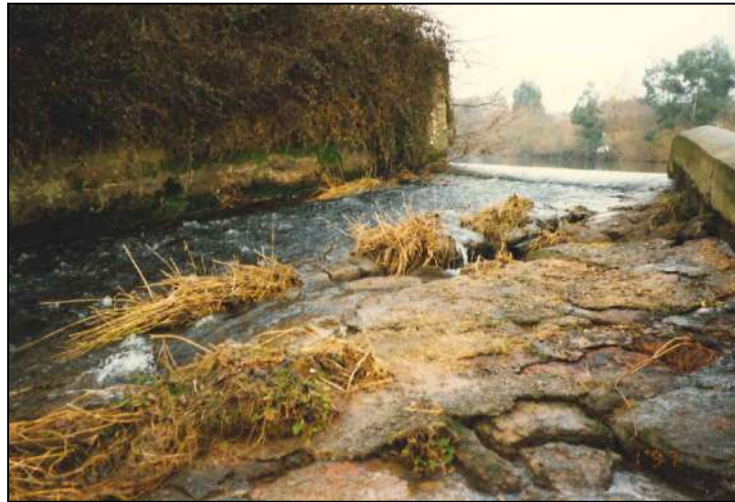
Figure 2-10: Location 1 in 1996

Whilst leakage and mortar loss in the weir at this location is considered to be a defect, a photo from 1997 (see Figure 2-10 below) taken before the baulk improvement works were carried out, shows the weir to be in similar condition at that time. Therefore, the weir in this location does not appear to be deteriorating at a noticeable rate and does not in itself present a threat to the integrity of the weir itself in the short or medium term.

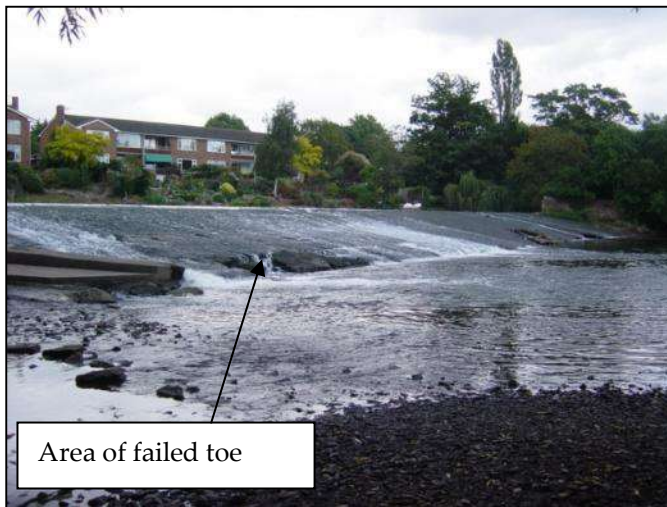
Historical photos show this failure originally occurred at some time between 1996 and 2003, see Figure 2-13 and Figure 2-14 below. The failure at this location

does not appear to have significantly worsened since 2003 and is therefore not considered to be a threat to the integrity of the weir in the short or medium term.

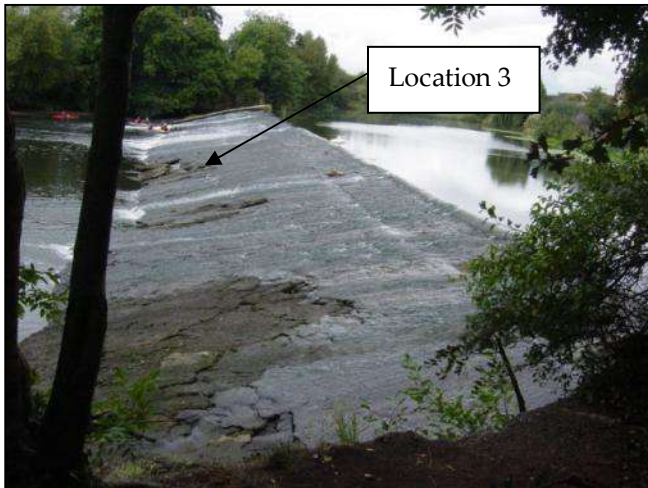
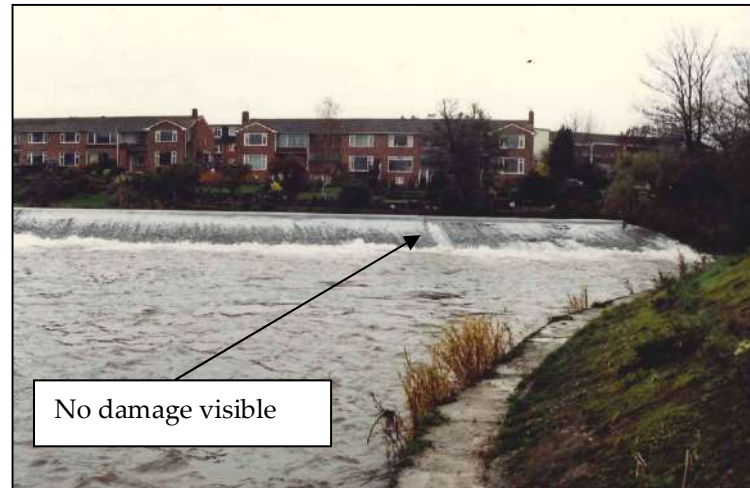
From historical photos, see Figure 2-17 and Figure 2-18 below, damage in this area was not apparent in 1996 but initial failure was evident at this location in 2003.

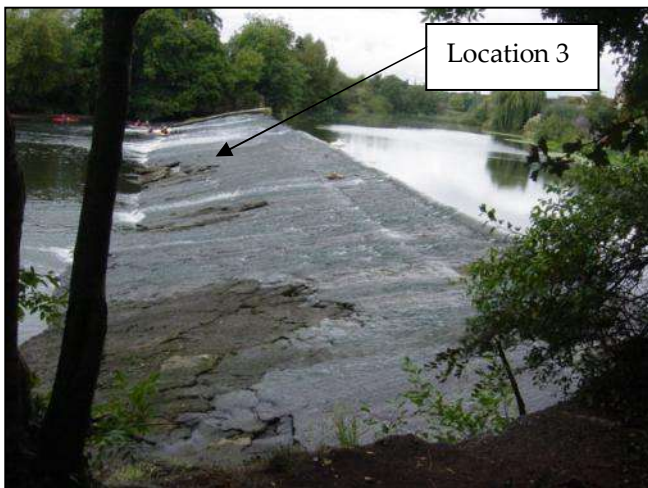
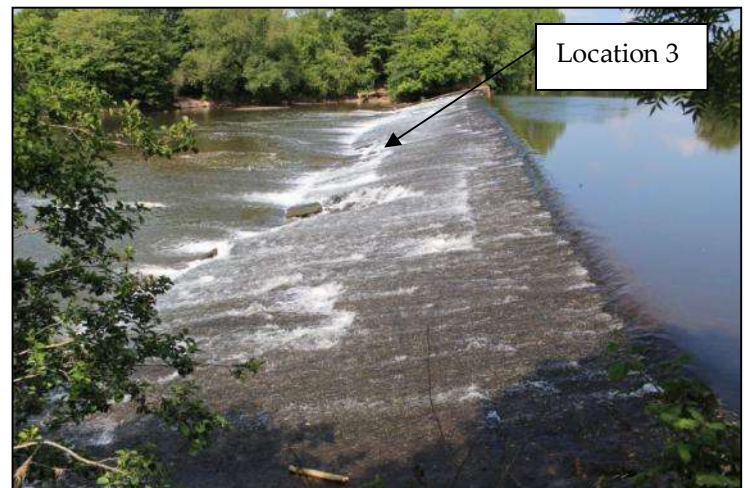
A comparison of the 2003 photo and 2013 photo, see Figure 2-19 and Figure 2-20 below, shows that the damage in this area has not significantly worsened in the last 10 years.

It is considered that the damage in this area is not a threat to the integrity of the weir in the short term, however further scour and progressive failure is expected in the medium term which could ultimately result in a breach in the weir.

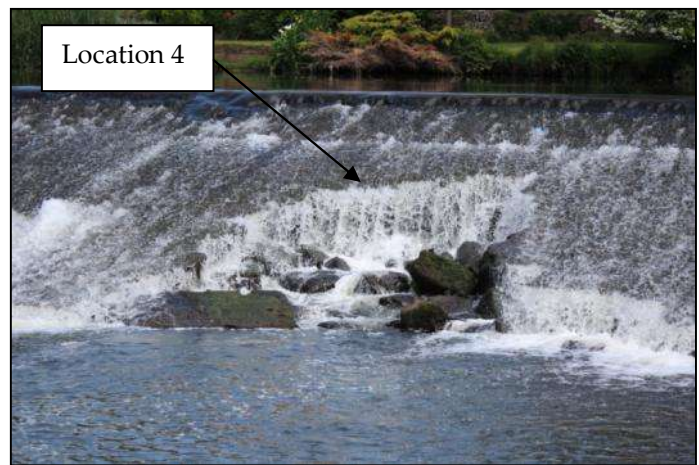
Figure 2-21: Location 4

Location 4 is the most significant area of damage of the weir. The damage comprises a large horseshoe shaped hole in the weir glacis. The edge of the whole is vertical and around 1.0m high. The vertical face is undercut by approximately 0.5m leaving a 4m width of weir between the back of the hole and the weir crest. In the base of the hole is a mixture of stone and concrete rubble. The hole extends approximately halfway through the weir structure, see Figure 2-21 and Figure 2-22 below. It would appear that the failure was initiated by progressive undermining of the toe from downstream due to turbulence in the weir pool. This led to the subsequent formation of a void under the glacis, leading to collapse of the glacis.

The rate at which the hole continues to grow will depend on the number of flood events occurring in forthcoming years as most damage is likely to be caused during high flows. If the hole continues to grow at the same rate as it has over the last 10 years, then a full breach of weir can be expected by 2023.

Once the main weir crest is breached and the alluvial material in the core of the weir exposed, it is expected that the breach would rapidly grow in size with a cycle of scour of the core material followed by collapse of the weir surface progressively widening the breach.

Therefore, it is recommended that the hole at location 4 be repaired by carrying out the following (see Figure 3-1 below):

- De-water the area using a combination of sand filled dumpy bags and a proprietary portable dam system such as 'Portadam';
- Break back concrete facing to sound material;
- Remove all loose stone, concrete and detritus from the hole;
- Excavate to bedrock at the weir toe;

- Pour a suitable fibre reinforced concrete to fill the hole and reform the weir glacis. The concrete should extend to bed rock at the weir toe to prevent scour; and
- Place graded rip rap at the weir toe.

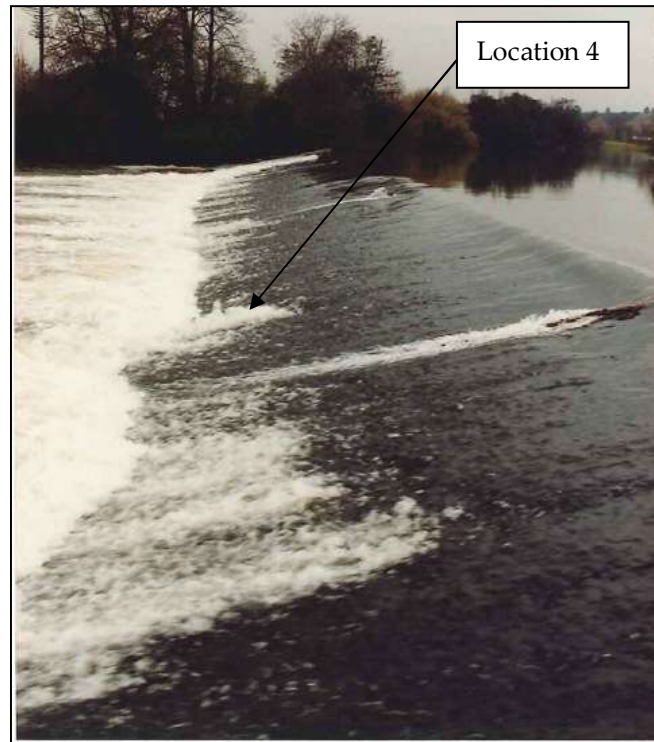
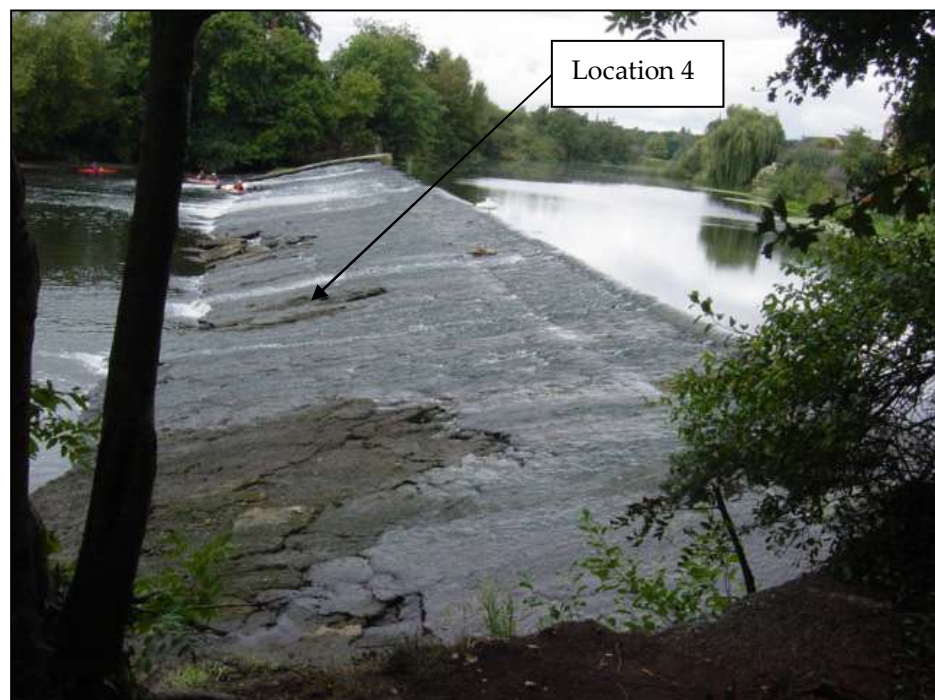
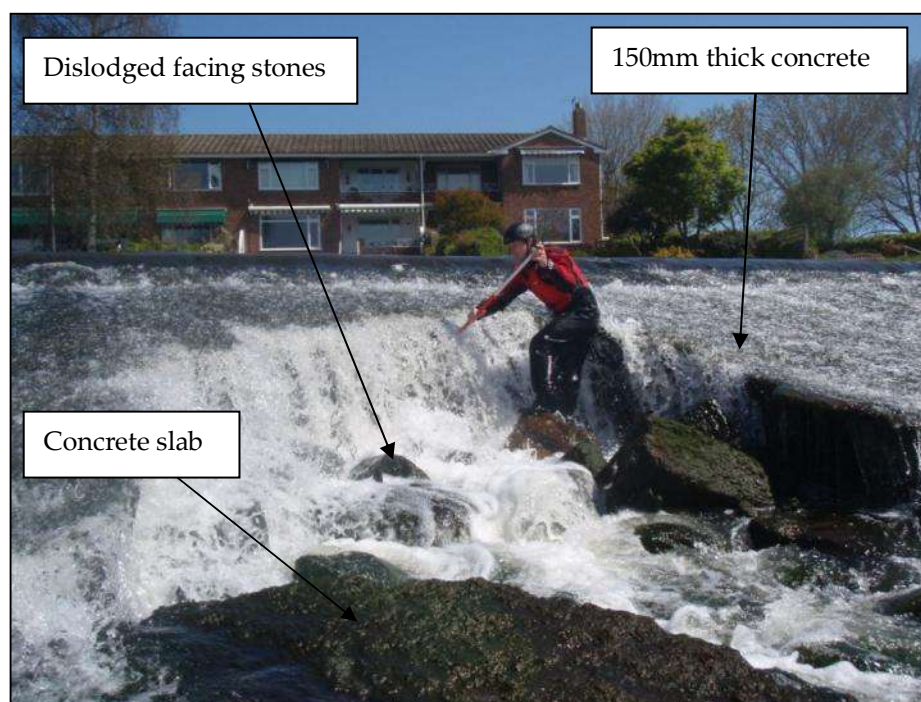
Historical photos, shown in Figure 2-23 and Figure 2-24 below, show the first signs of damage in this location in 1996. By 2003 the damage does not appear to have significantly worsened. However by 2013 the hole has grown significantly, extending through half of the weir.

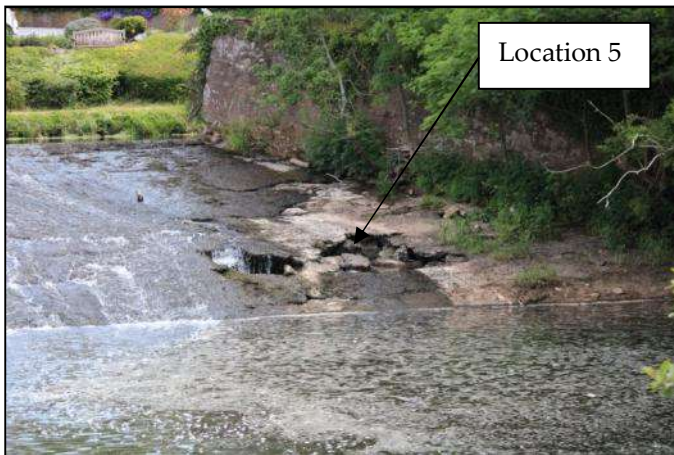
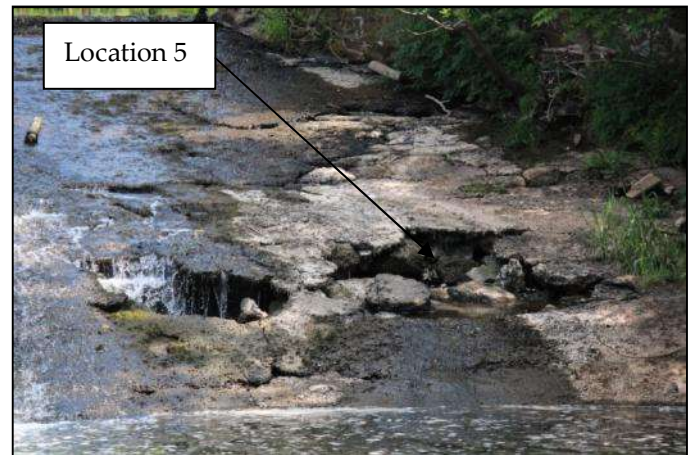
Figure 2-27: Location 5

Location 5 is the section of the lower half of the weir adjacent to the left bank. Significant leakage through the weir surface was observed. Sections of the concrete have broken away and stone blocks underneath are missing. In places, the original weir stone is exposed and any mortar that was laid between the stones has been eroded. See Figure 2-27 and Figure 2-28 below.

The weir crest at this location is slightly higher than the central part of the weir and therefore, at low flows this part of the weir remains dry.

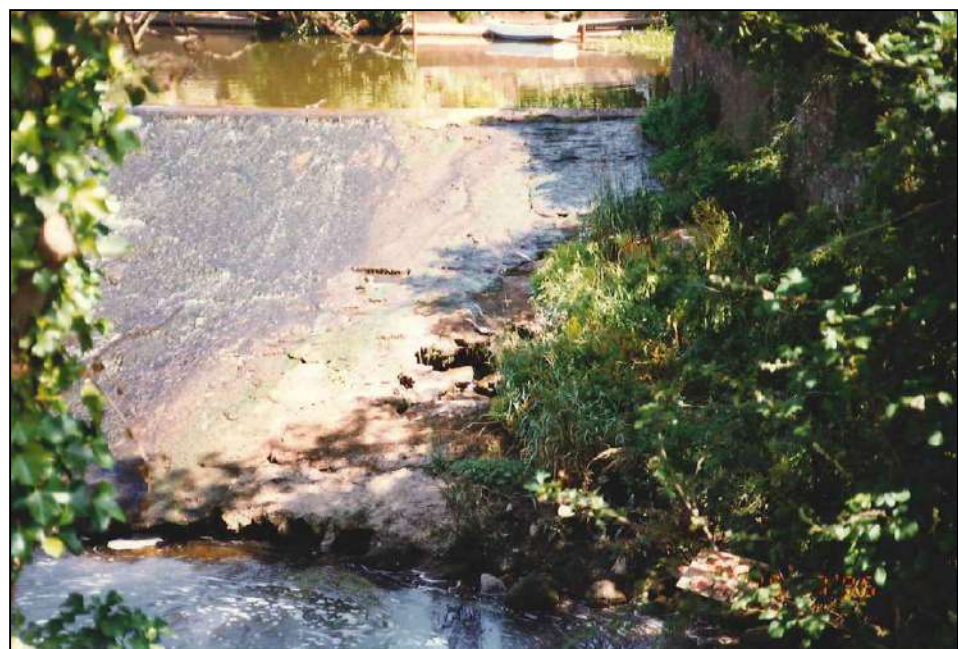
Figure 2-29: Location 5 in 1996

A photo from 1996, see Figure 2-29 below, shows this defect which doesn't appear to have significantly changed in the last 17 years.

Further loss of concrete capping and stone loss will lead to continuing growth of this area of damage. This defect is not considered to be a threat to the integrity of the weir in the short or medium term.
