# SOLVING COMPLICATED CASES WITH SIMPLE ANALYTICS

# Leirdøla hydropower plant

# Leirdøla hydropower plant – problems

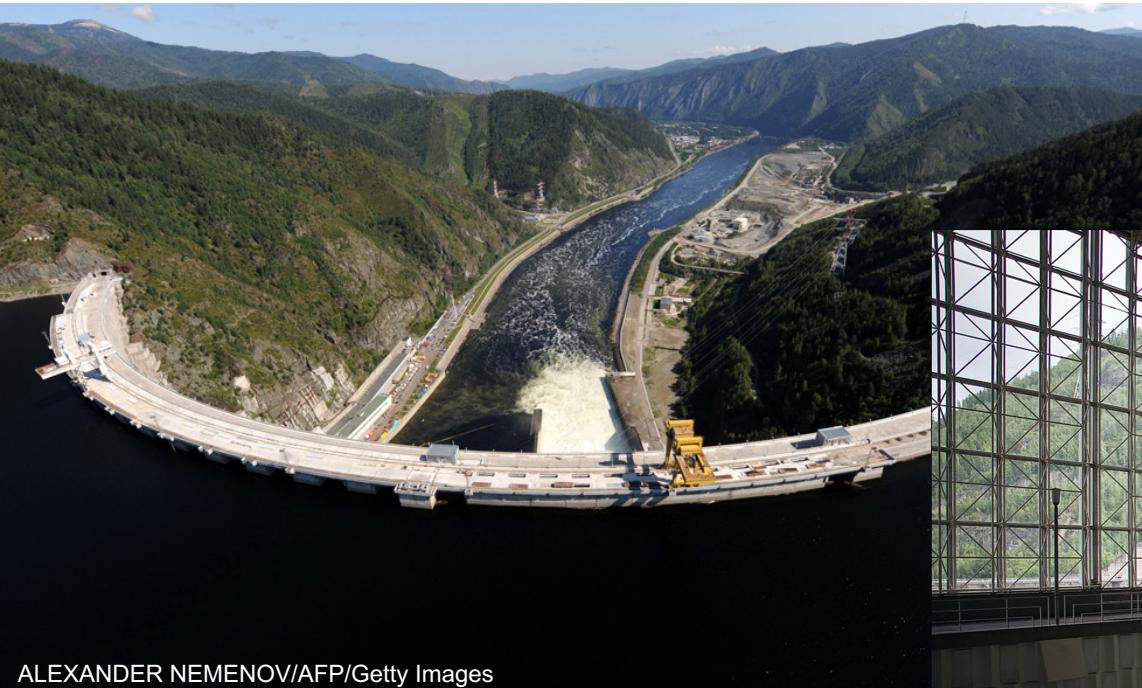
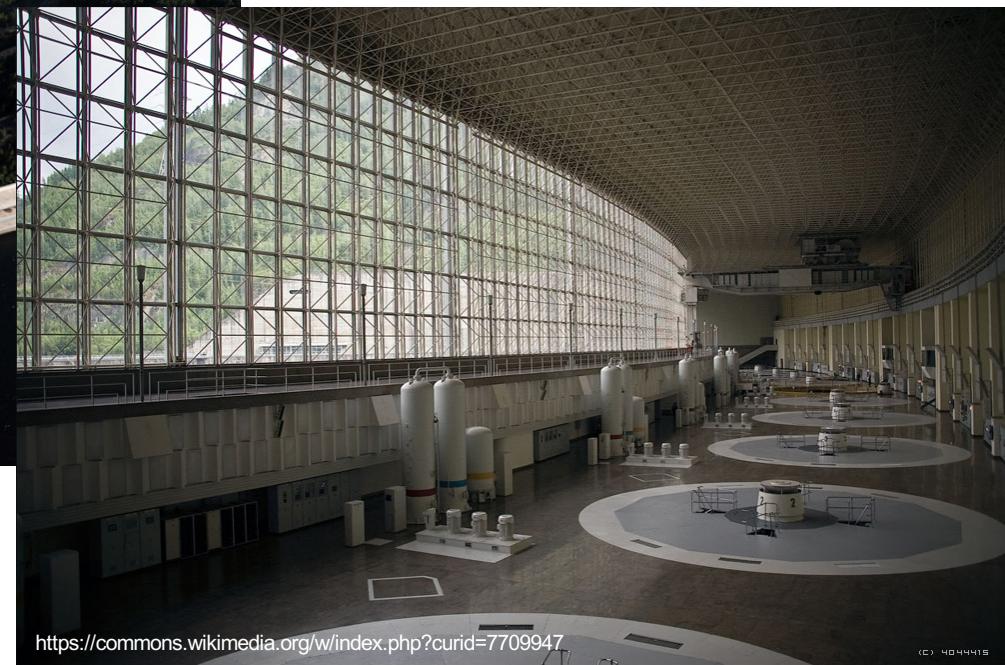
# 2009-Sayano-Shushenskaya power station accident
