TEST REPORT No. 368059

glazed railing without handrail named “M12”

resistance to horizontal linear static loading and dynamic loading in accordance with standard UNI 11678:2017

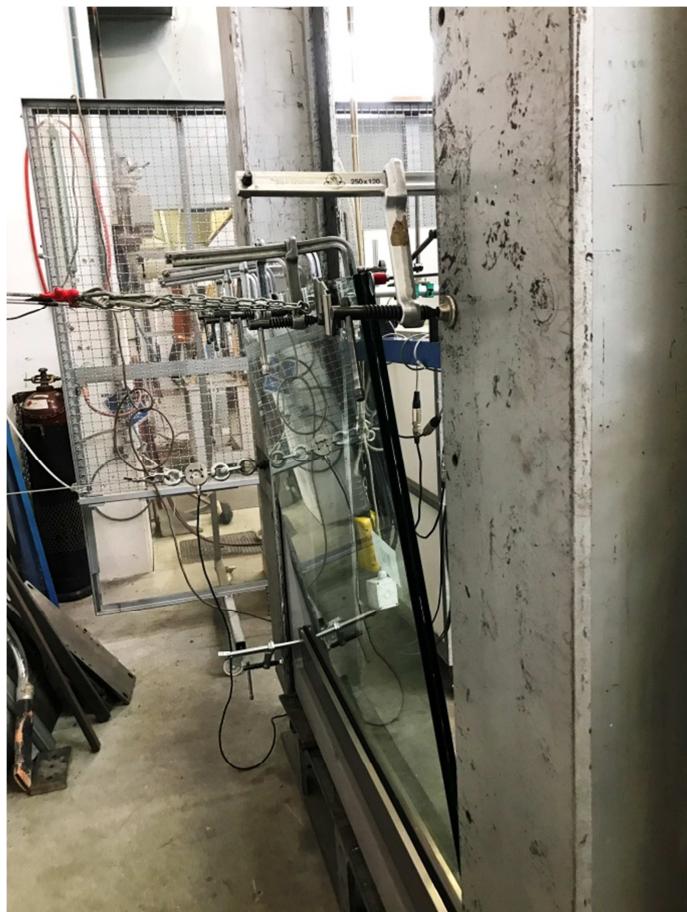
Load step	Load [kN/m]	Duration [min]	Deflection at the measuring points			Maximum allowed deformation [mm]	Effect
			A [mm]	B [mm]	C [mm]		
preload	0,5	5	//	//	//	//	no damage
working load	1,0	5	34,8	35,0	34,3	≤100	no damage
load removal	0,0	//	2,1	2,0	2,0	≤10	//
ultimate load	1,5	5	//	//	//	//	no damage
breakage of internal glass pane							
collapse load after glass pane breakage	0,3	1	//	//	//	//	no collapse

Photograph of the railing subjected to working load

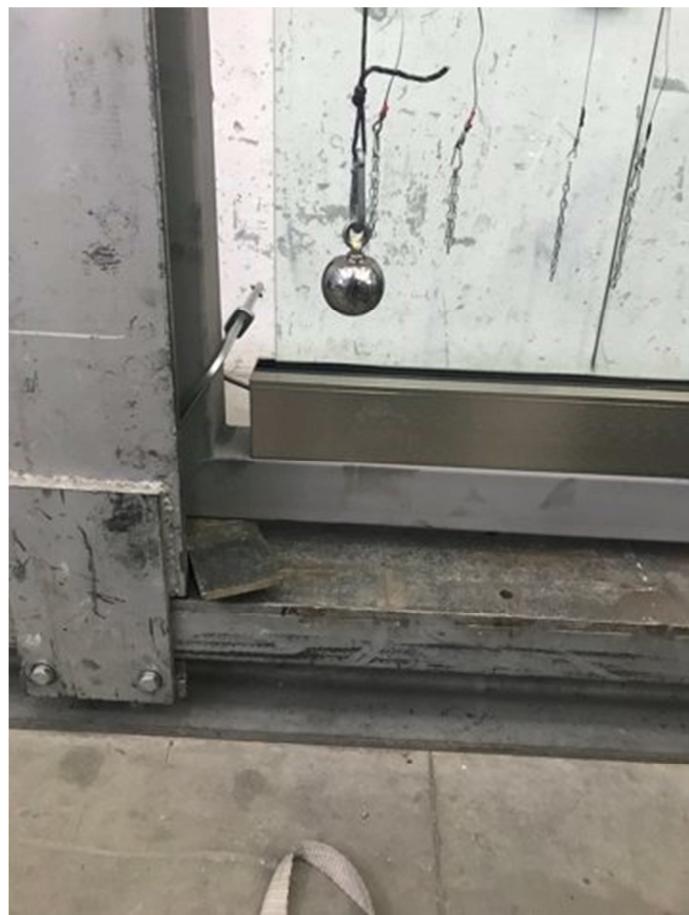
Impact type	Impact area	Drop height [mm]	Impact energy [J]	Effect
hard body	along the median 100 mm from the upper edge	1020	10	no damage
	at infill centre	1020	10	no damage
	near to a fixing point	1020	10	no damage
double-tire body	100 mm from top edge	700	350	no damage
	at infill centre	700	350	no damage
	250 mm from the corner along the bisectors	700	350	no damage

Photograph of the railing after hard body impact

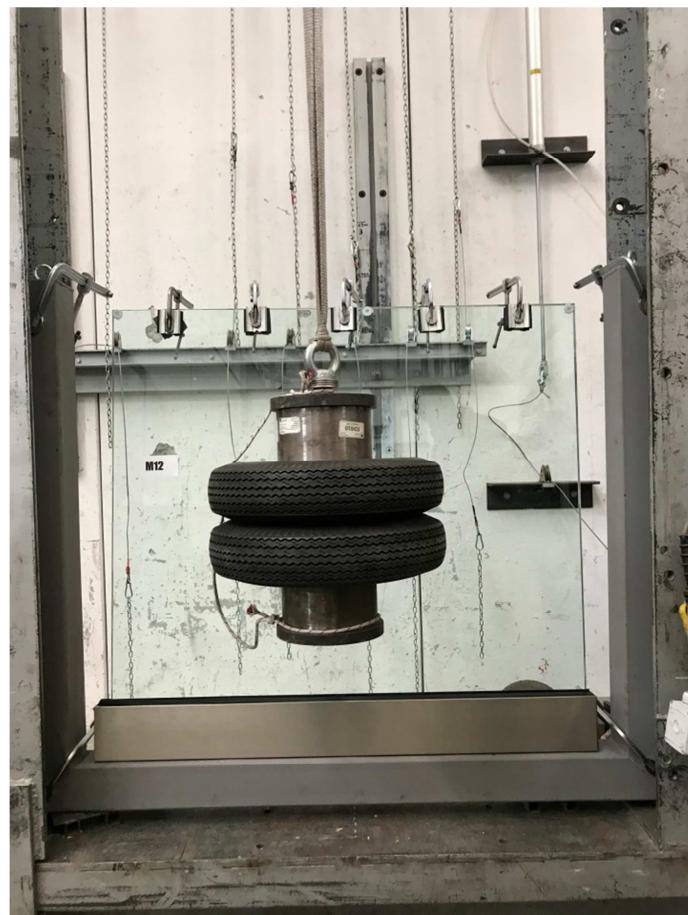
Photograph of the railing after double-tire body impact
