TEST REPORT No. 378567

Item*
**railing with glass infill
 named "M17 88.4 PVB"**

Activity
**resistance to horizontal linear static load
 and dynamic load
 in accordance with standard
 UNI 11678:2017/EC 1-2017/EC 2-2020**

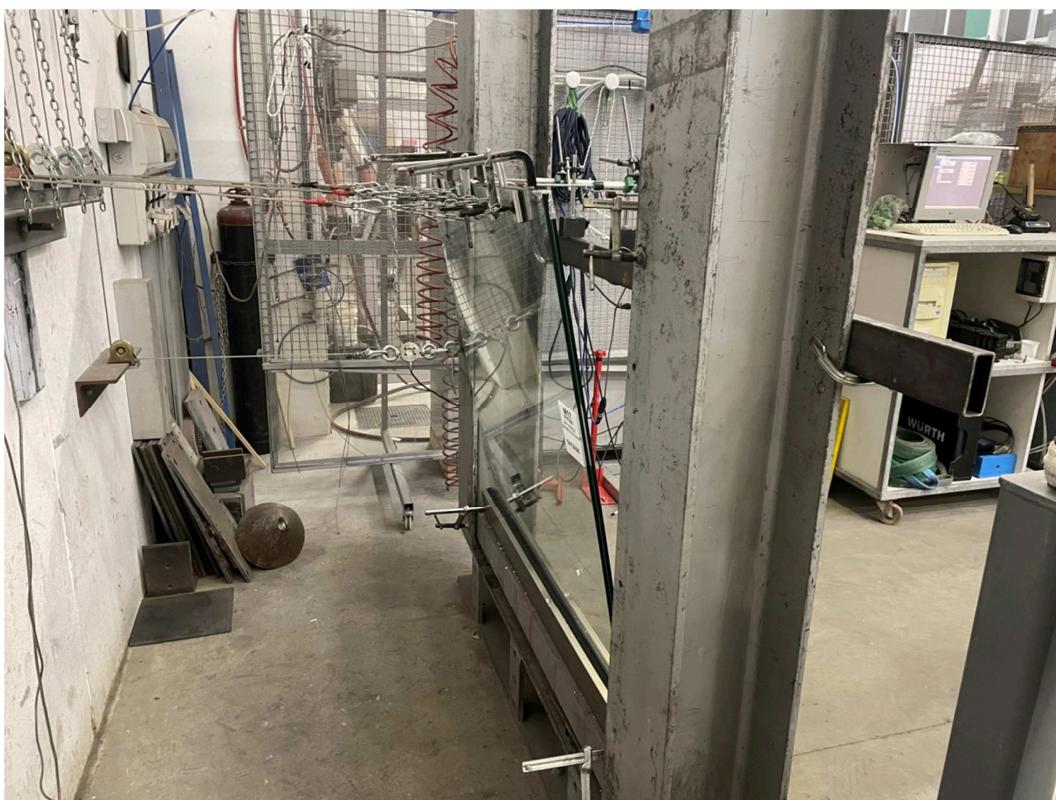
| Load step | Load [kN/m] | Duration [min] | Deflection at the measuring points | | | Maximum permissible deflection [mm] | Effect |
|--|---|---|---|---|---|--|---|
| ultimate limit state | 1,5 | 5 | // | // | // | // | no damage |
| breakage of laminated glass panel inner pane | | | | | | | |

Photograph of item during resistance to ultimate limit state loading test

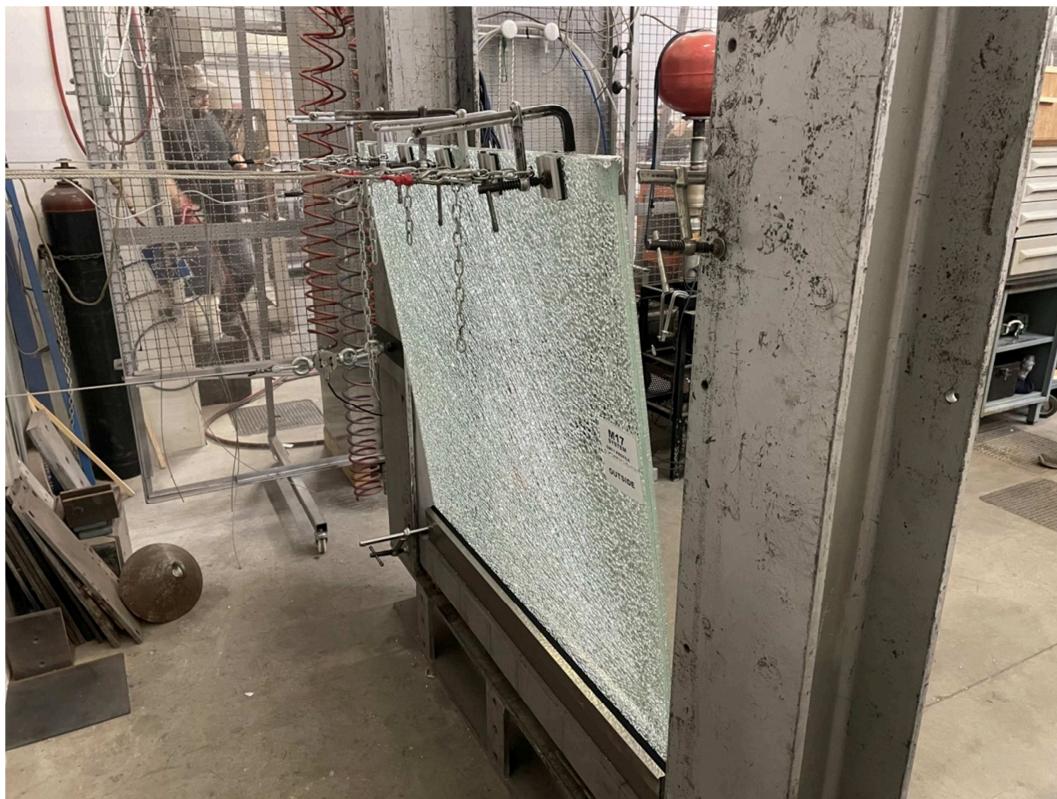
| Load step | Load [kN/m] | Duration [min] | Deflection at the measuring points | | | Maximum permissible deflection [mm] | Effect |
|--|---|---|---|---|---|--|---|
| collapse load after breakage | 0,3 | 1 | // | // | // | // | no collapse |

Photograph of item subjected to post-breakage load

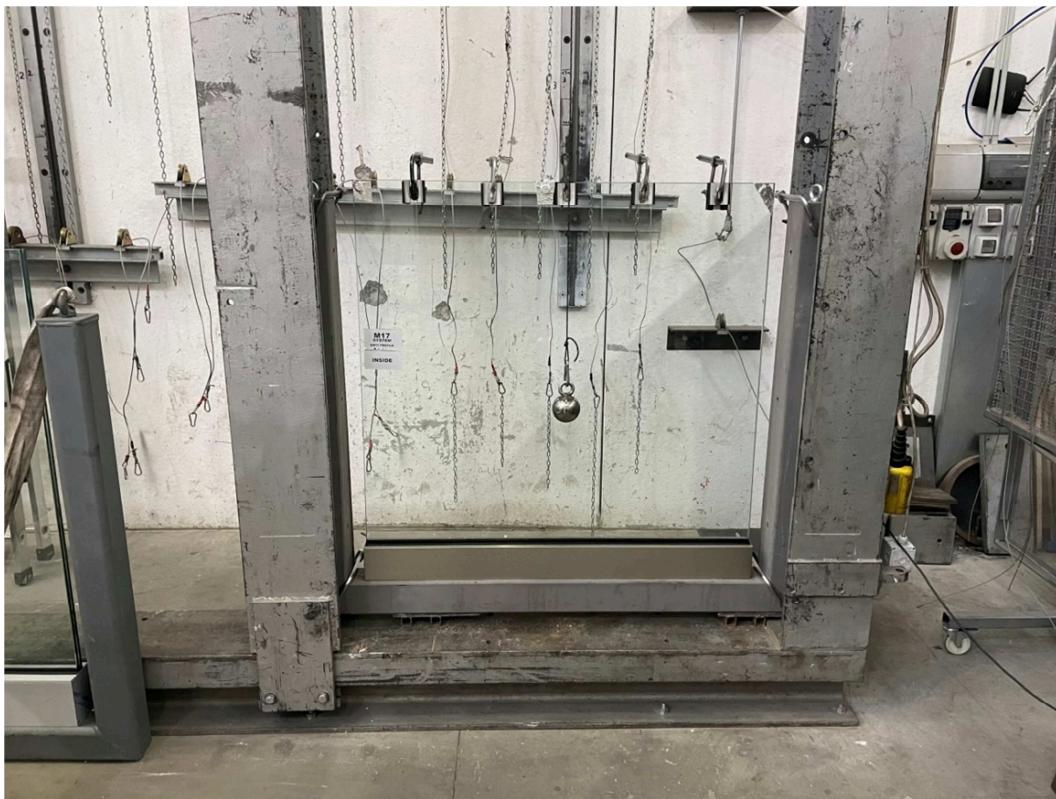
| Impact type | Impact area | Drop height [mm] | Impact energy [J] | Effect |
|---|--|---|---|---|
| | at centre of infill | 1020 | 10 | no glass fragmentation |

Photograph of item after hard-body impact in the centre of glass

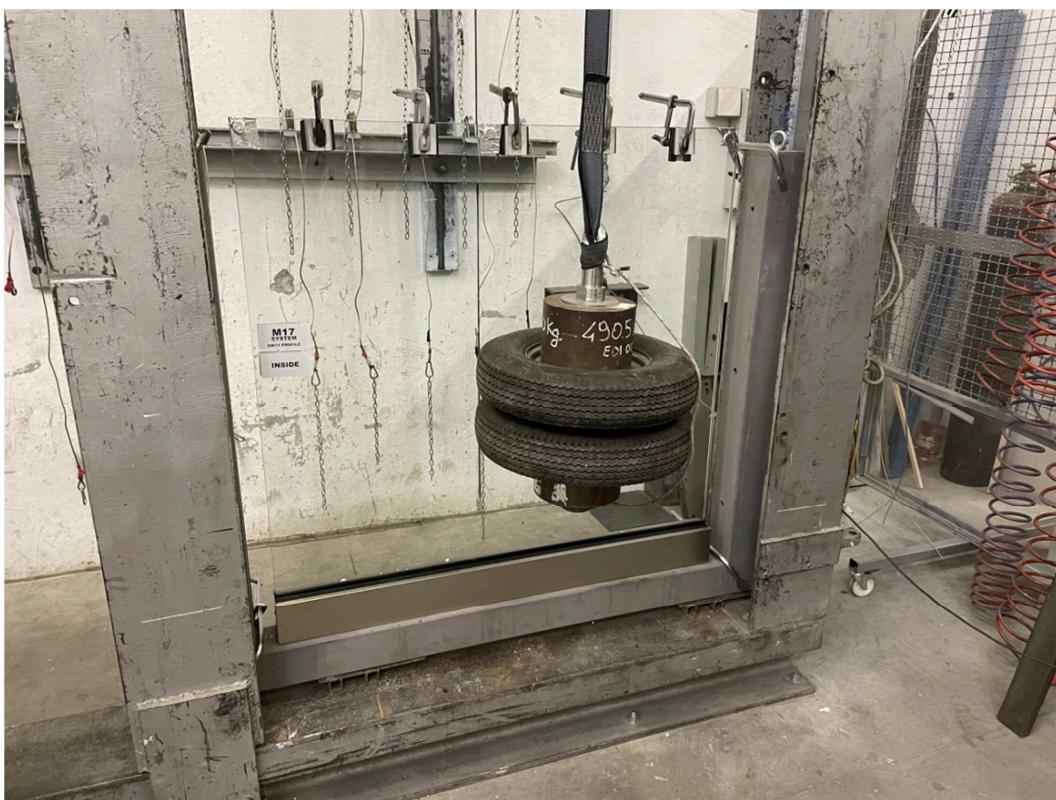
| Impact type | Impact area | Drop height [mm] | Impact energy [J] | Effect |
|---|--|---|---|---|
| | at centre of infill | 700 | 600 | no glass fragmentation |

Photograph of item after semi-rigid impact in the centre of glass
