MAJOR TURNAROUND 2025 PRESSURE VESSEL INSPECTION REPORT	
Equipment tag no: S-401 Equipment description: LPG Storage Sphere	Report no.: PLANT/01/VR-S-401/TA2025 Report date: 02 Dec 2025 Plant/Unit/Area: Plant 1

PHOTOS REPORT

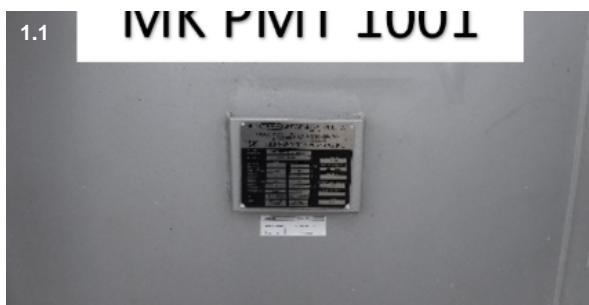
1.1 1.1 Significant deformation affecting structural integrity

1.2 Minor dent observed, depth < 5mm, no structural concern

1.3 Dent observed with depth 5-10mm, monitoring required

1.1 1.1 Immediate shutdown and repair required before return to service

1.2 Implement temporary repair and schedule permanent fix within 48 hours

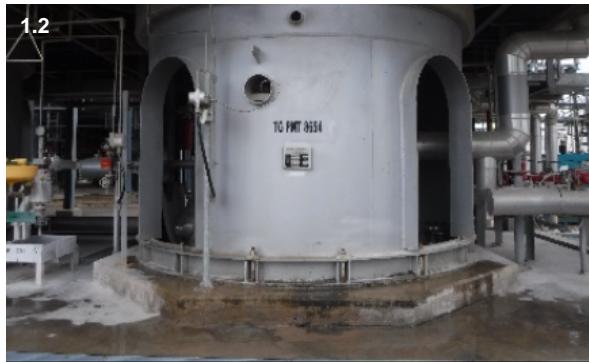
1.2 1.1 Significant deformation affecting structural integrity

1.2 Minor dent observed, depth < 5mm, no structural concern

1.3 Dent observed with depth 5-10mm, monitoring required

1.2 1.1 Immediate shutdown and repair required before return to service

1.2 Implement temporary repair and schedule permanent fix within 48 hours
