## AIRCRAFT MAINTENANCE MANUAL

### ENGINE ANTI-ICING VALVE - INSPECTION/CHECK

EMB145 - EMB135

TASK 30-21-01-200-801-A

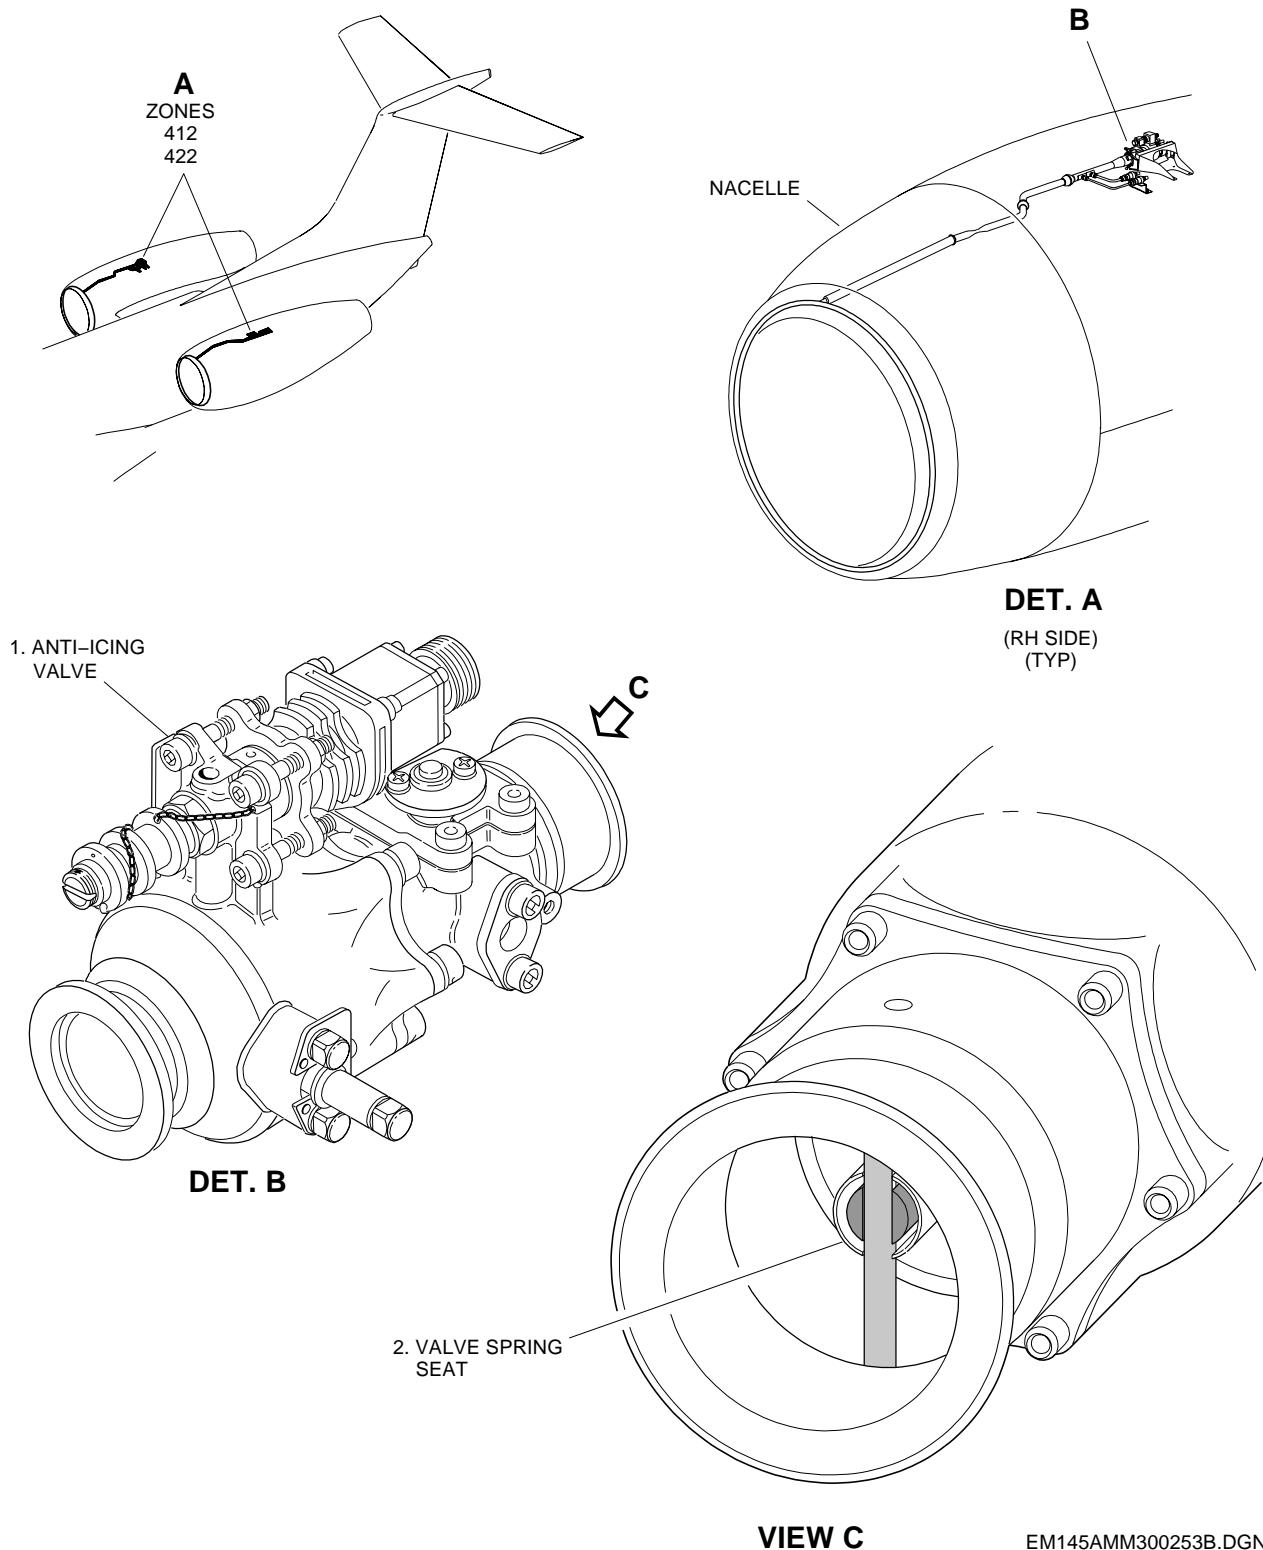
Figure 601

- (1) Do a special detailed inspection on the valve for integrity.
  - (a) Make sure that:  
Result:
    - 1 There is no piece of the valve spring seat broken off (refer to [Figure 601](#)).
  - (b) If there are inner parts of the valve broken off:  
Result:
    - 1 Remove the defective engine anti-icing valve from service.
    - 2 (PRE-MOD. [S.B.145-30-0044](#)) Do an inspection on the engine anti-icing duct looking for possible debris ([AMM TASK 30-21-05-200-801-A/600](#) or [AMM TASK 30-21-05-200-802-A/600](#).).
