A Tail of 2 Failed 3D Prints Printing Complex Objects - TRU Library Makerspace (C7elelkstén')

by Franklin Sayre, Makerspace Librarian

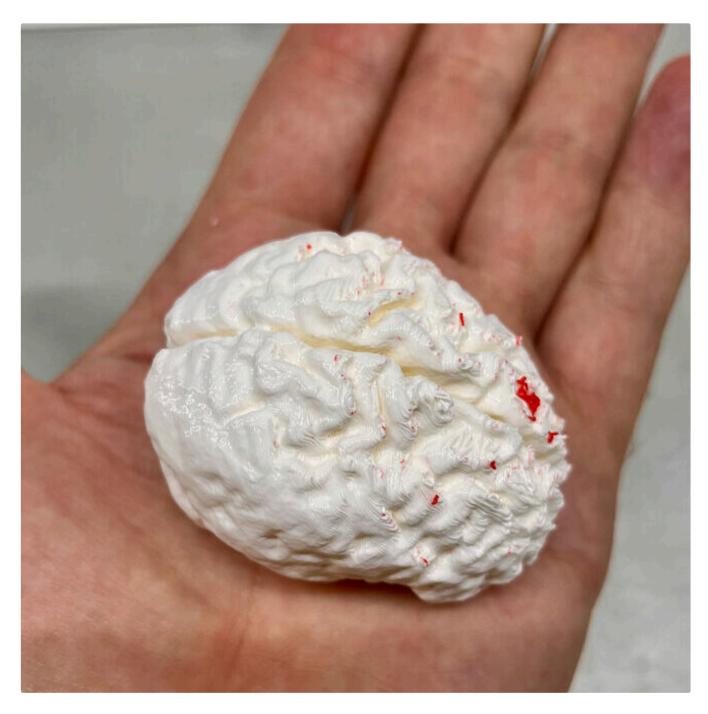
Objects with overhangs require support material. Usually we use PLA because it is easy to print with, and inexpensive. However, PLA can also cause scarring when the support material sticks to the object. Below is a good example of scarring using a print I made of my brain (yes, that is my actual brain, I had an MRI scan from years ago I was able to use). The brain itself is in white, and the red you see is the scarring from the PLA I used for support.

Normally it is fairly easy to remove this material after it's finished printing by clipping or sanding it away, but for a production-level print that wouldn't do.

Instead, we can use a material called PVA for support. PVA is a water-soluble material that can be used for support and then will disappear when immersed in water. However, it is more expensive and more difficult to print with. In this case, we had to use it because print quality was so important.

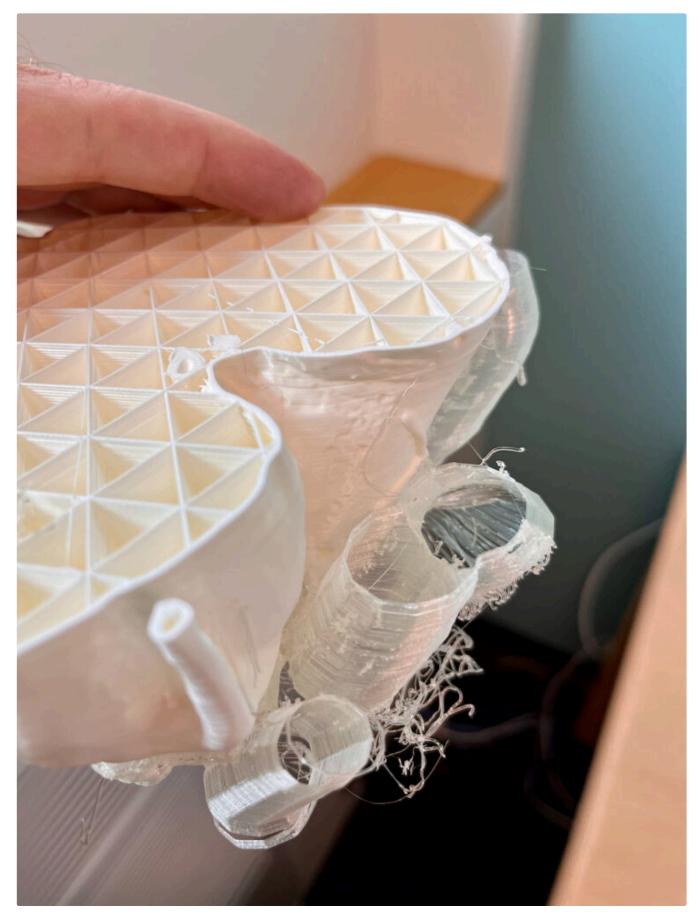
The second time the PVA supports failed. PVA isn't my favorite material. It absorbs water from the atmosphere and becomes brittle (breaking easily) and stringy when it prints (as the water evaporates in the print core). Both can make it fail. Because this was a long print, it stopped printing some of the supports properly and we had to cancel the print.

Example of print with PVA supports having failed. Strings you see are from water content of PVA.

The third time I printed it, I changed strategies. There is an advanced setting within Cura that lets you print most of the supports with one material, and then use a second material just for the part of the support that touches the object. This is called interface support. It lets us use PLA to print the support towers, which is great because PLA is cheaper and easier to print with, and PVA only for the important parts.

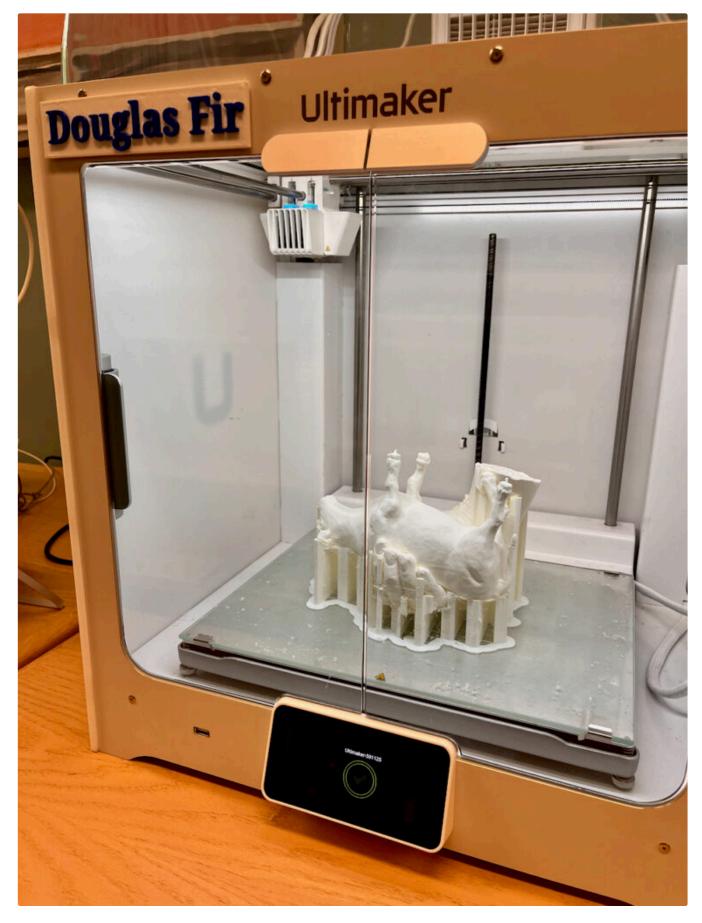
Finished Cow Print

This time it printed perfectly and it was time for the cow to have a bath to get rid of that PVA. This was hard because the PVA was hidden under a thick layer of PLA, so it took 2 days of soaking the print, removing material, and soaking it again.
