STRUCTURAL AUDIT REPORT
FOR
“VISHAL SAHYADRI CO – OP HSG. SOC. LTD”,
“C8 – WING”
SITUATED AT
SAHYADRI NAGAR, CHARKOP,
KANDIVALI (W) MUMBAI – 400 067

PREPARED BY
LATESH S. SANKLECHA
CONSULTING STRUCTURAL ENGINEERS

978/B1/LSS/2021

JUNE 21, 2021

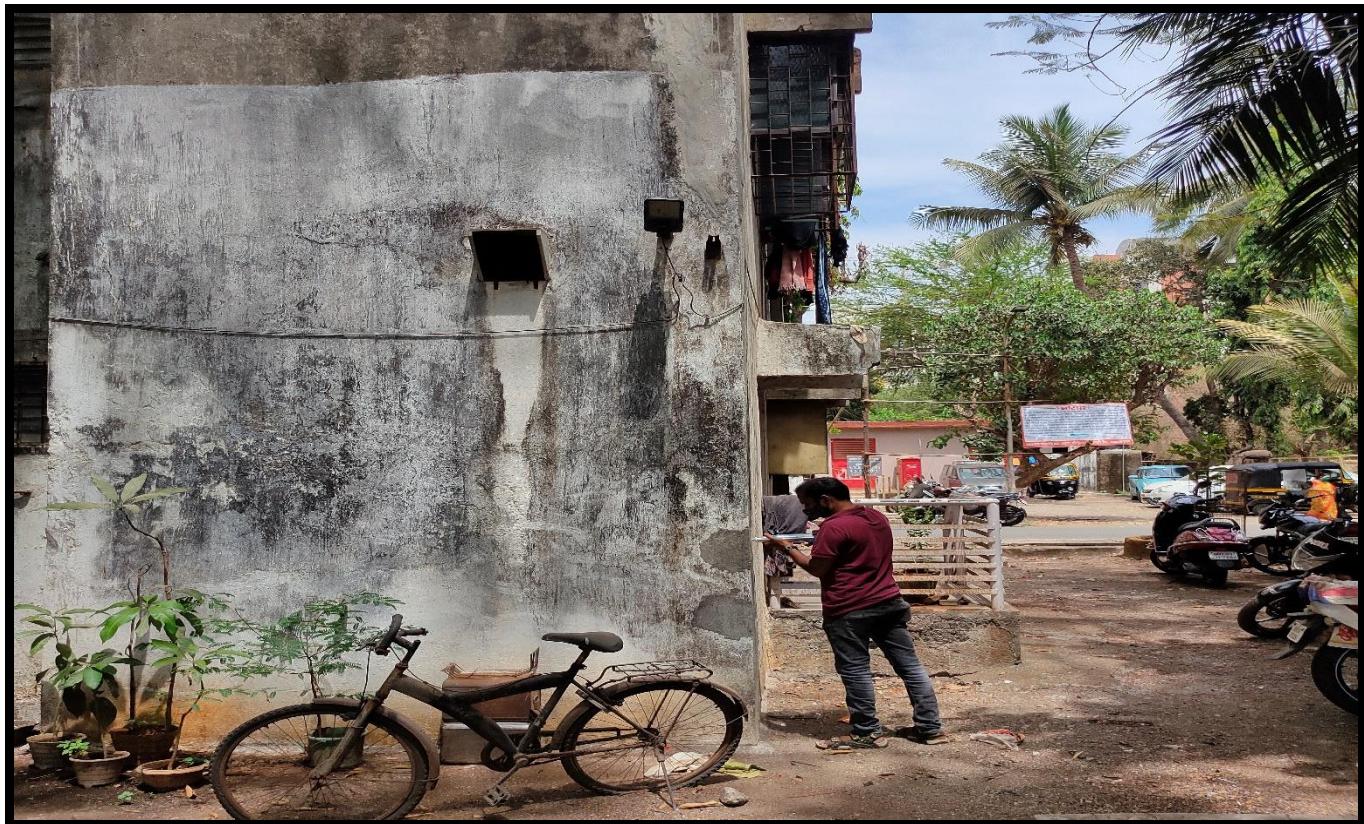
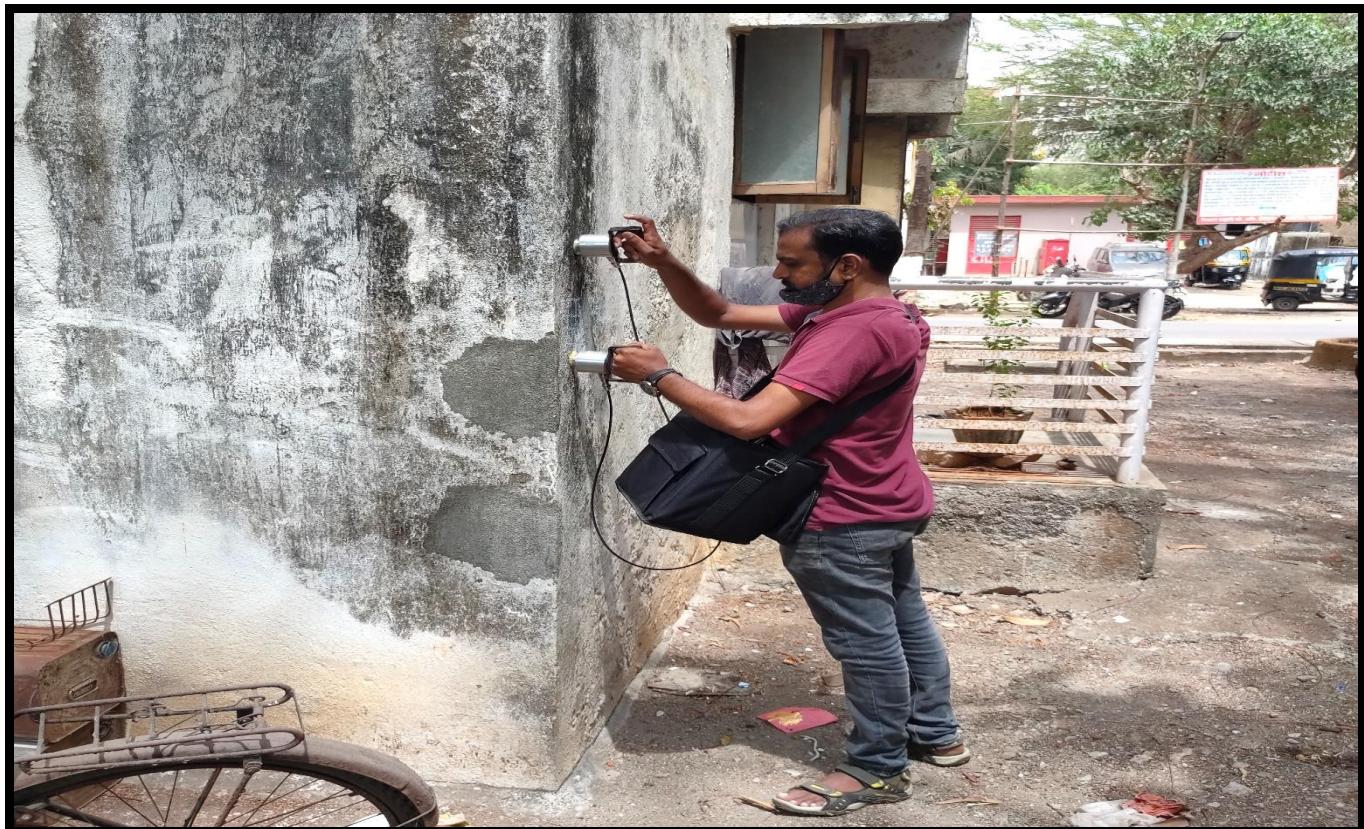
NON -DESTRUCTIVE TEST PHOTO

Half Cell Potential tested for corrosion activity by half – cell potential tests. Value is taken on Column. The result on tested column is – 326 mV.

This indicates the probability of corrosion is 50% on tested column steel reinforcement.

Carbonation test was conducted to assess carbonation depth. Readings are taken on Column. Result indicates the carbonation penetration depth is 35.00 mm. Carbonation depths have reached to the reinforcement level in all of the RCC elements. It is essential to give a suitable anti-corrosion treatment to all the RCC members to stop further carbonation and corrosion of concrete.

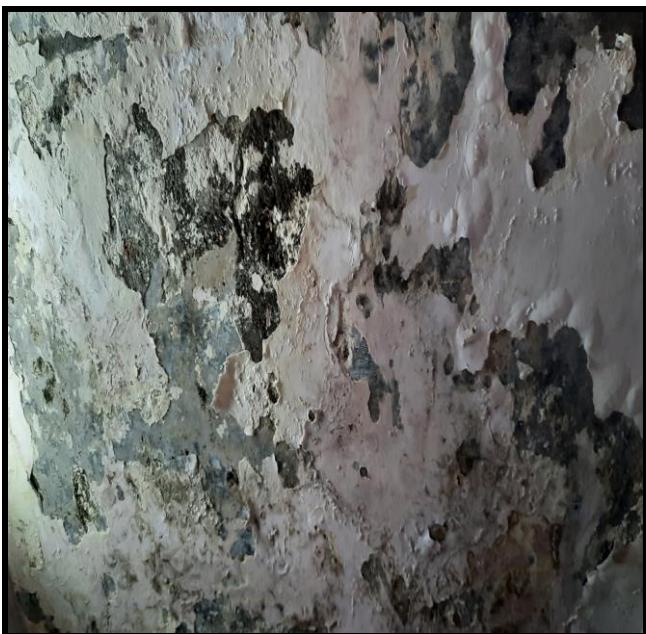
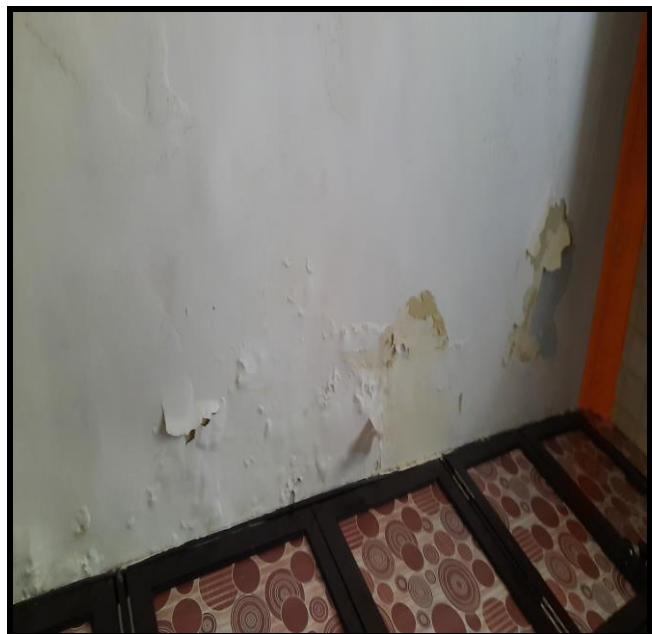
FLAT NO – 04

- ❖ **HALL** – Leakage mark observed on ceiling.
- ❖ **KITCHEN** – Leakage mark observed on ceiling.
- ❖ **PASSAGE** – O.K.
- ❖ **TOILET & BATH ROOM** – O.K.

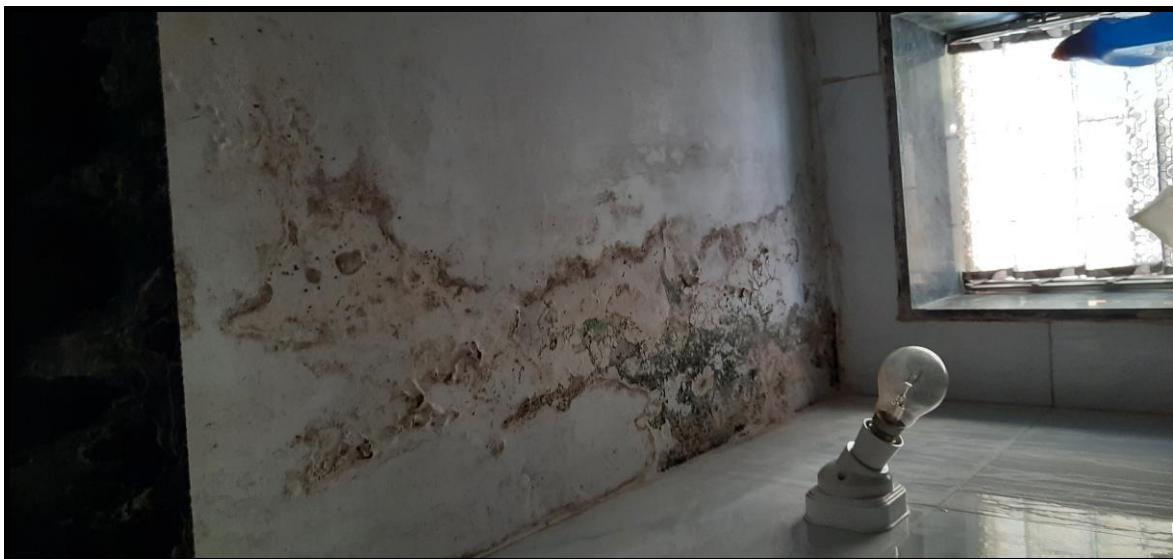
FLAT NO – 05

- ❖ **HALL** – O.K.
- ❖ **KITCHEN** – Leakage mark observed on ceiling.
- ❖ **PASSAGE** – O.K.
- ❖ **TOILET & BATH ROOM** – Leakage mark observed on ceiling.

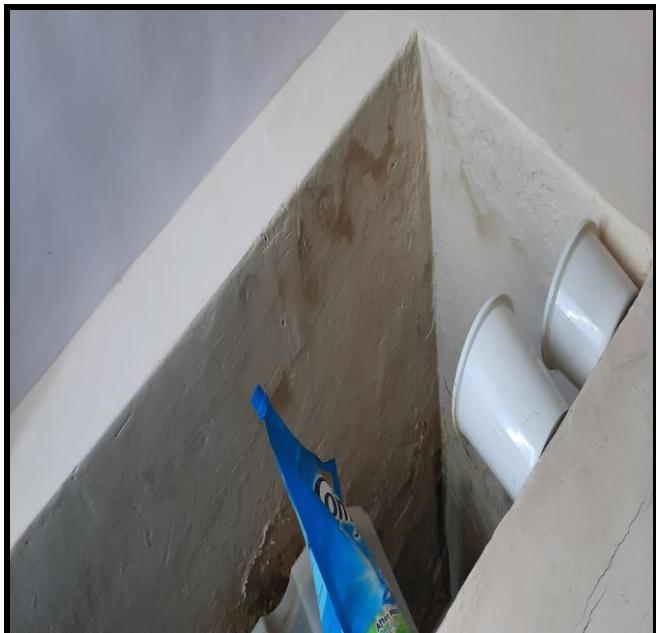
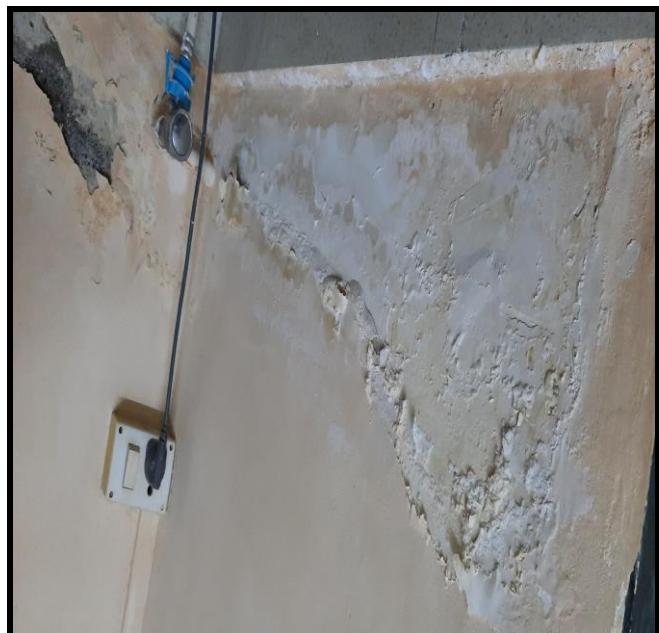
FLAT NO – 11

- ❖ **HALL** – O.K.
- ❖ **KITCHEN** – Leakage mark observed on wall & ceiling.
- ❖ **PASSAGE** – O.K.
- ❖ **TOILET & BATH ROOM** – O.K.

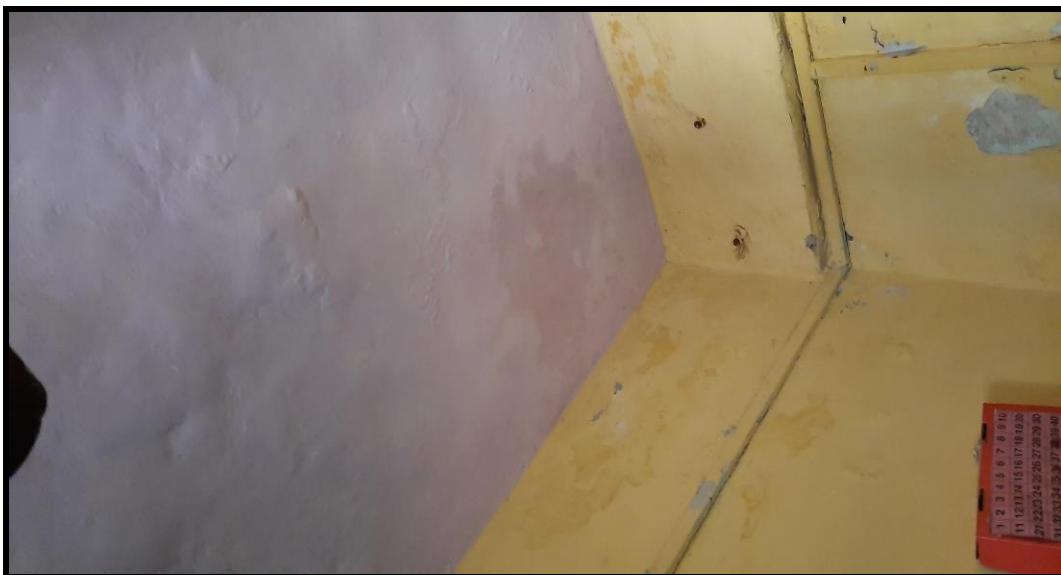
FLAT NO – 13

- ❖ **HALL** – Leakage mark observed on ceiling.
- ❖ **KITCHEN** – Leakage mark observed on wall & ceiling.
- ❖ **PASSAGE** – O.K.
- ❖ **TOILET & BATH ROOM** – O.K.

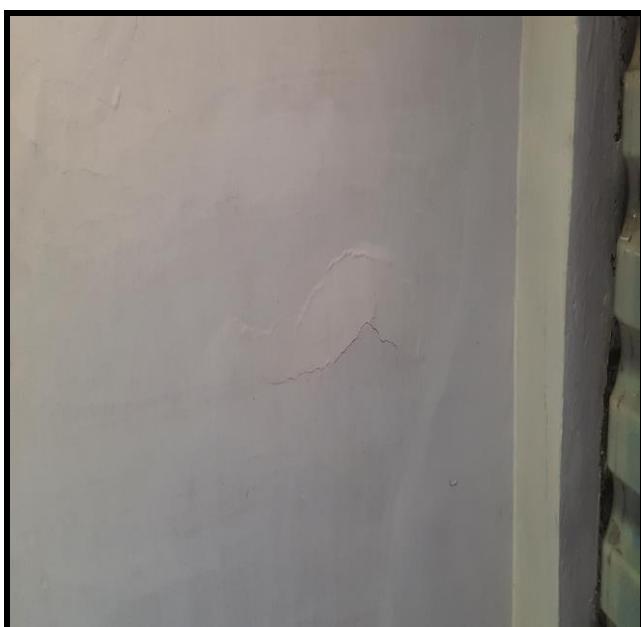
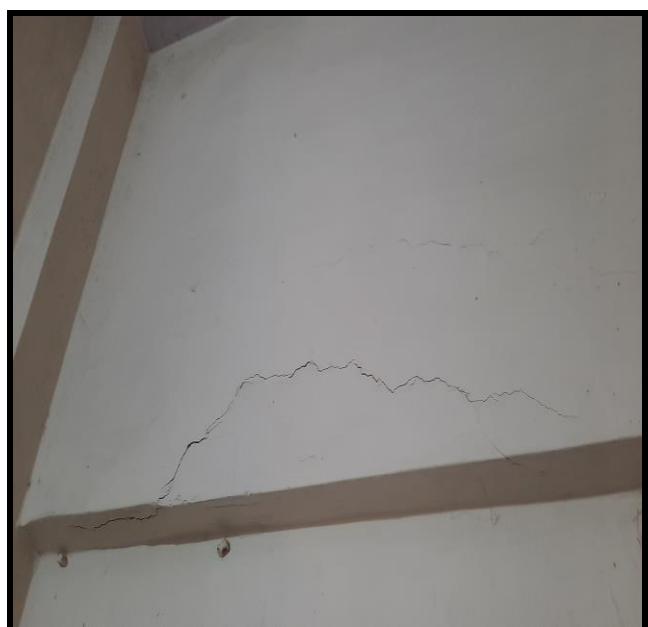
FLAT NO – 16

- ❖ **HALL** – Structural crack observed on beam.
 - Leakage observed on wall in monsoon.
- ❖ **KITCHEN** – Structural crack observed on ceiling.
- ❖ **PASSAGE** – O.K.
- ❖ **TOILET & BATH ROOM** – O.K.

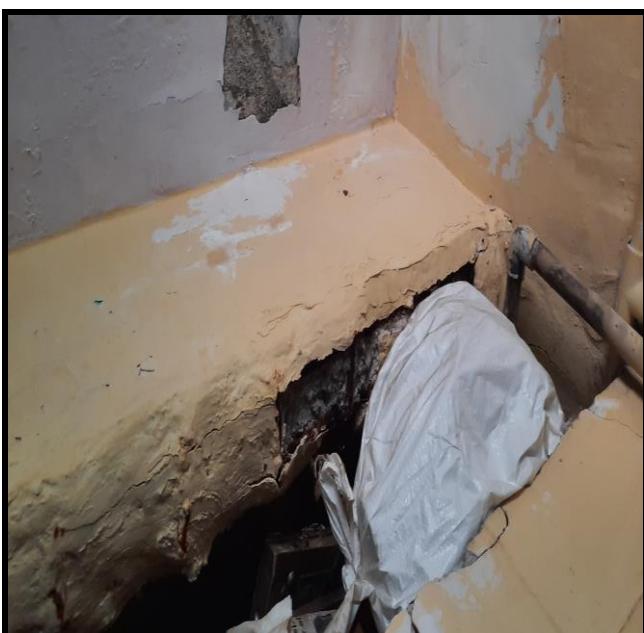
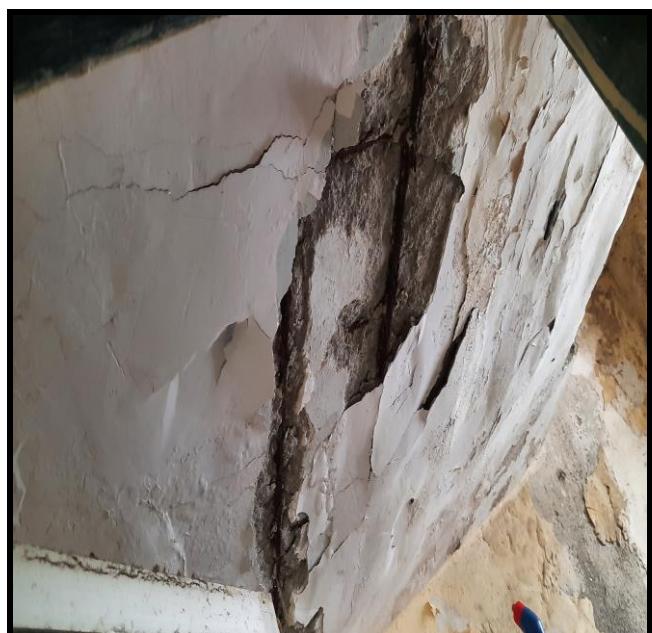
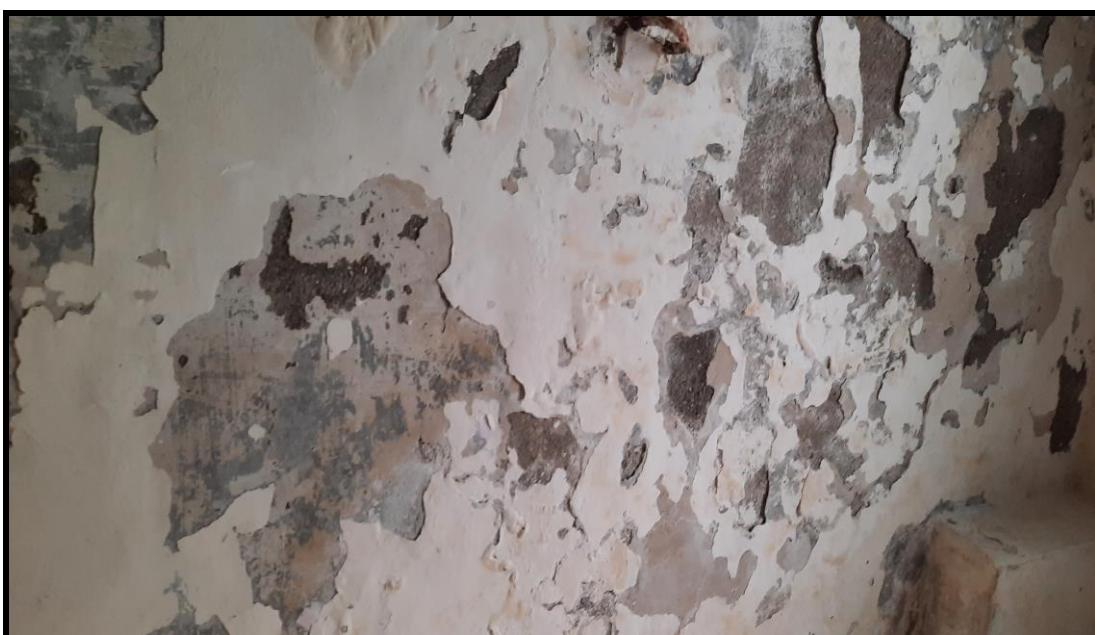
FLAT NO – 18

- ❖ **HALL** – O.K.
- ❖ **KITCHEN** – Leakage mark observed on ceiling.
 - Beam & ceiling plaster get damaged & steel get exposed & corroded.
- ❖ **PASSAGE** – O.K.
- ❖ **TOILET & BATH ROOM** – O.K.

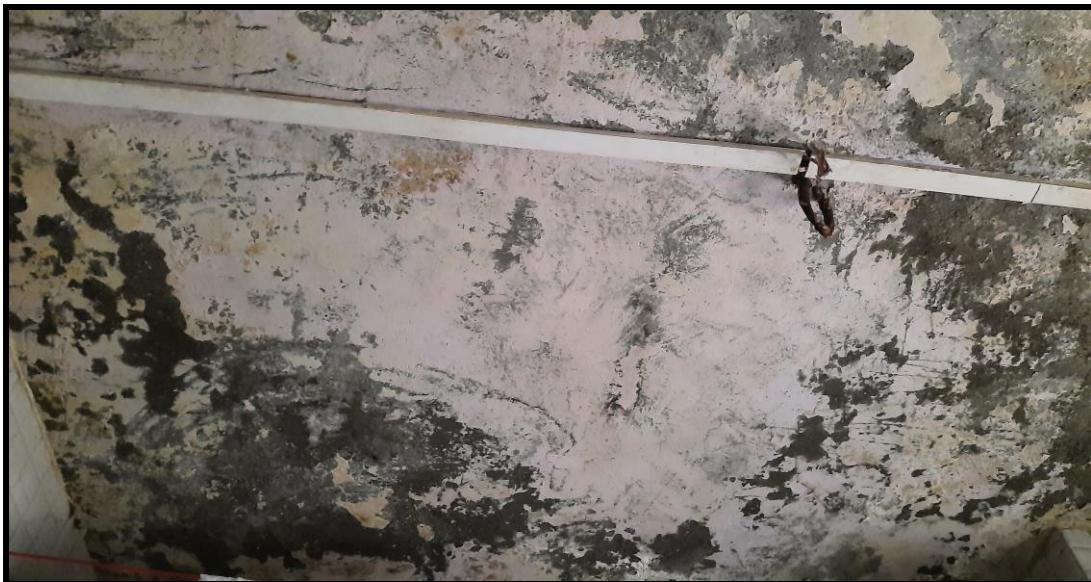
FLAT NO – 22

- ❖ **HALL** – Leakage mark observed on ceiling.
- ❖ **KITCHEN** – Leakage mark observed on ceiling.
- ❖ **PASSAGE** – O.K.
- ❖ **TOILET & BATH ROOM** – O.K.

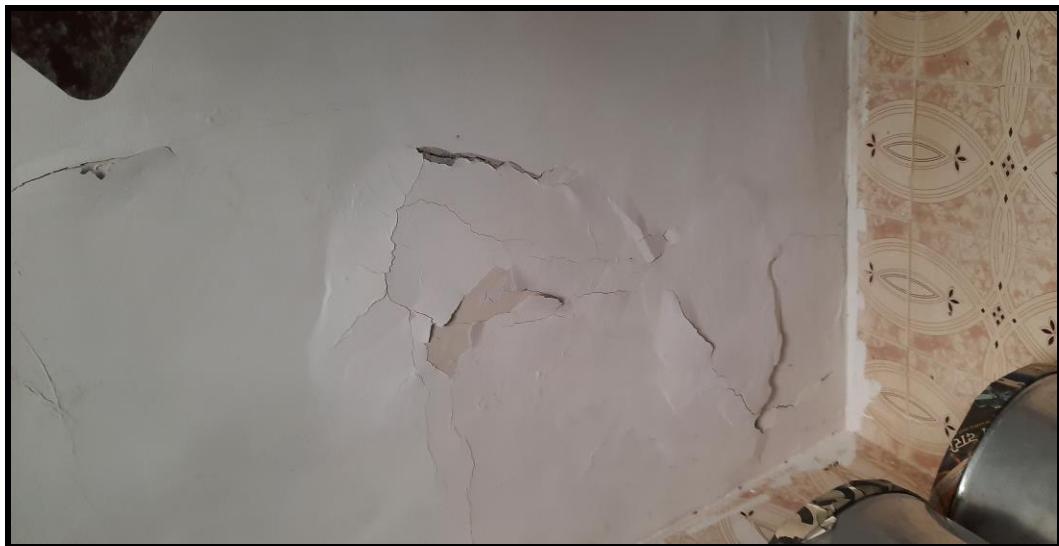
FLAT NO – 25

- ❖ **HALL** – O.K.
- ❖ **KITCHEN** – Structural damage observed on ceiling.
- ❖ **PASSAGE** – O.K.
- ❖ **TOILET & BATH ROOM** – O.K.

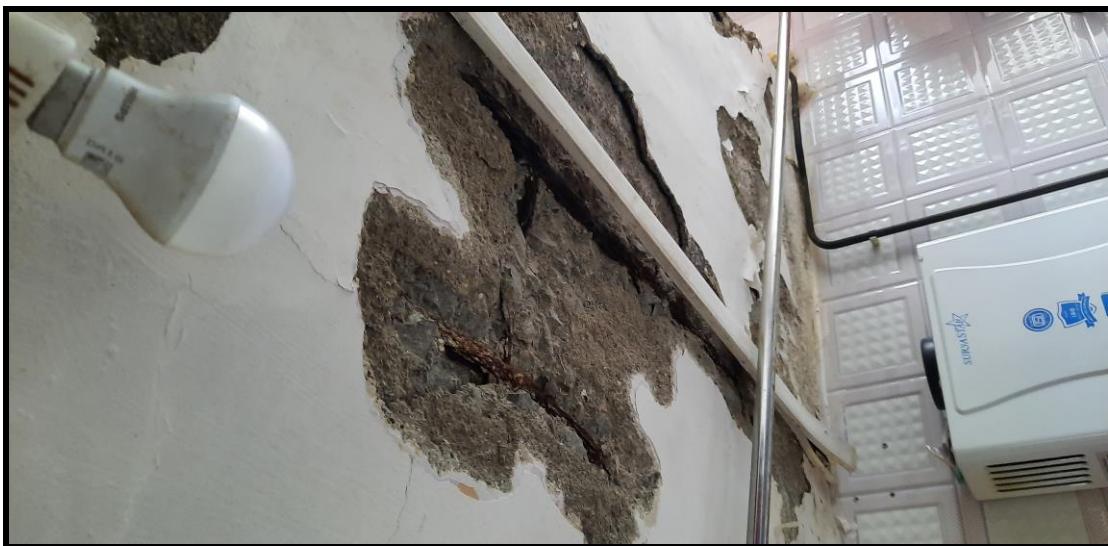
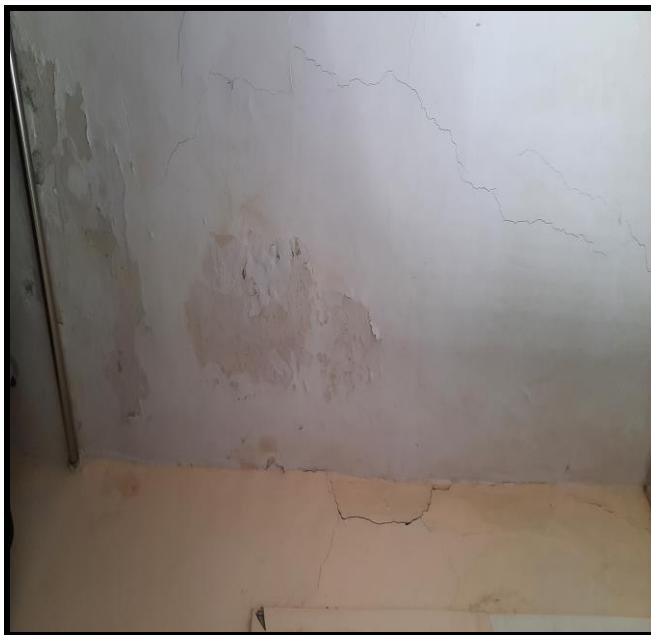
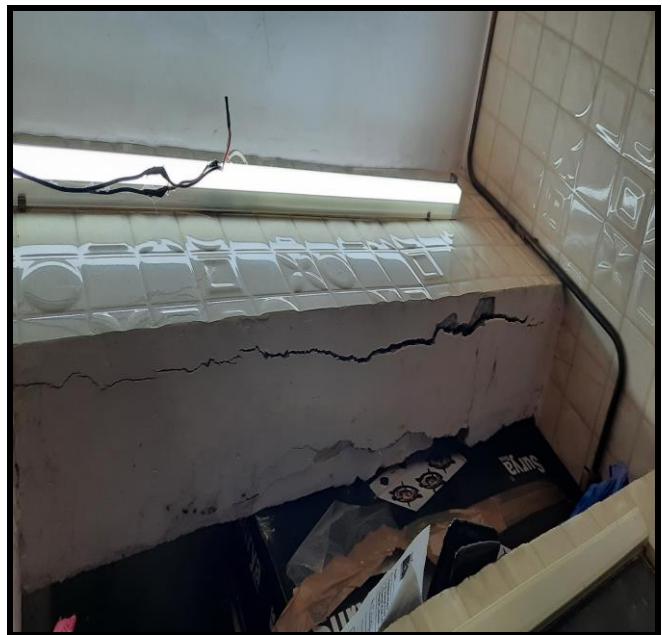
FLAT NO – 26

- ❖ **HALL** – Leakage mark observed on ceiling.
 - Structural crack observed on beam & ceiling.
- ❖ **KITCHEN** – Structural crack observed on beam & ceiling.
- ❖ **PASSAGE** – O.K.
- ❖ **TOILET & BATH ROOM** – Ceiling plaster get damaged & steel get exposed & corroded.

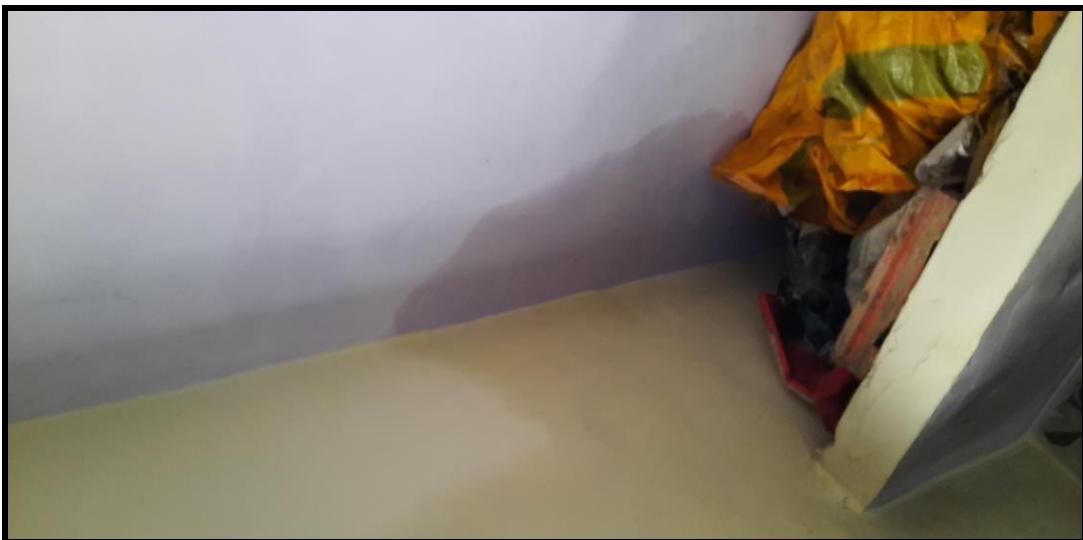
FLAT NO – 33

- ❖ **HALL** – Dampness observed on wall.
- ❖ **KITCHEN** – O.K.
- ❖ **PASSAGE** – O.K.
- ❖ **TOILET & BATH ROOM** – O.K.

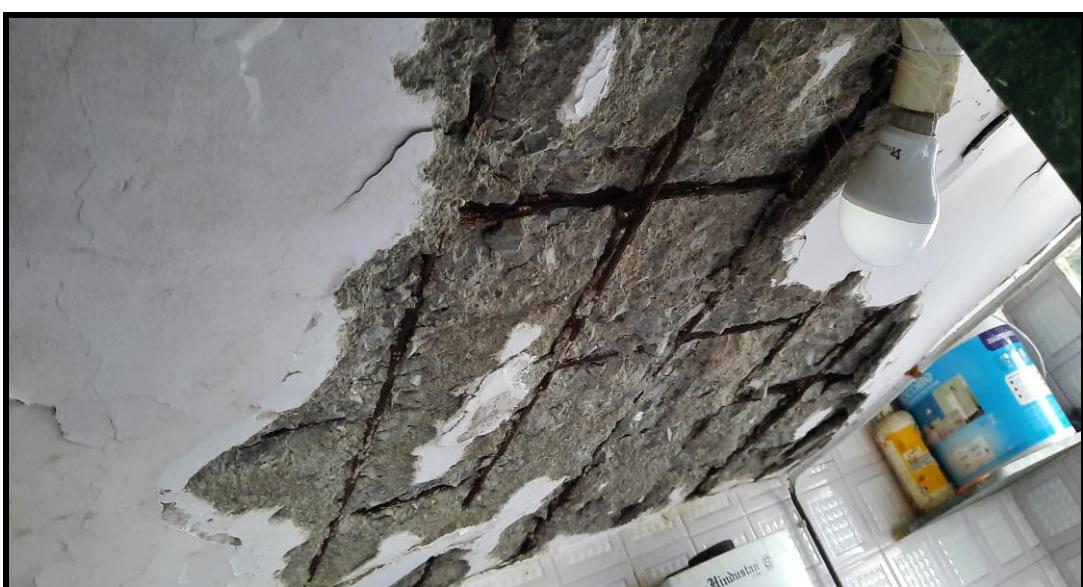
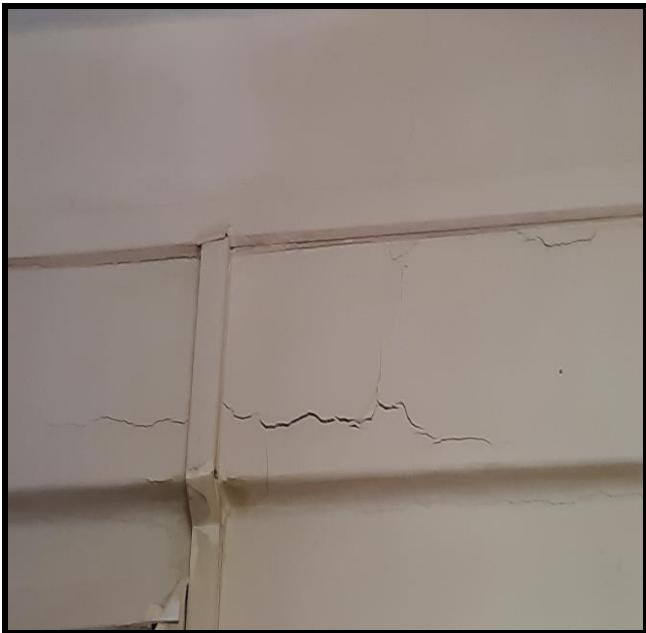
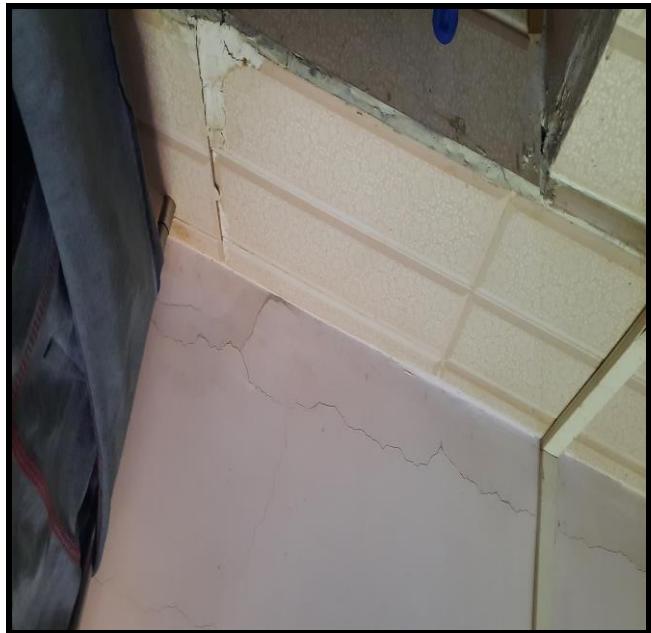
FLAT NO – 34

- ❖ **HALL** – Structural crack observed on beam.
 - Leakage mark observed on wall.
- ❖ **KITCHEN** – Structural crack observed on beam & ceiling.
- ❖ **PASSAGE** – O.K.
- ❖ **TOILET & BATH ROOM** – Ceiling plaster get damaged & steel get exposed & corroded.

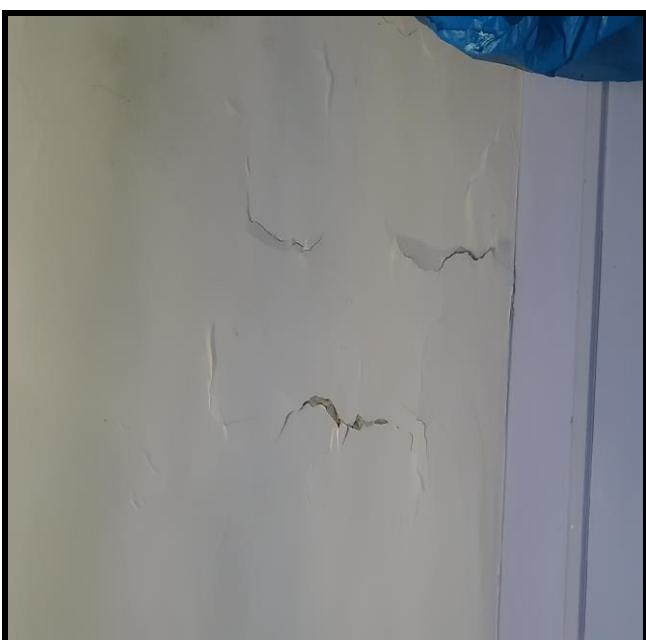
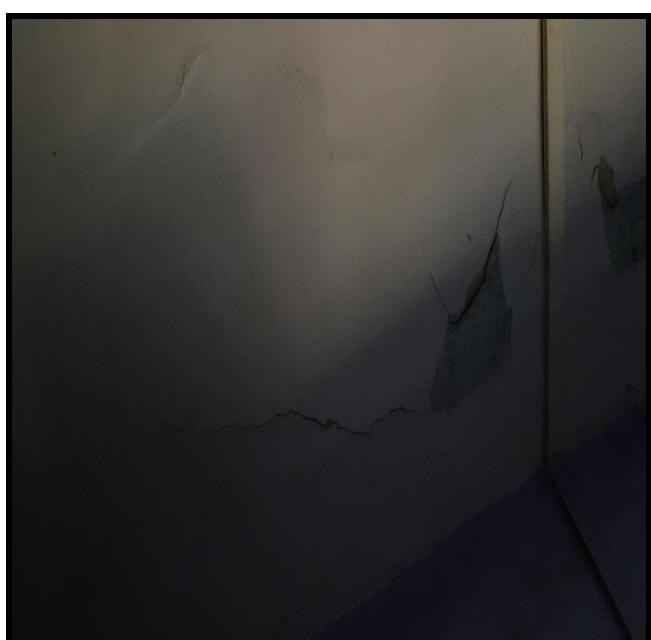
FLAT NO – 35

- ❖ **HALL** – O.K.
- ❖ **KITCHEN** – Structural damage observed on ceiling.
- ❖ **PASSAGE** – O.K.
- ❖ **TOILET & BATH ROOM** – O.K.

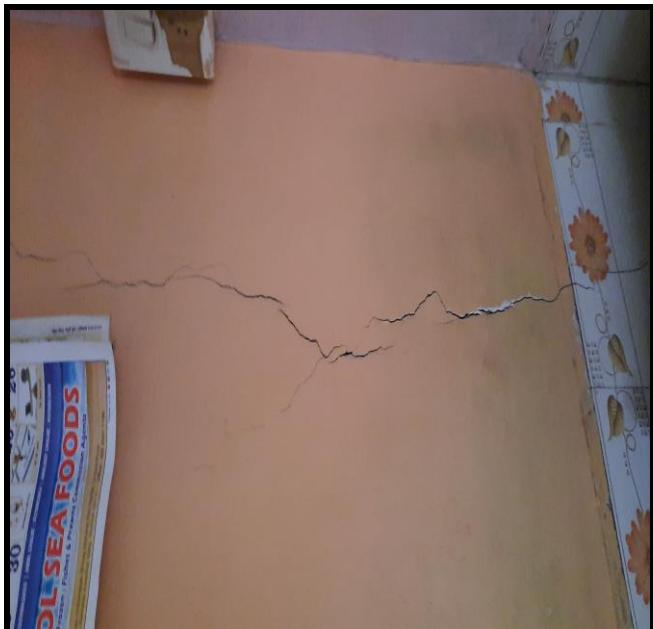
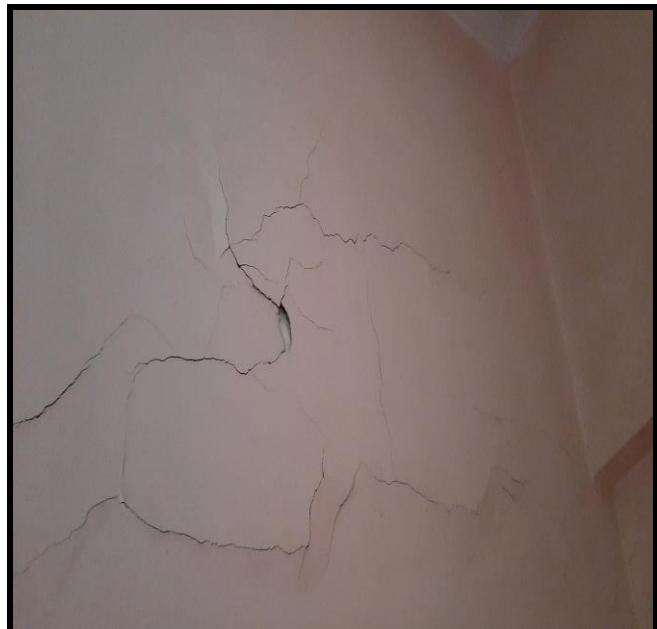
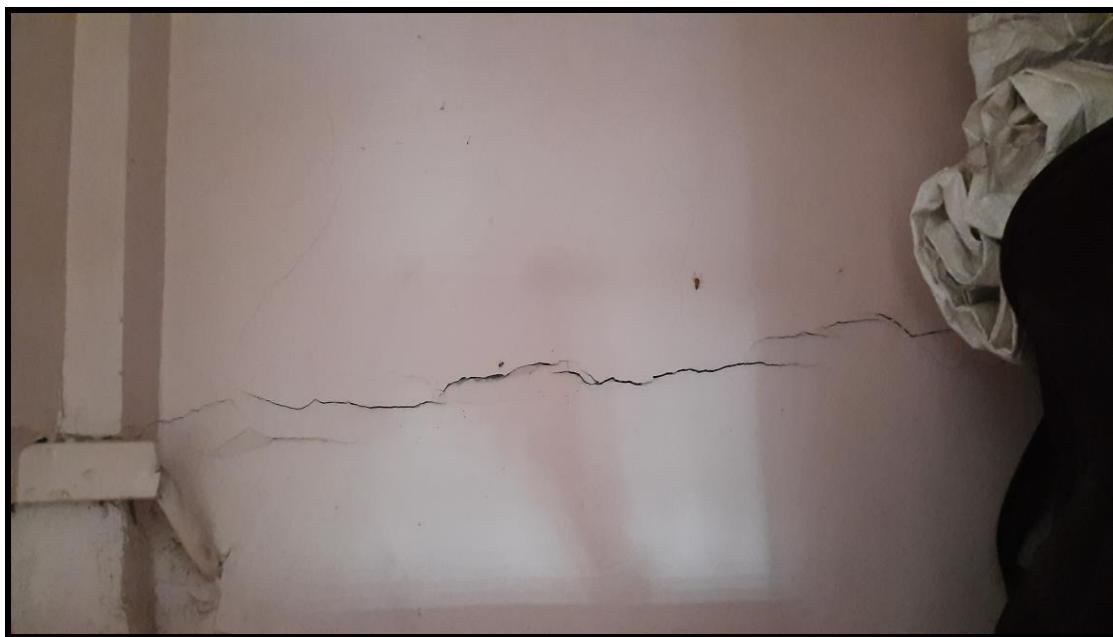
FLAT NO – 38

- ❖ **HALL** – Structural crack observed on beam, column & ceiling.
 - Major crack observed on wall.
- ❖ **KITCHEN** – Structural crack observed on beam & ceiling.
- ❖ **PASSAGE** – O.K.
- ❖ **TOILET & BATH ROOM** – O.K.

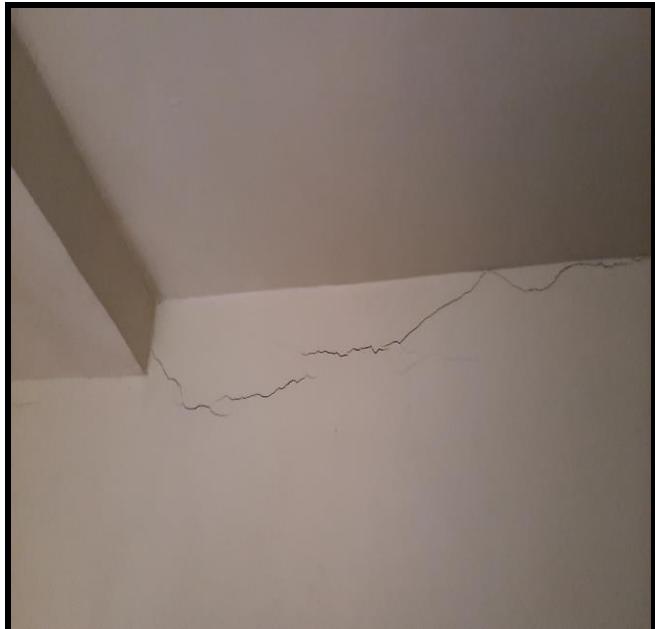
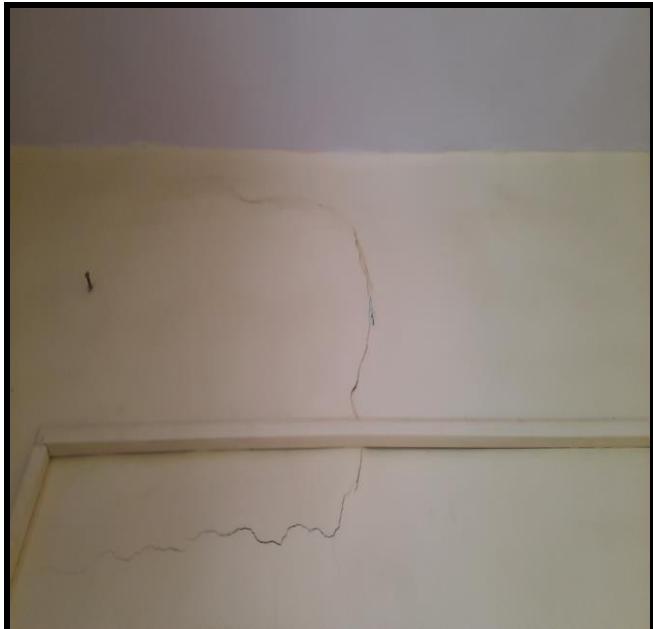
FLAT NO – 40

- ❖ **HALL** – Structural crack observed on beam & column.
 - Leakage observed on wall in monsoon.
- ❖ **KITCHEN** – O.K.
- ❖ **PASSAGE** – O.K.
- ❖ **TOILET & BATH ROOM** – O.K.

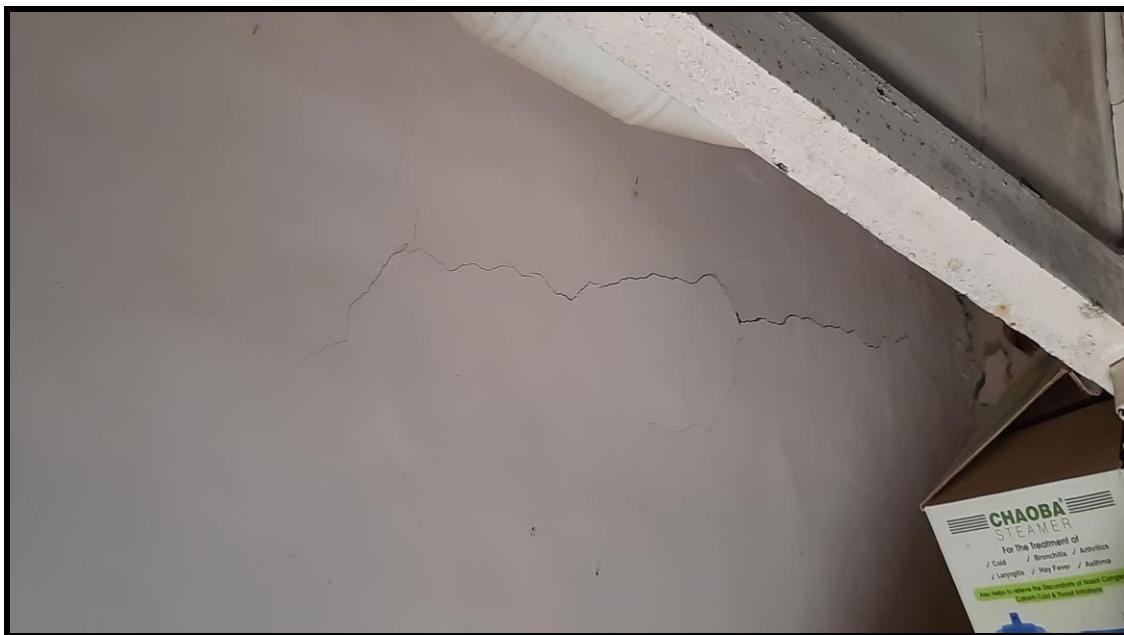
FLAT NO – 45

- ❖ **HALL** – Structural crack observed on ceiling.
- ❖ **KITCHEN** – O.K.
- ❖ **PASSAGE** – O.K.
- ❖ **TOILET & BATH ROOM** – O.K.

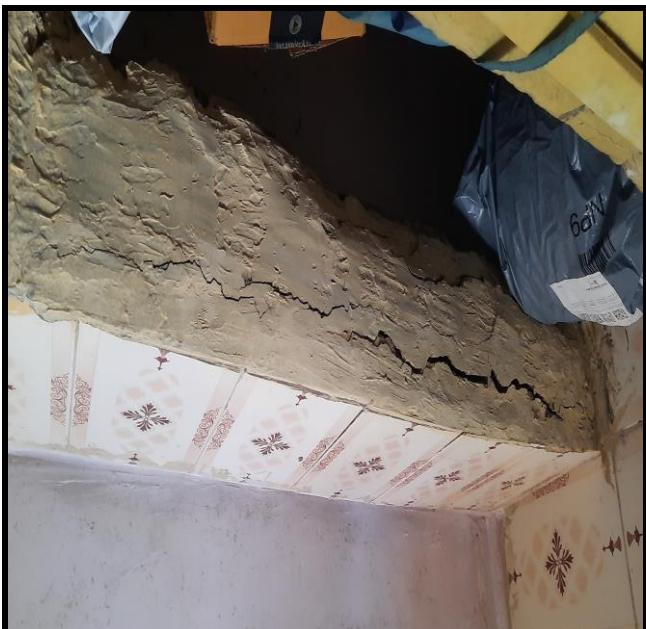
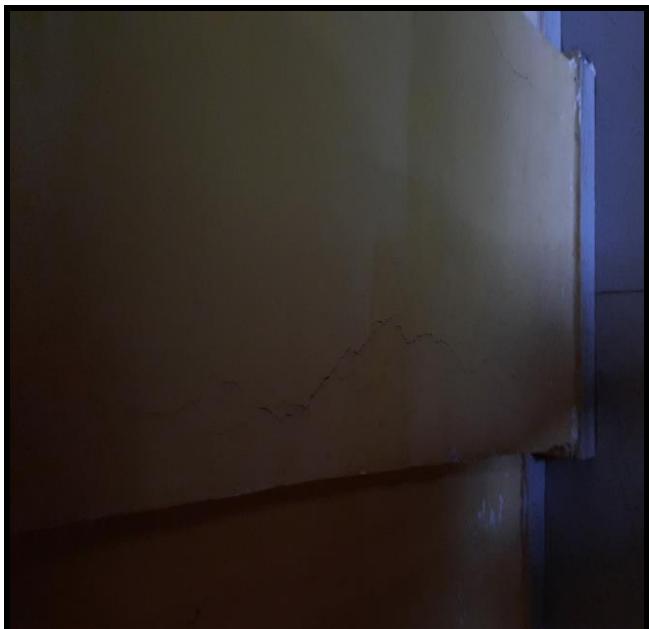
FLAT NO – 50

- ❖ **HALL** – Structural crack observed on column.
- ❖ **KITCHEN** – Structural crack observed on beam.
- ❖ **PASSAGE** – O.K.
- ❖ **TOILET & BATH ROOM** – O.K.

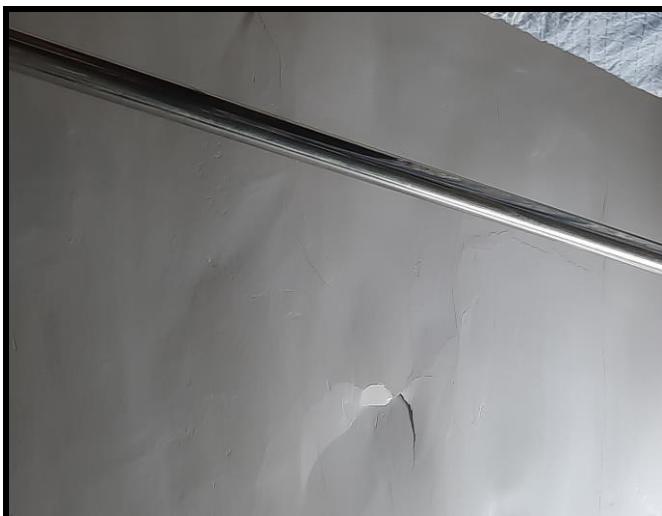
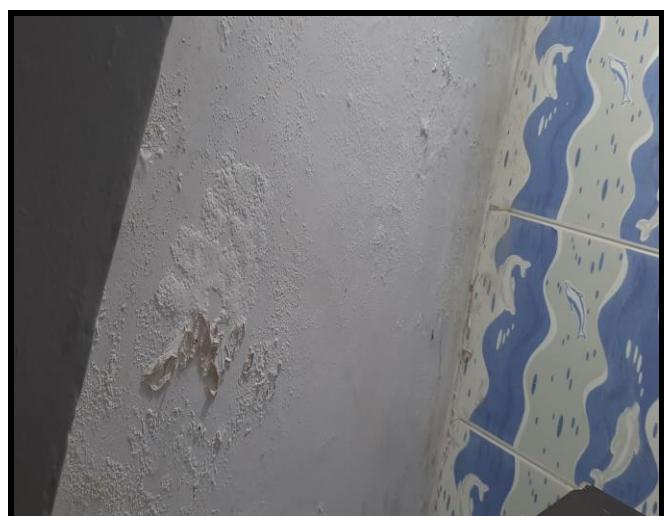
FLAT NO – 51

- ❖ **HALL** – O.K.
- ❖ **KITCHEN** – Structural crack observed on ceiling.
- ❖ **PASSAGE** – O.K.
- ❖ **TOILET & BATH ROOM** – Leakage mark observed on ceiling.

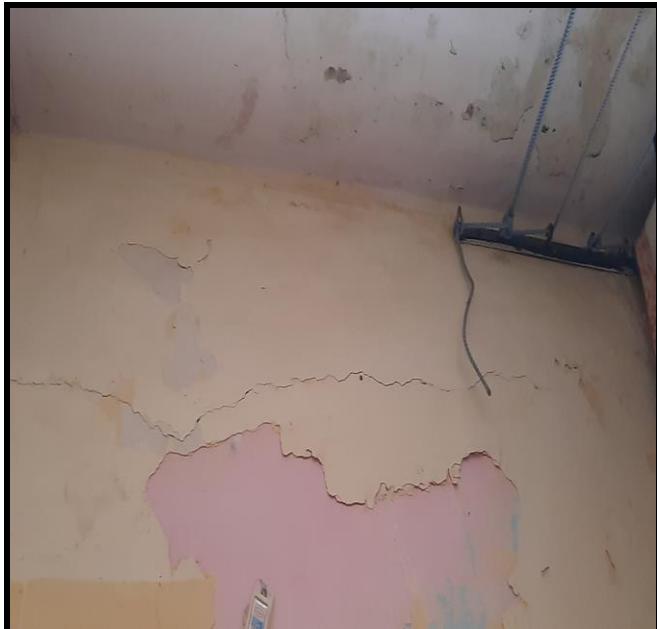
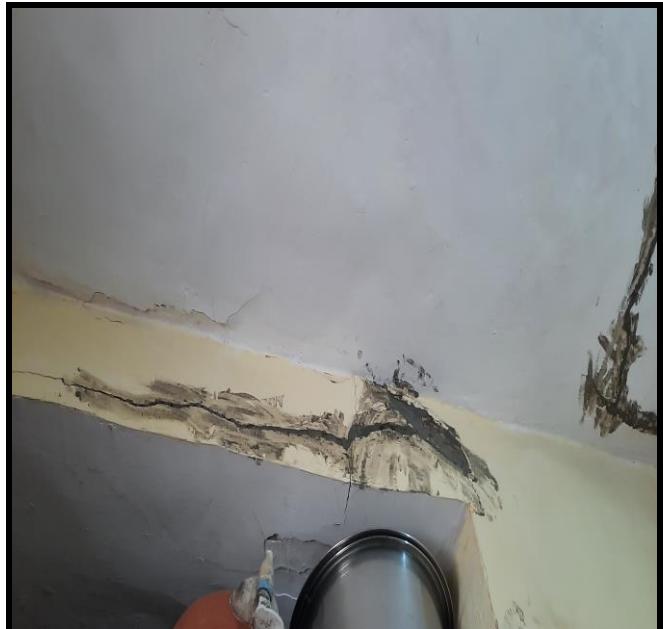
FLAT NO – 52

- ❖ **HALL** – Leakage mark observed on wall.
 - Structural crack observed on beam & ceiling.
- ❖ **KITCHEN** – Structural crack observed on beam & ceiling.
- ❖ **PASSAGE** – O.K.
- ❖ **TOILET & BATH ROOM** – O.K.

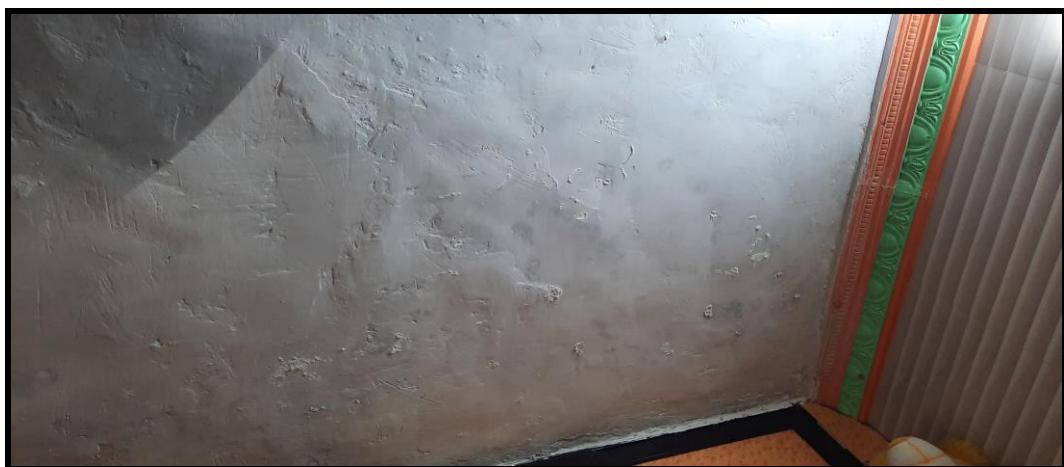
FLAT NO – 54

- ❖ **HALL** – Leakage mark observed on ceiling.
- ❖ **KITCHEN** – Leakage mark observed on ceiling.
- ❖ **PASSAGE** – O.K.
- ❖ **TOILET & BATH ROOM** – O.K.

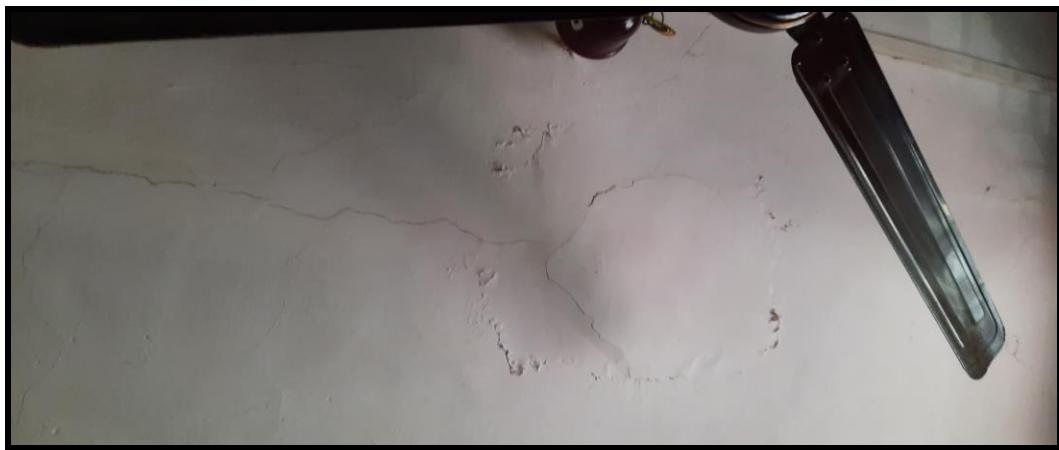
FLAT NO – 59

- ❖ **HALL** – Structural crack observed on ceiling.
- ❖ **KITCHEN** – O.K.
- ❖ **PASSAGE** – O.K.
- ❖ **TOILET & BATH ROOM** – O.K.

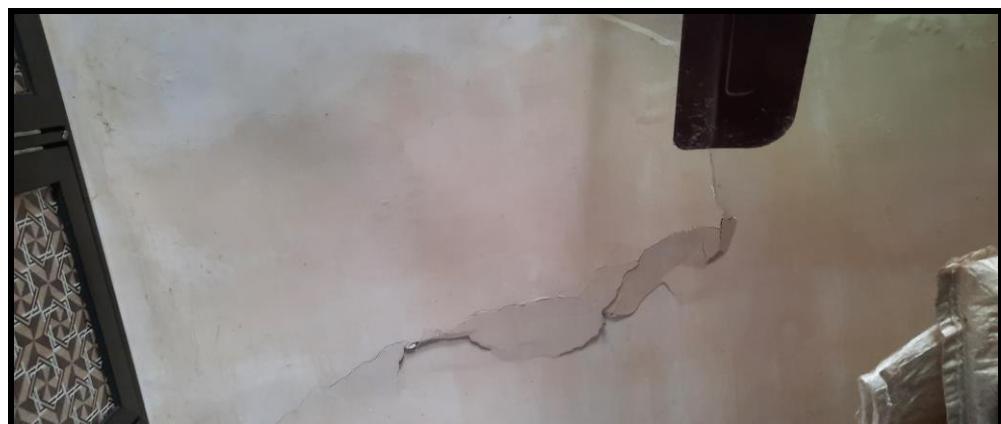
FLAT NO – 63

- ❖ **HALL** – Leakage observed on ceiling in monsoon.
- ❖ **KITCHEN** – Structural damage observed on ceiling.
- ❖ **PASSAGE** – O.K.
- ❖ **TOILET & BATH ROOM** – O.K.

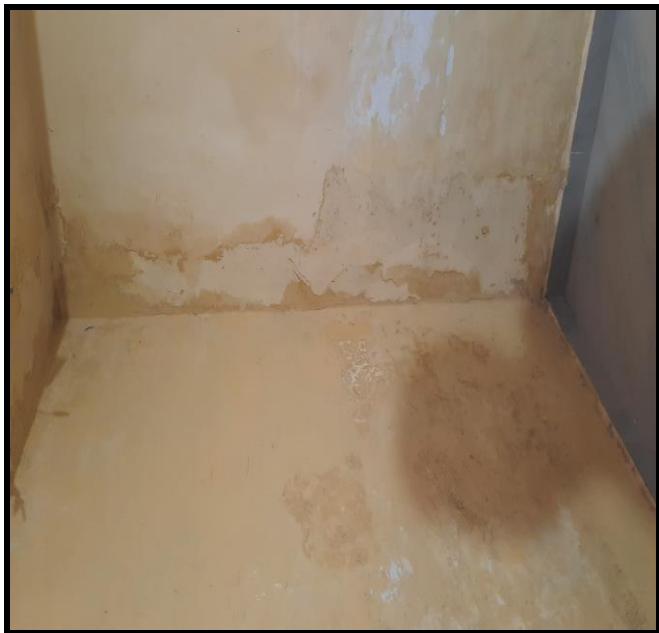
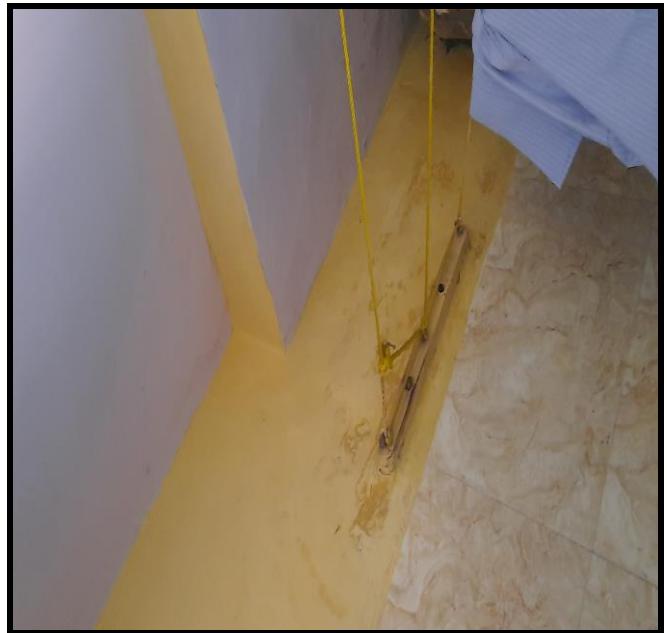
FLAT NO – 68

- ❖ **HALL** – Leakage observed on wall in monsoon.
- ❖ **KITCHEN** – Leakage observed on wall in monsoon.
- ❖ **PASSAGE** – O.K.
- ❖ **TOILET & BATH ROOM** – O.K.

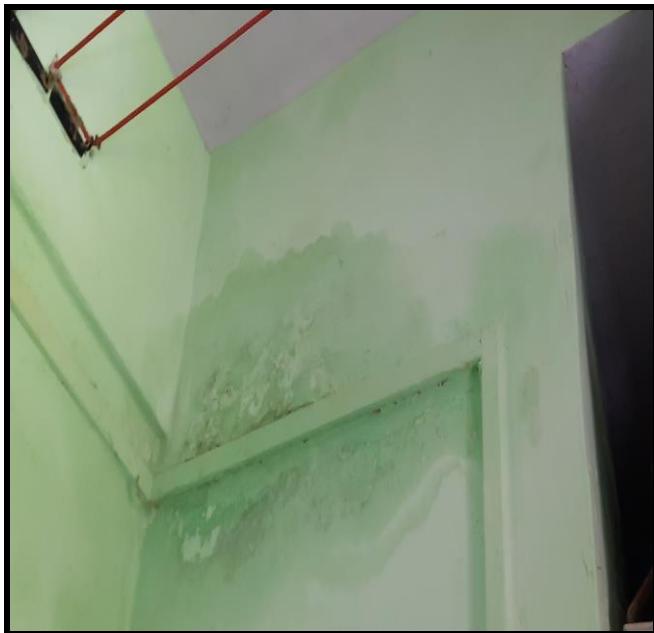
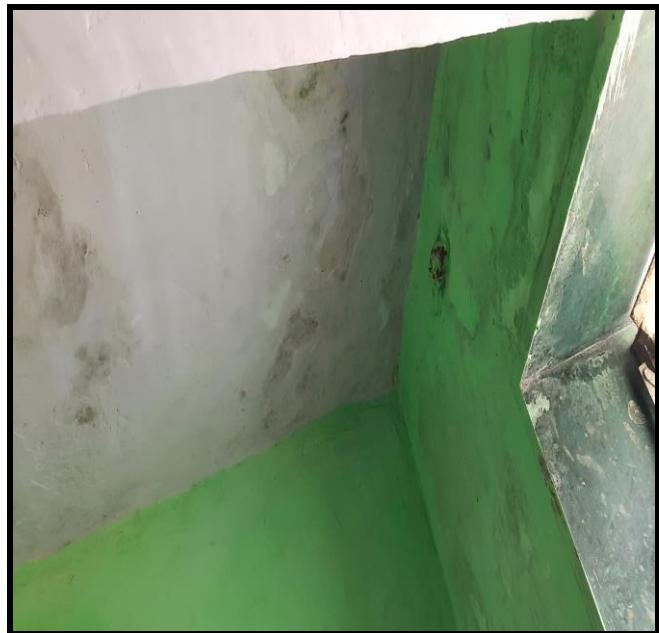
FLAT NO – 69

- ❖ **HALL** – Dampness observed on ceiling.
- ❖ **KITCHEN** – Dampness observed on wall.
- ❖ **PASSAGE** – O.K.
- ❖ **TOILET & BATH ROOM** – O.K.
