STRUCTURAL AUDIT REPORT
FOR
“VISHAL SAHYADRI CO – OP HSG. SOC. LTD”,
“C8 – WING”
SITUATED AT
SAHYADRI NAGAR, CHARKOP,
KANDIVALI (W) MUMBAI – 400 067

PREPARED BY
LATESH S. SANKLECHA
CONSULTING STRUCTURAL ENGINEERS

978/B1/LSS/2021

JUNE 21, 2021

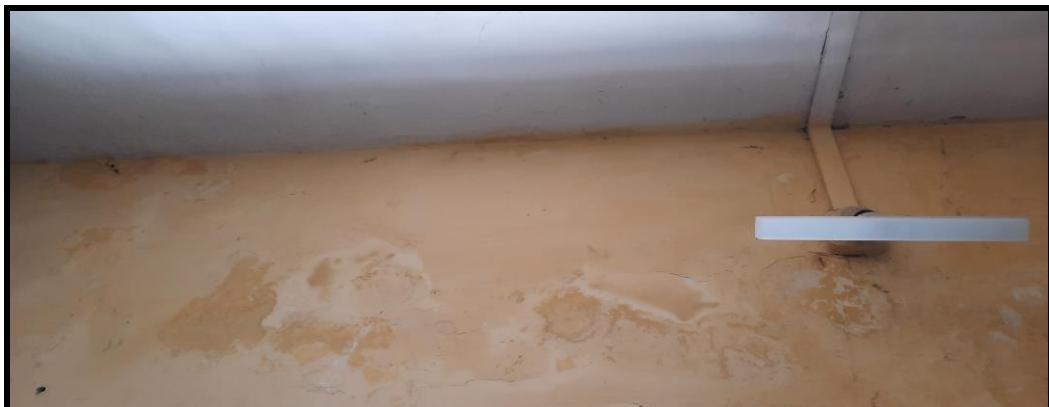
FLAT NO – 73

- ❖ **HALL** – Leakage mark observed on wall.
- ❖ **KITCHEN** – O.K.
- ❖ **PASSAGE** – O.K.
- ❖ **TOILET & BATH ROOM** – O.K.

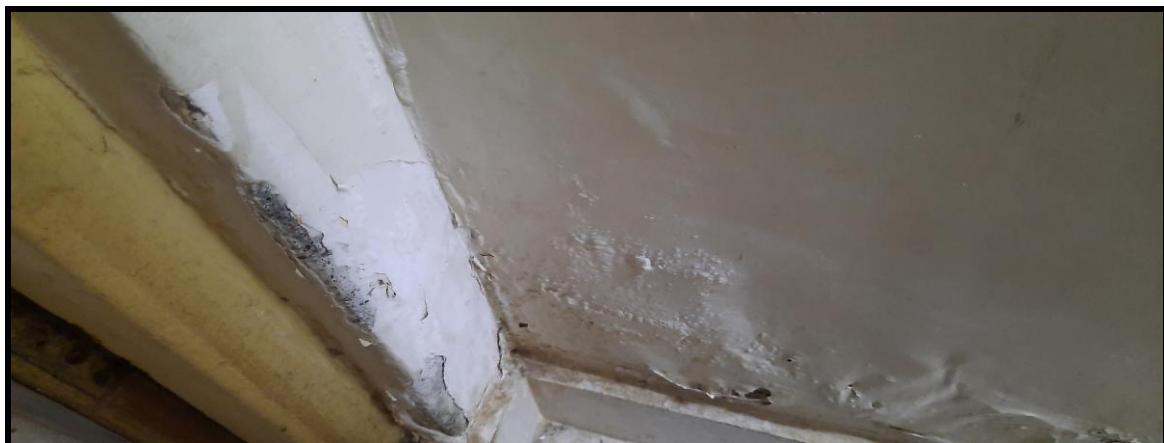
FLAT NO – 78

- ❖ **HALL** – Leakage mark observed on wall.
- ❖ **KITCHEN** – Leakage observed on wall in monsoon.
- ❖ **PASSAGE** – O.K.
- ❖ **TOILET & BATH ROOM** – O.K.

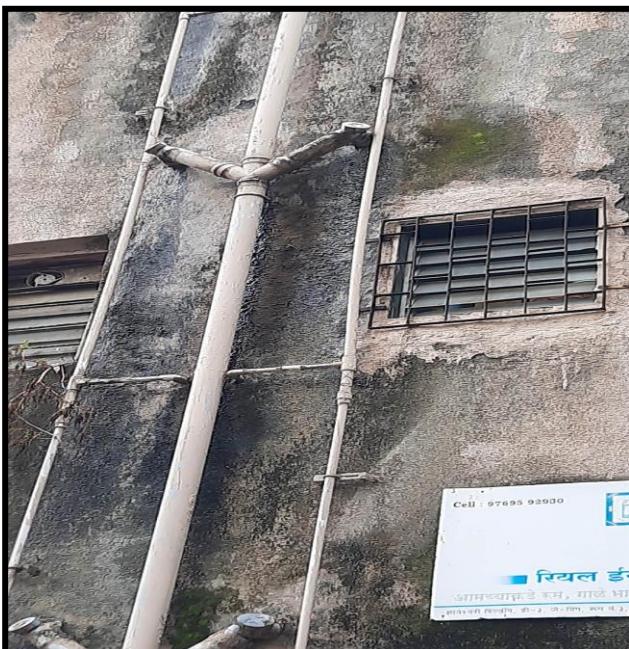
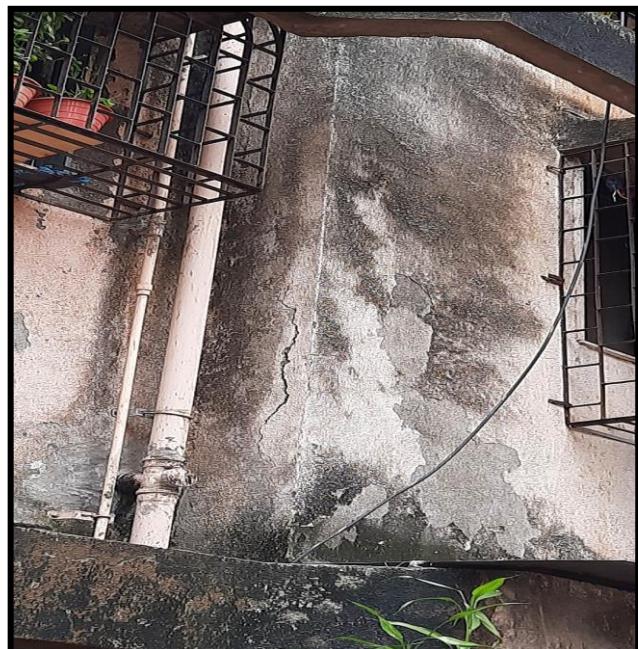
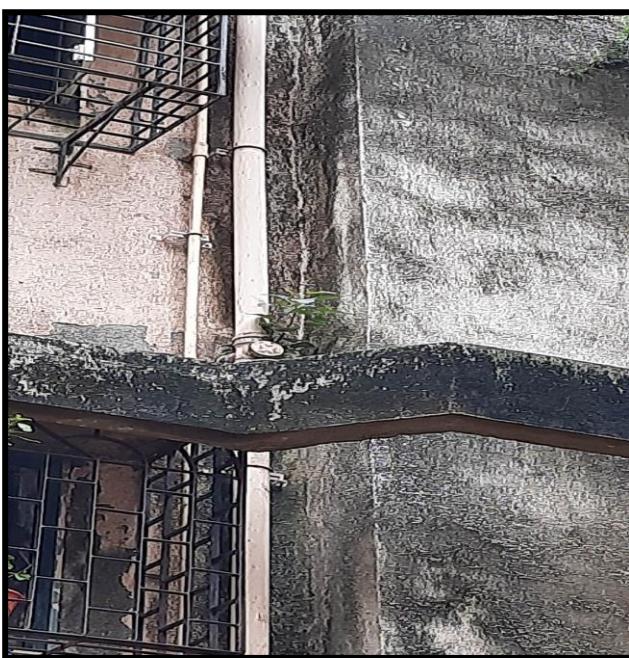
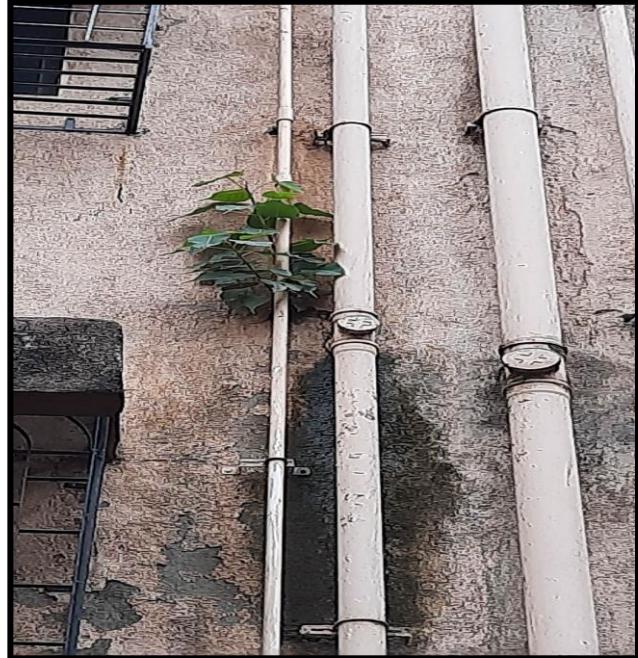
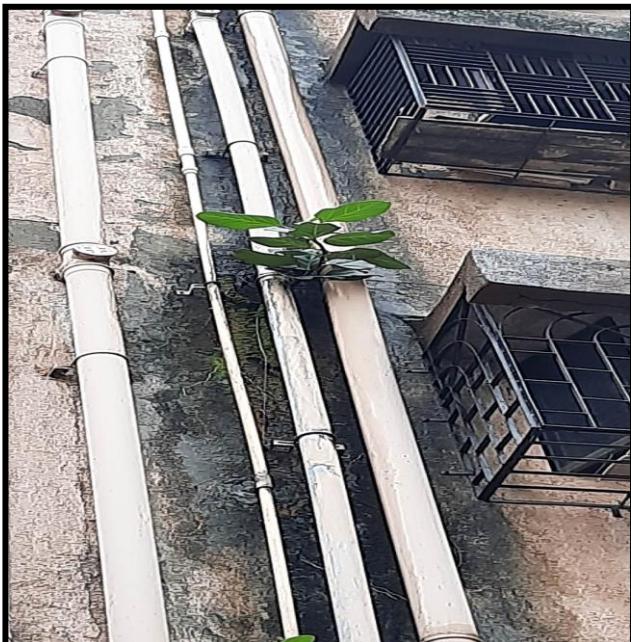
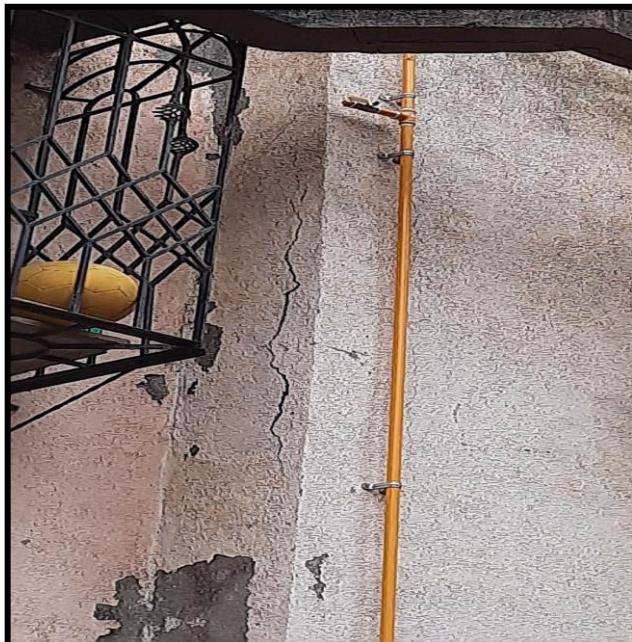
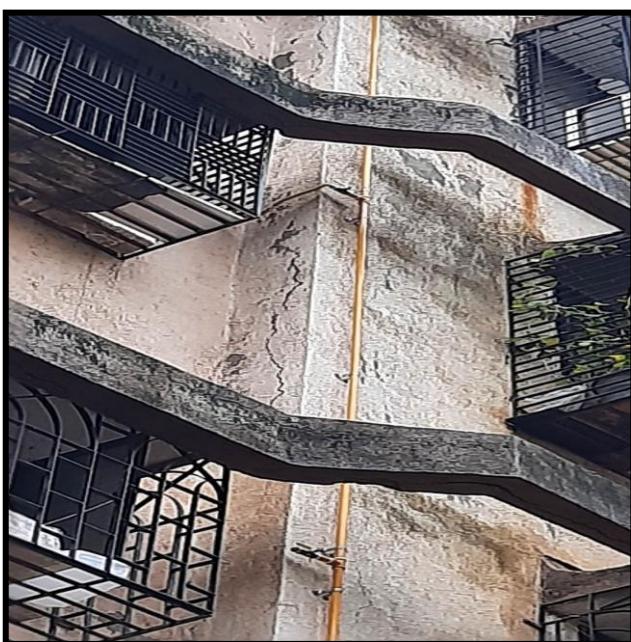
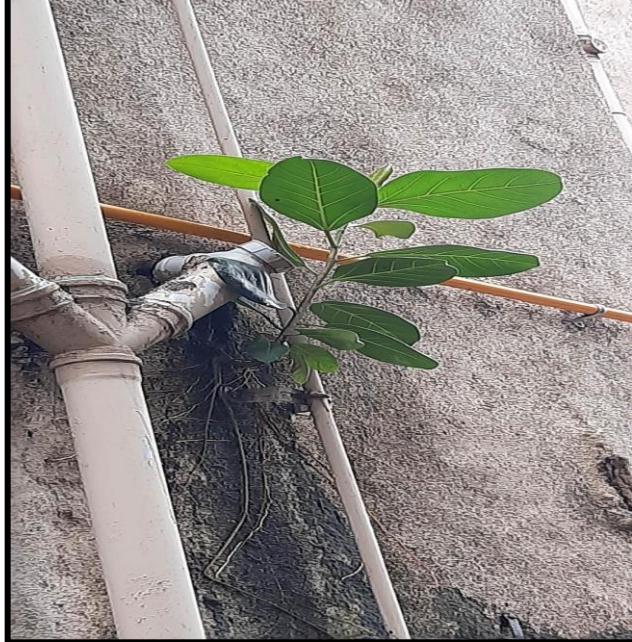
FRONT SIDE

- ❖ Structural crack observed at several places on column.
- ❖ Major crack observed at several places on wall.
- ❖ Vegetation growth observed at several places on wall.

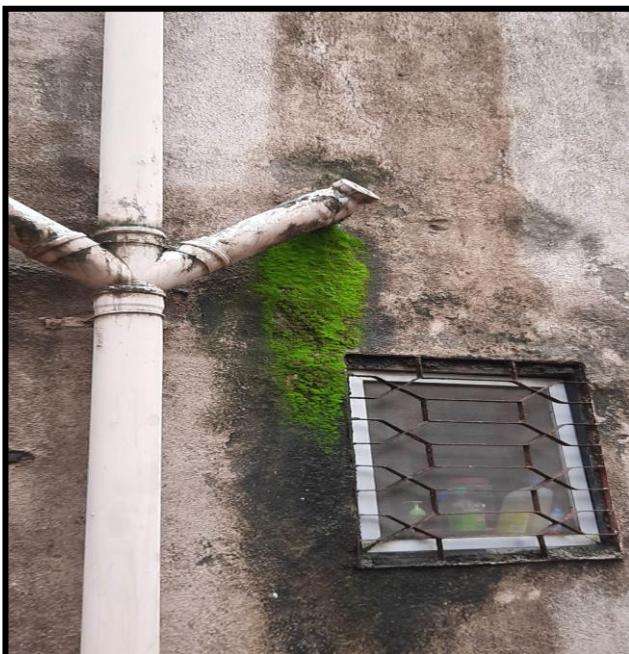
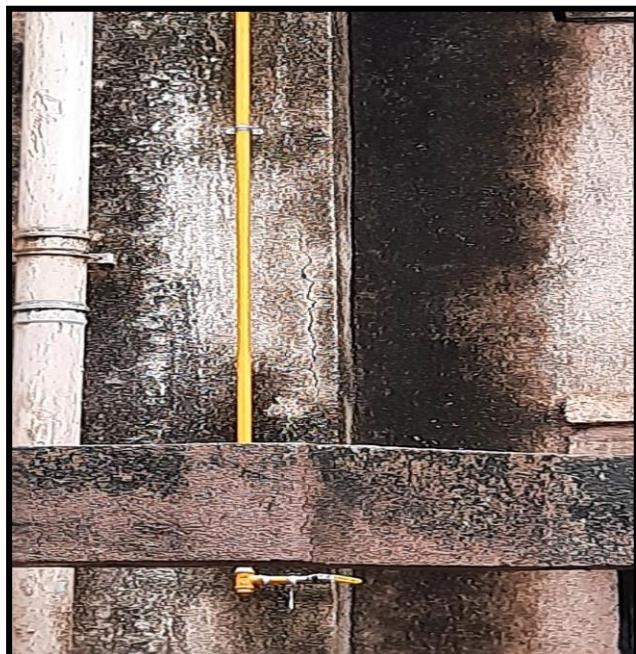
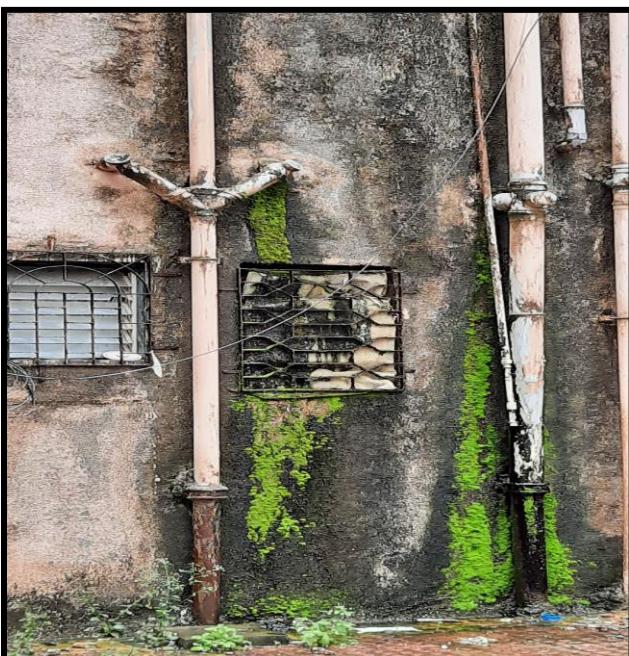
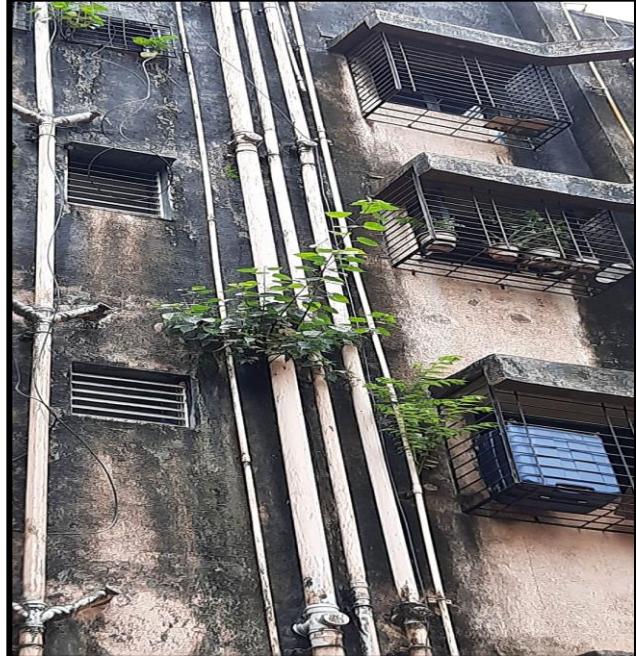
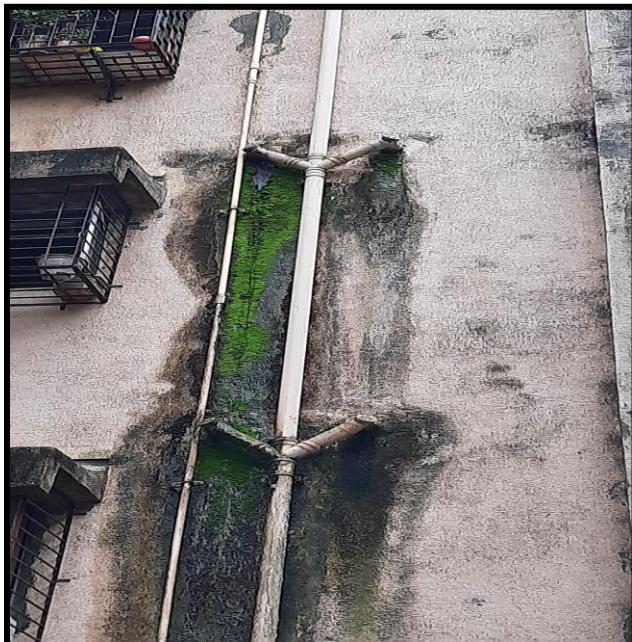
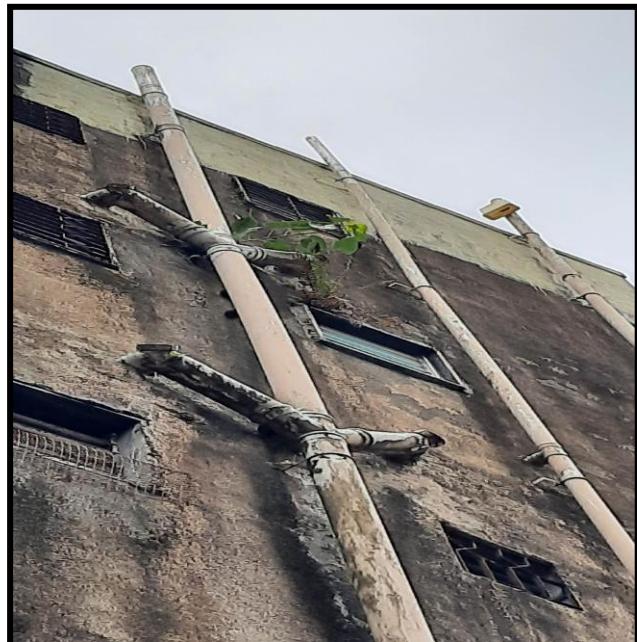
BACK SIDE

- ❖ Structural crack observed at several places on column.
- ❖ Major crack observed at several places on wall.
- ❖ Vegetation growth observed at several places on wall.
- ❖ Algae observed at several places on wall.

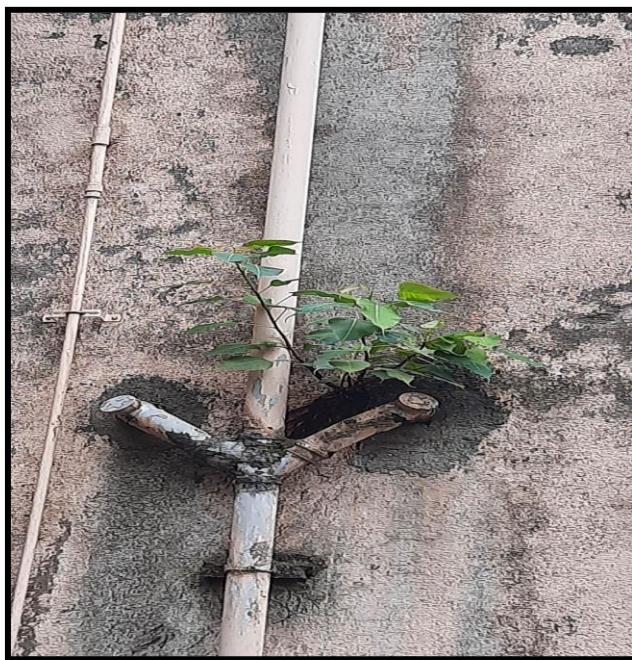
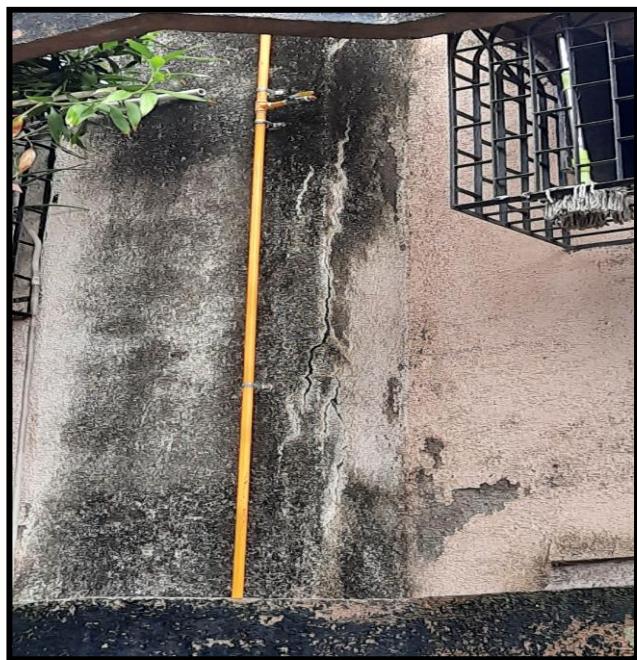
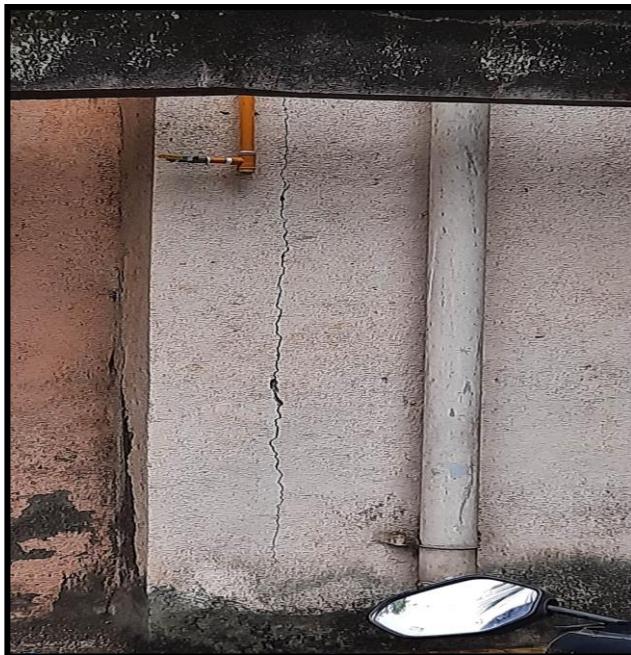
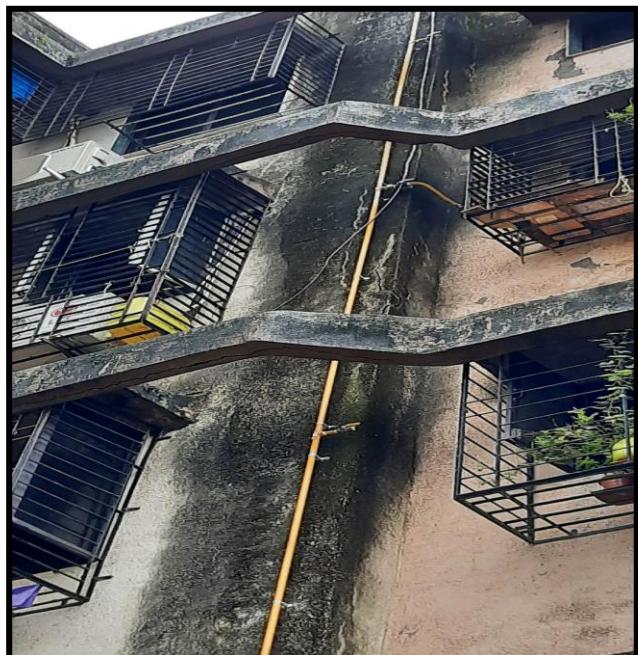
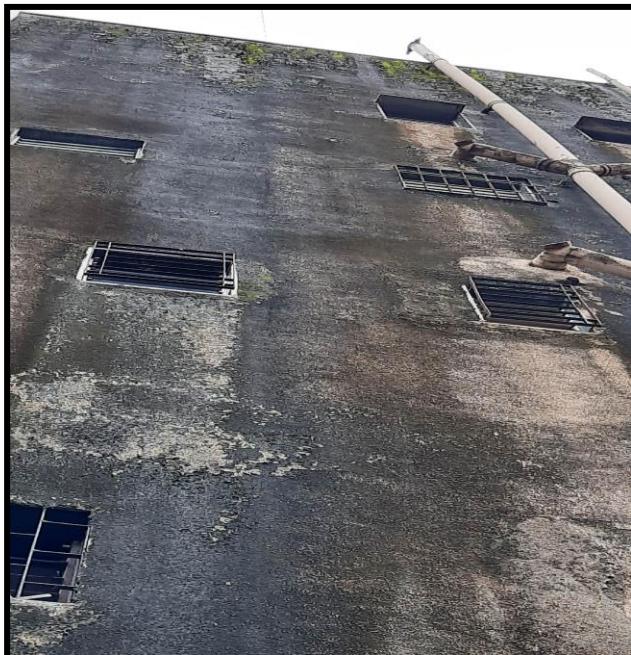
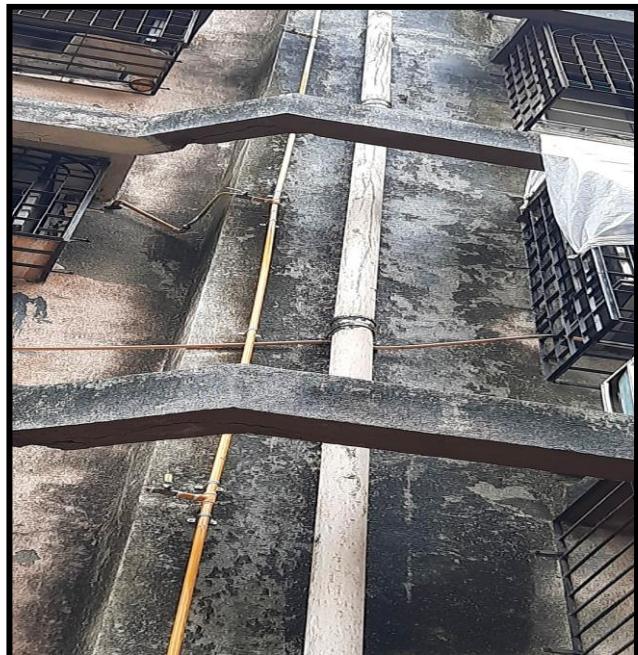
NORTH SIDE

- ❖ Structural crack observed at several places on column.
- ❖ Major crack observed at several places on wall.
- ❖ Vegetation growth observed at several places on wall.

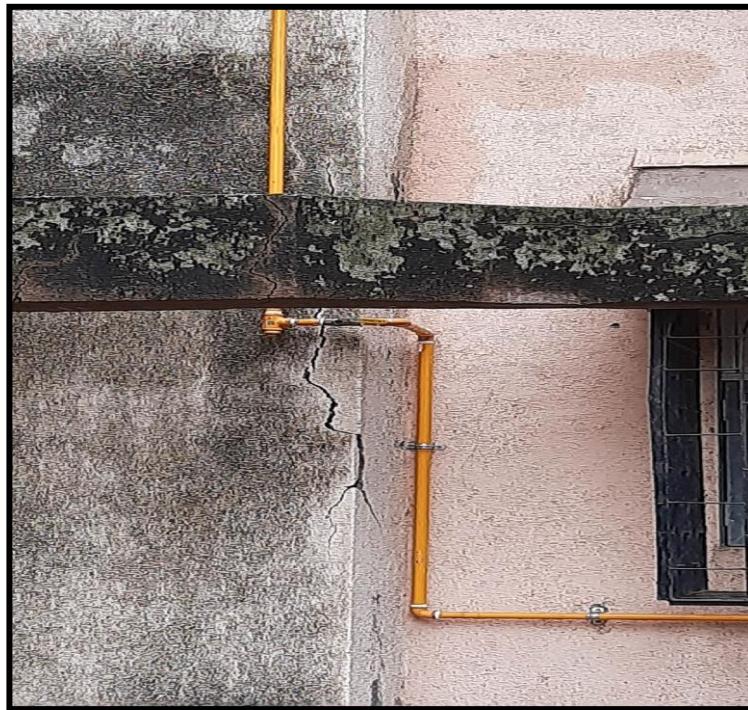
SOUTH SIDE

- ❖ Structural crack observed at several places on column.
- ❖ Major crack observed at several places on wall.
- ❖ Vegetation growth observed at several places on wall.
- ❖ Algae observed at several places on wall.
