STRUCTURAL AUDIT REPORT
FOR
“VISHAL SAHYADRI CO – OP HSG. SOC. LTD”,
“A1 – WING”
SITUATED AT
SAHYADRI NAGAR, CHARKOP,
KANDIVALI (W) MUMBAI – 400 067

978/B4/LSS/2021

JUNE 24, 2021

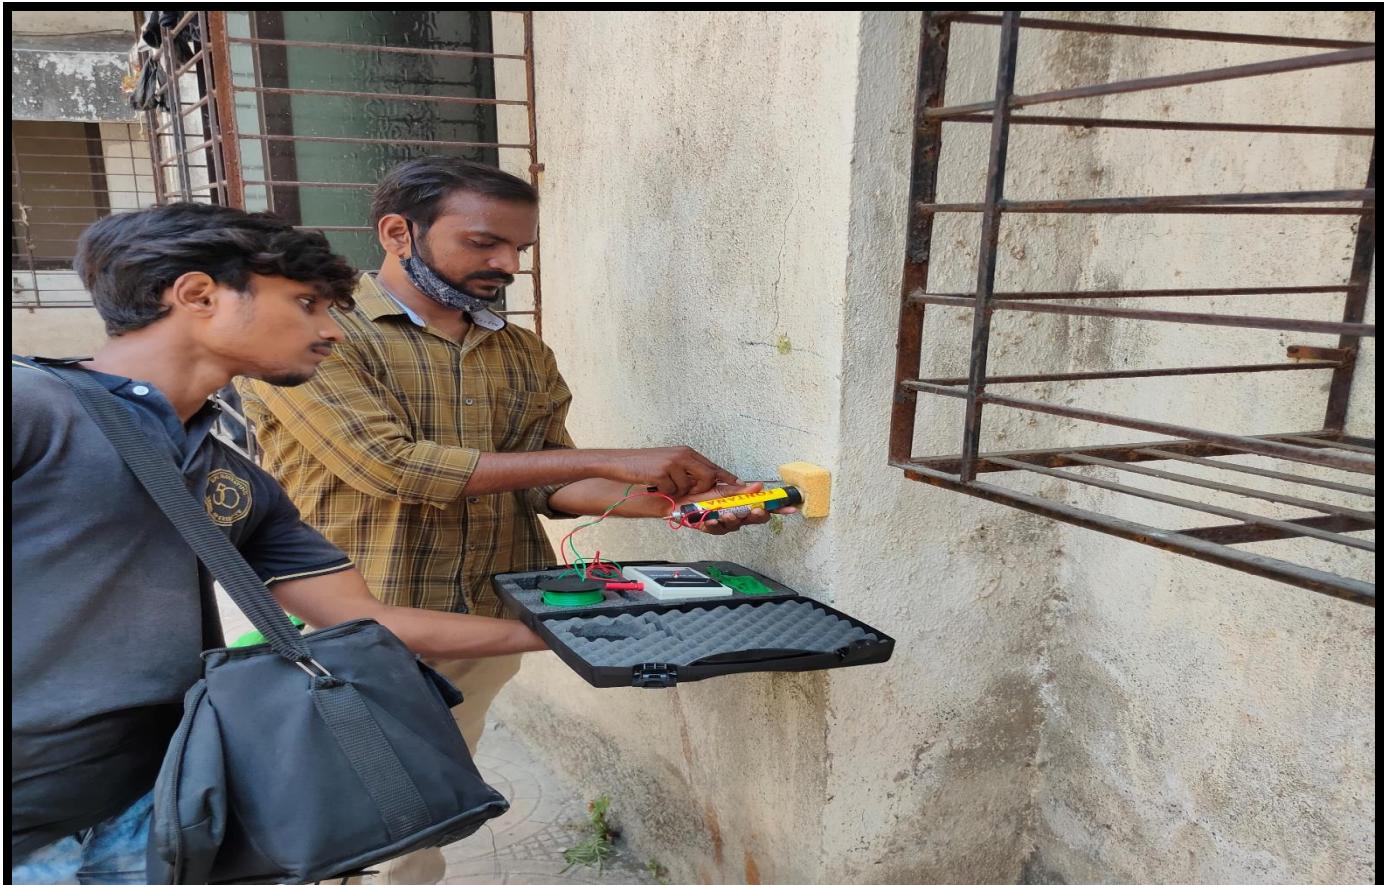
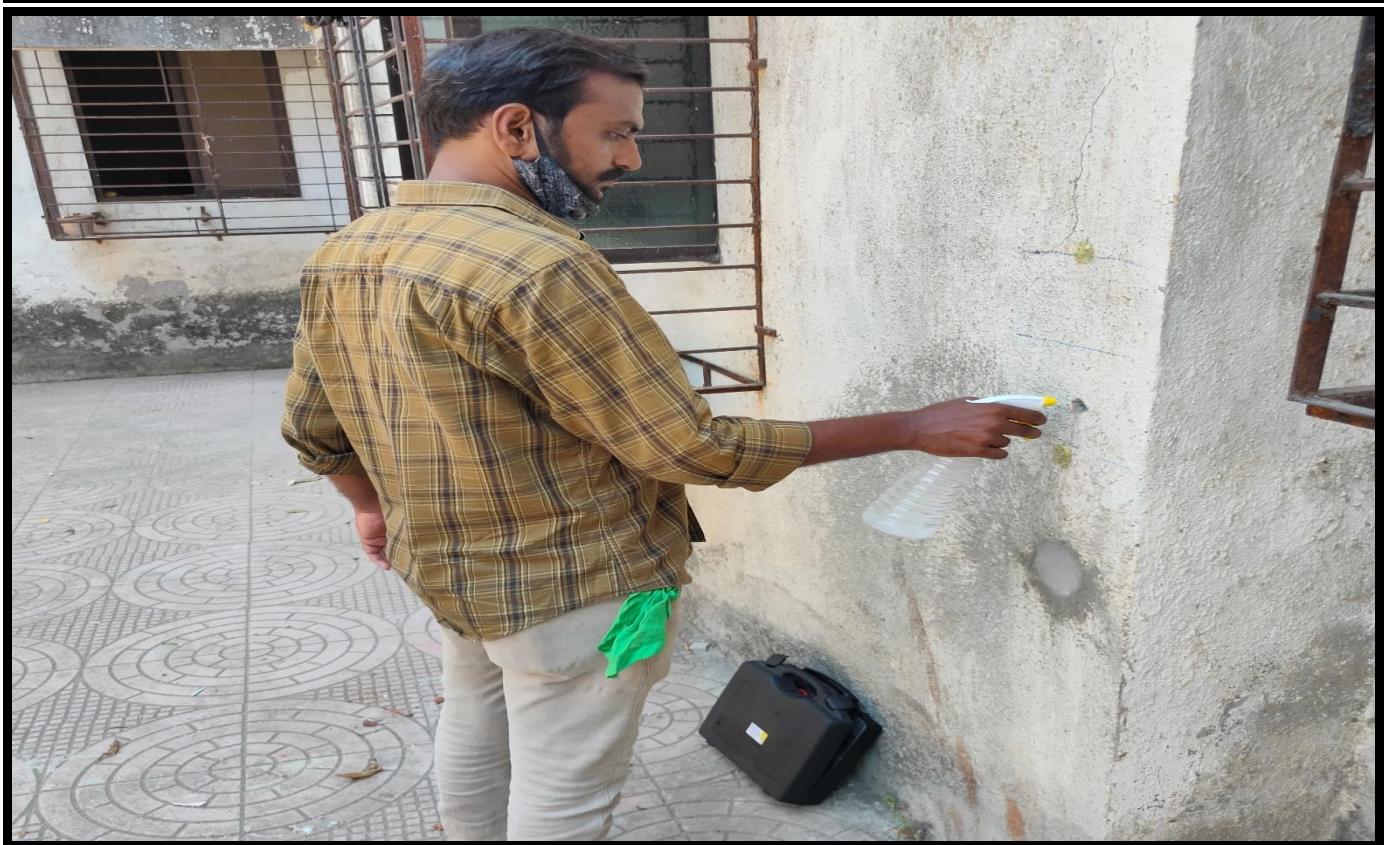
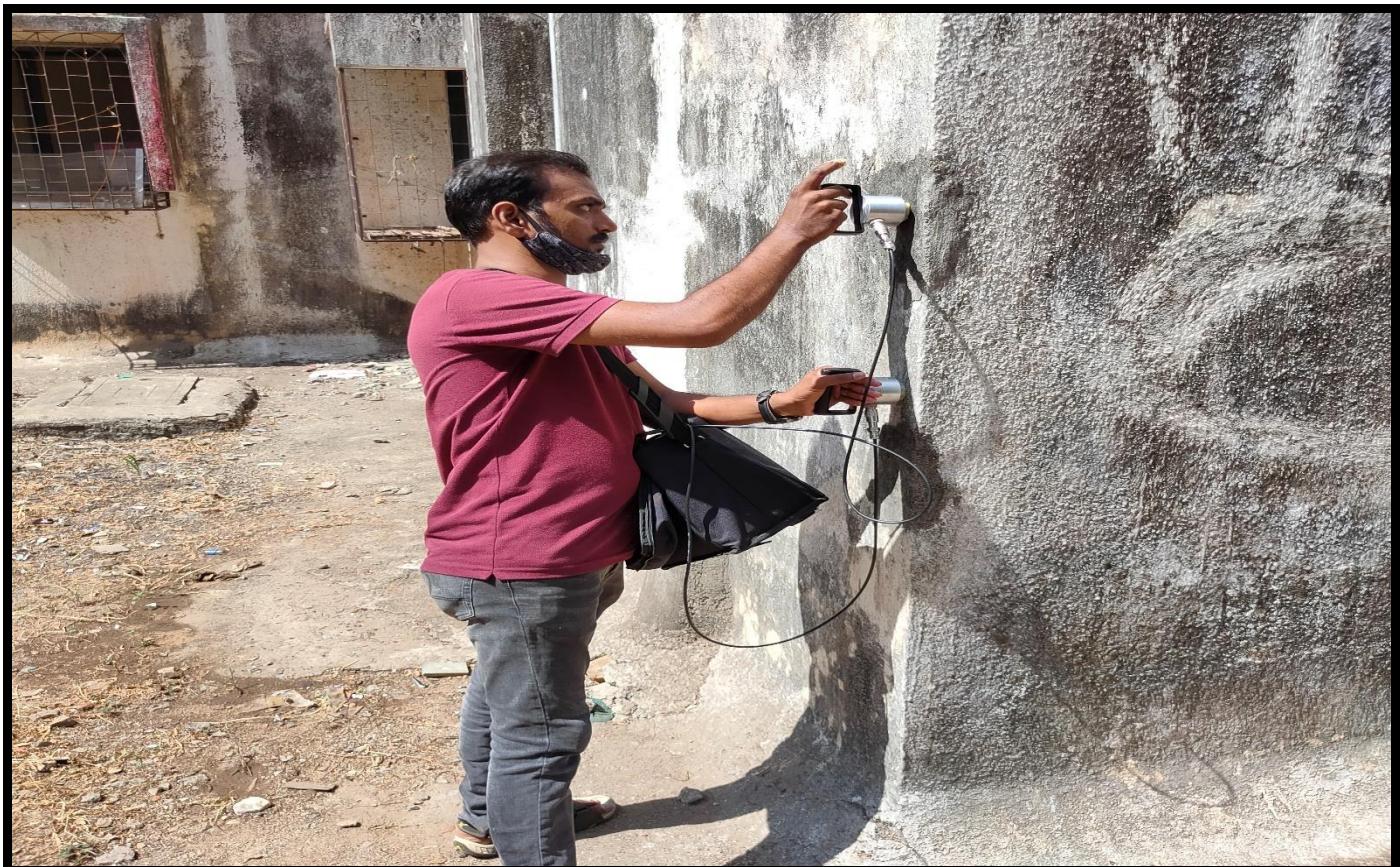
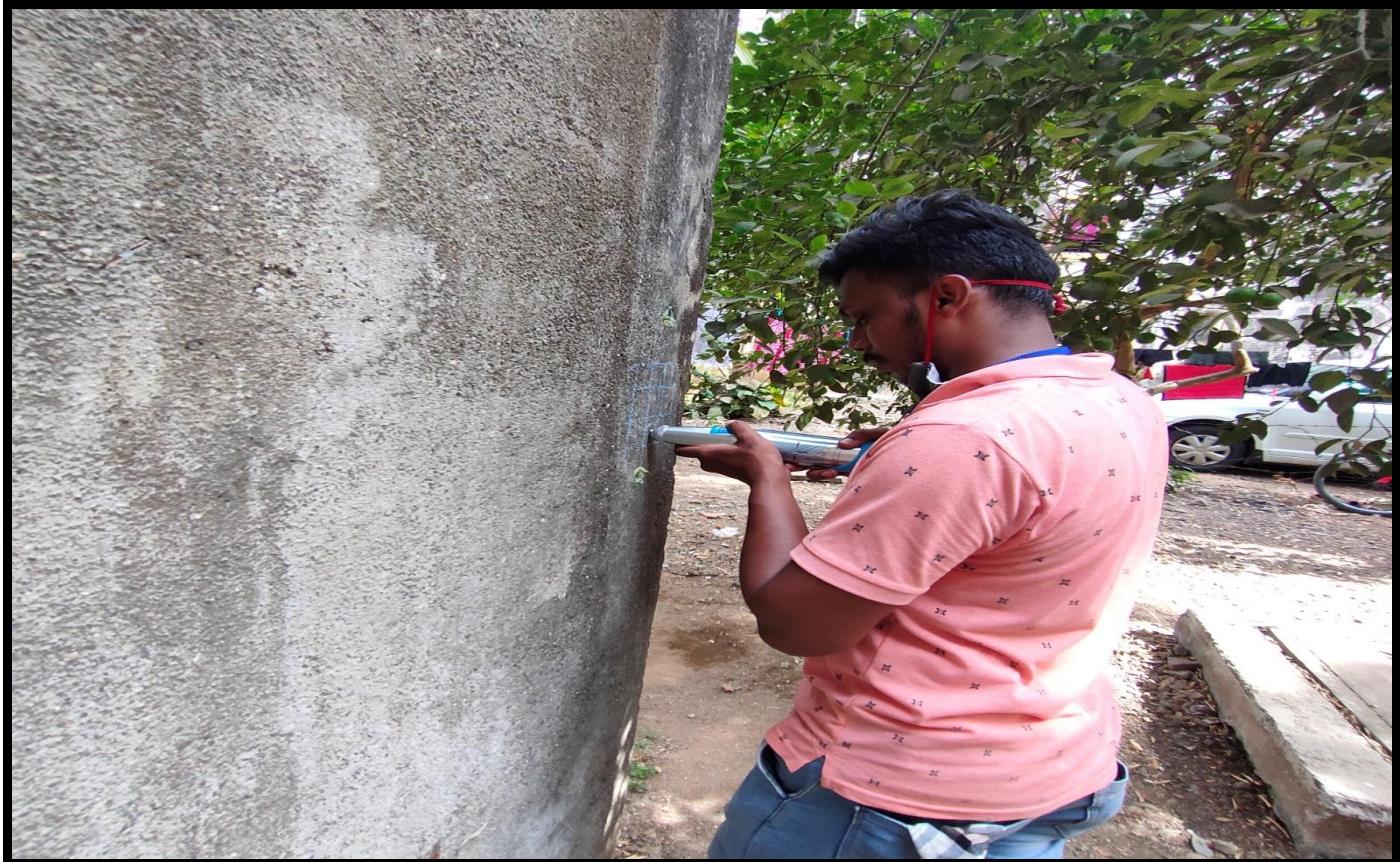
NON -DESTRUCTIVE TEST PHOTO

Rebound Hammer was tested for compressive strength at surface by Schmidt rebound hammer. Results indicate the compressive strength at surface of all the RCC columns is ranging between 14.90 MPa to 21.80 MPa.

The UPV values are ranging between 2.70 Km/Sec to 3.40 Km/Sec.

Out of 4 locations 2 locations was below 3.0 Km/Sec means concrete quality is poor & 2 locations was between 3.0 Km/Sec to 3.75 Km/Sec means concrete quality is doubtful.

This indicates there are progressive internal cracks in the RCC members due to corrosion of reinforced steel. These members are under distress condition.

Half Cell Potential tested for corrosion activity by half – cell potential tests. Values are taken on Column. The result on tested column is – 345 mV.

This indicates the probability of corrosion is 50% on tested column steel reinforcement.

Carbonation test was conducted to assess carbonation depth. Readings are taken on Column. Result indicates the carbonation penetration depth is 35.00 mm. Carbonation depths have reached to the reinforcement level in all of the RCC elements. It is essential to give a suitable anti-corrosion treatment to all the RCC members to stop further carbonation and corrosion of concrete.

RCC elements indicating UPV values less than 3 Km/sec needs immediate attention.

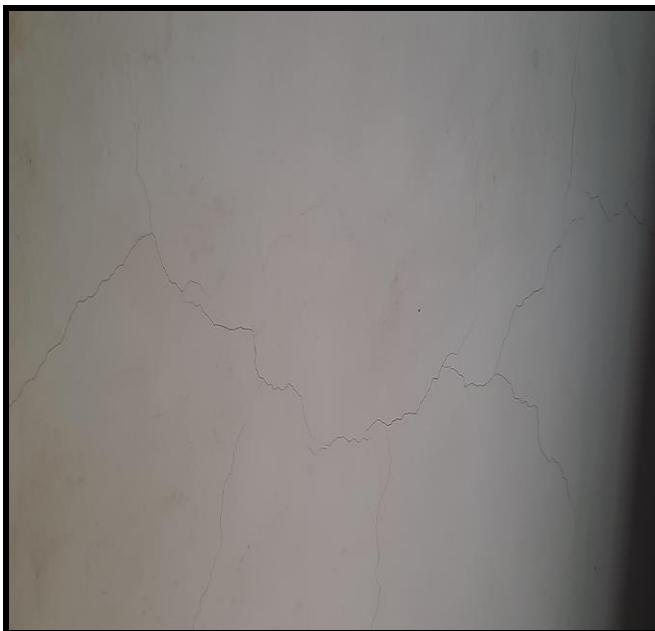
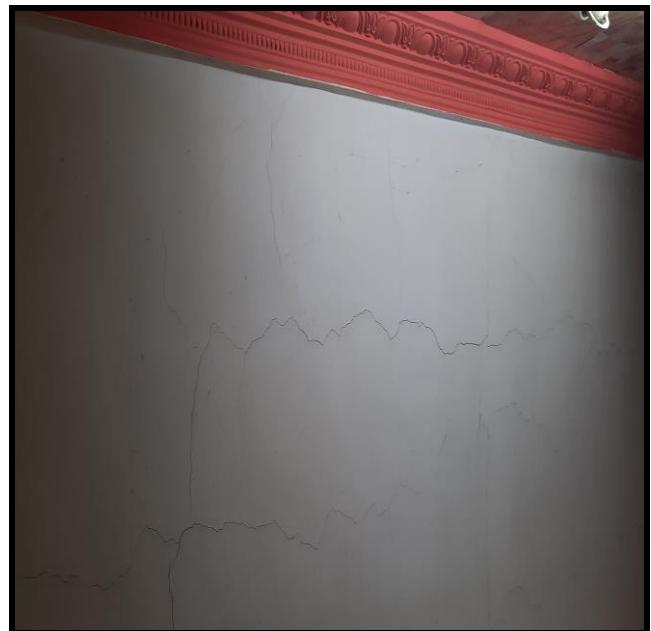
FLAT NO – 02

- ❖ **HALL** – Structural crack observed on ceiling.
- ❖ **KITCHEN** – O.K.
- ❖ **BEDROOM** – Structural crack observed on ceiling.
- ❖ **PASSAGE** – Structural crack observed on beam.
- ❖ **TOILET & BATH ROOM** – O.K.

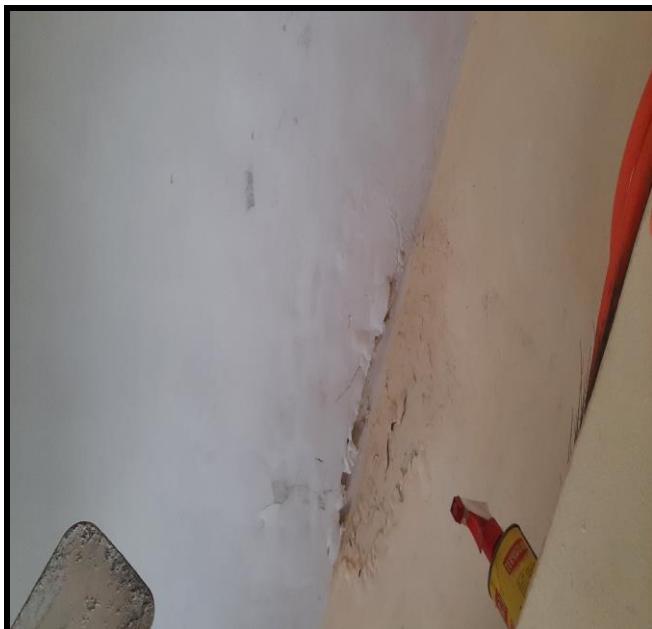
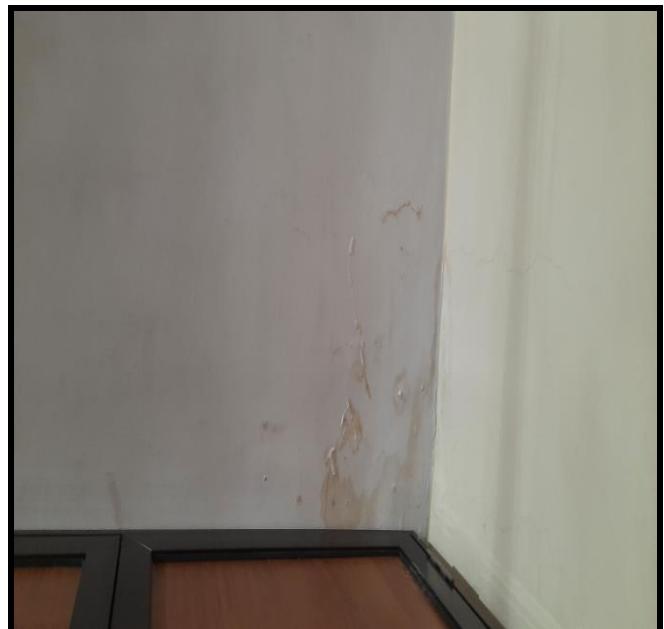
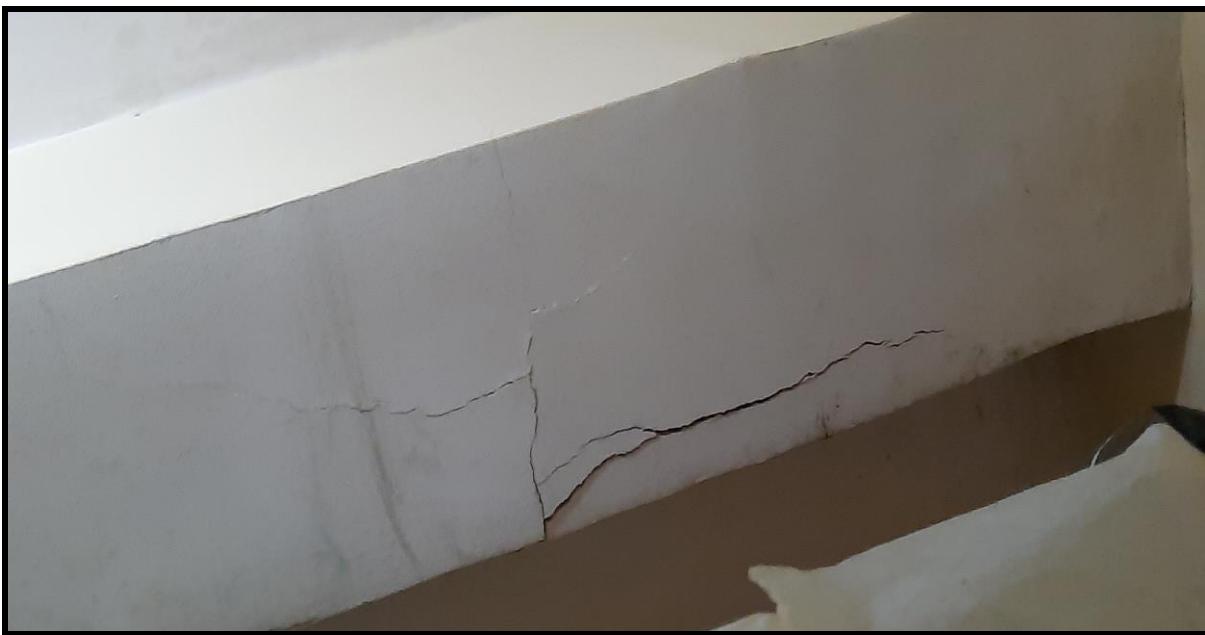
FLAT NO – 06

- ❖ **HALL** – O.K.
- ❖ **KITCHEN** – Leakage mark observed on ceiling.
- ❖ **BEDROOM** – Leakage mark observed on ceiling.
- ❖ **PASSAGE** – O.K.
- ❖ **TOILET & BATH ROOM** – O.K.

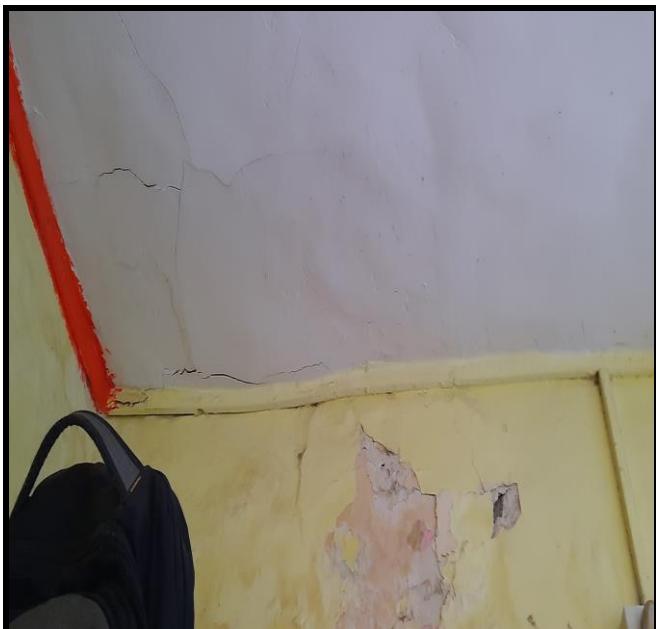
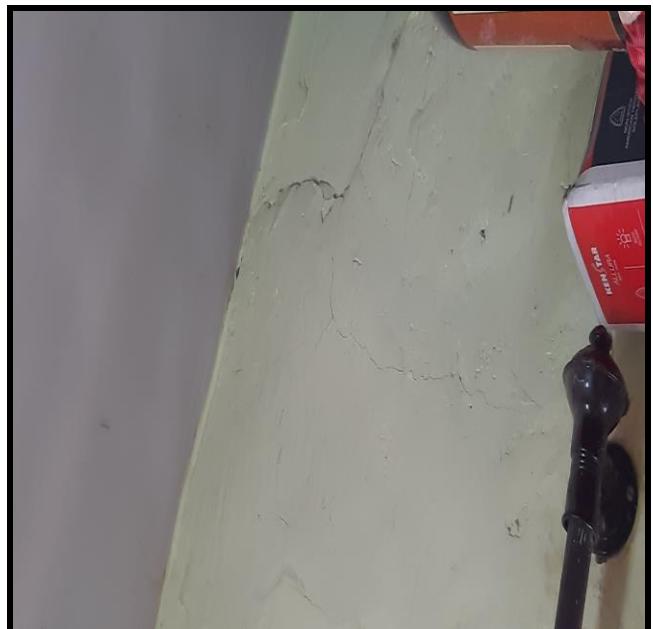
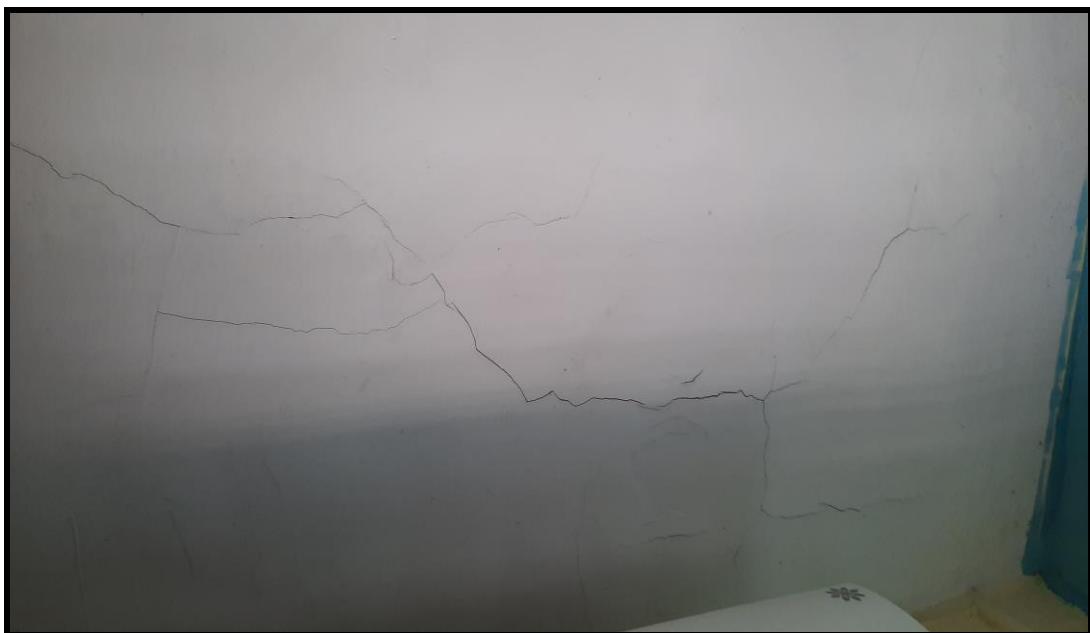
FLAT NO – 07

- ❖ **HALL** – Structural crack observed on ceiling.
 - Leakage mark observed on wall.
- ❖ **KITCHEN** – O.K.
- ❖ **BEDROOM** – Structural damage observed on beam.
- ❖ **PASSAGE** – O.K.
- ❖ **TOILET & BATH ROOM** – O.K.

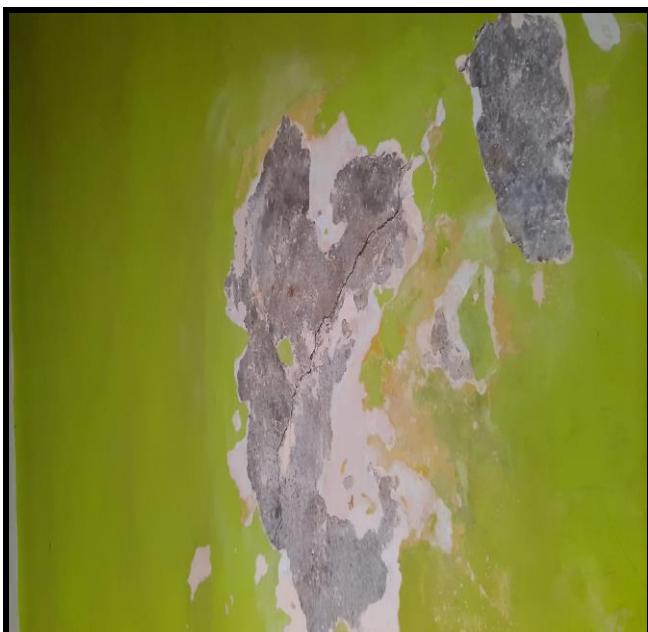
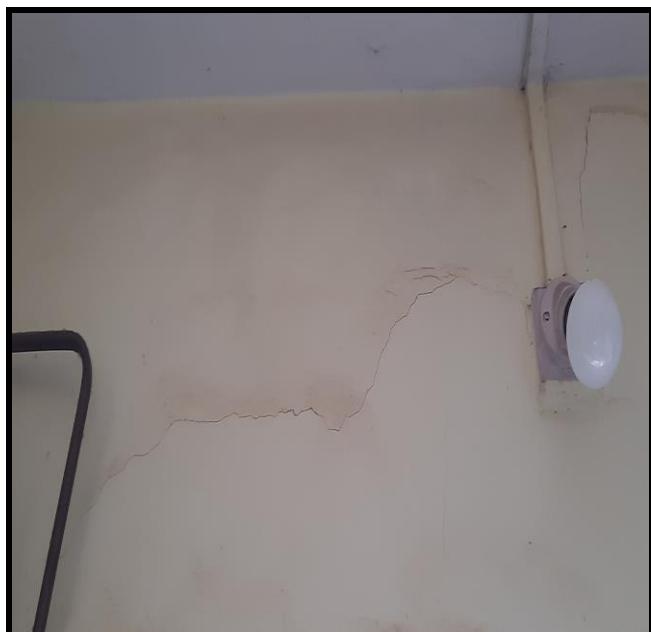
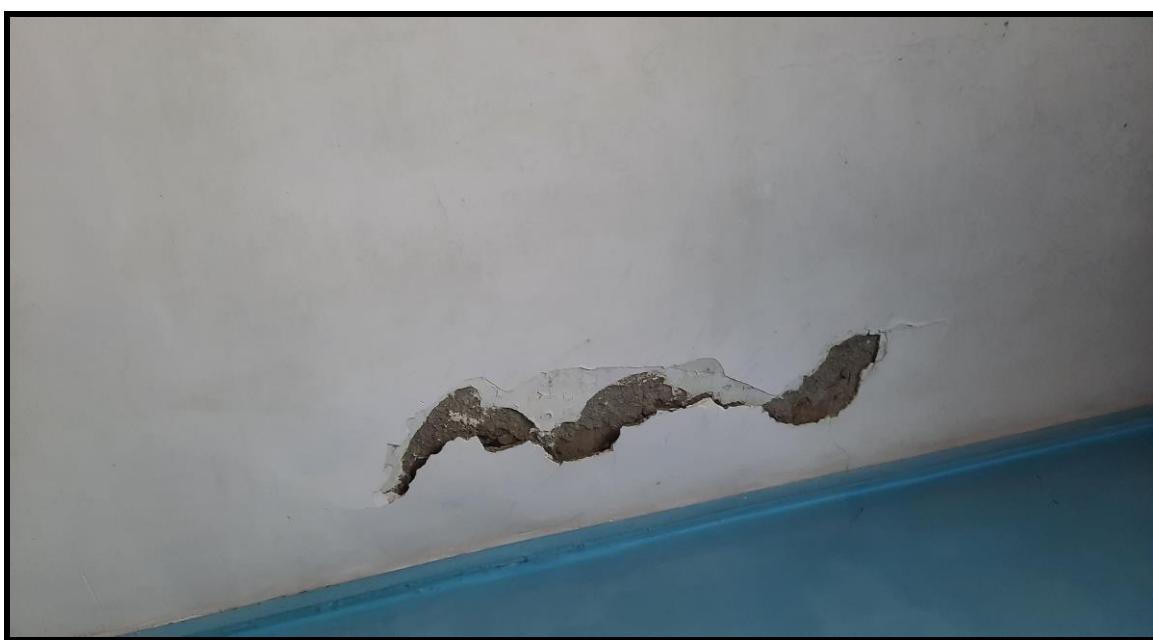
FLAT NO – 08

- ❖ **HALL** – Leakage mark observed on wall.
 - Major crack observed on wall.
- ❖ **KITCHEN** – Structural crack observed on beam.
- ❖ **BEDROOM** – Structural crack observed on beam.
 - Structural damage observed on ceiling.
 - Dampness observed on wall in monsoon.
- ❖ **PASSAGE** – O.K.
- ❖ **TOILET & BATH ROOM** – O.K.

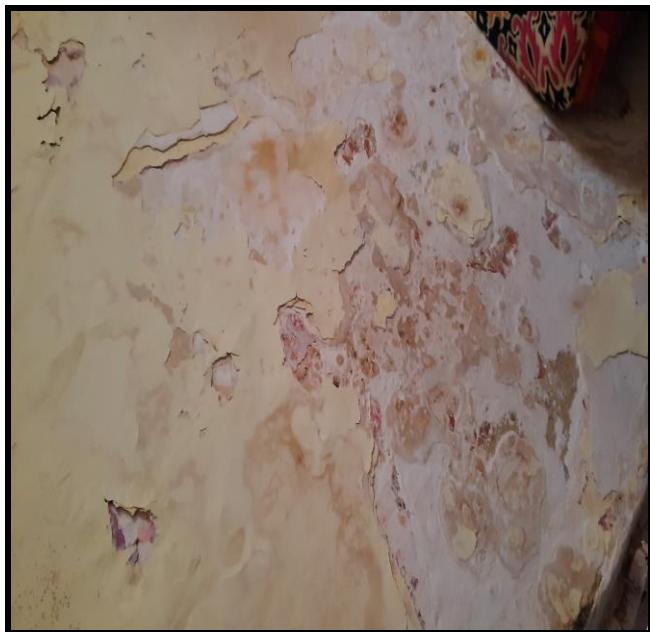
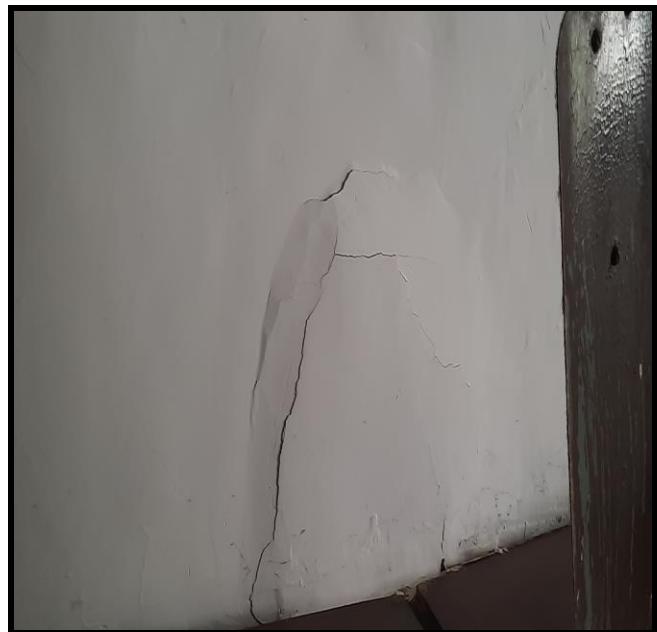
FLAT NO – 09

- ❖ **HALL** – O.K.
- ❖ **KITCHEN** – Structural crack observed on beam.
 - Structural damage observed on ceiling.
- ❖ **BEDROOM** – Leakage mark observed on wall.
- ❖ **PASSAGE** – O.K.
- ❖ **TOILET & BATH ROOM** – O.K.

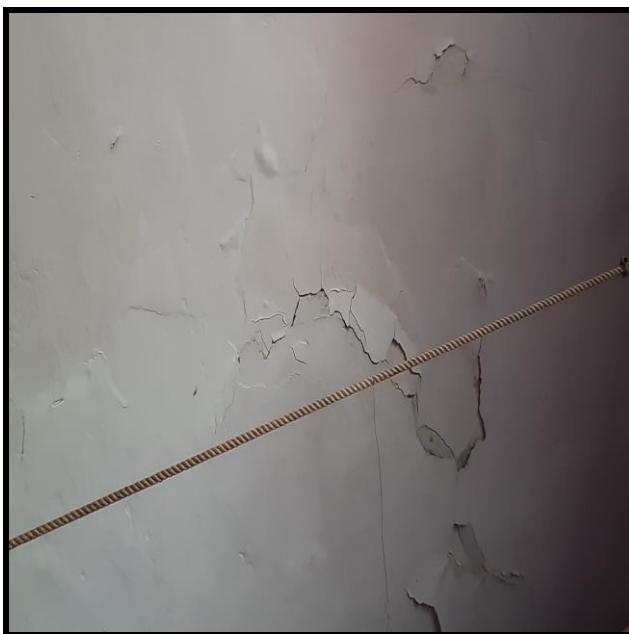
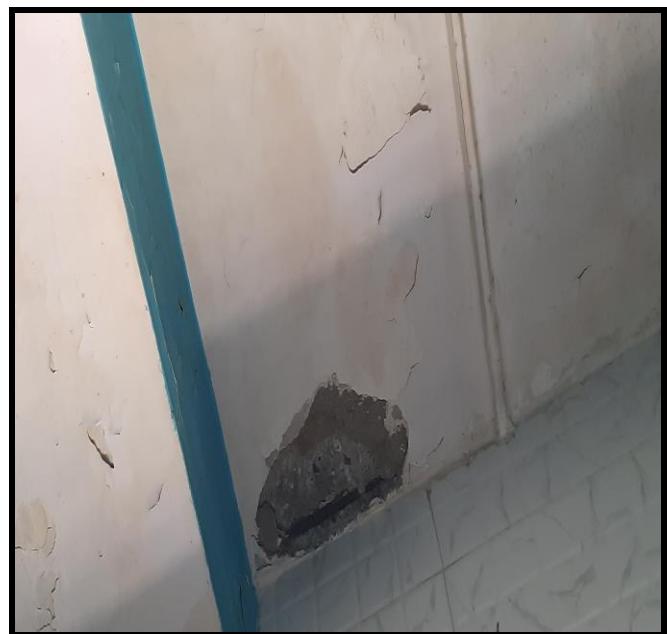
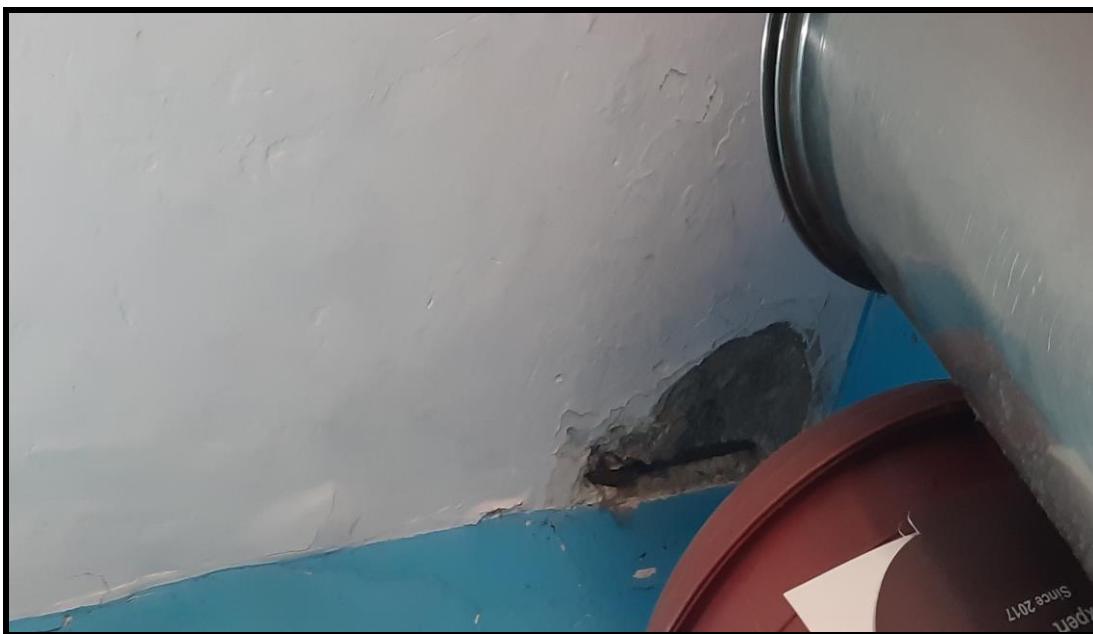
FLAT NO – 11

- ❖ **HALL** – Structural damage observed on ceiling.
 - Dampness observed on wall in monsoon.
- ❖ **KITCHEN** – Ceiling plaster get damaged & steel get exposed & corroded.
- ❖ **BEDROOM** – O.K.
- ❖ **PASSAGE** – O.K.
- ❖ **TOILET & BATH ROOM** – Ceiling plaster get damaged & steel get exposed & corroded.

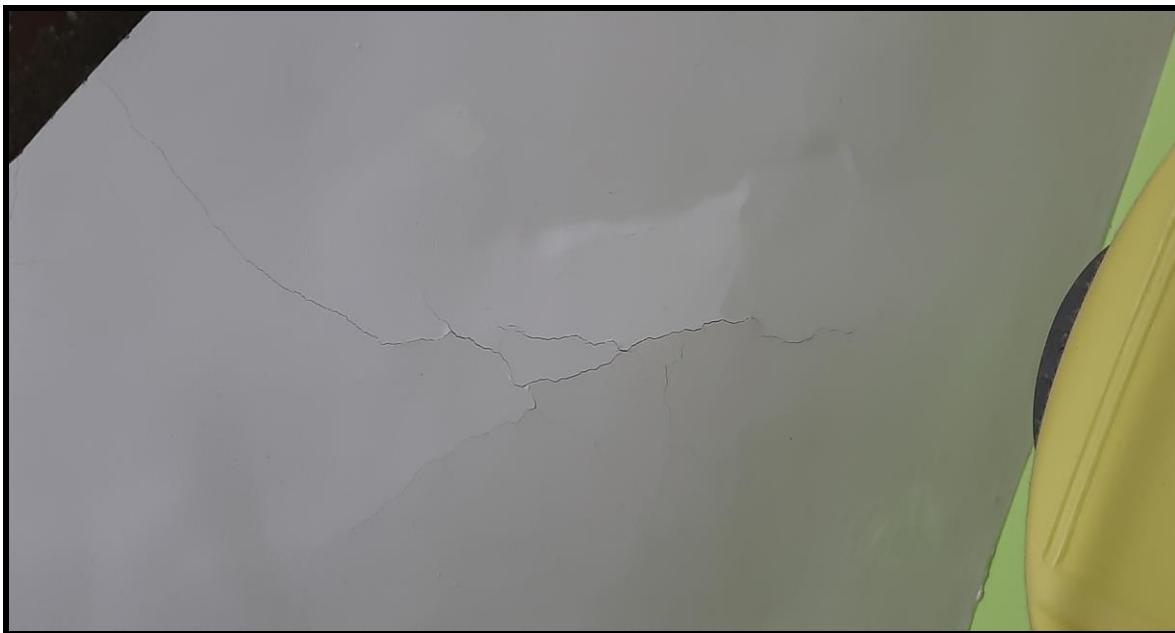
FLAT NO – 13

- ❖ **HALL** – O.K.
- ❖ **KITCHEN** – Structural crack observed on ceiling.
- ❖ **BEDROOM** – O.K.
- ❖ **PASSAGE** – O.K.
- ❖ **TOILET & BATH ROOM** – O.K.

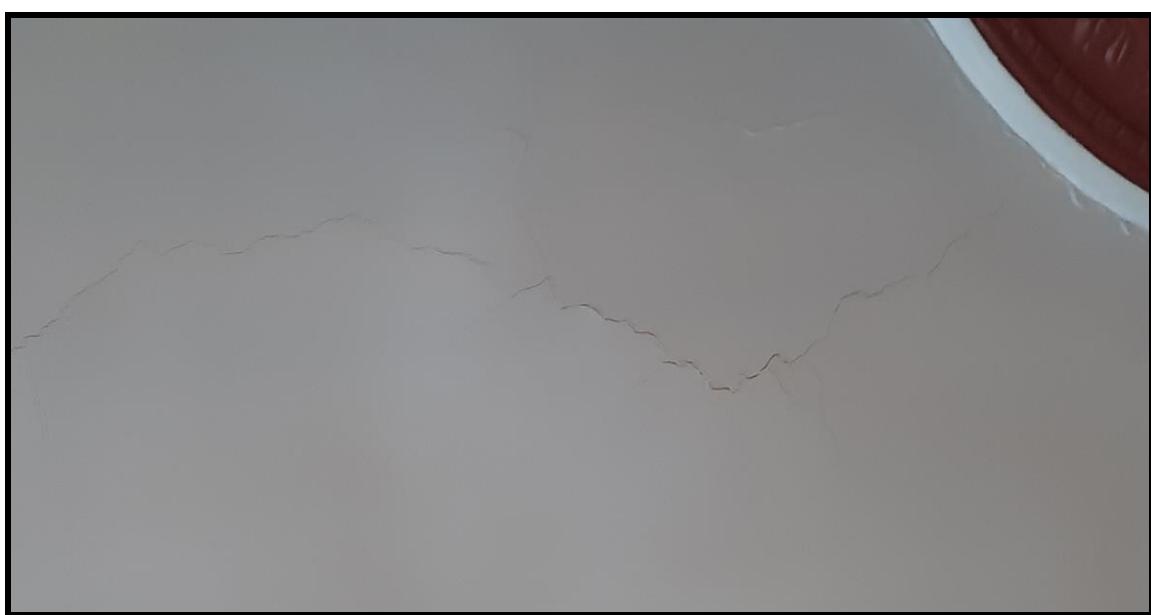
FLAT NO – 28

- ❖ **HALL** – Structural crack observed on ceiling.
- ❖ **KITCHEN** – O.K.
- ❖ **BEDROOM** – O.K.
- ❖ **PASSAGE** – O.K.
- ❖ **TOILET & BATH ROOM** – O.K.

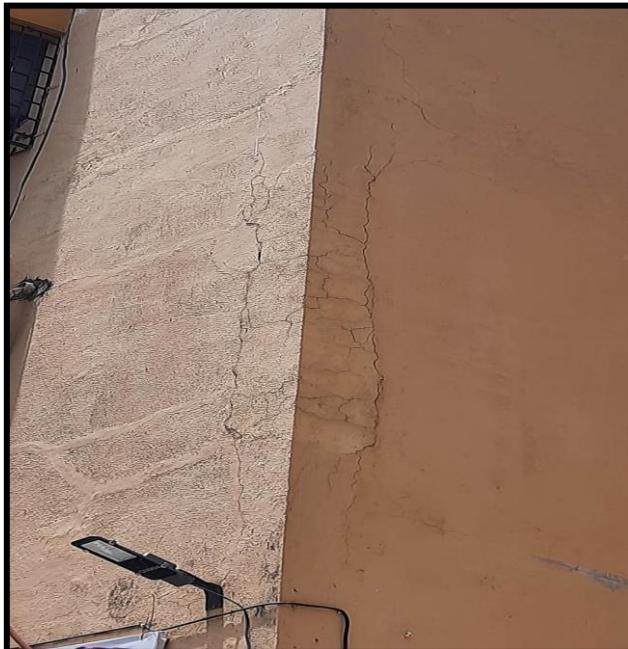
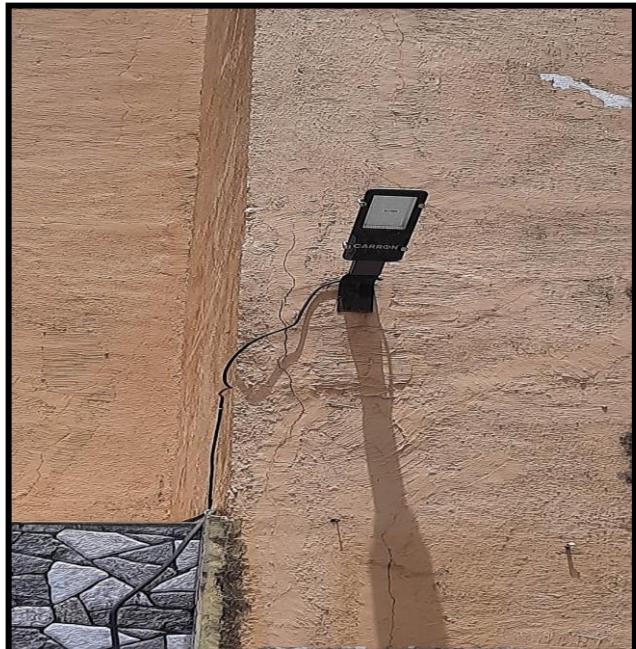
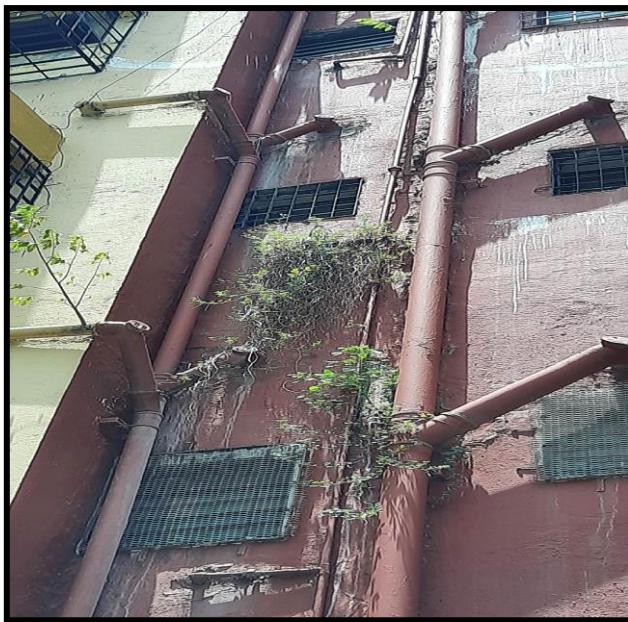
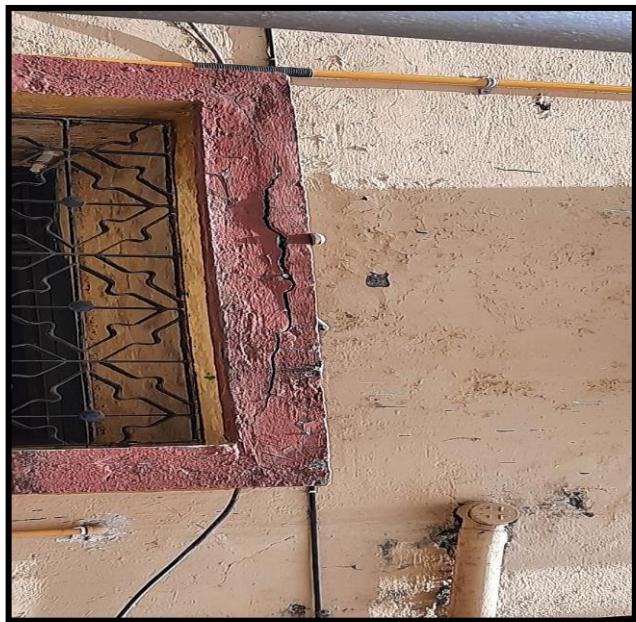
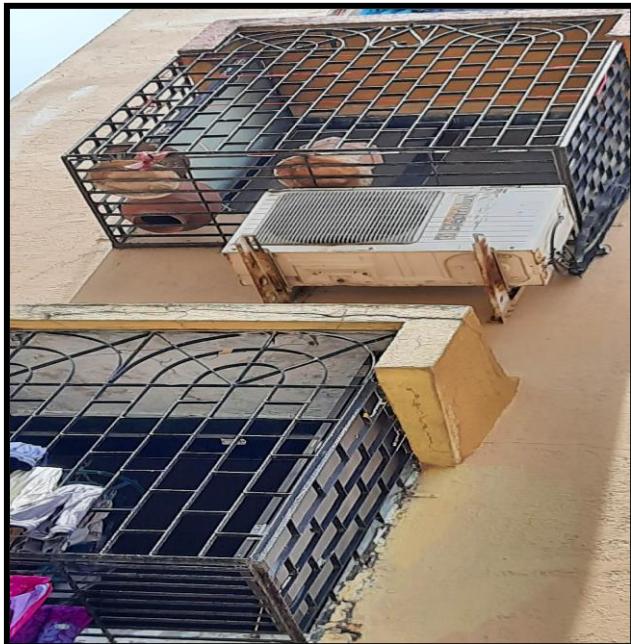
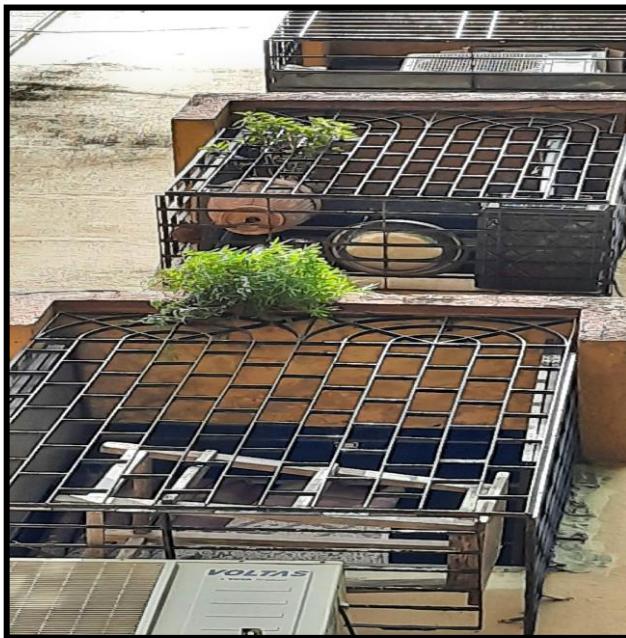
FRONT SIDE

- ❖ Structural crack observed at several places on column & chajjas.
- ❖ Major crack observed at several places on wall.
- ❖ Vegetation growth observed at several places on wall.

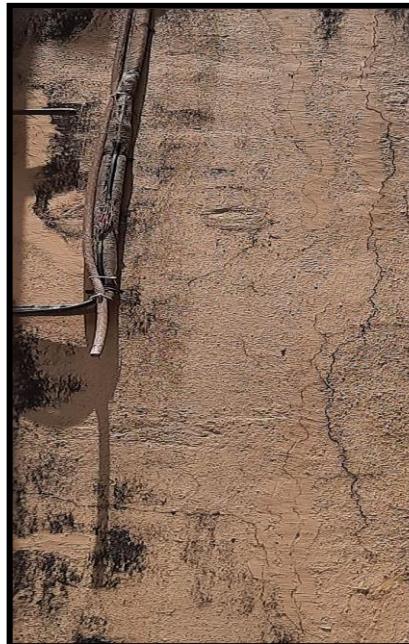
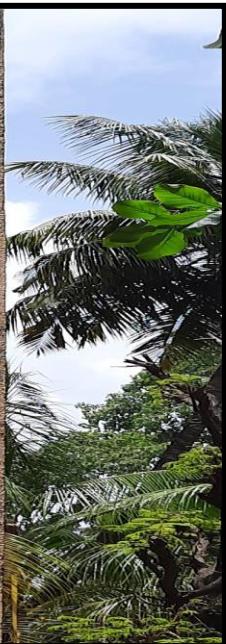
BACK SIDE

- ❖ Structural crack observed at several places on column.

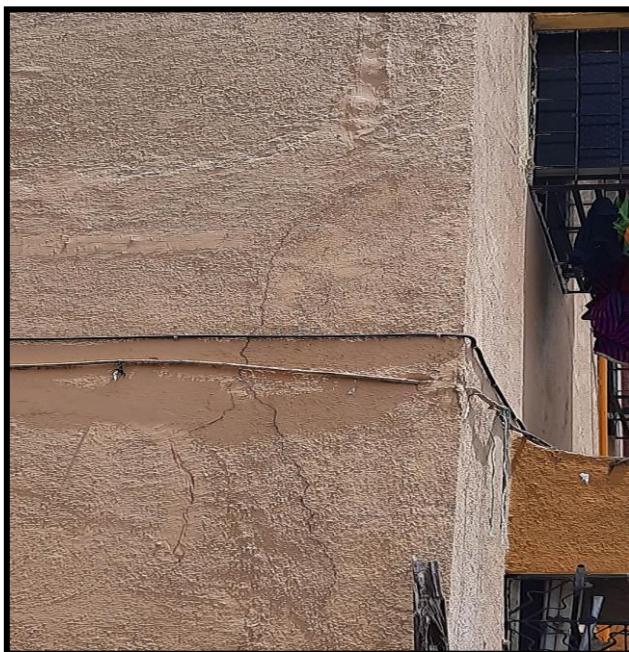
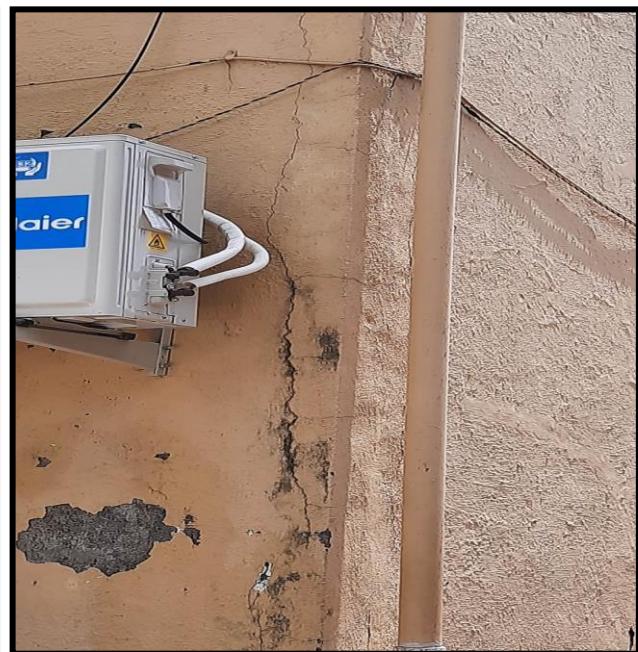
NORTH SIDE

- ❖ Structural crack observed at several places on column.
- ❖ Major crack observed at several places on wall.
- ❖ Vegetation growth observed at several places on wall.

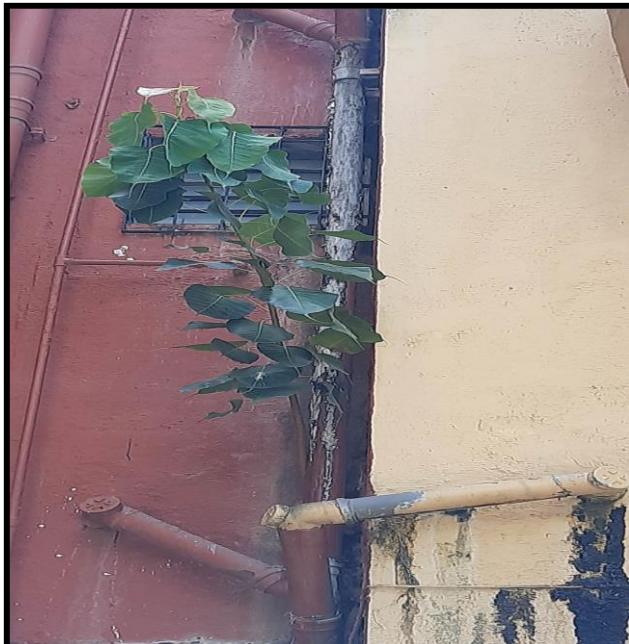
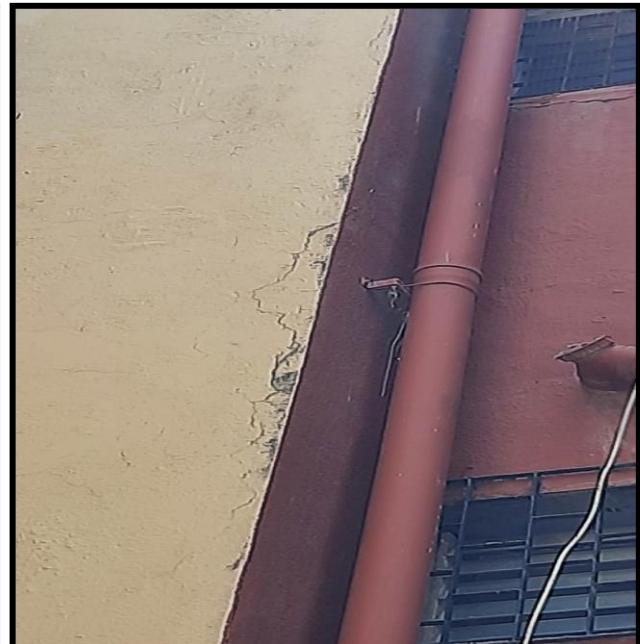
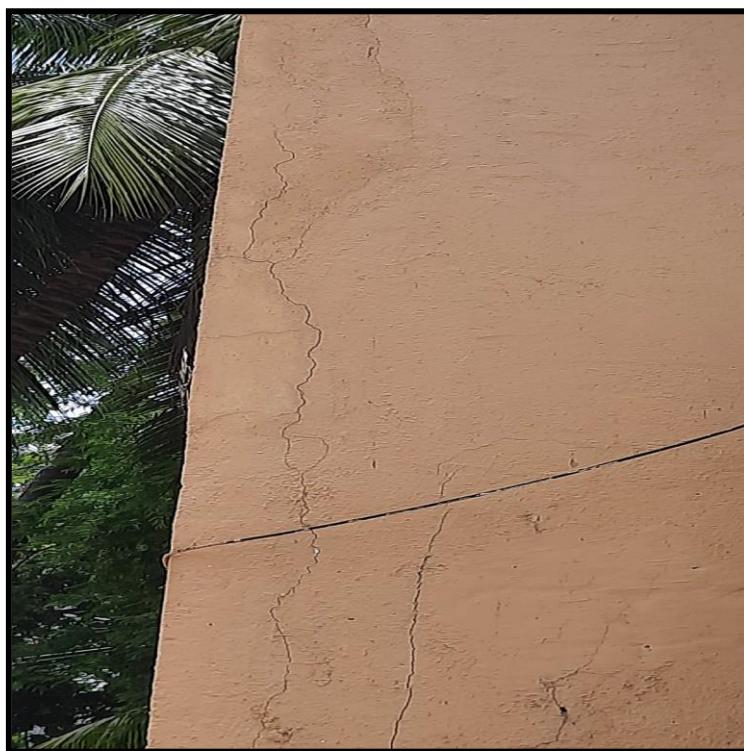
SOUTH SIDE

- ❖ Structural crack observed at several places on column & chajjas.
- ❖ Major crack observed at several places on wall.
