STRUCTURAL AUDIT REPORT
FOR
“VISHAL SAHYADRI CO – OP HSG. SOC. LTD”,
“B1 – WING”
SITUATED AT
SAHYADRI NAGAR, CHARKOP,
KANDIVALI (W) MUMBAI – 400 067

978/B1/LSS/2021

JULY 19, 2021

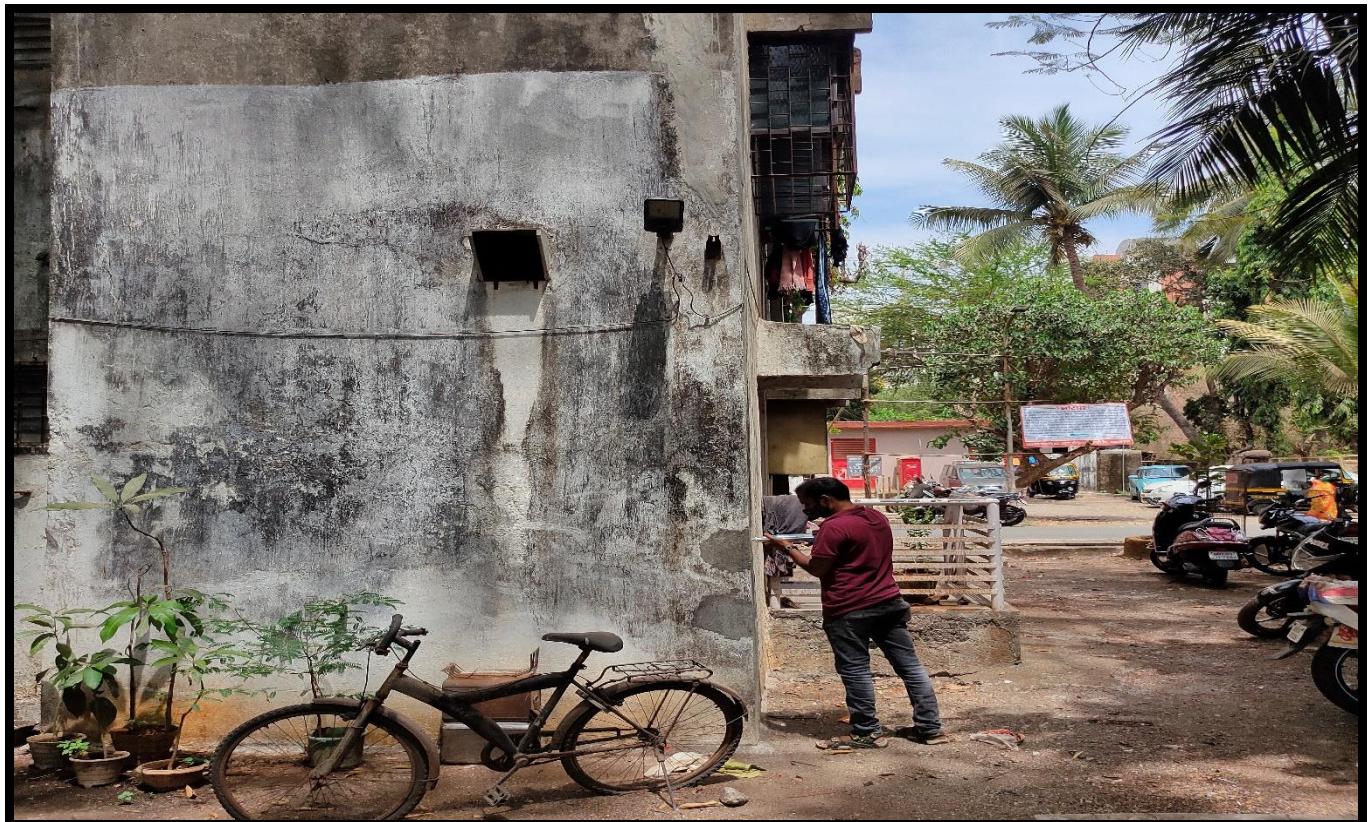
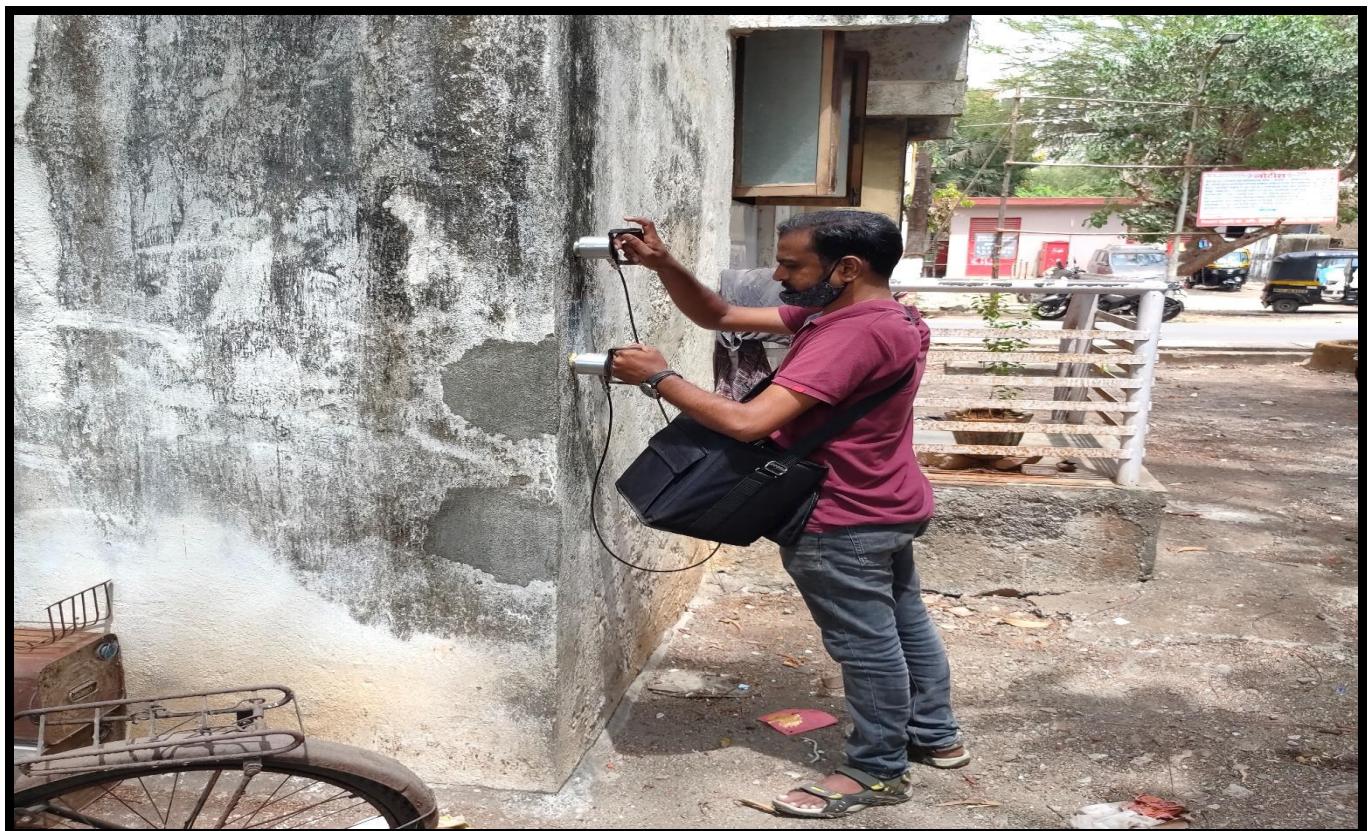
NON -DESTRUCTIVE TEST PHOTO

Rebound Hammer was tested for compressive strength at surface by Schmidt rebound hammer. Results indicate the compressive strength at surface of the RCC columns & beam in is ranging between 12.50 MPa to 20.30 MPa.

The UPV values are ranging between 1.80 Km/Sec to 3.75 Km/Sec.

Out of 4 locations 2 locations was below 3.0 Km/Sec means concrete quality is poor, 1 location ranging between 3.0 to 3.75 Km/Sec means concrete quality is doubtful and 1 location ranging between 3.75 to 4.40 Km/Sec means concrete quality is good.

Half Cell Potential tested for corrosion activity by half – cell potential tests. Value is taken on Column. The result on tested column is – 369 mV.

Carbonation test was conducted to assess carbonation depth. Readings are taken on Column. Result indicates the carbonation penetration depth is 40.00 mm. Carbonation depths have reached to the reinforcement level in all of the RCC elements. It is essential to give a suitable anti-corrosion treatment to all the RCC members to stop further carbonation and corrosion of concrete.

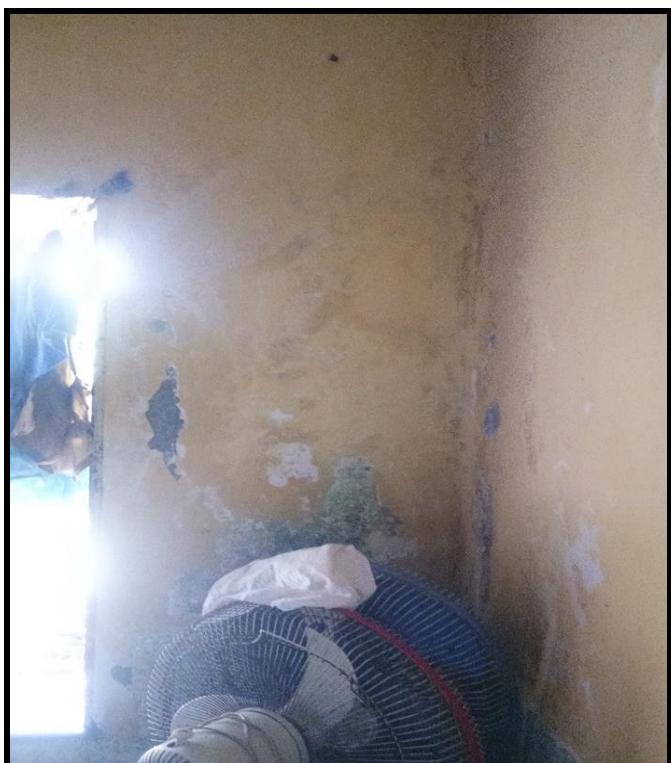
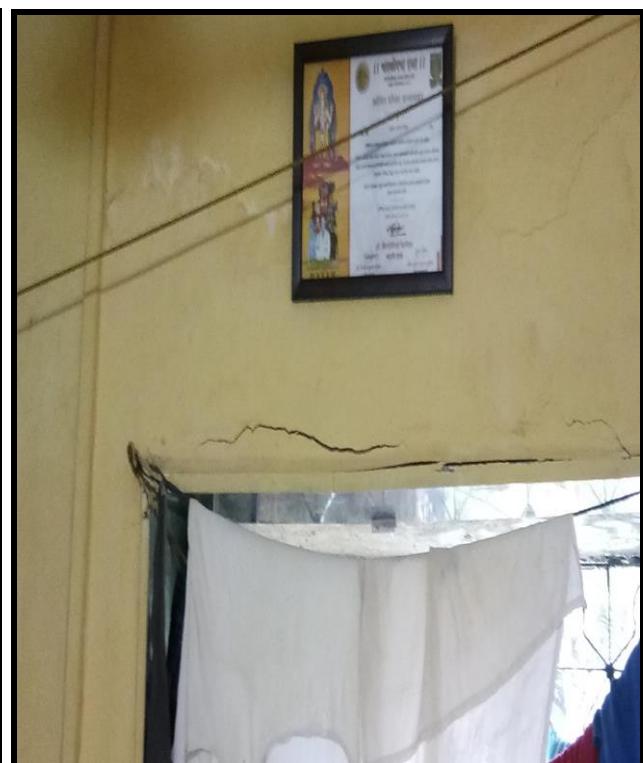
FLAT NO – 05

- ❖ **HALL** – Leakage mark observed on South wall during monsoon.
 - Peeling of paint observed on wall.
- ❖ **KITCHEN** – Major structural crack observed on wall.
 - Major structural crack observed on beam.
- ❖ **BED ROOM** – Peeling of paint observed on ceiling.
- ❖ **PASSAGE** – Dampness observed on ceiling.
- ❖ **TOILET & BATH ROOM** – Seepage mark observed on wall.

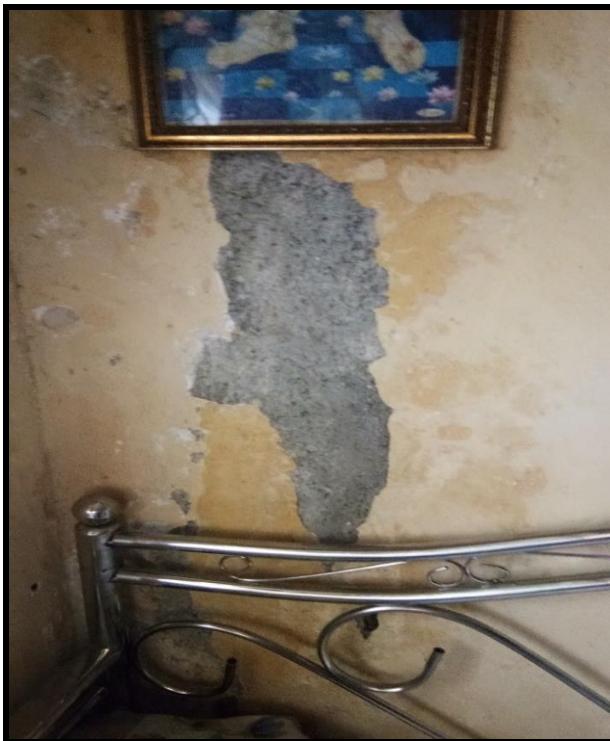
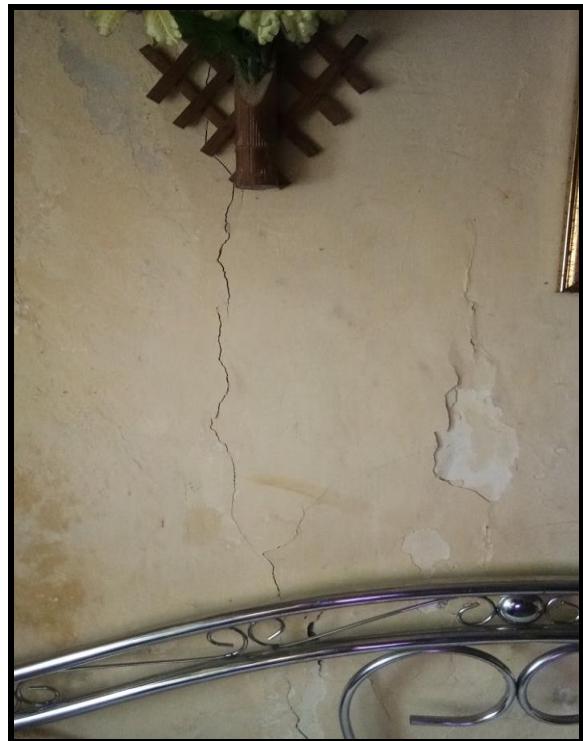
FLAT NO – 11

- ❖ **HALL** – Leakage mark observed on South side wall during monsoon.
 - Leakage mark observed on North side wall during monsoon.
 - Seepage mark observed on North side wall.
- ❖ **KITCHEN** – Seepage mark observed on East side wall.
 - Major structural crack observed on North side wall.
 - Hallow sound observed on beam after tapping.
- ❖ **BED ROOM** – Peeling observed on Ceiling.
- ❖ **PASSAGE** – Seepage mark observed on Ceiling,
- ❖ **TOILET & BATH ROOM** – Seepage mark observed on Window side wall during monsoon.

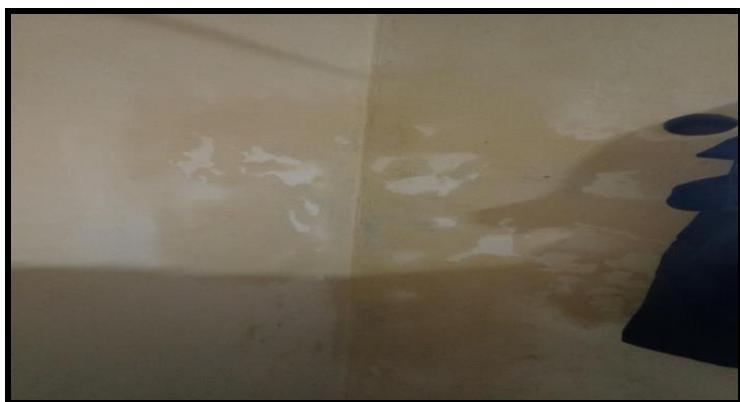
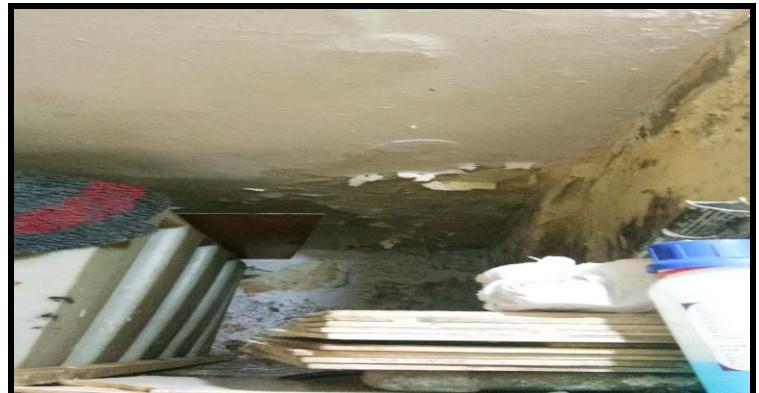
FLAT NO – 14

- ❖ **HALL** – Leakage mark observed on South side wall during monsoon.
 - Leakage mark observed on North side wall during monsoon.
- ❖ **KITCHEN** – Seepage mark observed on Ceiling.
- ❖ **BED ROOM** – Major structural crack observed on beam.
- ❖ **PASSAGE** – Peeling of paint observed on North side wall.
- ❖ **TOILET & BATH ROOM** – Seepage mark observed on Window side wall during monsoon.

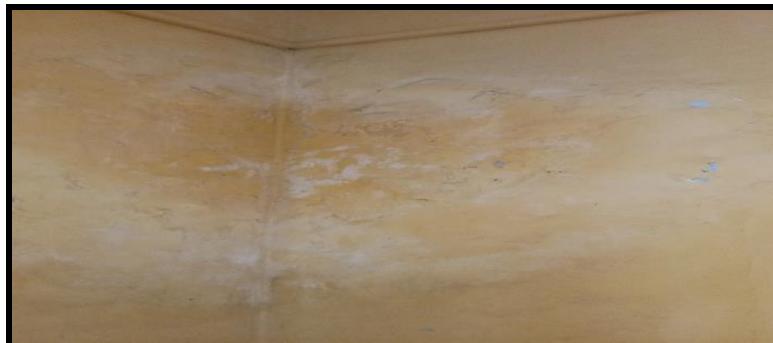
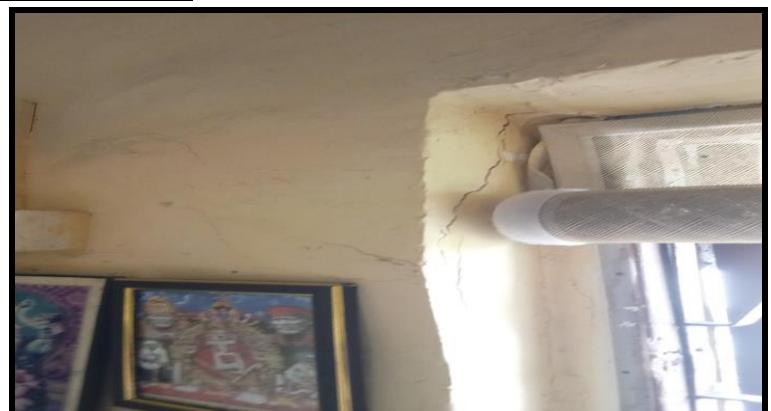
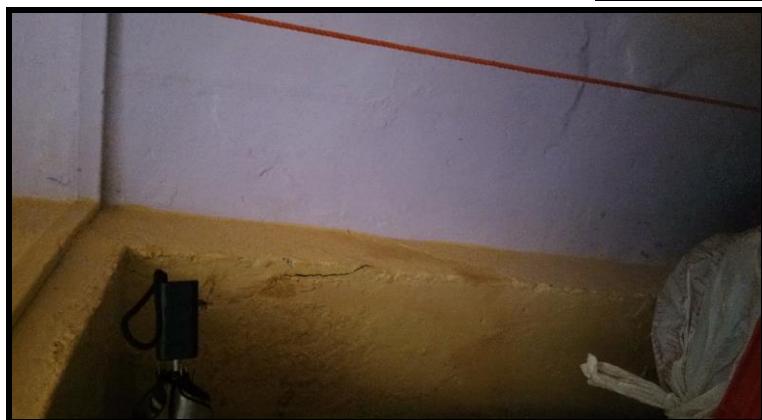
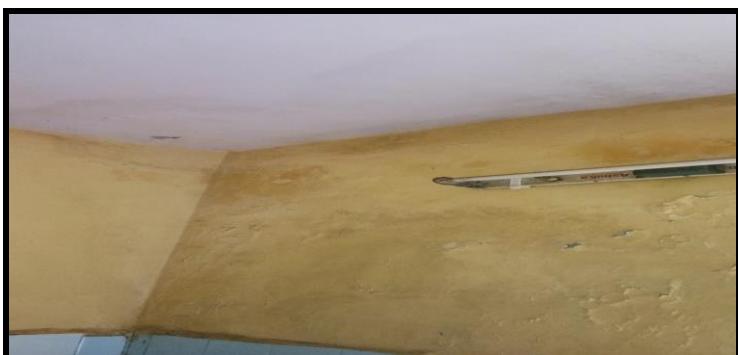
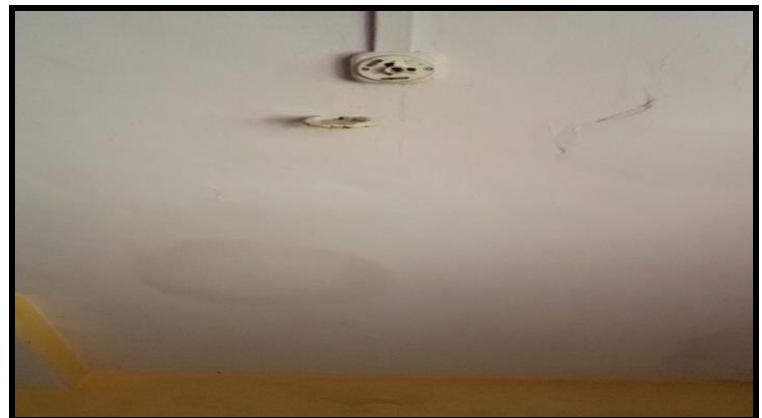
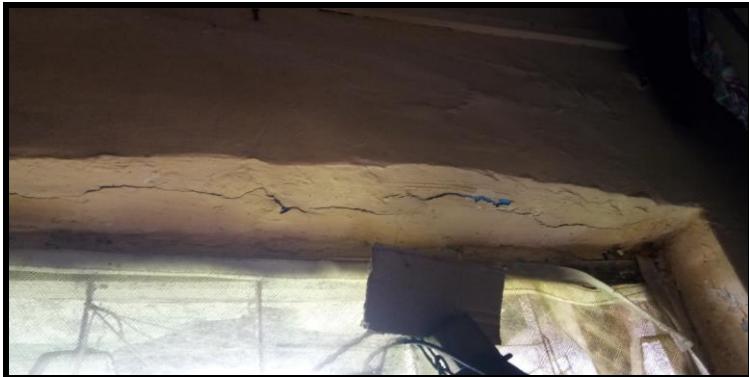
FLAT NO – 19

- ❖ **HALL** – Major structural crack observed on South side wall.
 - Major leakage mark observed on North side wall during monsoon.
 - Seepage mark observed on South side wall.
- ❖ **KITCHEN** – Seepage mark observed on North side wall.
- ❖ **BED ROOM** – Peeling of paint observed on ceiling.
- ❖ **PASSAGE** – Peeling of paint observed on North side wall.
- ❖ **TOILET & BATH ROOM** – Leakage mark observed on Ceiling during monsoon.

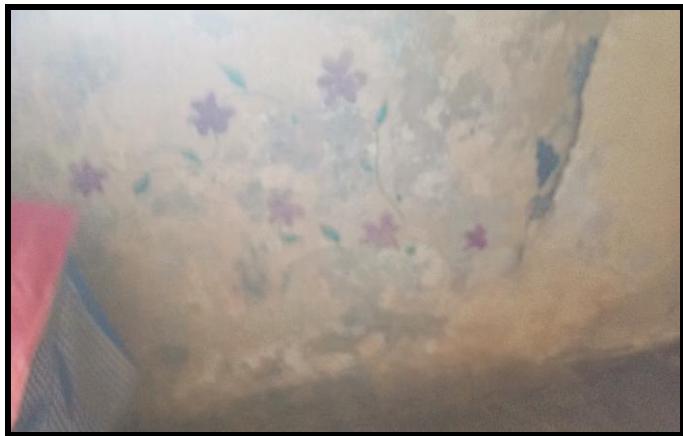
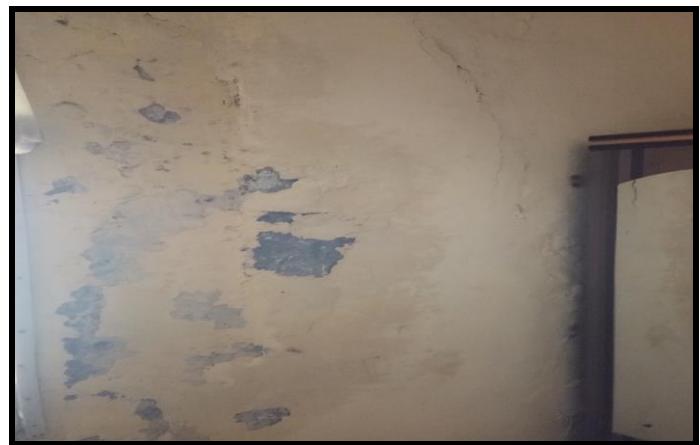
FLAT NO – 23

- ❖ **HALL** – Hallow sound observed on South side wall. (It may fall)
 - Hallow sound observed on Ceiling. (It may fall)
 - Major structural crack observed on beam and column. (It may fall)
 - Major leakage mark observed on beam and column. (It may fall)
- ❖ **KITCHEN** – Peeling of paint observed on South side wall.
 - Major leakage mark observed on South side wall during monsoon.
- ❖ **BED ROOM** – Peeling of paint observed on Ceiling.
- ❖ **PASSAGE** – Hallow sound observed on ceiling. (It may fall)
 - Major structural Crack observed on beam.
 - Seepage mark observed on South side wall during monsoon.
- ❖ **TOILET & BATH ROOM** – Seepage mark observed on South side wall during monsoon.

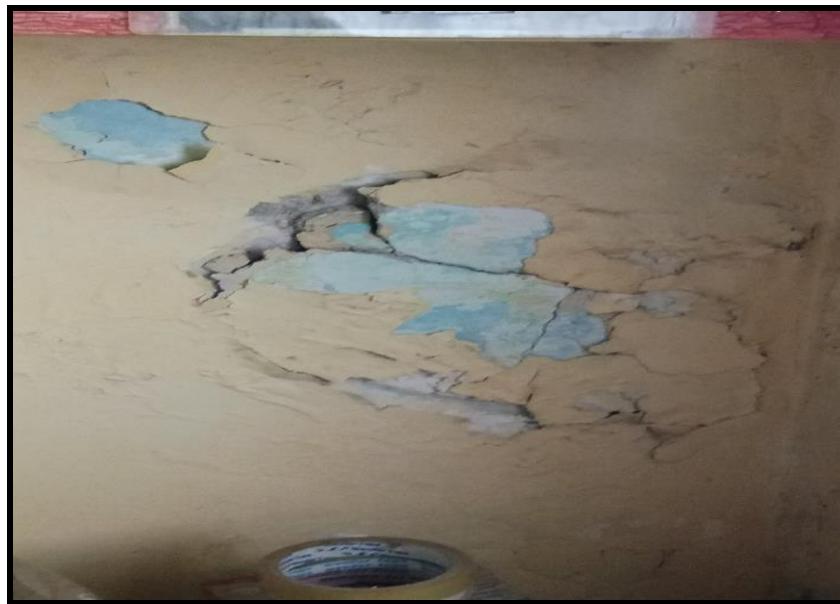
FLAT NO – 29

- ❖ **HALL** – Hallow sound observed on South side wall after tapping.
 - Major structural crack observed on beam.
- ❖ **KITCHEN** – Hallow sound observed on Wall after tapping. (It may fall)
 - Steel get exposed and corroded.
 - Chajja's steel get exposed and corroded.
- ❖ **BED ROOM** – Peeling of paint observed on South side wall.
- ❖ **PASSAGE** – Seepage mark observed on Ceiling.
- ❖ **TOILET & BATH ROOM** – O.K.

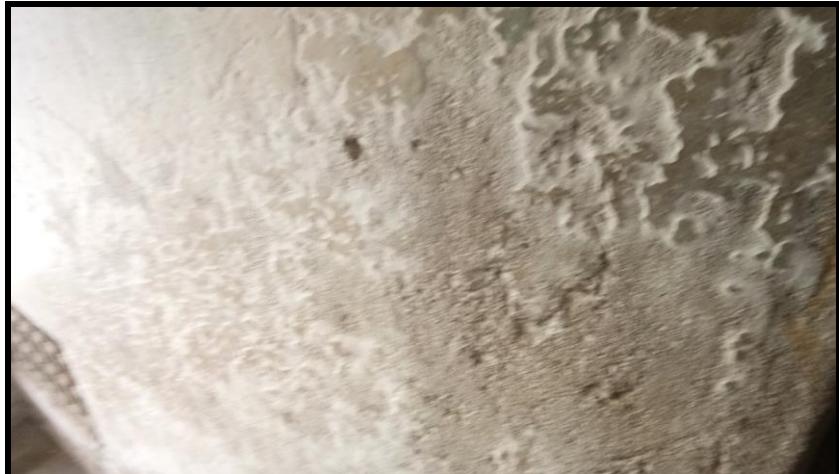
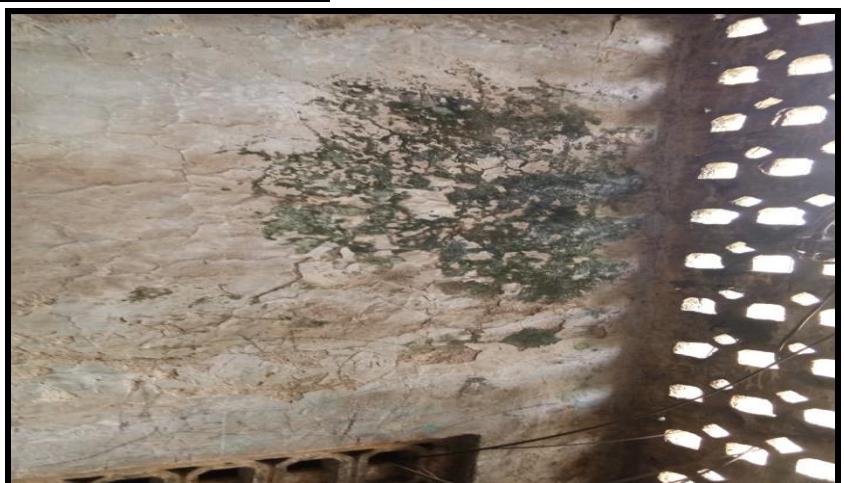
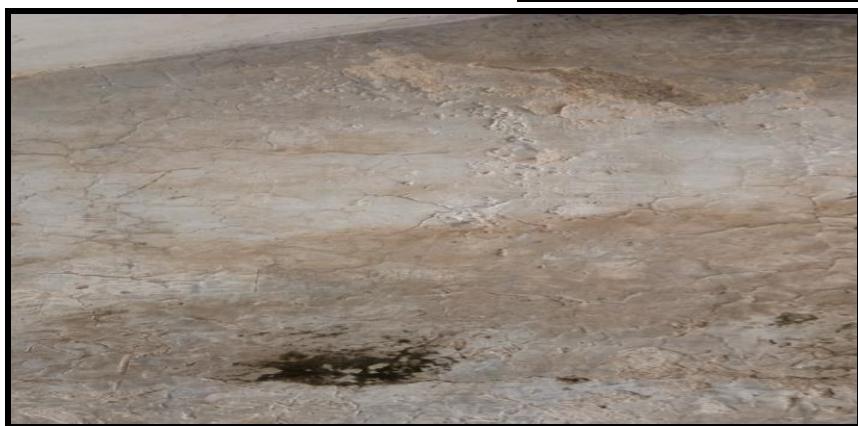
Fourth Floor to third floor:-

- ❖ Peeling of paint observed on South side wall.
- ❖ Algae formation observed on wall.
- ❖ Crack observed on South side wall.

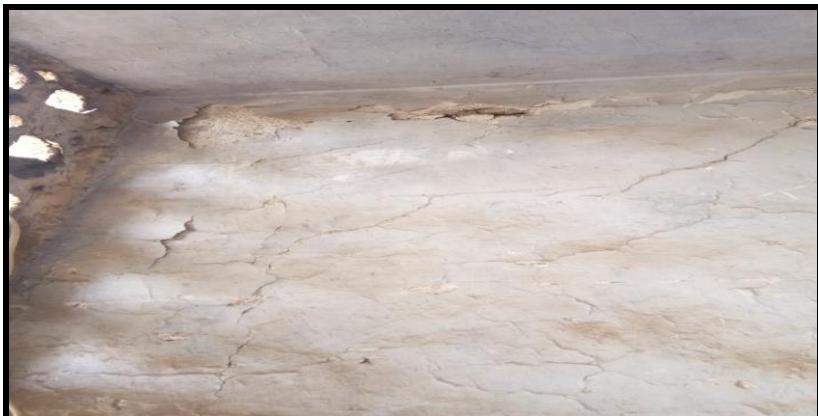
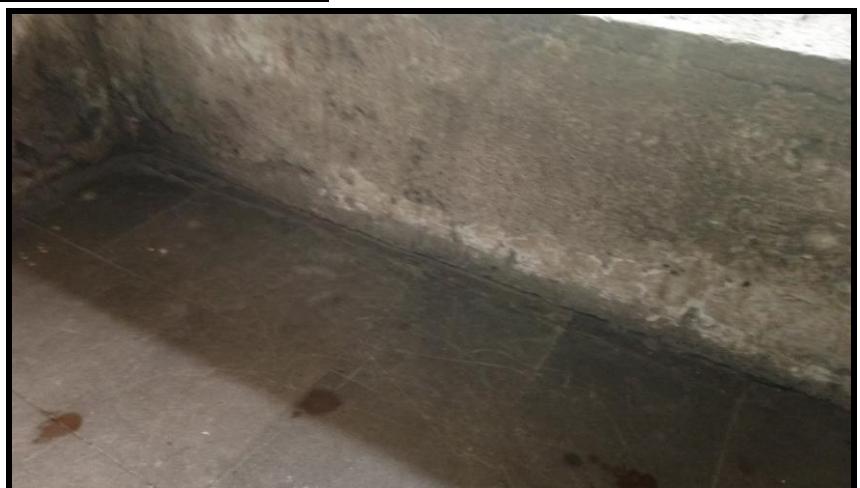
Third floor to second floor:-

- ❖ Peeling of paint observed on Wall.
- ❖ Crack observed on South side wall.
- ❖ Seepage mark observed on North side wall.

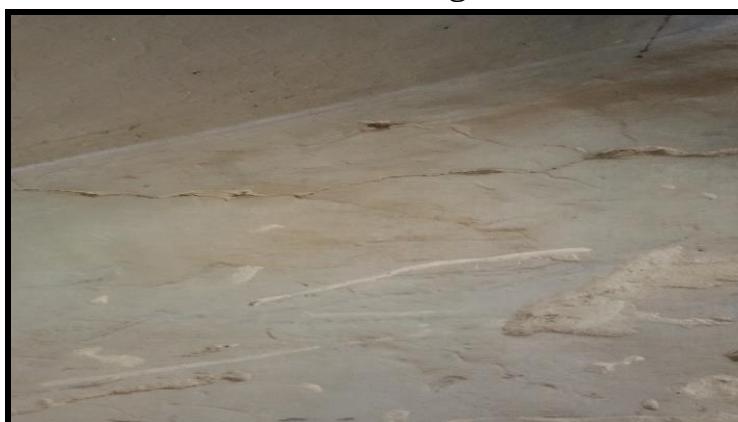
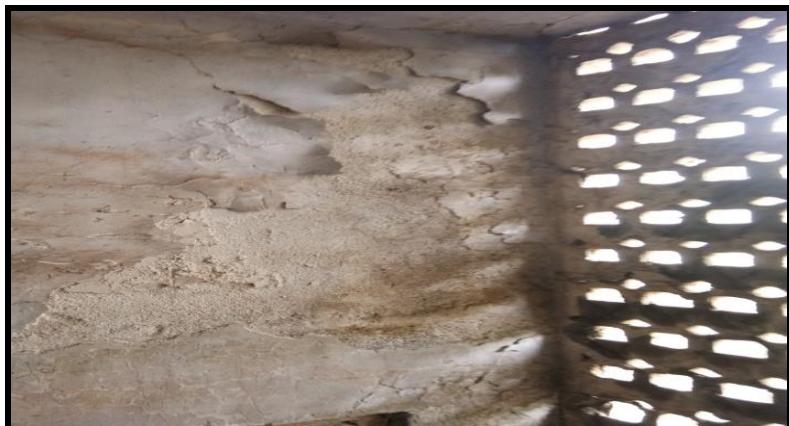
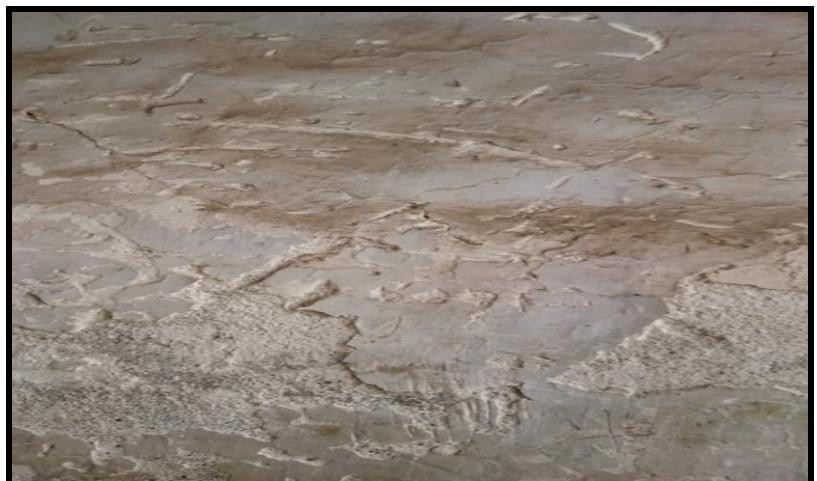
Second floor to First floor:-

- ❖ Major structural crack observed on Wall.
- ❖ Peeling of paint observed on Wall.
- ❖ Major structural crack observed on Ceiling.

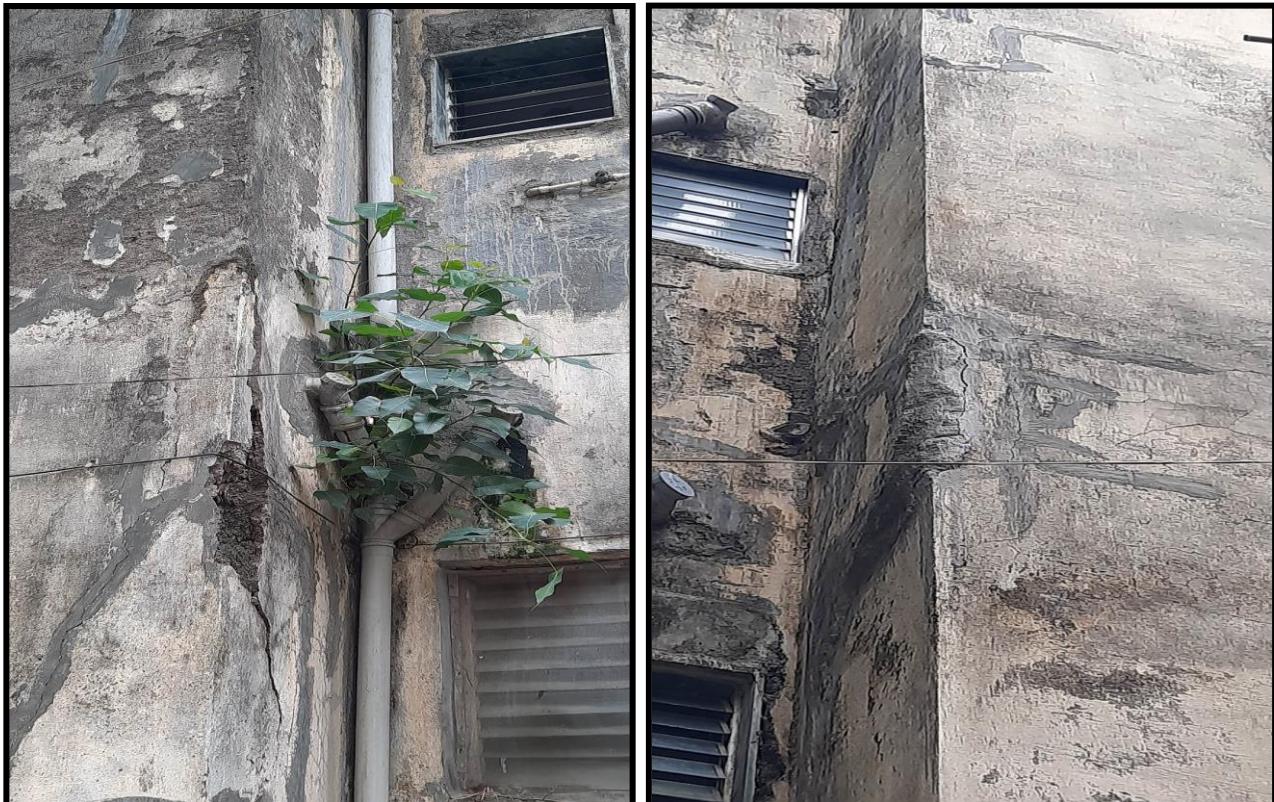
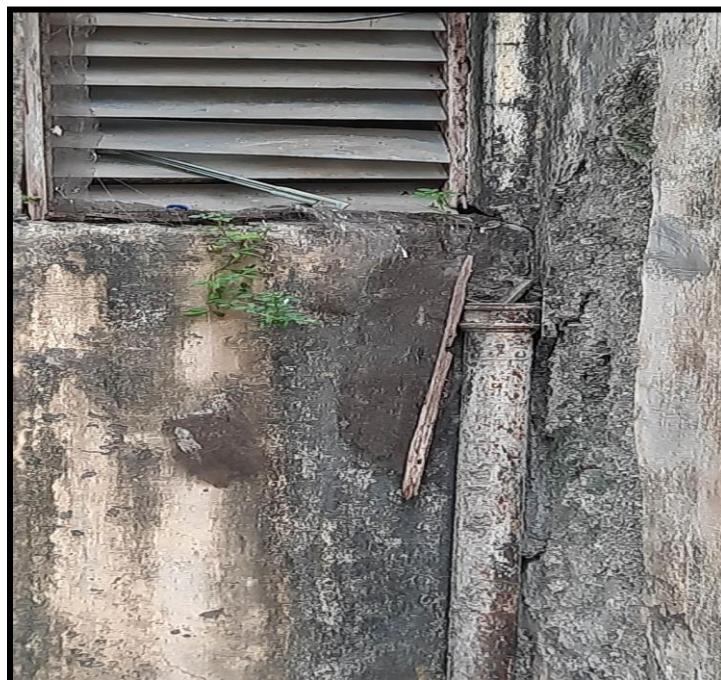
FRONT SIDE

- ❖ Structural crack observed at several places on column.
- ❖ Major crack observed at several places on wall.
- ❖ Vegetation growth observed at several places on wall.

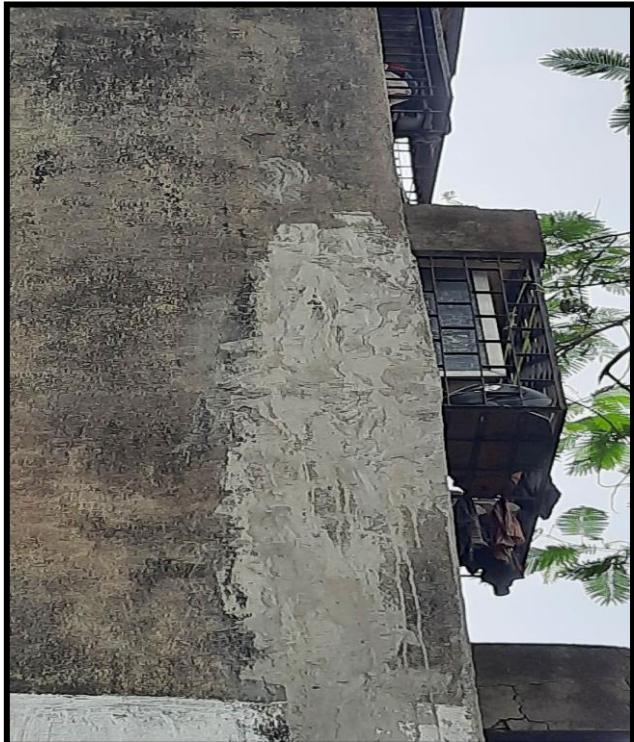
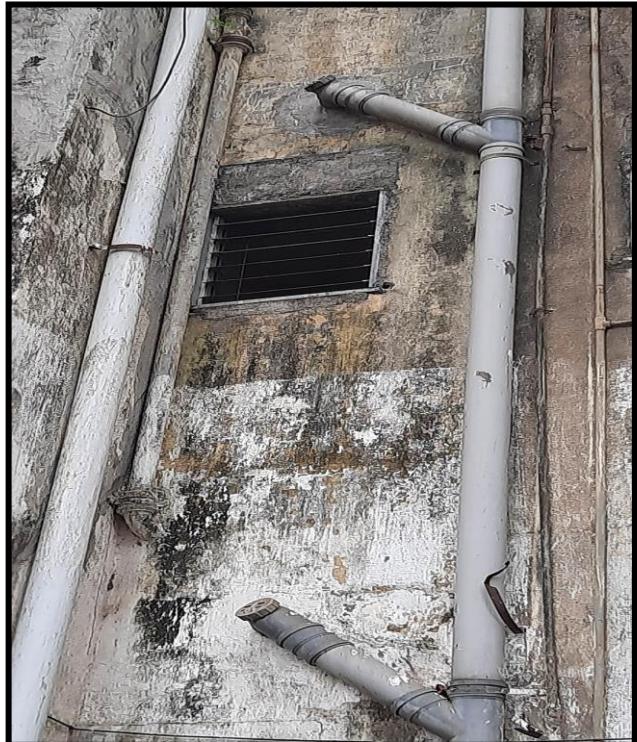
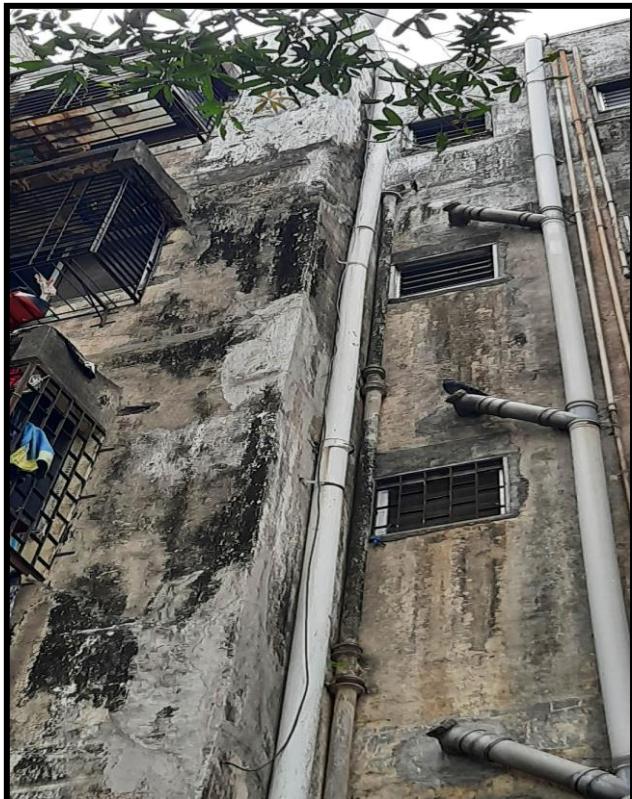
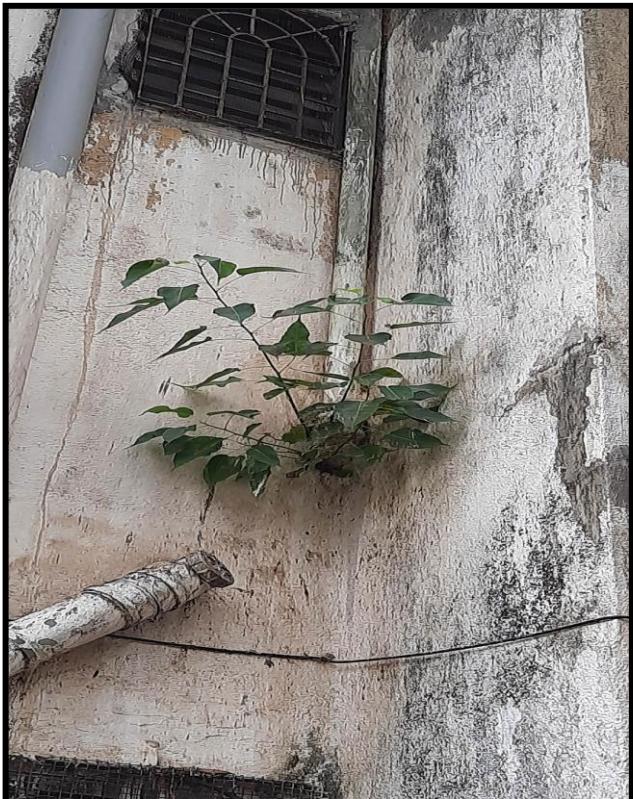
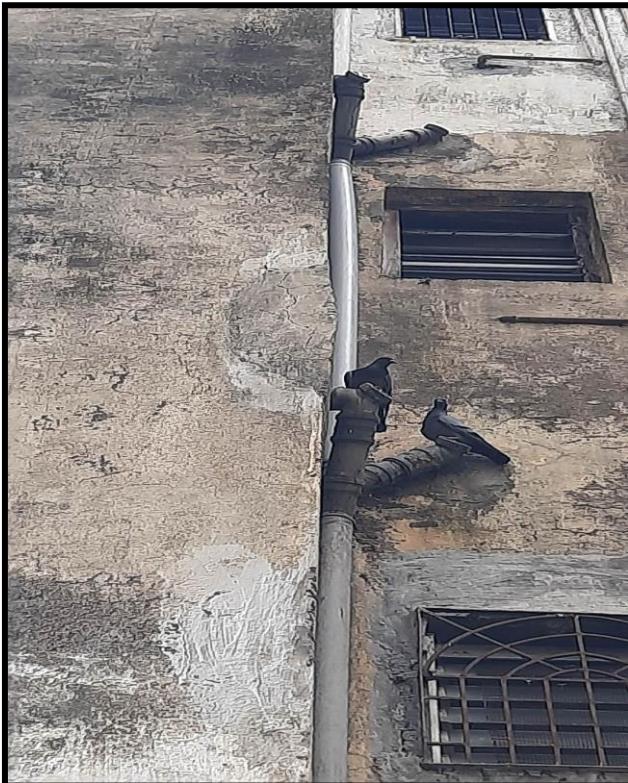
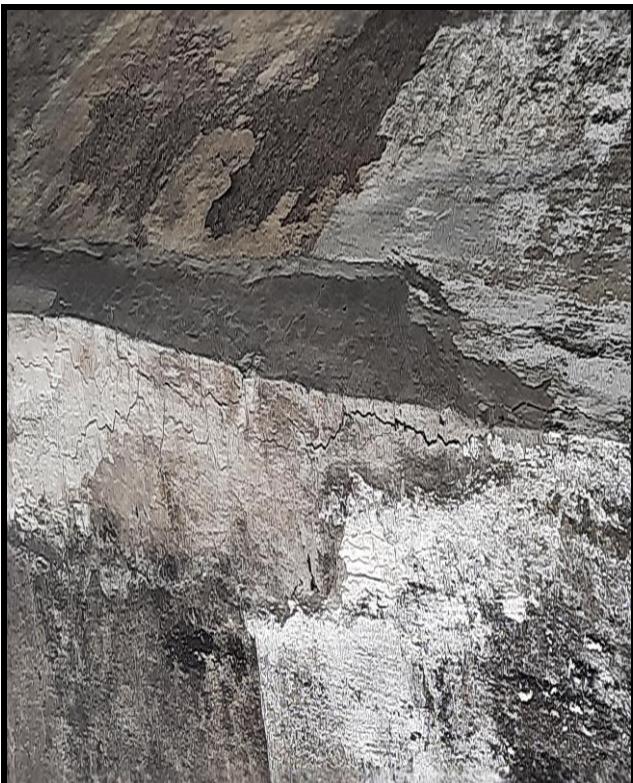
BACK SIDE

- ❖ Structural crack observed at several places on column.
- ❖ Major crack observed at several places on wall.
- ❖ Vegetation growth observed at several places on wall.
- ❖ Column & chajja plaster get damaged & steel get exposed & corroded.

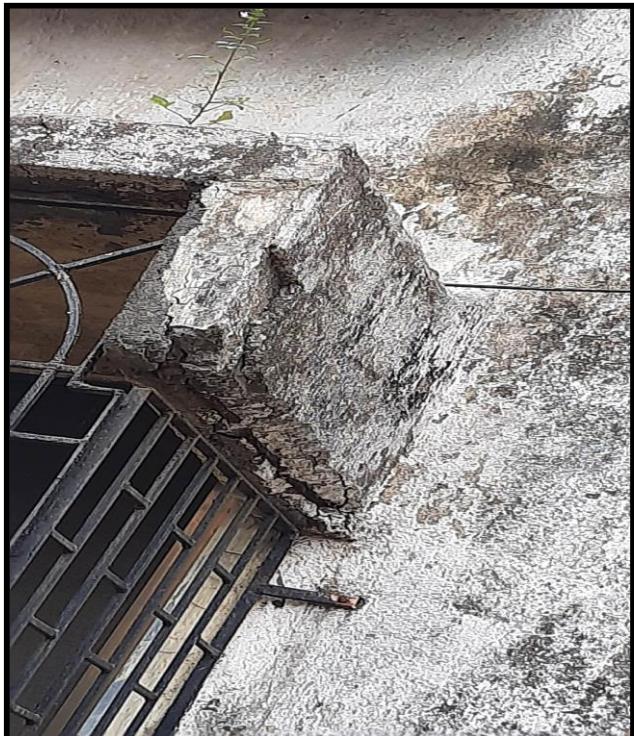
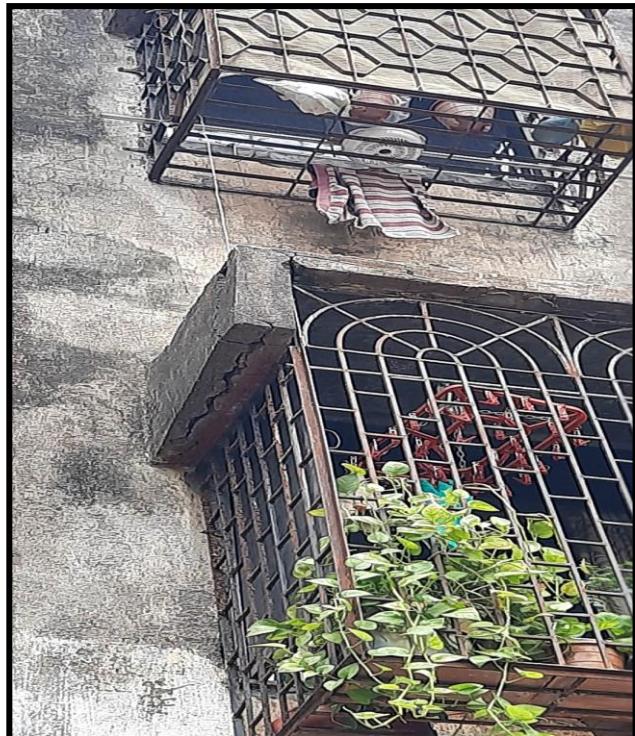
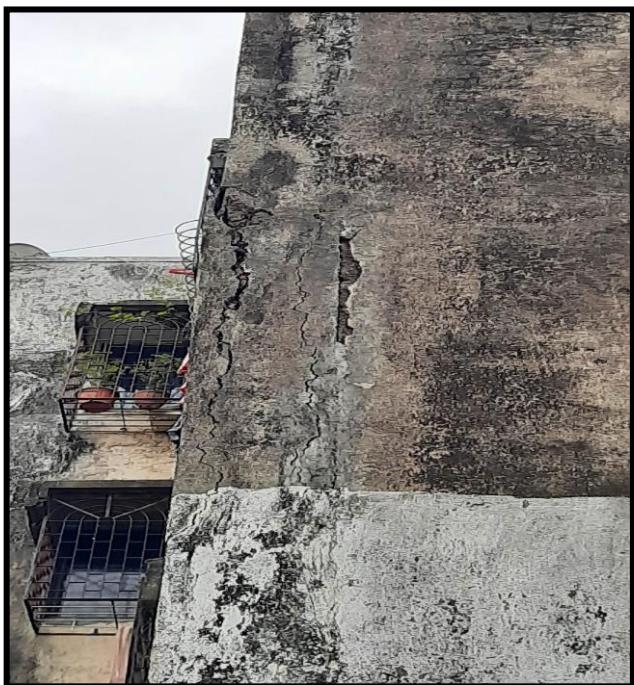
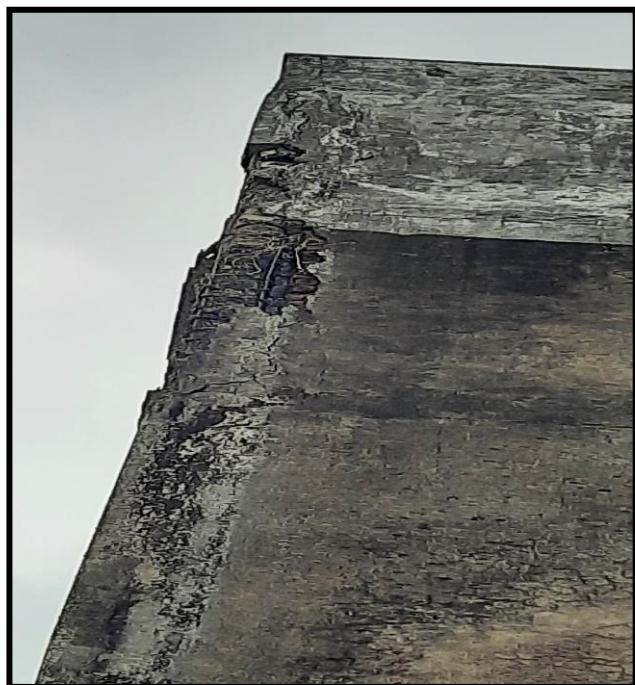
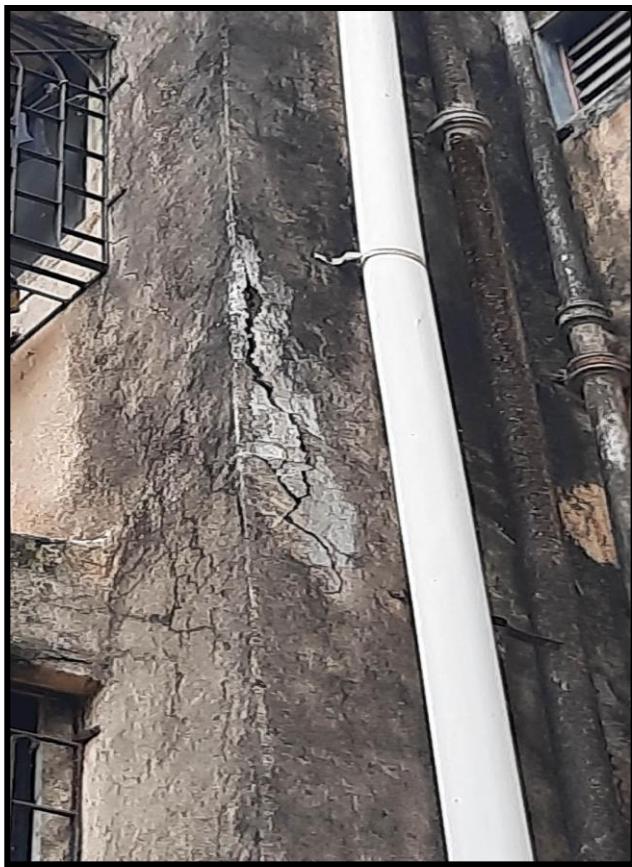
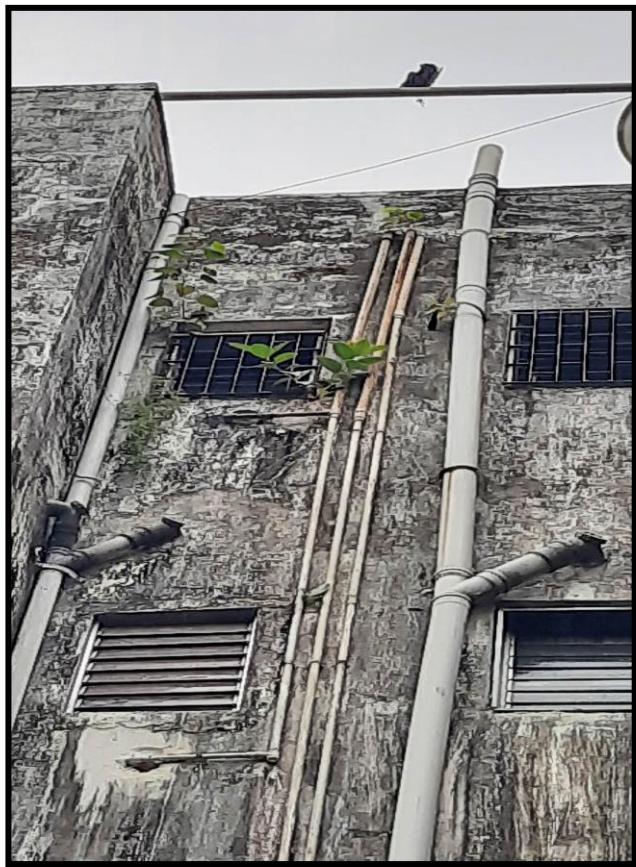
NORTH SIDE

- ❖ Structural crack observed at several places on column.
- ❖ Major crack observed at several places on wall.
- ❖ Vegetation growth observed at several places on wall.

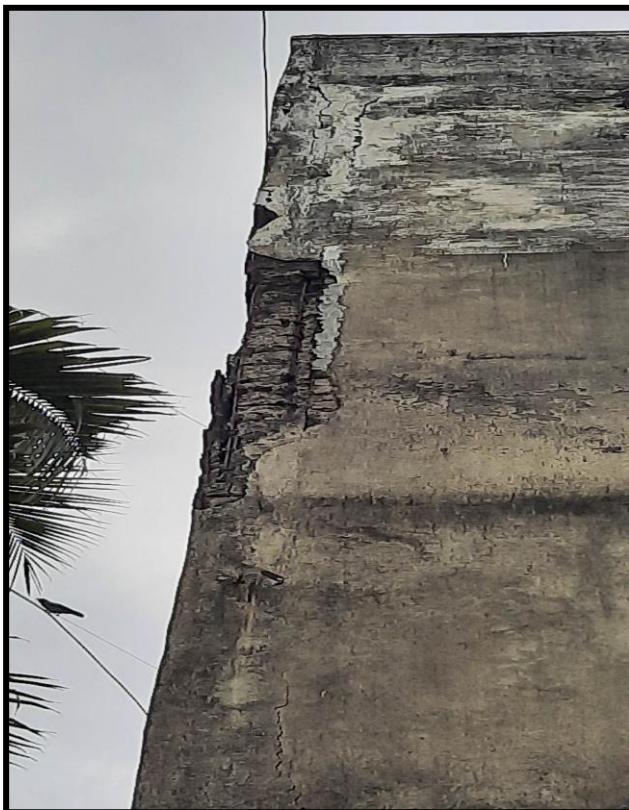
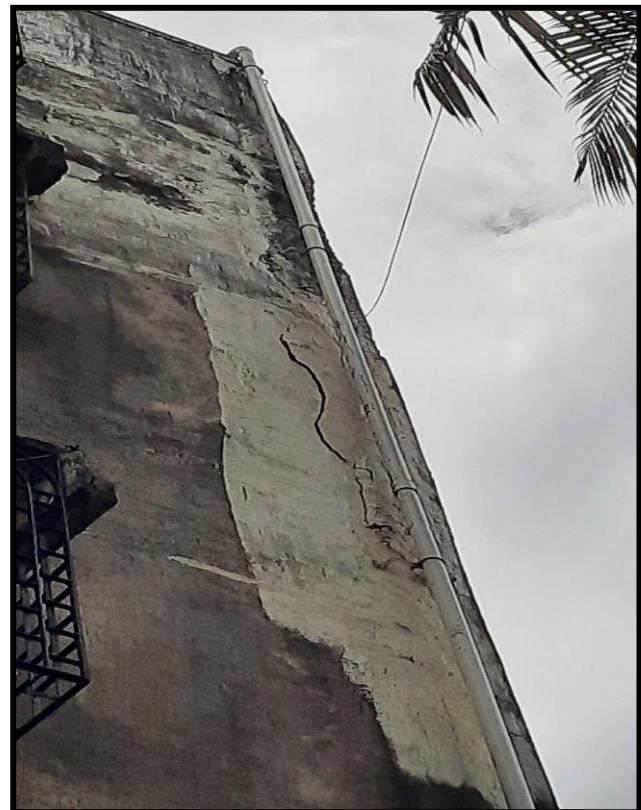
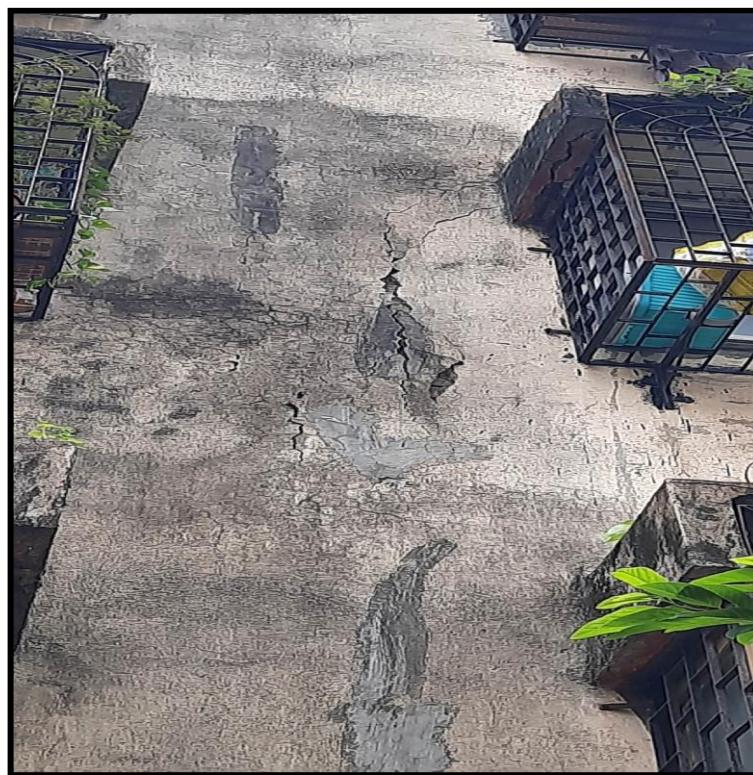
SOUTH SIDE

- ❖ Structural crack observed at several places on column.
- ❖ Major crack observed at several places on wall.
- ❖ Vegetation growth observed at several places on wall.
- ❖ Chajja plaster get damaged & steel get exposed & corroded.
