STRUCTURAL AUDIT REPORT
FOR
“VISHAL SAHYADRI CO – OP HSG. SOC. LTD”,
“C7 – WING”
SITUATED AT
SAHYADRI NAGAR, CHARKOP,
KANDIVALI (W) MUMBAI – 400 067

PREPARED BY
LATESH S. SANKLECHA
CONSULTING STRUCTURAL ENGINEERS

978/B1/LSS/2021

JUNE 24, 2021

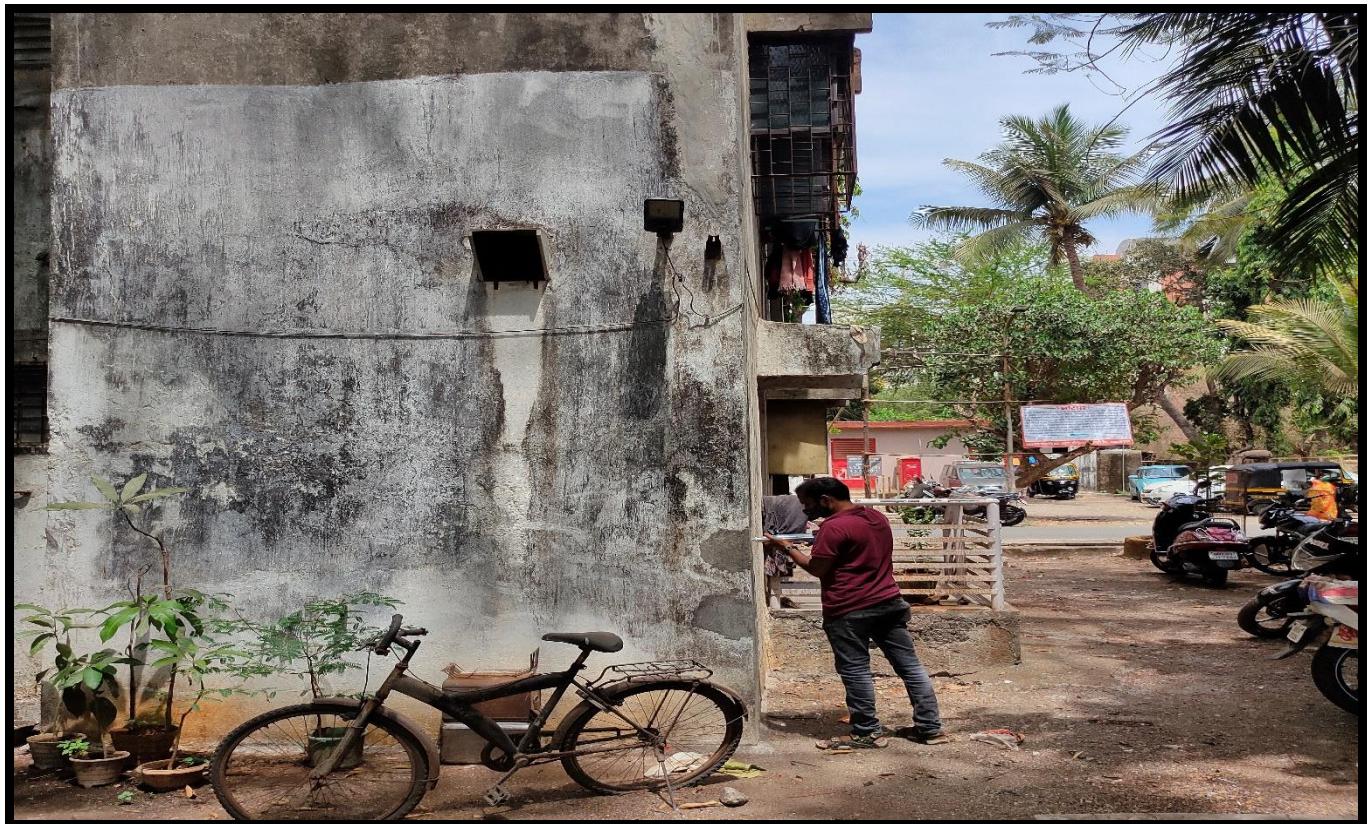
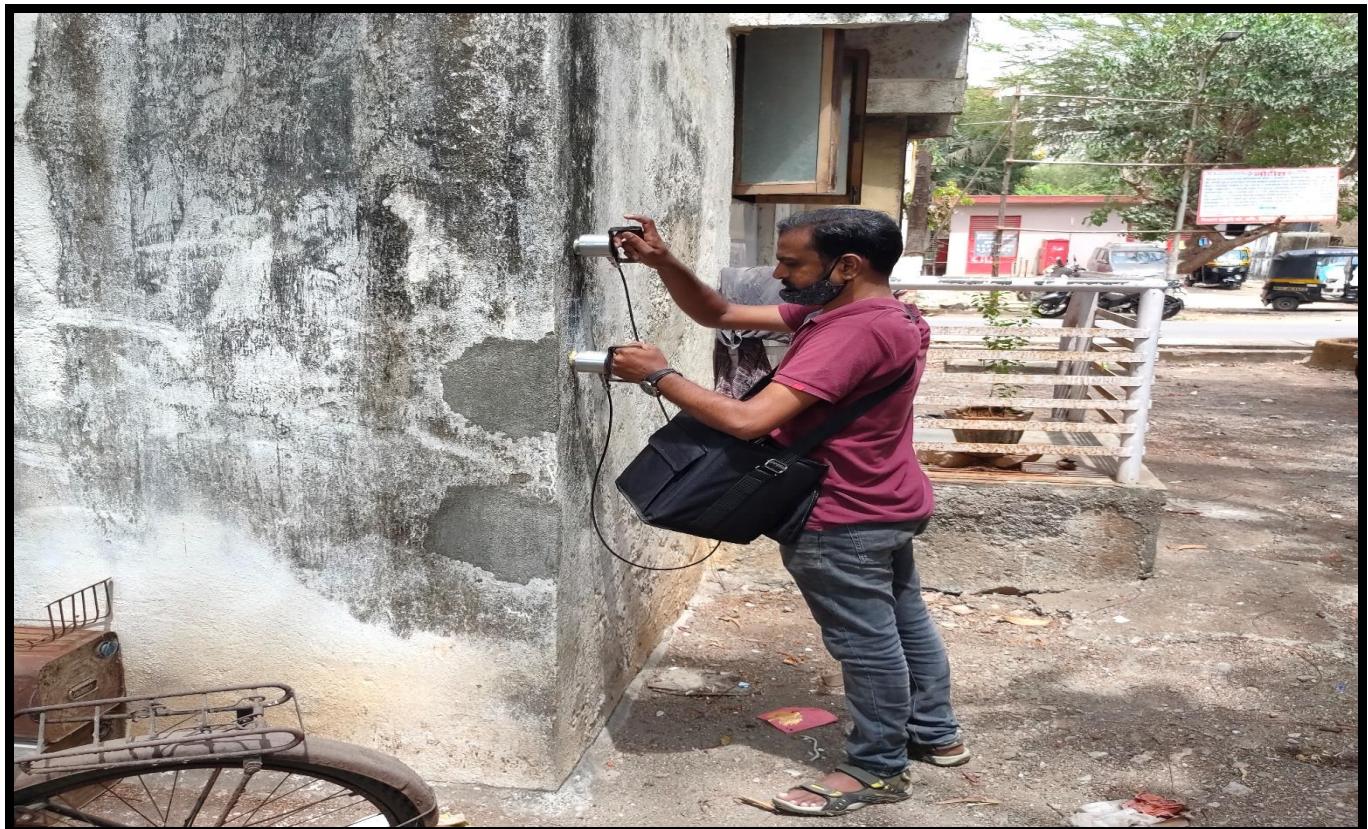
NON -DESTRUCTIVE TEST PHOTO

Half Cell Potential tested for corrosion activity by half – cell potential tests. Value is taken on Column. The result on tested column is – 390 mV.

This indicates the probability of corrosion is 90% on tested column steel reinforcement.

Carbonation test was conducted to assess carbonation depth. Readings are taken on Column. Result indicates the carbonation penetration depth is 40.00 mm. Carbonation depths have reached to the reinforcement level in all of the RCC elements. It is essential to give a suitable anti-corrosion treatment to all the RCC members to stop further carbonation and corrosion of concrete.

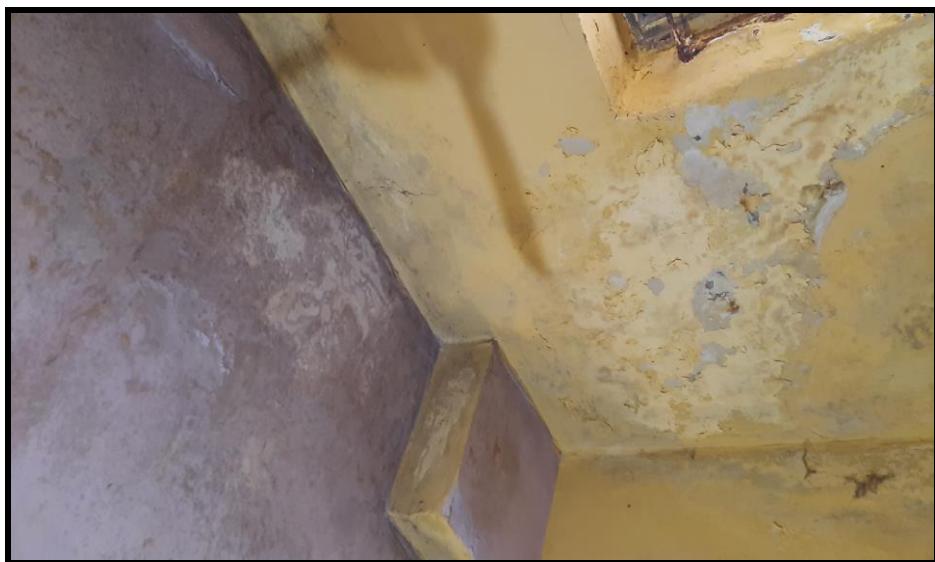
FLAT NO – 02

- ❖ **HALL** – O.K.
- ❖ **KITCHEN** – Leakage mark observed on wall & ceiling.
- ❖ **PASSAGE** – O.K.
- ❖ **TOILET & BATH ROOM** – O.K.

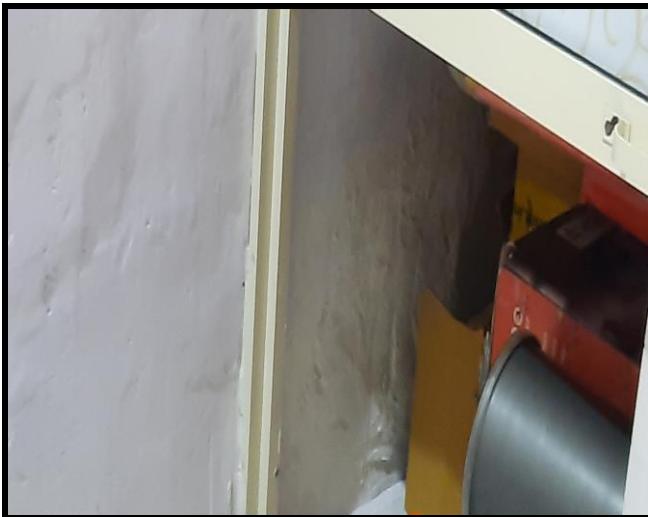
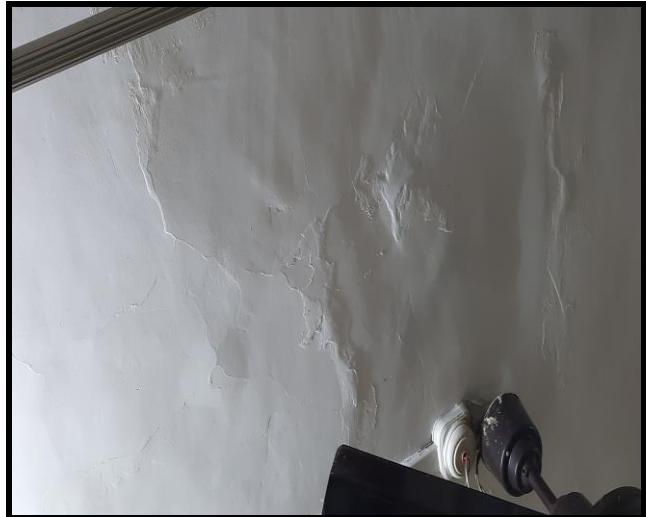
FLAT NO – 03

- ❖ **HALL** – Leakage mark observed on ceiling
- ❖ **KITCHEN** – Structural damage observed on ceiling.
 - Leakage mark observed on ceiling.
- ❖ **PASSAGE** – O.K.
- ❖ **TOILET & BATH ROOM** – O.K.

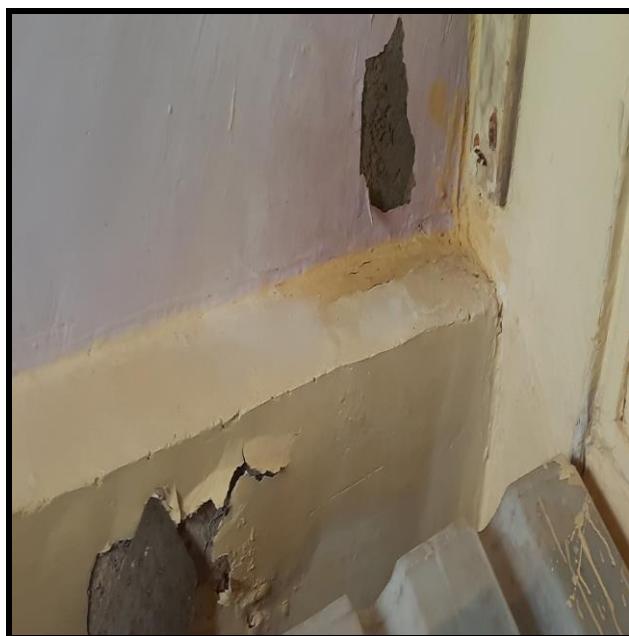
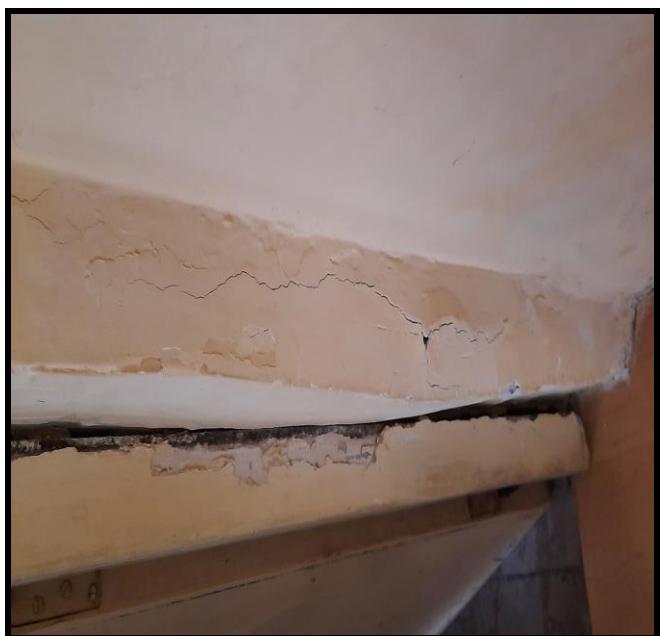
FLAT NO – 07

- ❖ **HALL** – Structural crack observed on column.
- ❖ **KITCHEN** – Dampness observed on ceiling.
- ❖ **PASSAGE** – O.K.
- ❖ **TOILET & BATH ROOM** – O.K.

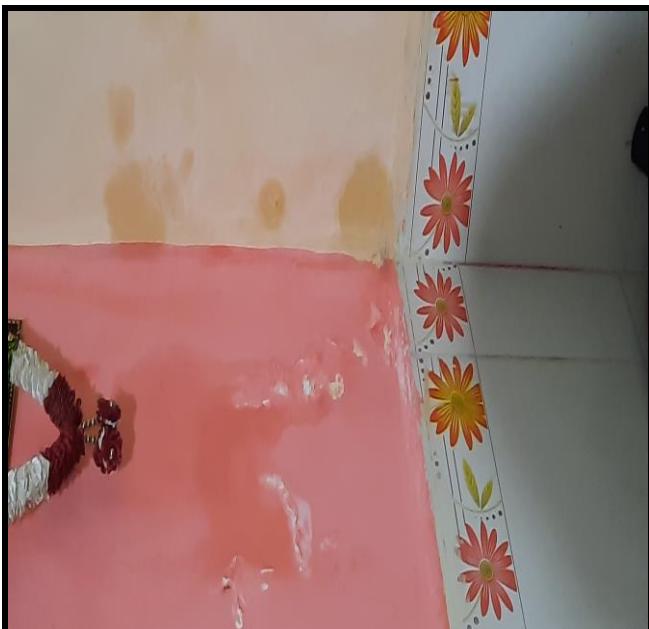
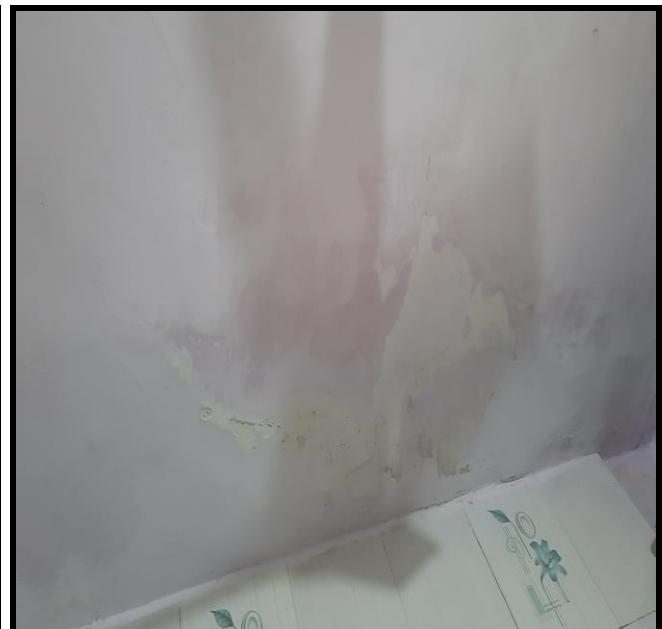
FLAT NO – 10

- ❖ **HALL** – Leakage mark observed on wall.
- ❖ **KITCHEN** – Leakage mark observed on ceiling.
- ❖ **PASSAGE** – O.K.
- ❖ **TOILET & BATH ROOM** – O.K.

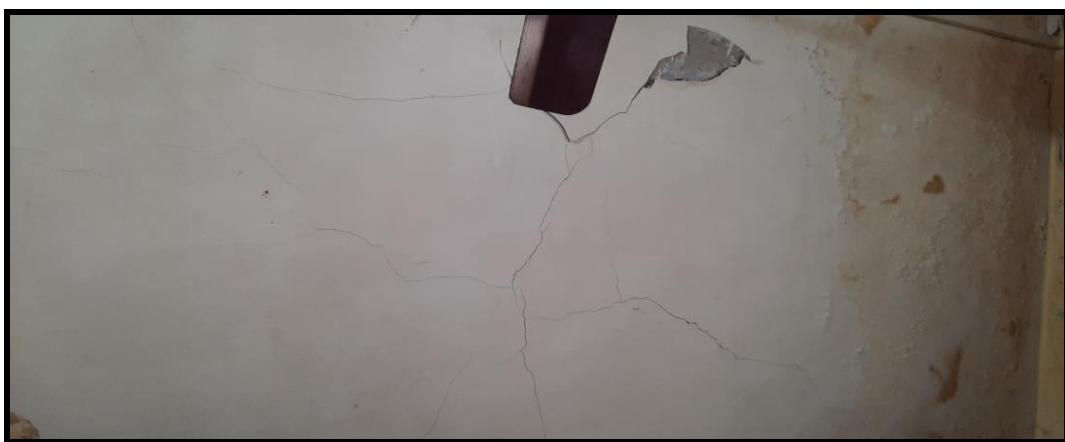
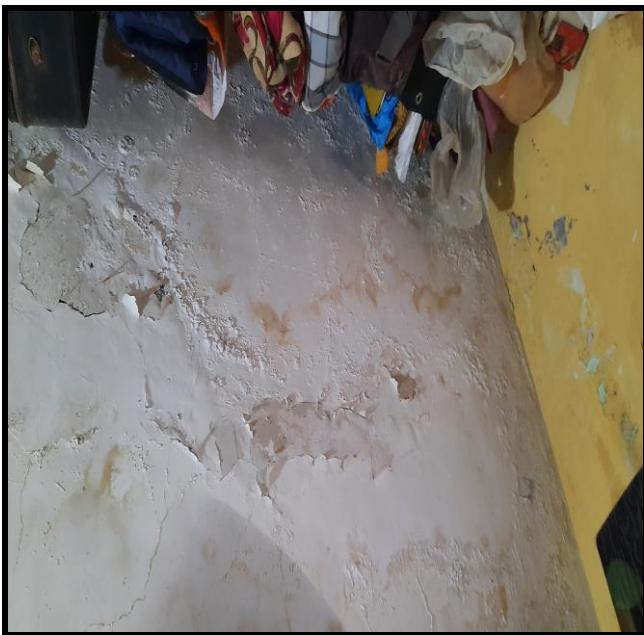
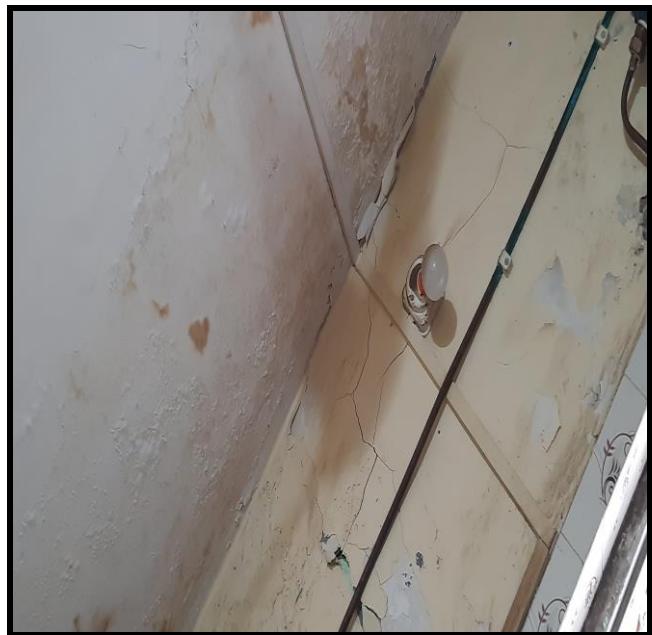
FLAT NO – 11

- ❖ **HALL** – Leakage mark observed on wall & ceiling.
 - Dampness observed on wall.
- ❖ **KITCHEN** – Leakage mark observed on wall & ceiling.
 - Structural crack observed on beam & ceiling.
- ❖ **PASSAGE** – O.K.
- ❖ **TOILET & BATH ROOM** – O.K.

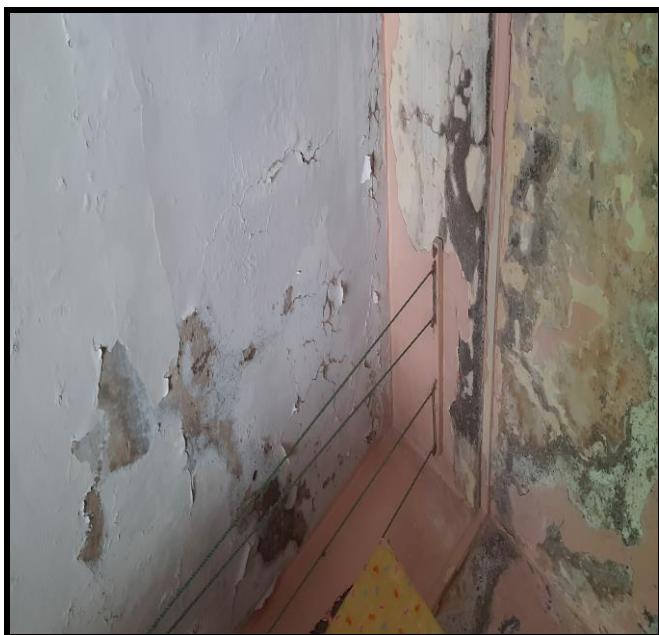
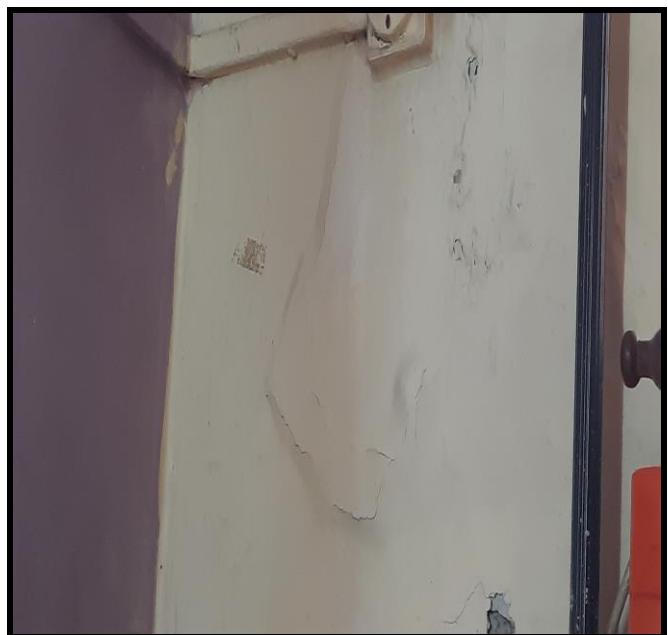
FLAT NO - 13

- ❖ **HALL** – Dampness observed on wall in monsoon.
- ❖ **KITCHEN** – Leakage mark observed on wall & ceiling.
- ❖ **PASSAGE** – O.K.
- ❖ **TOILET & BATH ROOM** – O.K.

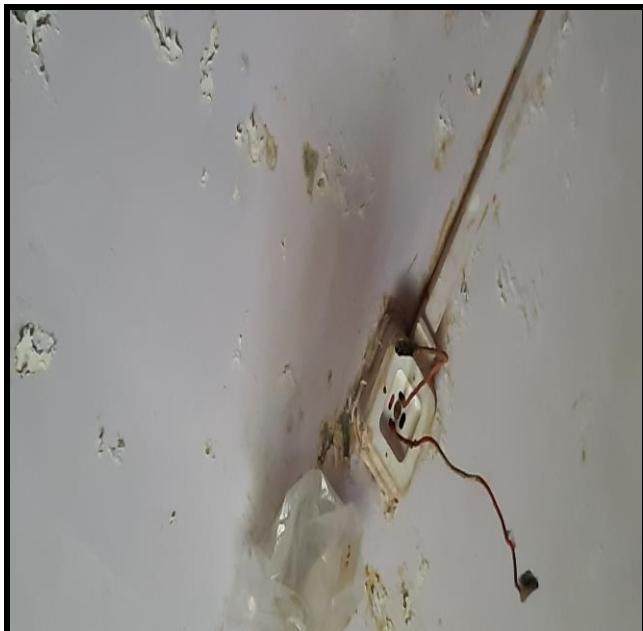
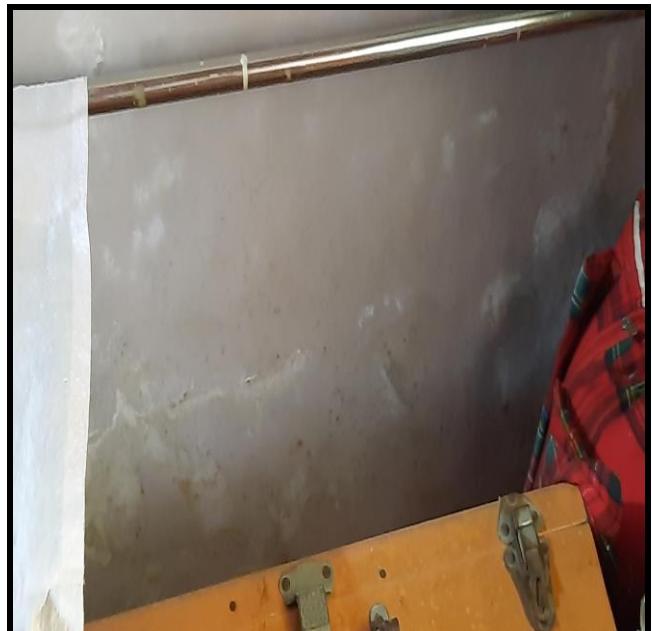
FLAT NO – 14

- ❖ **HALL** – Leakage mark observed on ceiling.
- ❖ **KITCHEN** – Leakage observed on ceiling.
- ❖ **PASSAGE** – O.K.
- ❖ **TOILET & BATH ROOM** – O.K.

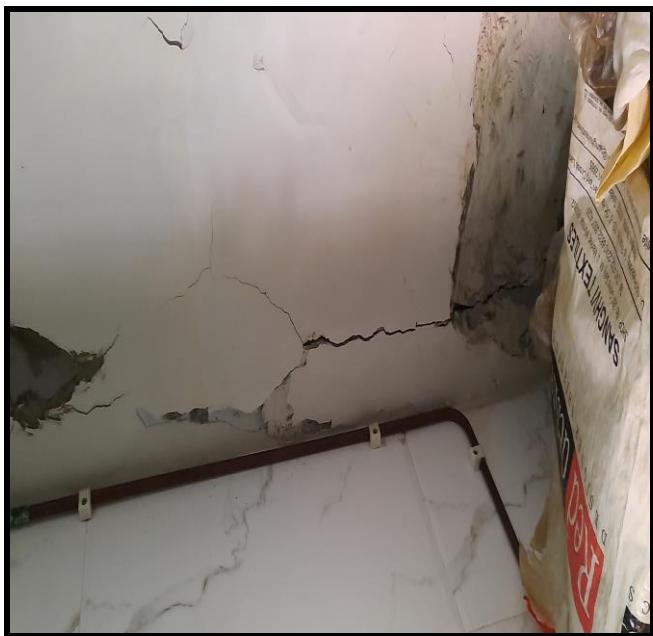
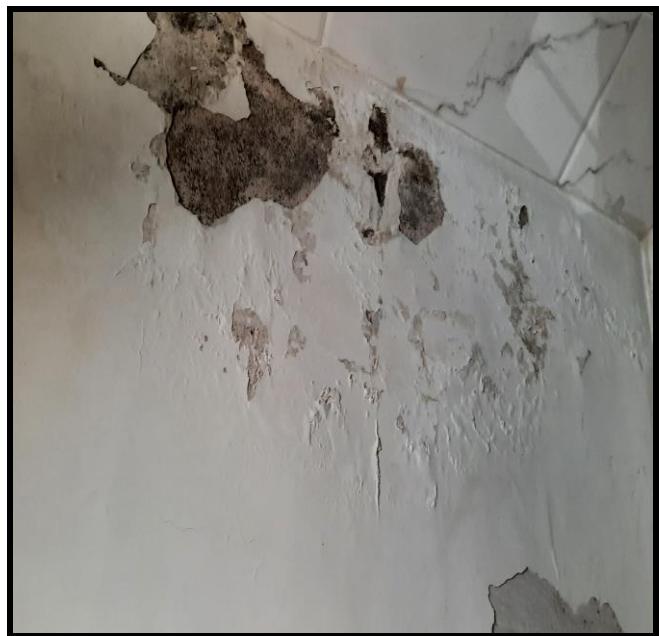
FLAT NO – 20

- ❖ **HALL** – O.K.
- ❖ **KITCHEN** – Leakage mark observed on ceiling.
 - Structural damage observed on ceiling.
- ❖ **PASSAGE** – O.K.
- ❖ **TOILET & BATH ROOM** – O.K.

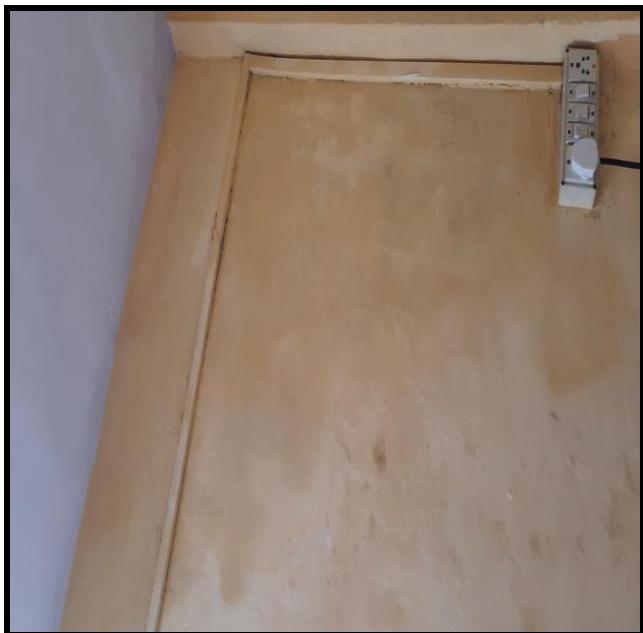
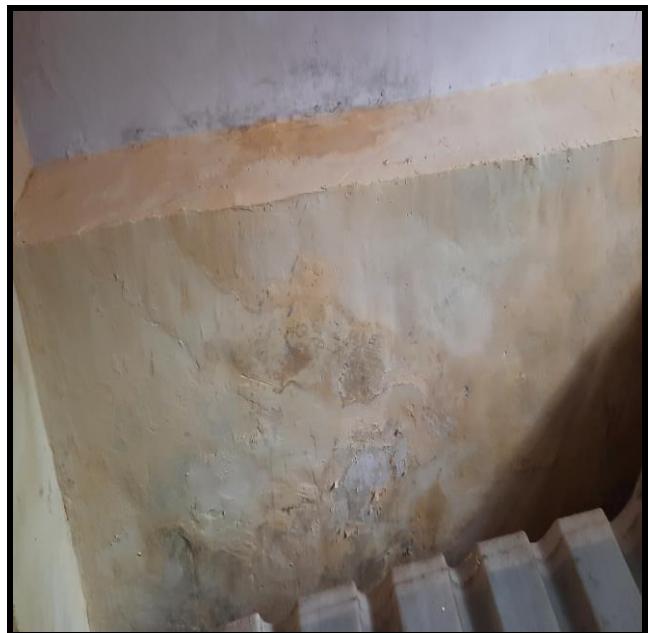
FLAT NO – 24

- ❖ **HALL** – Dampness observed on wall.
- ❖ **KITCHEN** – Dampness observed on wall & ceiling.
- ❖ **PASSAGE** – O.K.
- ❖ **TOILET & BATH ROOM** – O.K.

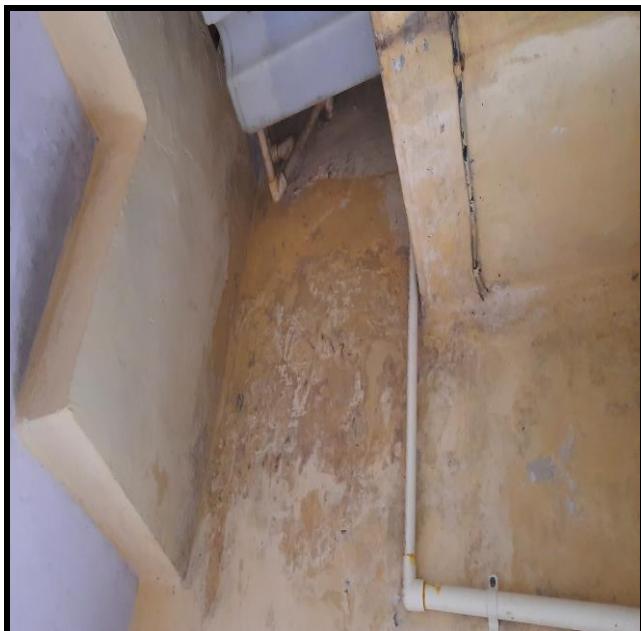
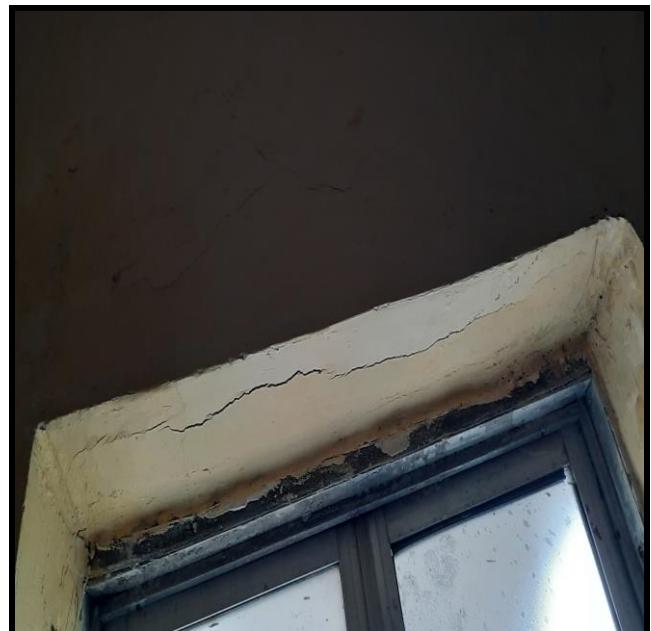
FLAT NO – 27

- ❖ **HALL** – Dampness observed on wall in monsoon.
- ❖ **KITCHEN** – Dampness observed on wall.
 - Structural crack observed on beam.
- ❖ **PASSAGE** – O.K.
- ❖ **TOILET & BATH ROOM** – O.K.

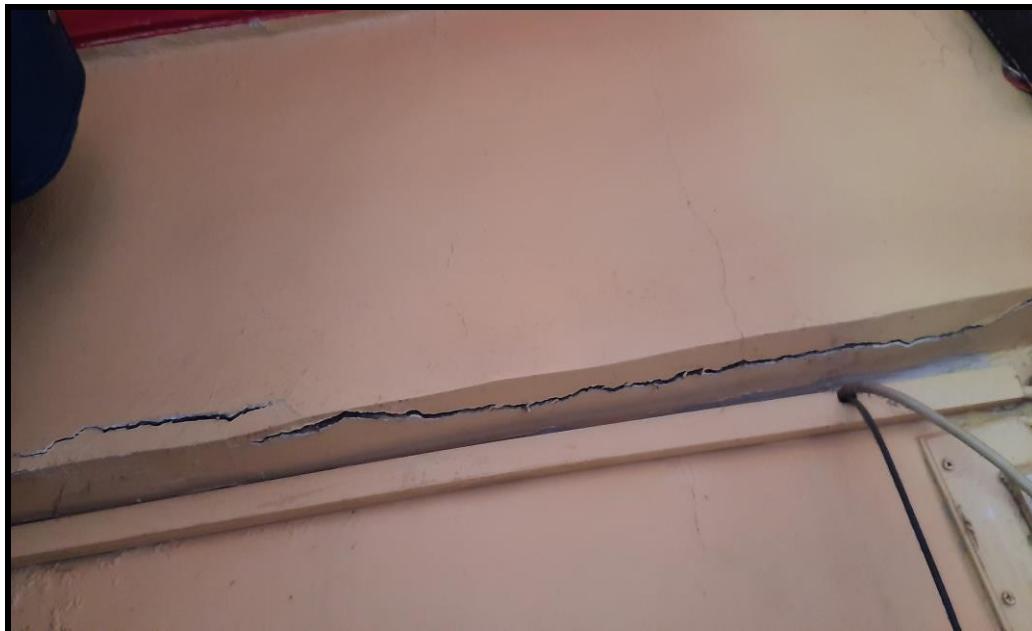
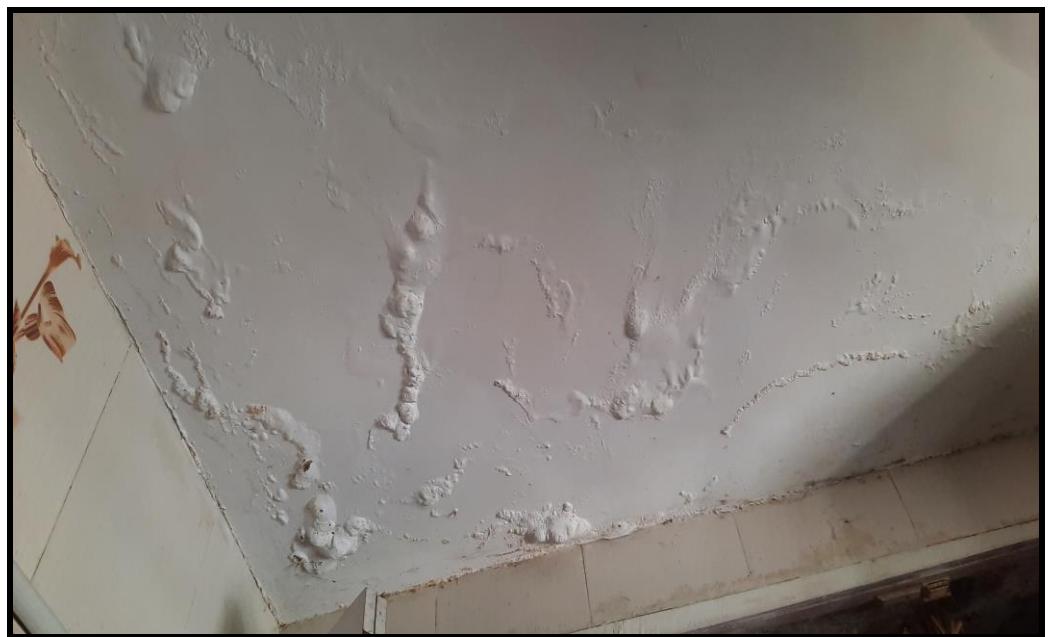
FLAT NO – 32

- ❖ **HALL** – Leakage observed on wall in monsoon.
 - Structural crack observed on beam.
- ❖ **KITCHEN** – Leakage mark observed on ceiling.
- ❖ **PASSAGE** – O.K.
- ❖ **TOILET & BATH ROOM** – O.K.

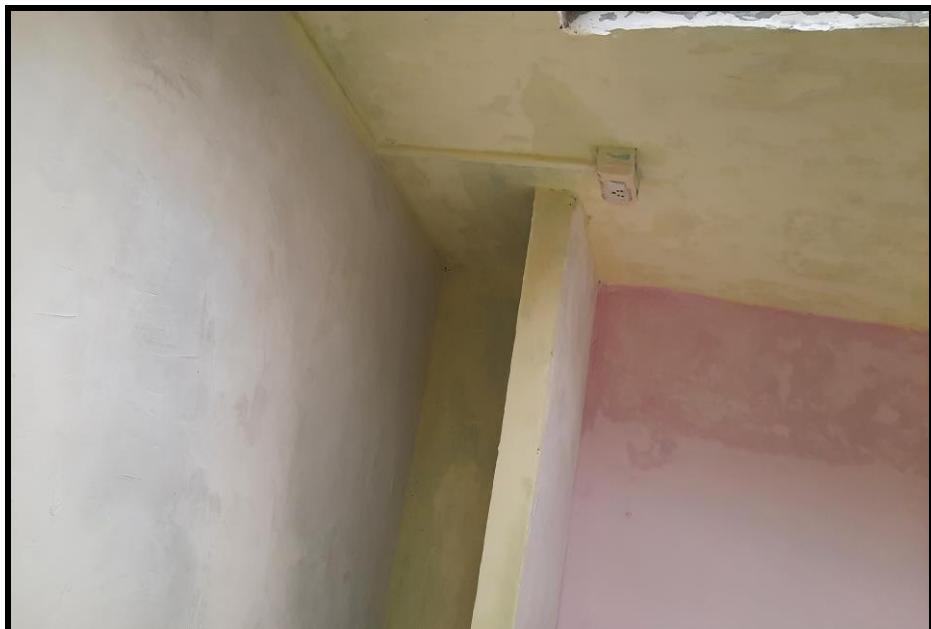
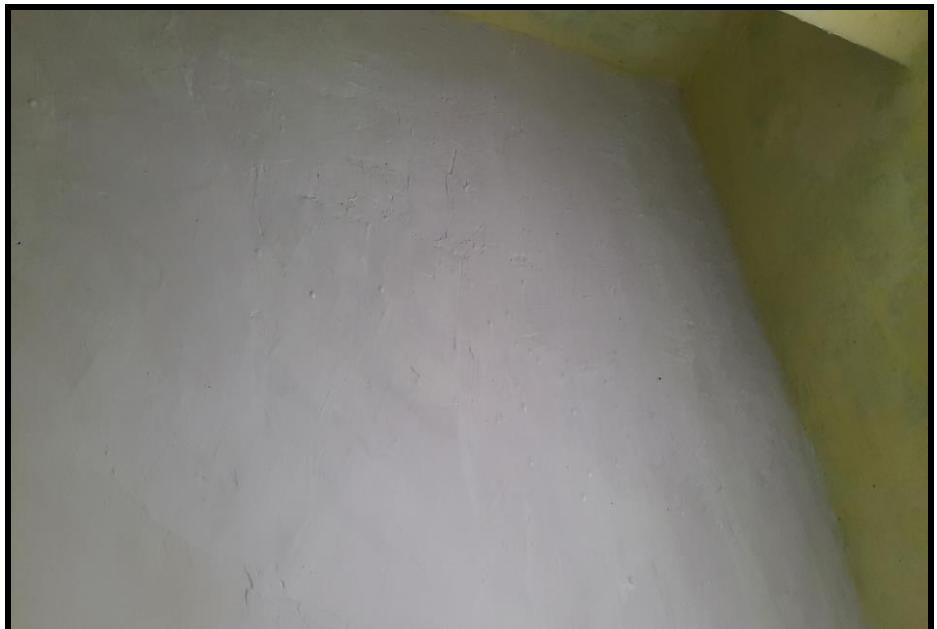
FLAT NO – 36

- ❖ **HALL** – Dampness observed on wall & ceiling.
- ❖ **KITCHEN** – Leakage observed on ceiling.
- ❖ **PASSAGE** – O.K.
- ❖ **TOILET & BATH ROOM** – O.K.

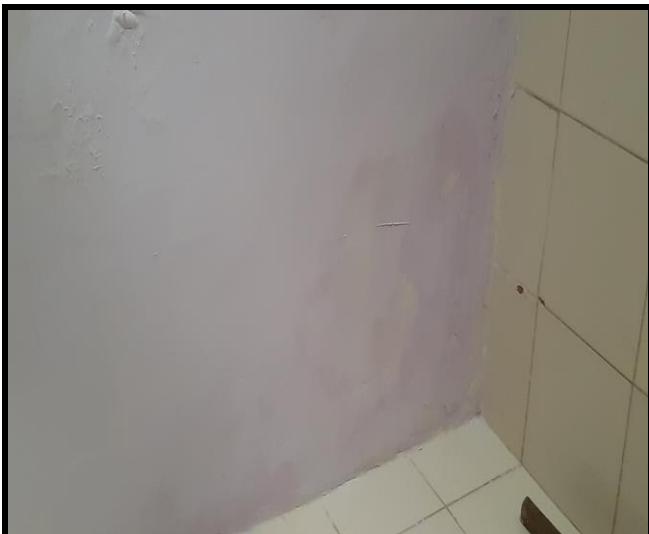
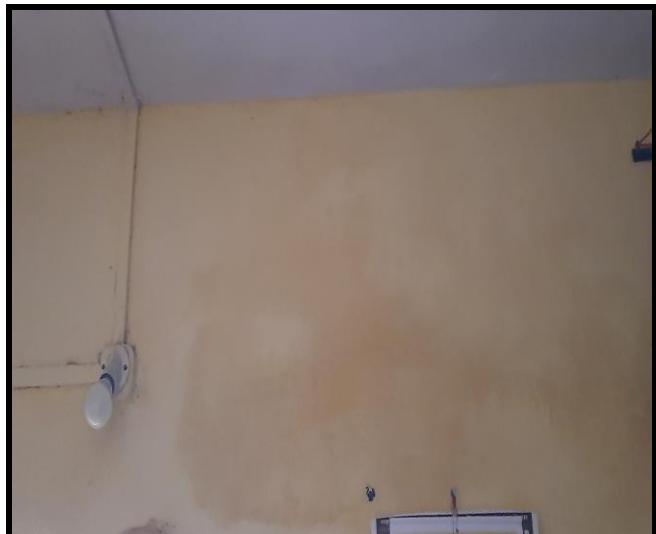
FLAT NO – 41

- ❖ **HALL** – Leakage mark observed on wall.
- ❖ **KITCHEN** – Leakage mark observed on ceiling.
- ❖ **PASSAGE** – O.K.
- ❖ **TOILET & BATH ROOM** – O.K.

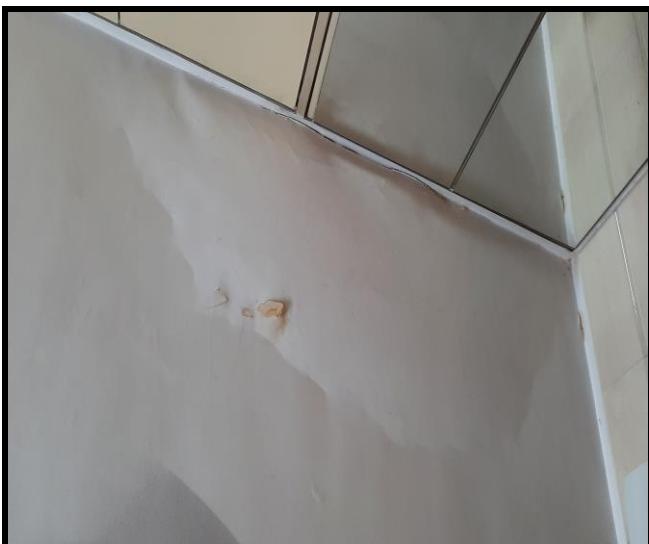
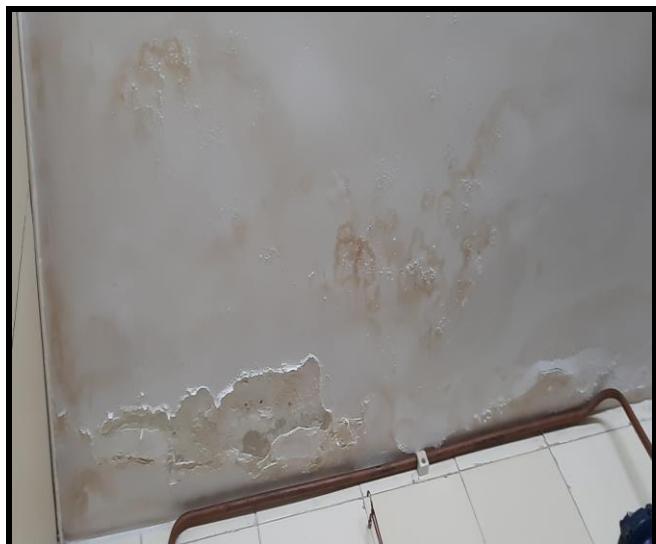
FLAT NO – 46

- ❖ **HALL** – Leakage mark observed on ceiling.
- ❖ **KITCHEN** – Leakage mark observed on ceiling.
- ❖ **PASSAGE** – O.K.
- ❖ **TOILET & BATH ROOM** – O.K.

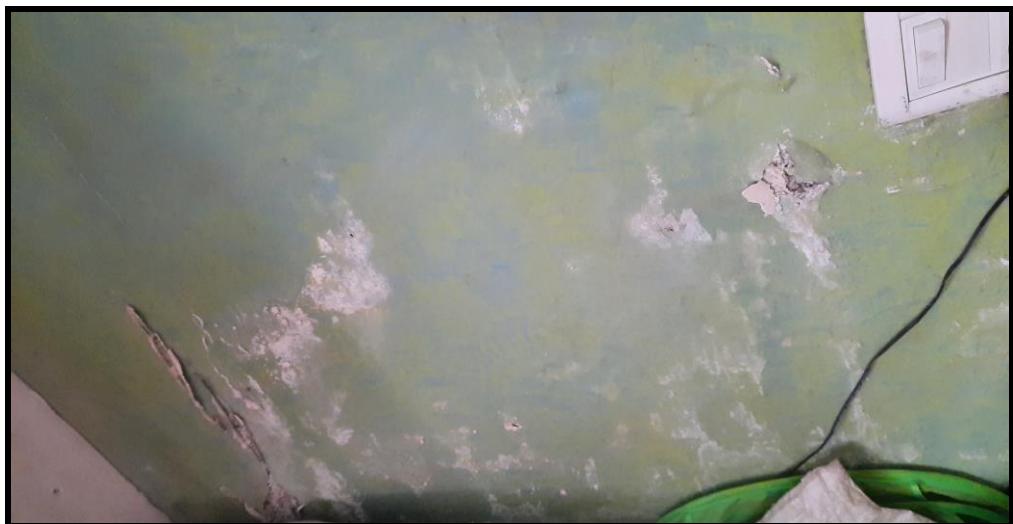
FLAT NO – 54

- ❖ **HALL** – Seepage observed on wall.
- ❖ **KITCHEN** – O.K.
- ❖ **PASSAGE** – O.K.
- ❖ **TOILET & BATH ROOM** – O.K.

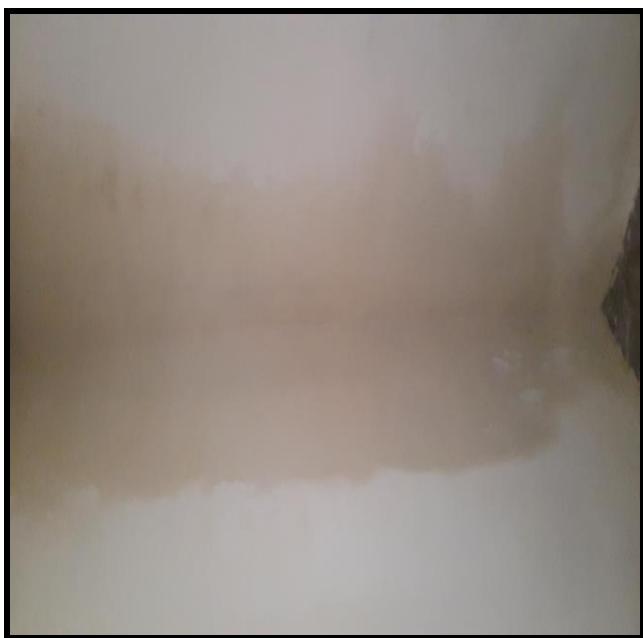
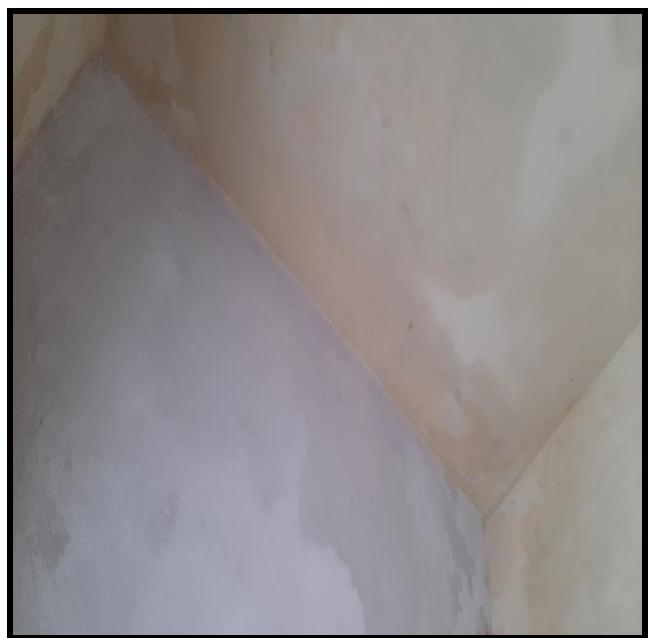
FLAT NO – 61

- ❖ **HALL** – Dampness observed on wall & ceiling.
- ❖ **KITCHEN** – Dampness observed on wall & ceiling.
- ❖ **PASSAGE** – O.K.
- ❖ **TOILET & BATH ROOM** – Dampness observed on wall & ceiling.

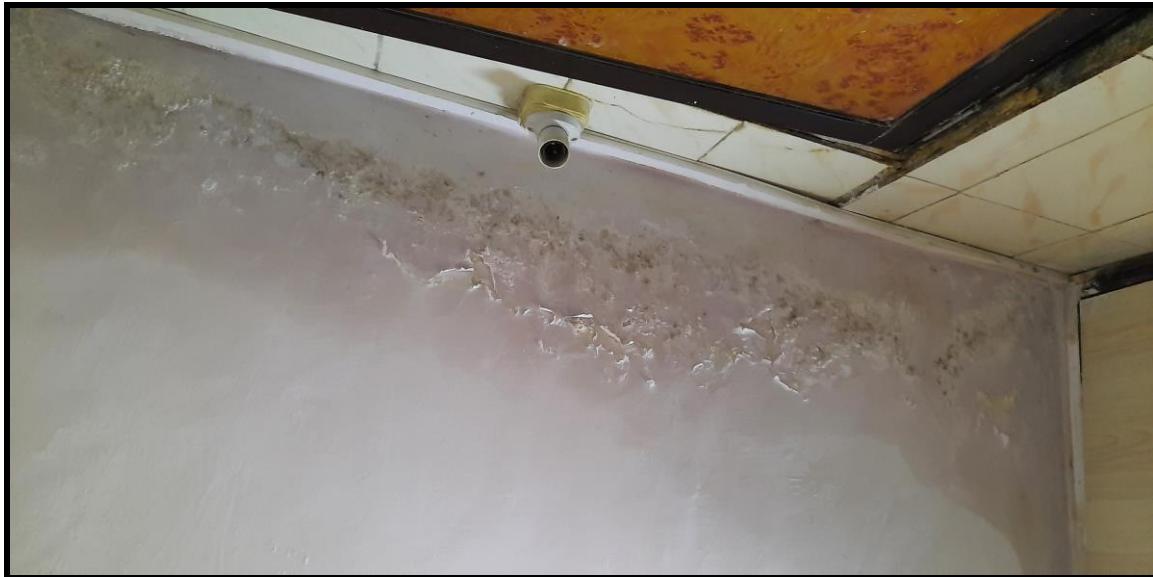
FLAT NO – 64

- ❖ **HALL** – Dampness observed on wall in monsoon.
 - Leakage observed on ceiling in monsoon.
- ❖ **KITCHEN** – Leakage mark observed on ceiling.
- ❖ **PASSAGE** – O.K.
- ❖ **TOILET & BATH ROOM** – O.K.

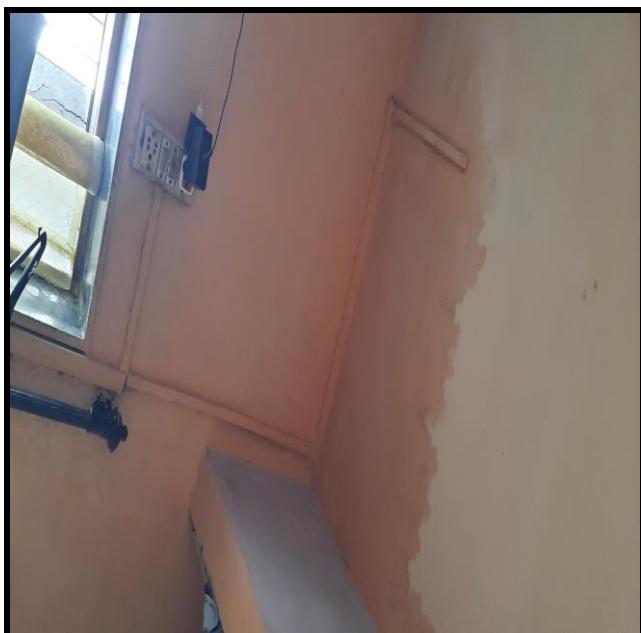
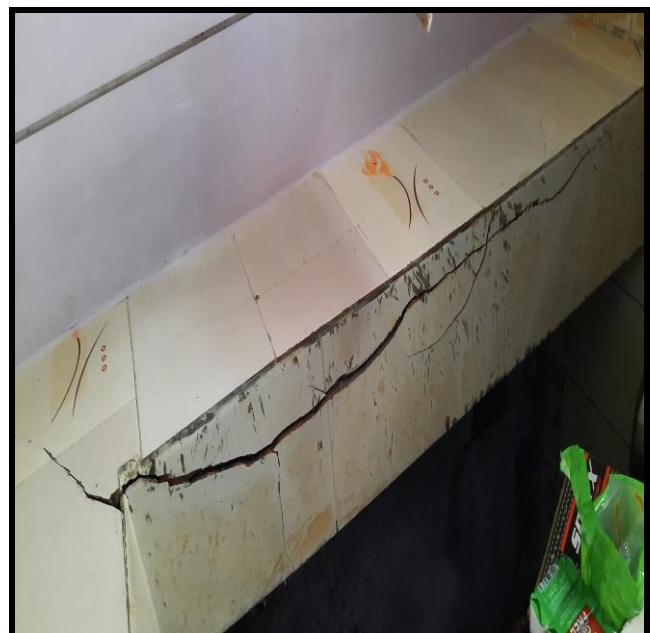
FLAT NO – 73

- ❖ **HALL** – Dampness observed on wall & ceiling.
- ❖ **KITCHEN** – Dampness observed on ceiling.
 - Structural crack observed on beam.
- ❖ **PASSAGE** – O.K.
- ❖ **TOILET & BATH ROOM** – O.K.

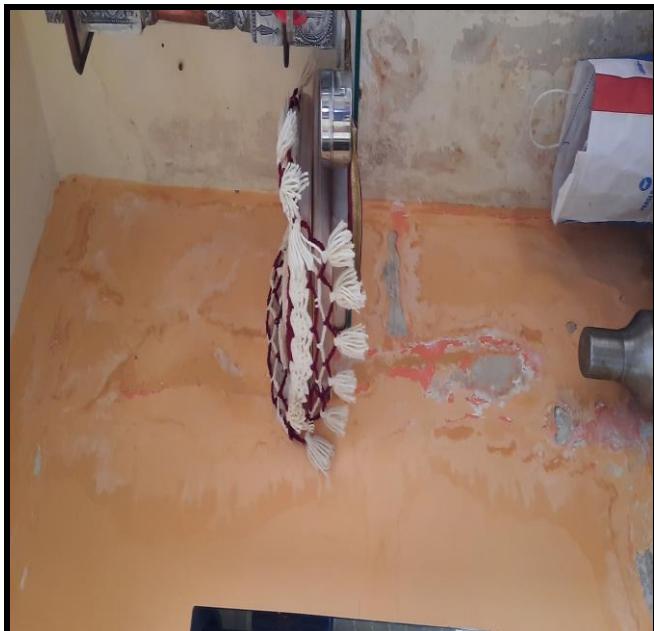
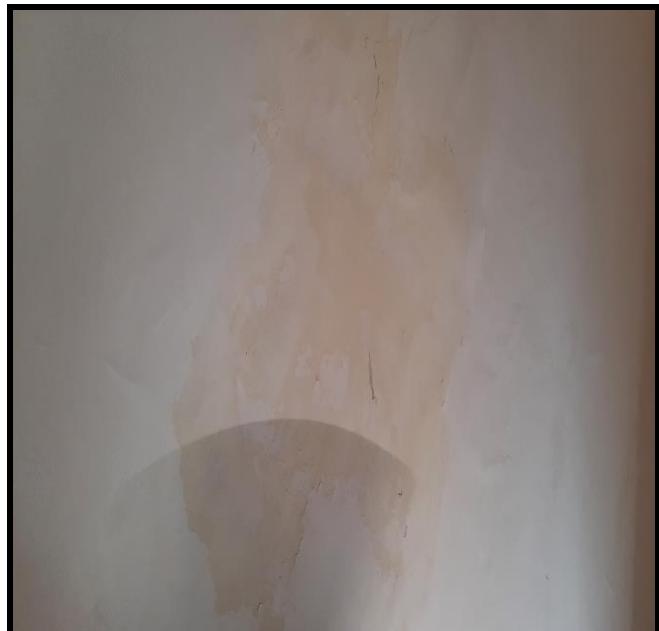
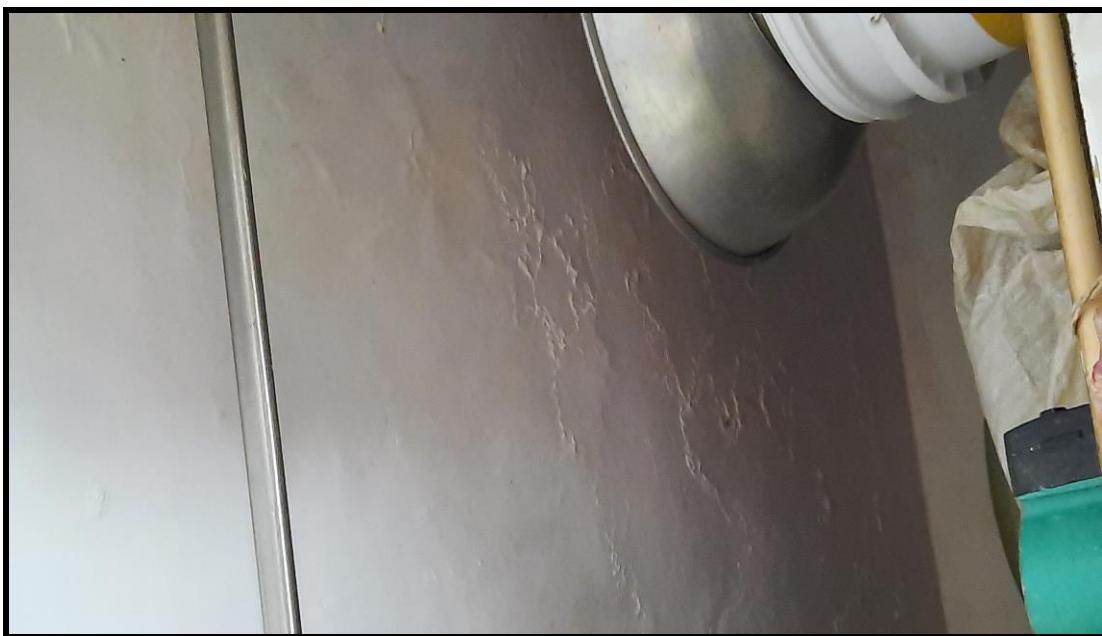
FLAT NO - 77

- ❖ **HALL** – Leakage mark observed on wall & ceiling.
- ❖ **KITCHEN** – Leakage mark observed on ceiling.
- ❖ **PASSAGE** – O.K.
- ❖ **TOILET & BATH ROOM** – O.K.

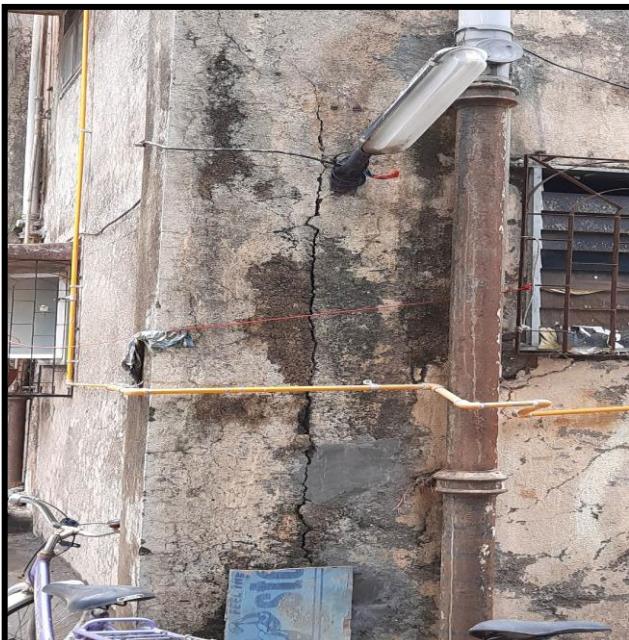
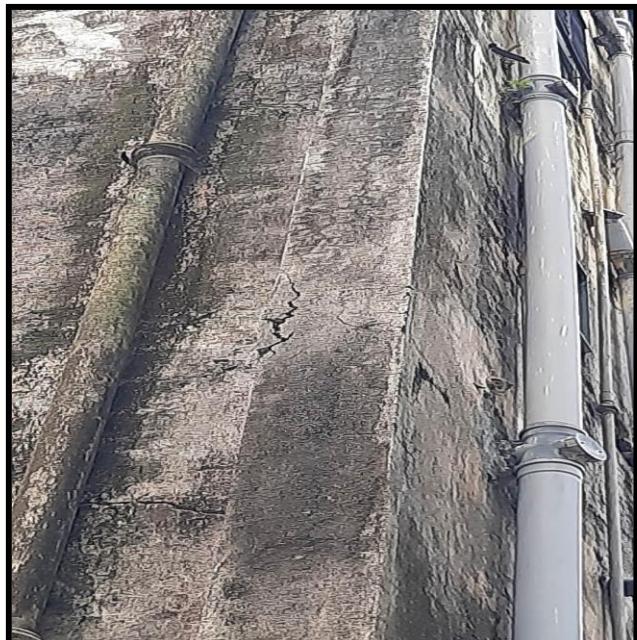
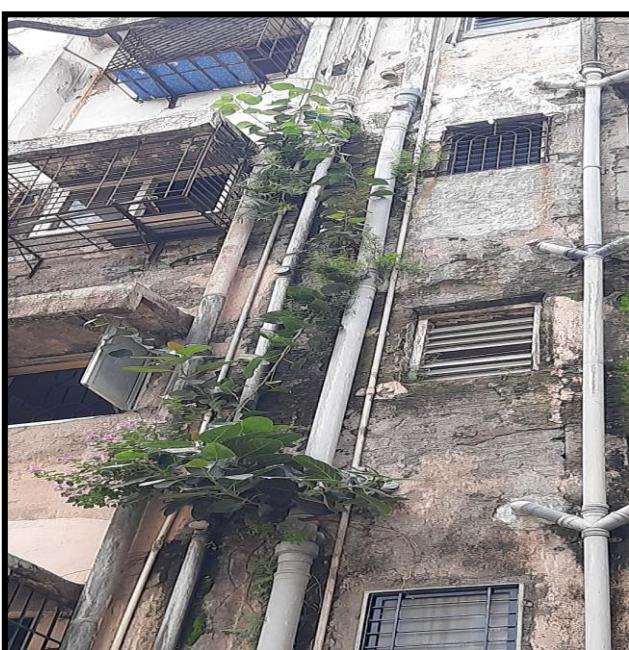
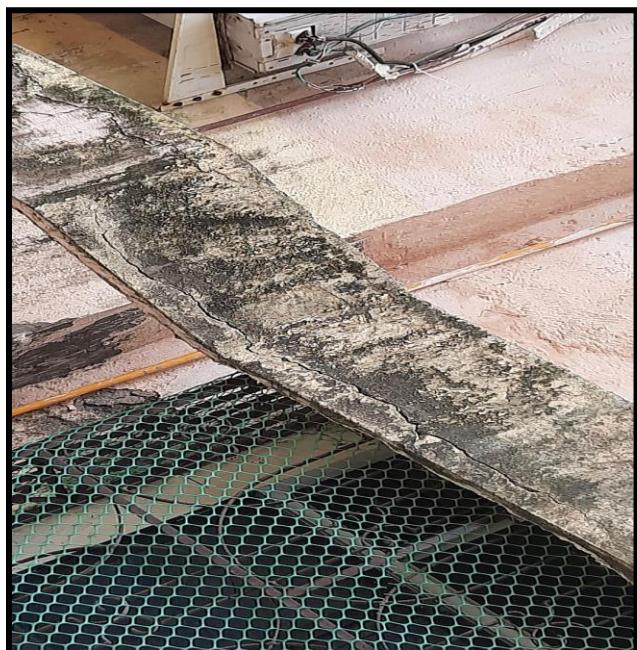
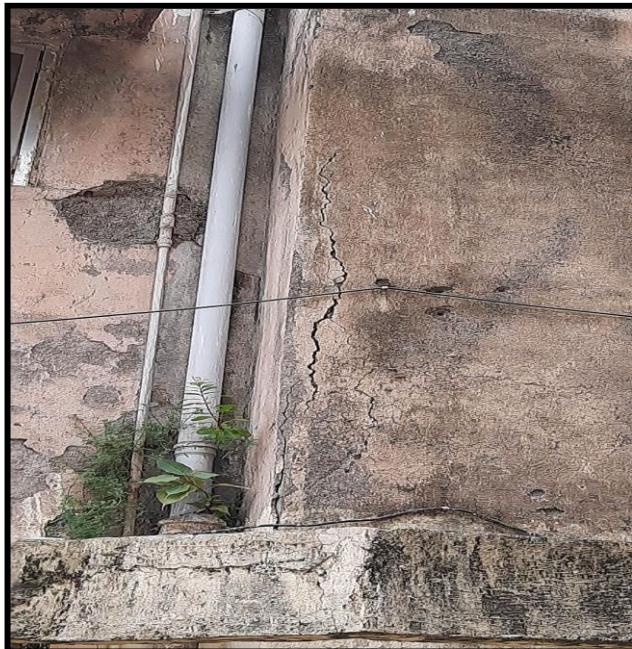
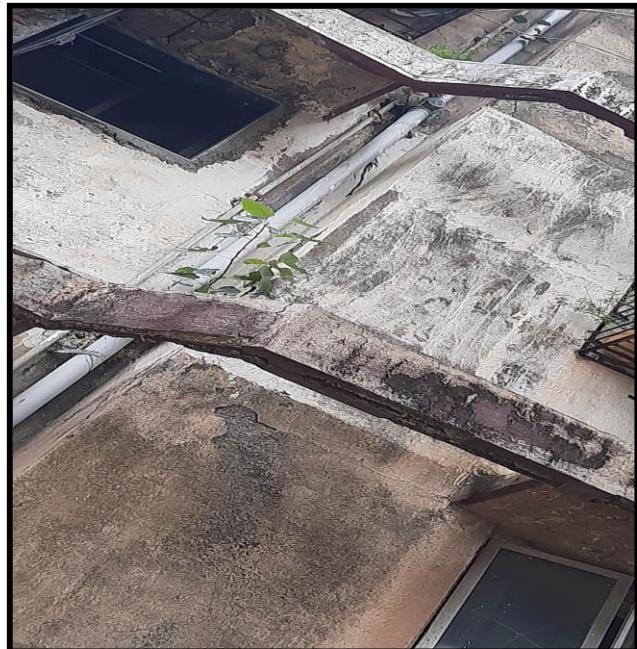
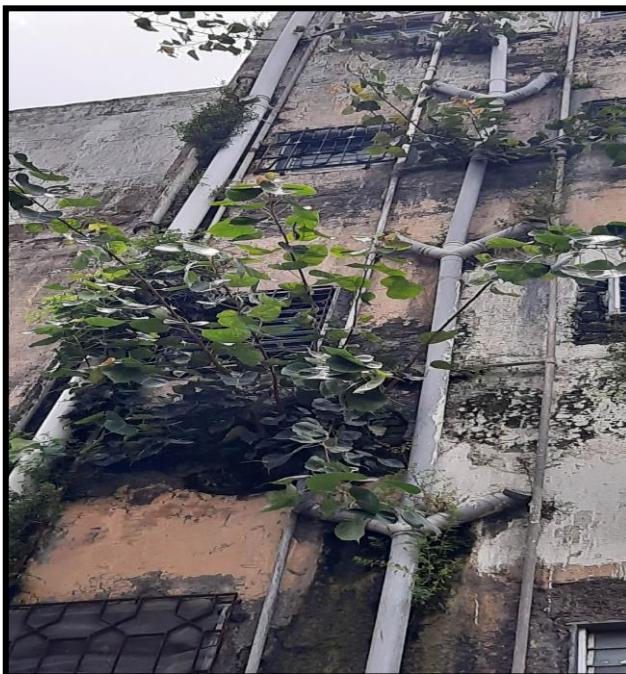
FRONT SIDE

- ❖ Structural crack observed at several places on column & chajjas.
- ❖ Major crack observed at several places on wall.
- ❖ Vegetation growth observed at several places on wall.
