STRUCTURAL AUDIT REPORT
FOR
“VISHAL SAHYADRI CO – OP HSG. SOC. LTD”,
“C7 – WING”
SITUATED AT
SAHYADRI NAGAR, CHARKOP,
KANDIVALI (W) MUMBAI – 400 067

PREPARED BY
LATESH S. SANKLECHA
CONSULTING STRUCTURAL ENGINEERS

978/B1/LSS/2021

JUNE 24, 2021

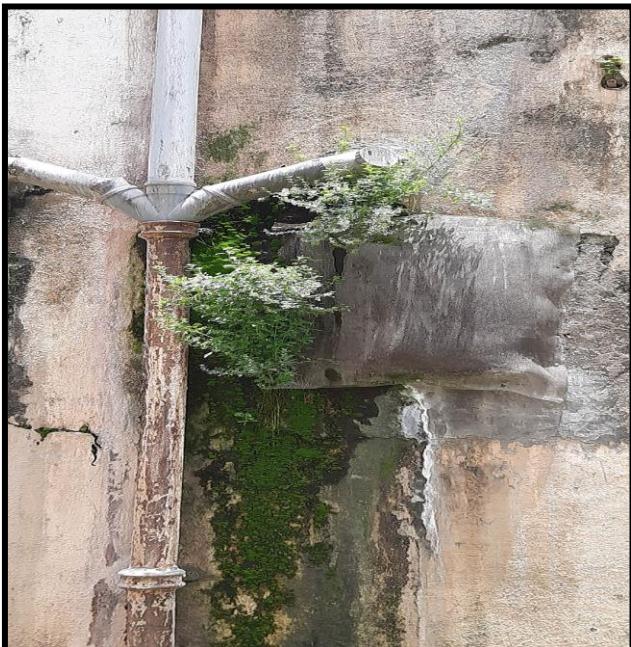
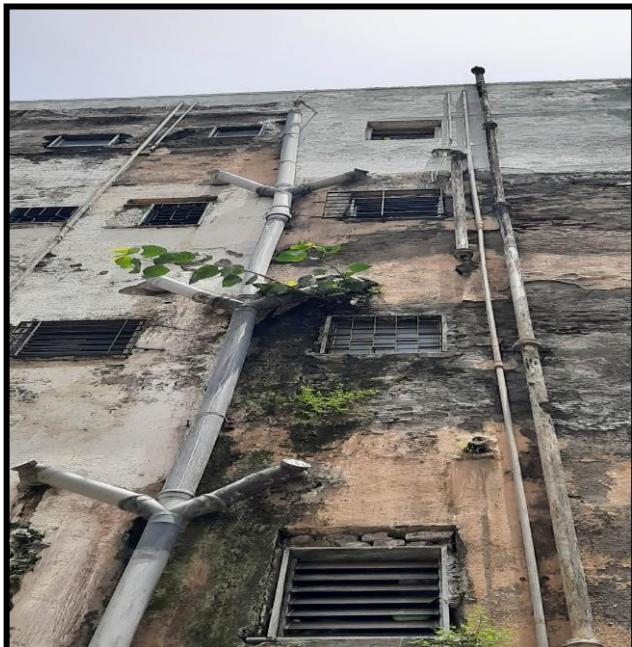
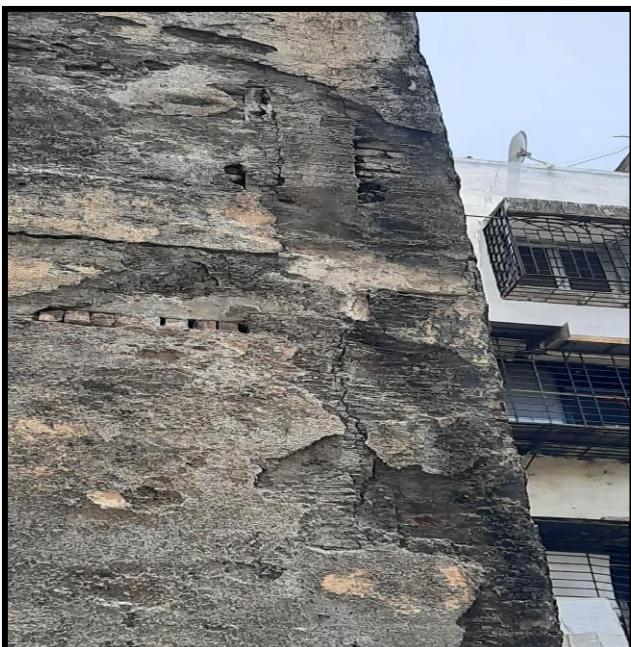
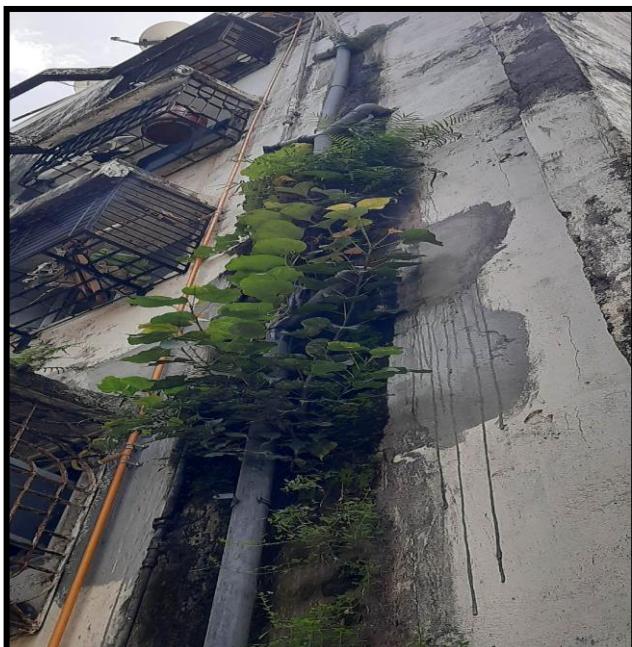
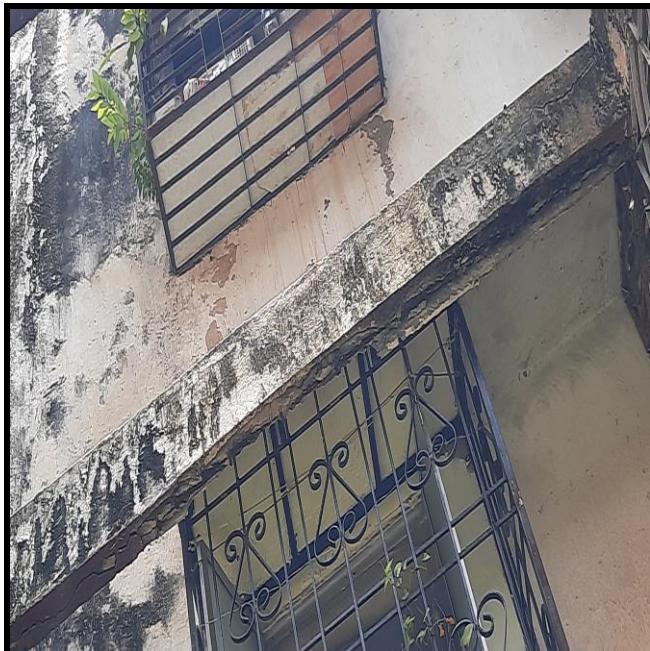
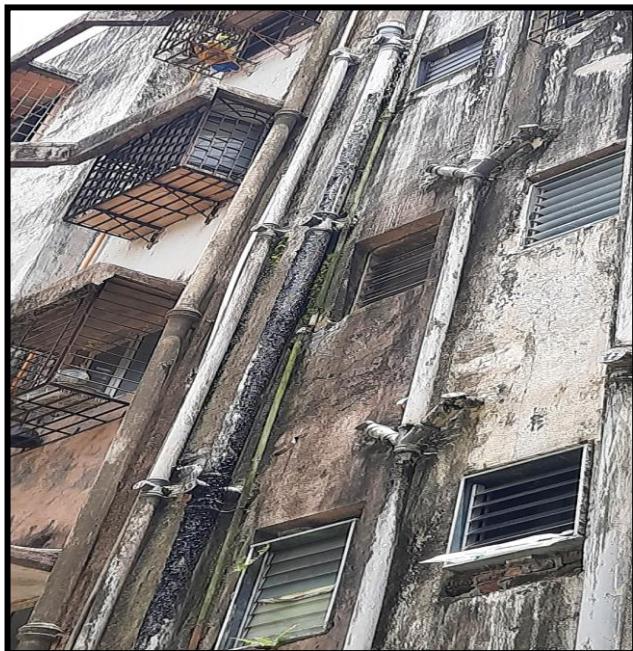
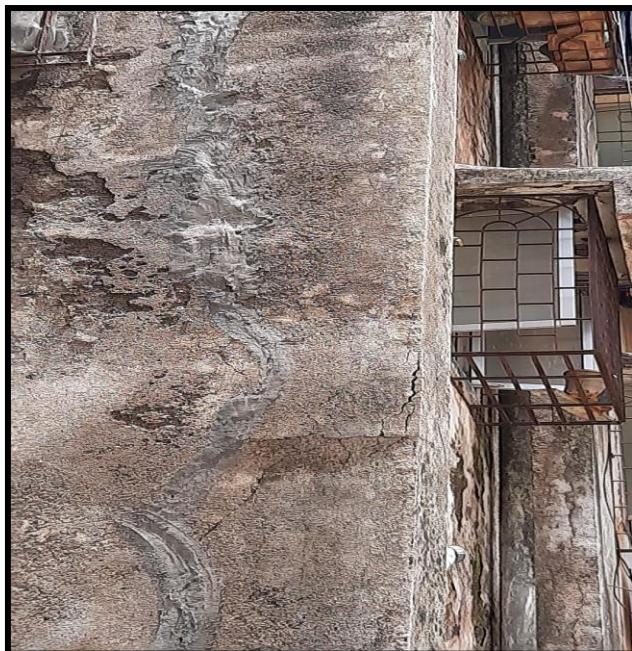
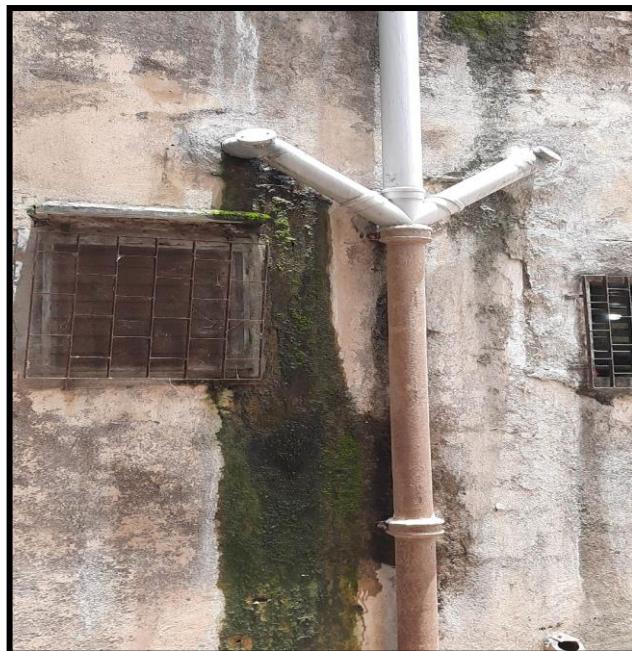
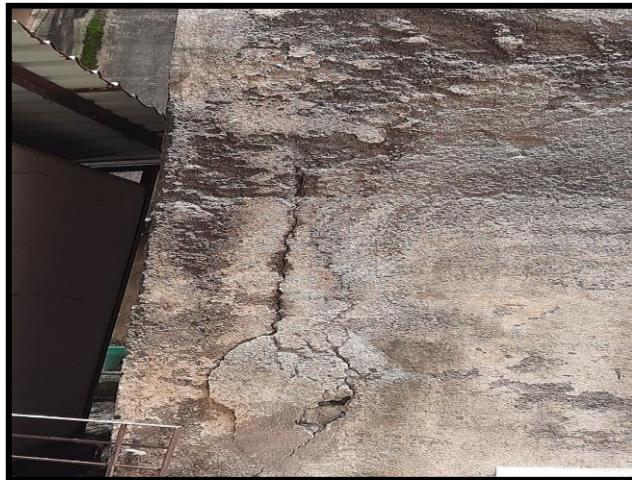
BACK SIDE

- ❖ Structural crack observed at several places on column.
- ❖ Major crack observed at several places on wall.
- ❖ Vegetation growth observed at several places on wall.
- ❖ Column & chajja plaster get damaged & steel get exposed & corroded.
- ❖ Algae observed at several places on wall.

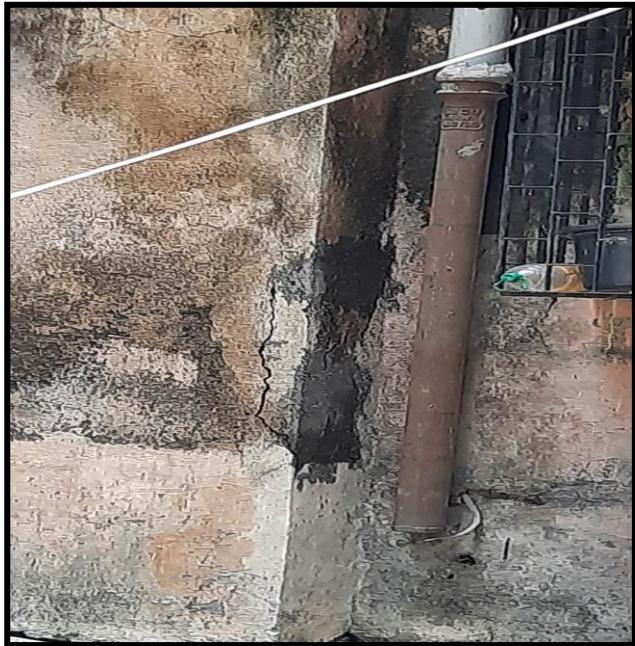
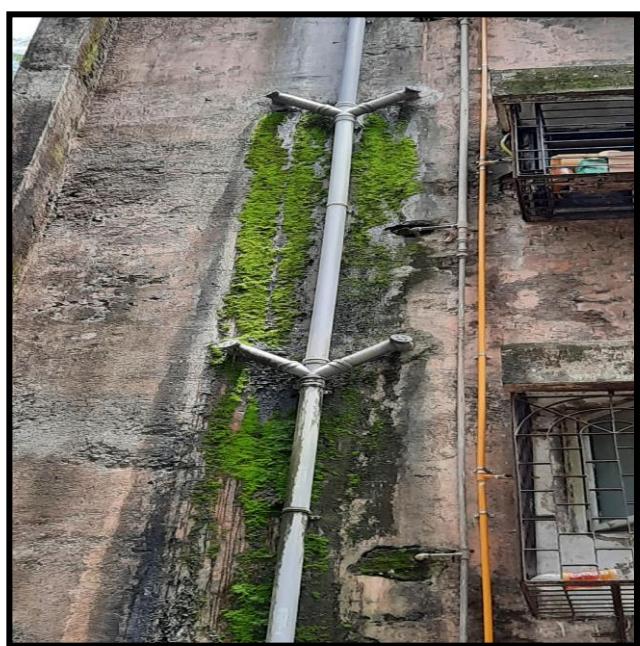
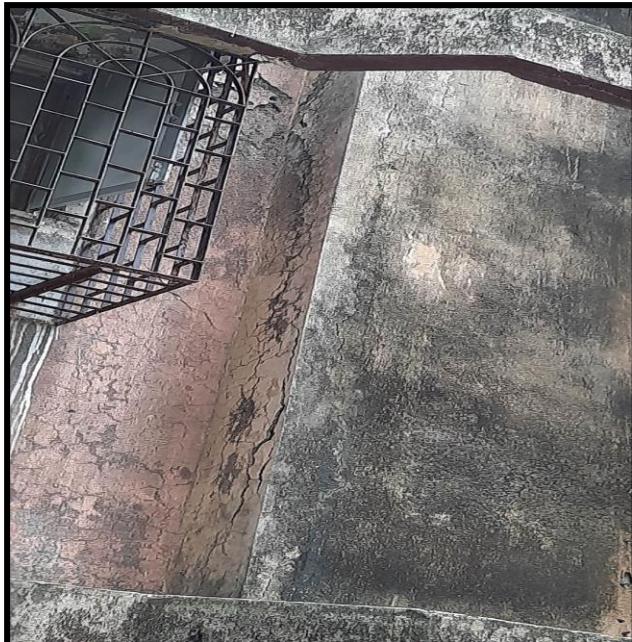
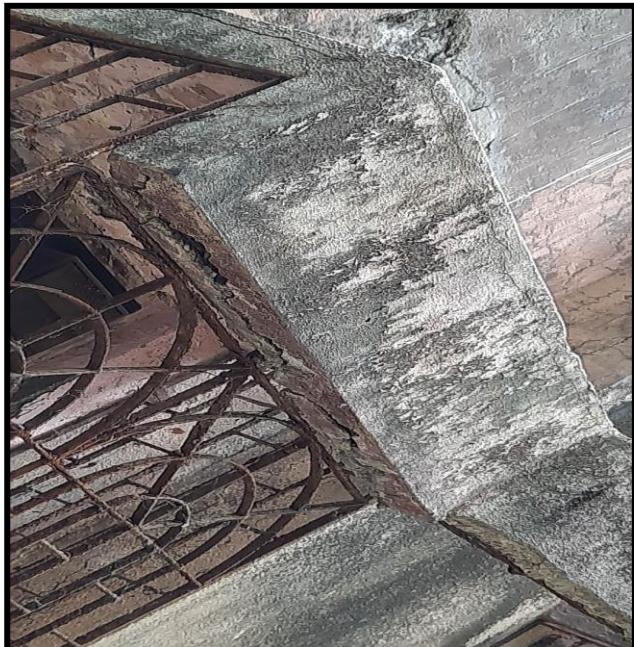
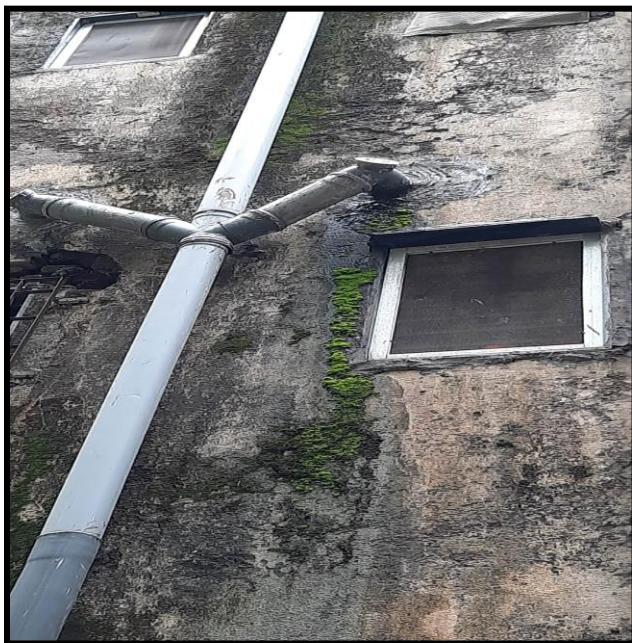
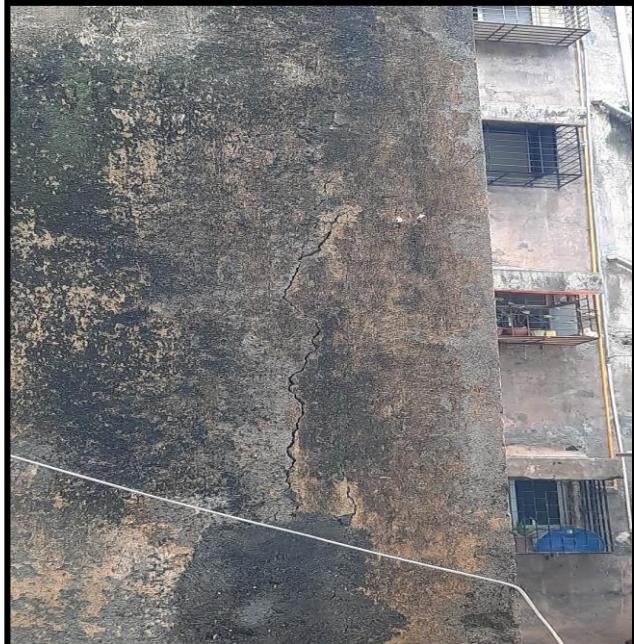
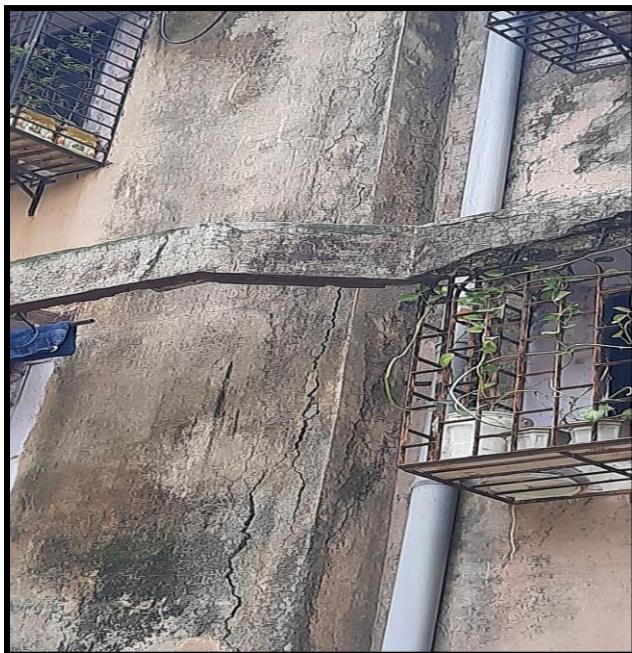
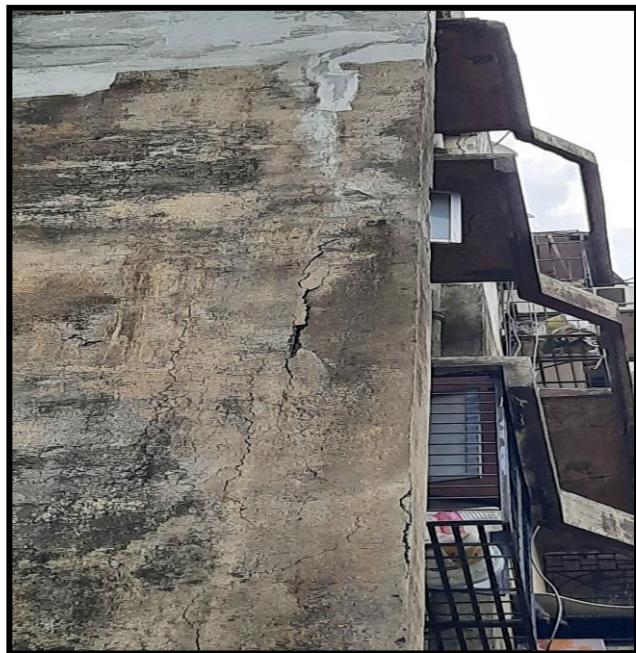
EAST SIDE

- ❖ Structural crack observed at several places on column & chajjas.
- ❖ Major crack observed at several places on wall.
- ❖ Vegetation growth observed at several places on wall.
- ❖ Algae observed at several places on wall.

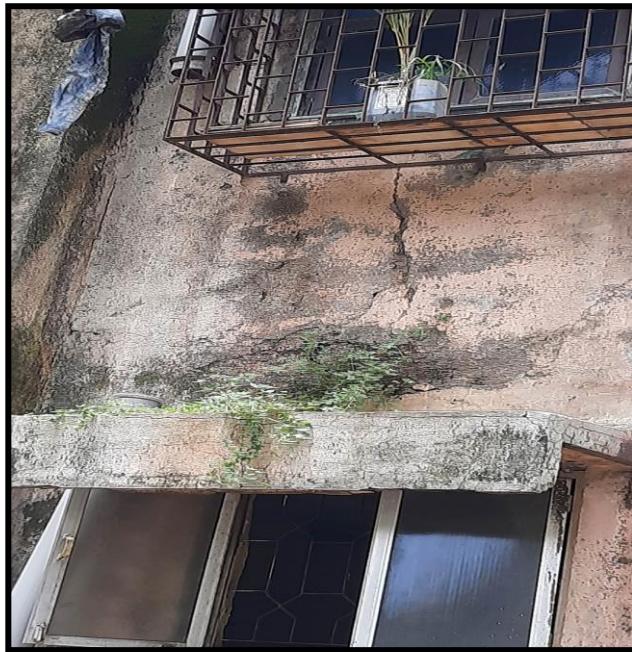
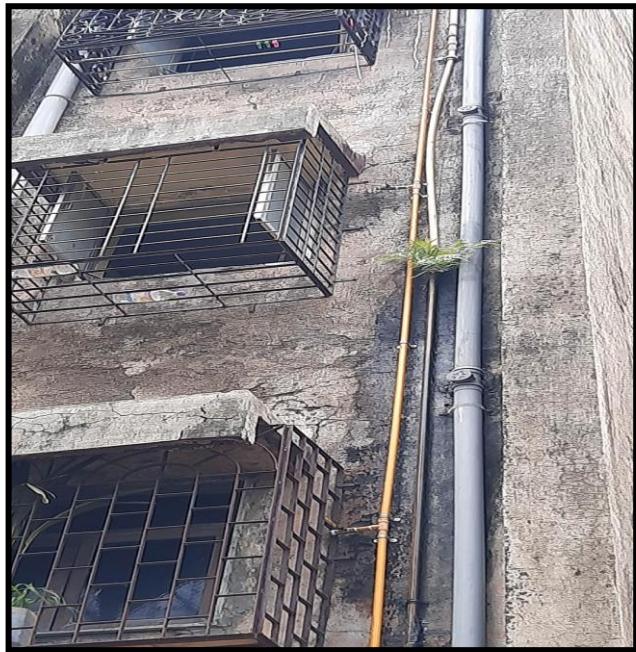
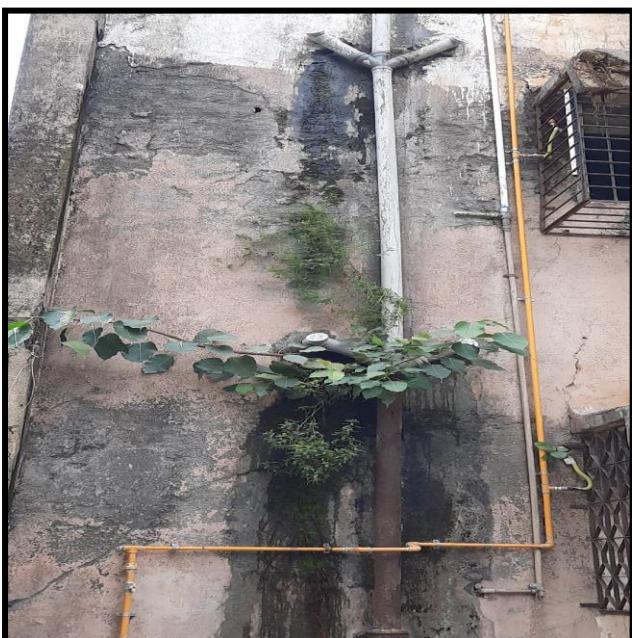
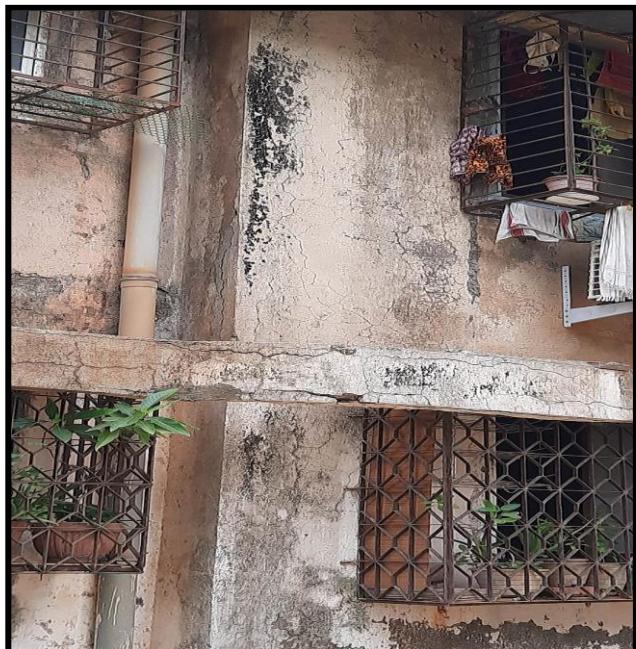
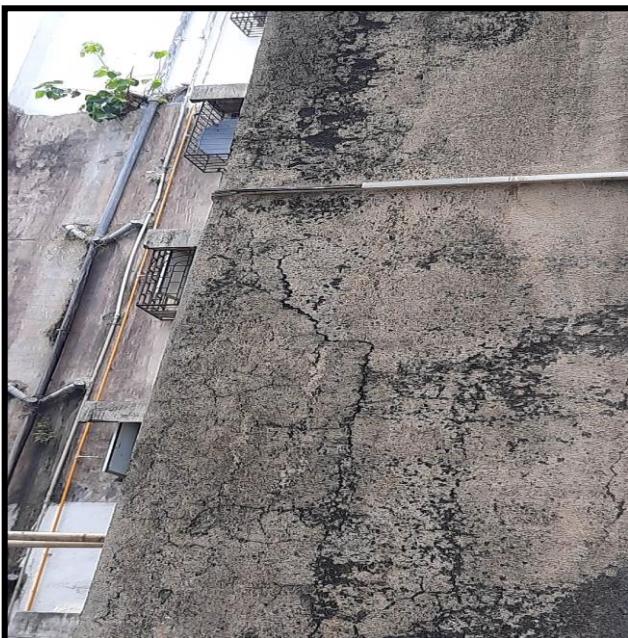
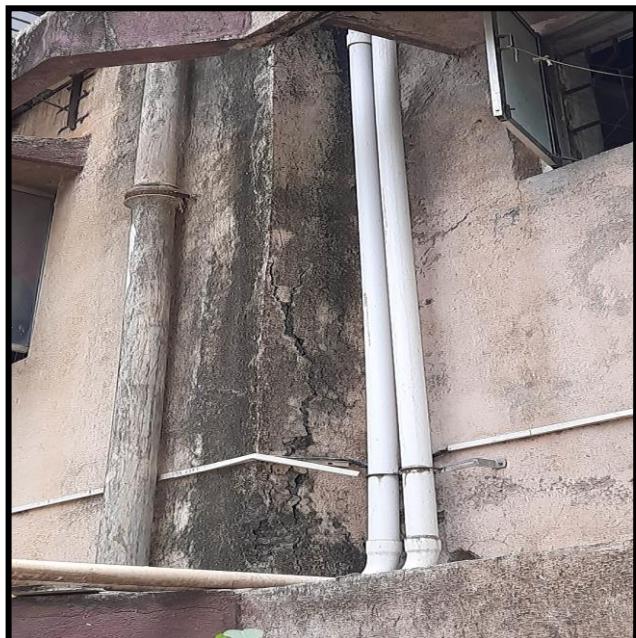
WEST SIDE

- ❖ Structural crack observed at several places on column.
- ❖ Major crack observed at several places on wall.
- ❖ Vegetation growth observed at several places on wall.
- ❖ Chajja plaster get damaged & steel get exposed & corroded.
