STRUCTURAL AUDIT REPORT
FOR
“VISHAL SAHYADRI CO – OP HSG. SOC. LTD”,
“B8 – WING”
SITUATED AT
SAHYADRI NAGAR, CHARKOP,
KANDIVALI (W) MUMBAI – 400 067

PREPARED BY
LATESH S. SANKLECHA
CONSULTING STRUCTURAL ENGINEERS

978/B8/LSS/2021

JULY 24, 2021

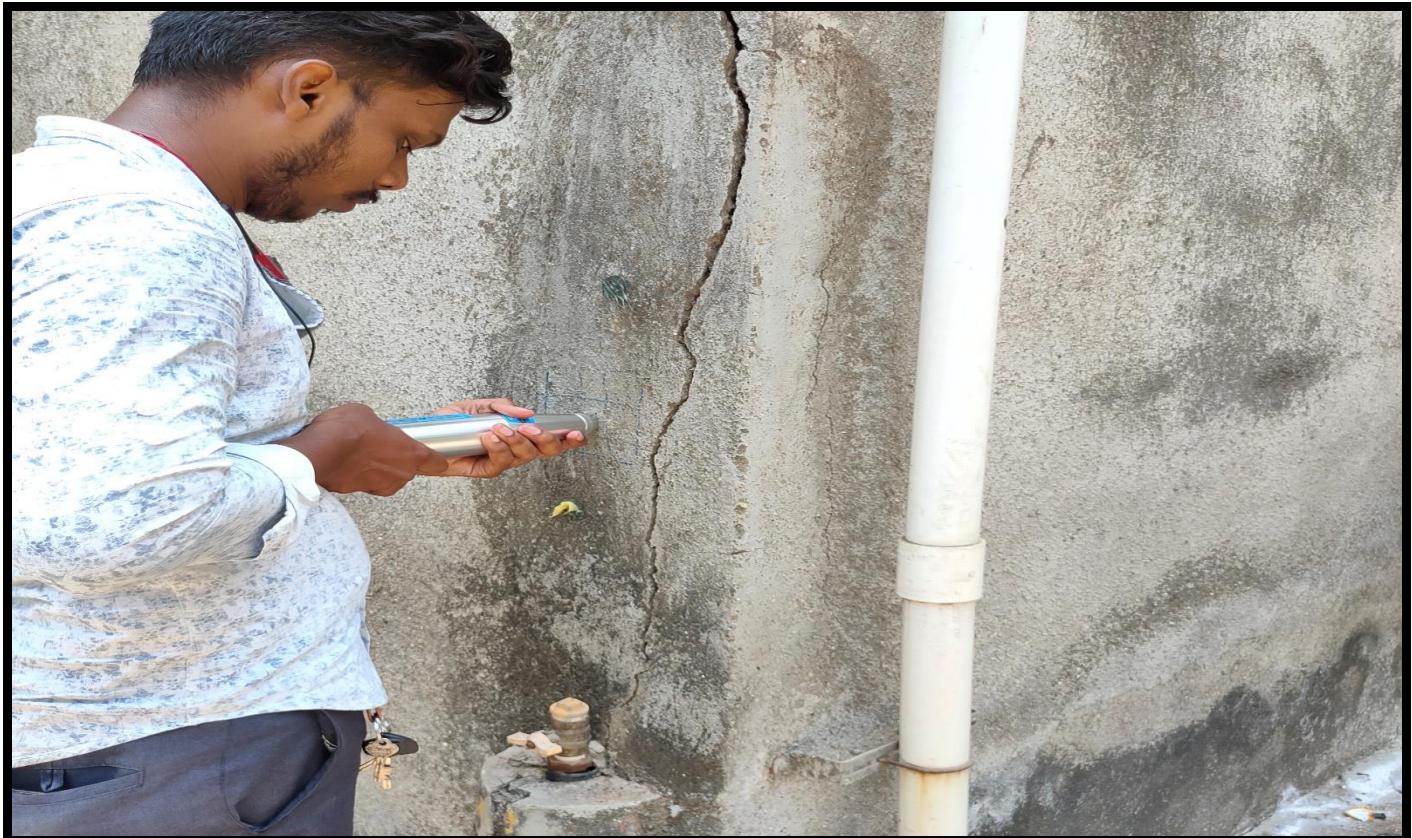
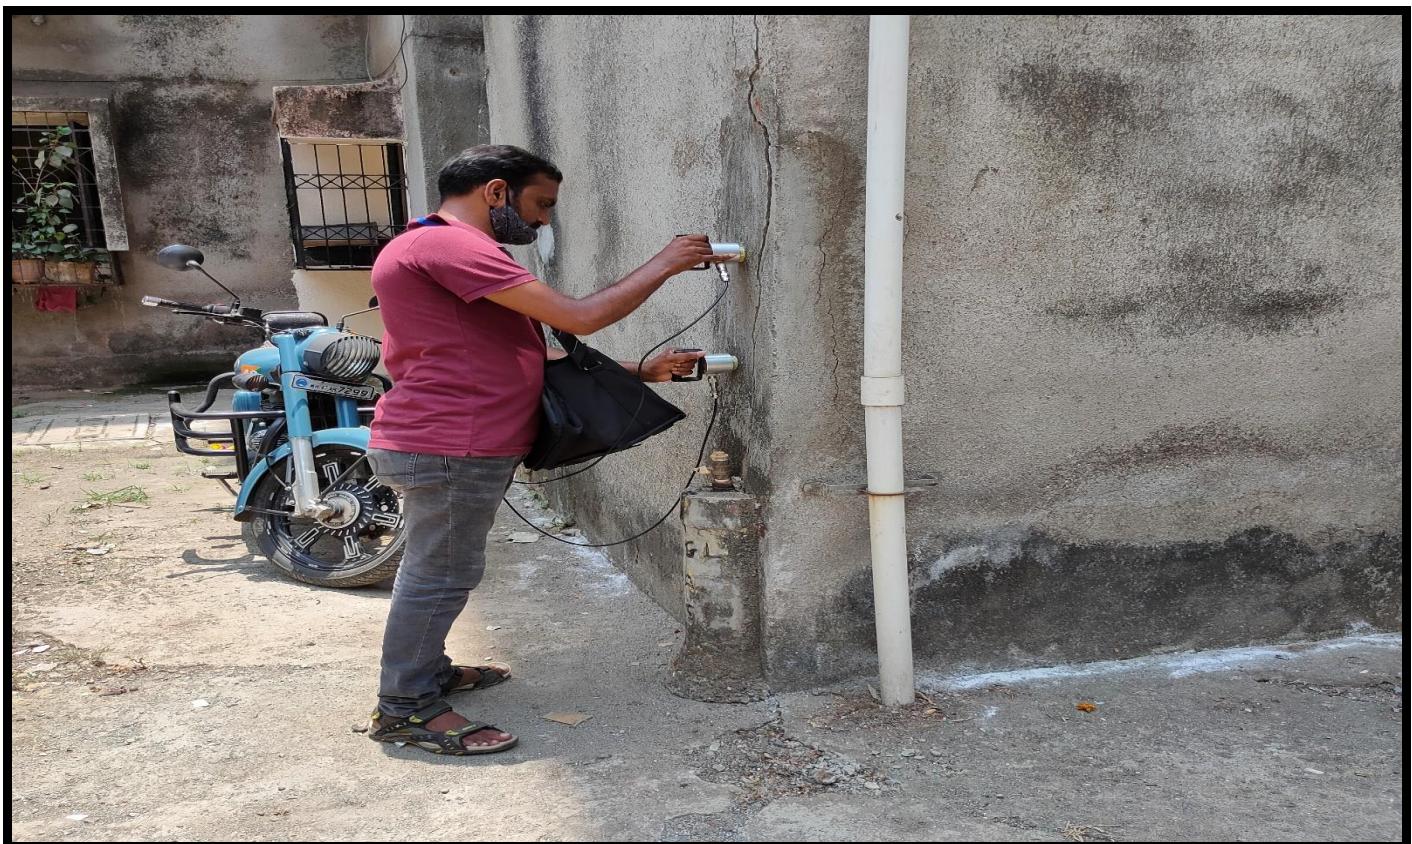
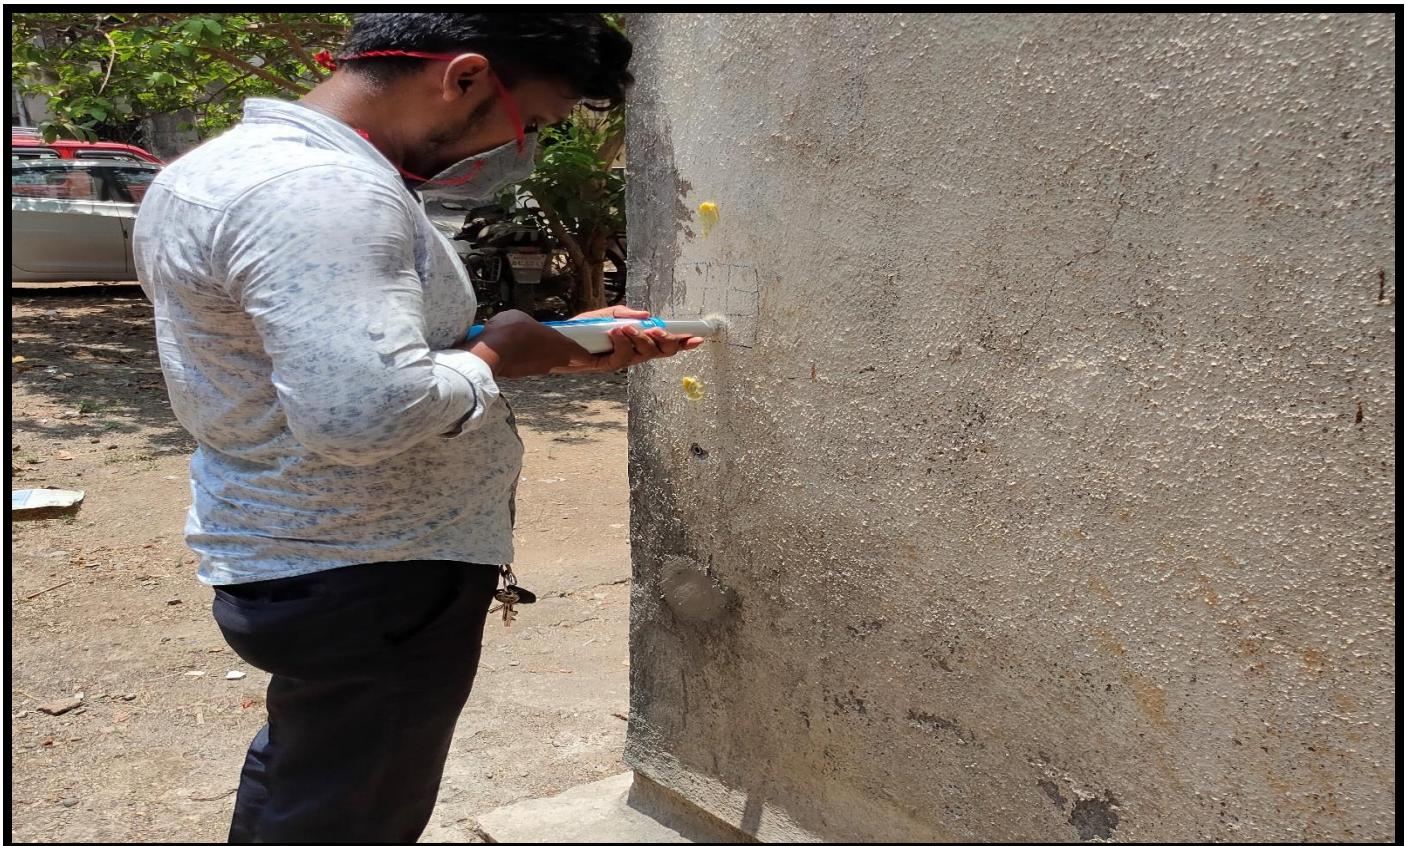
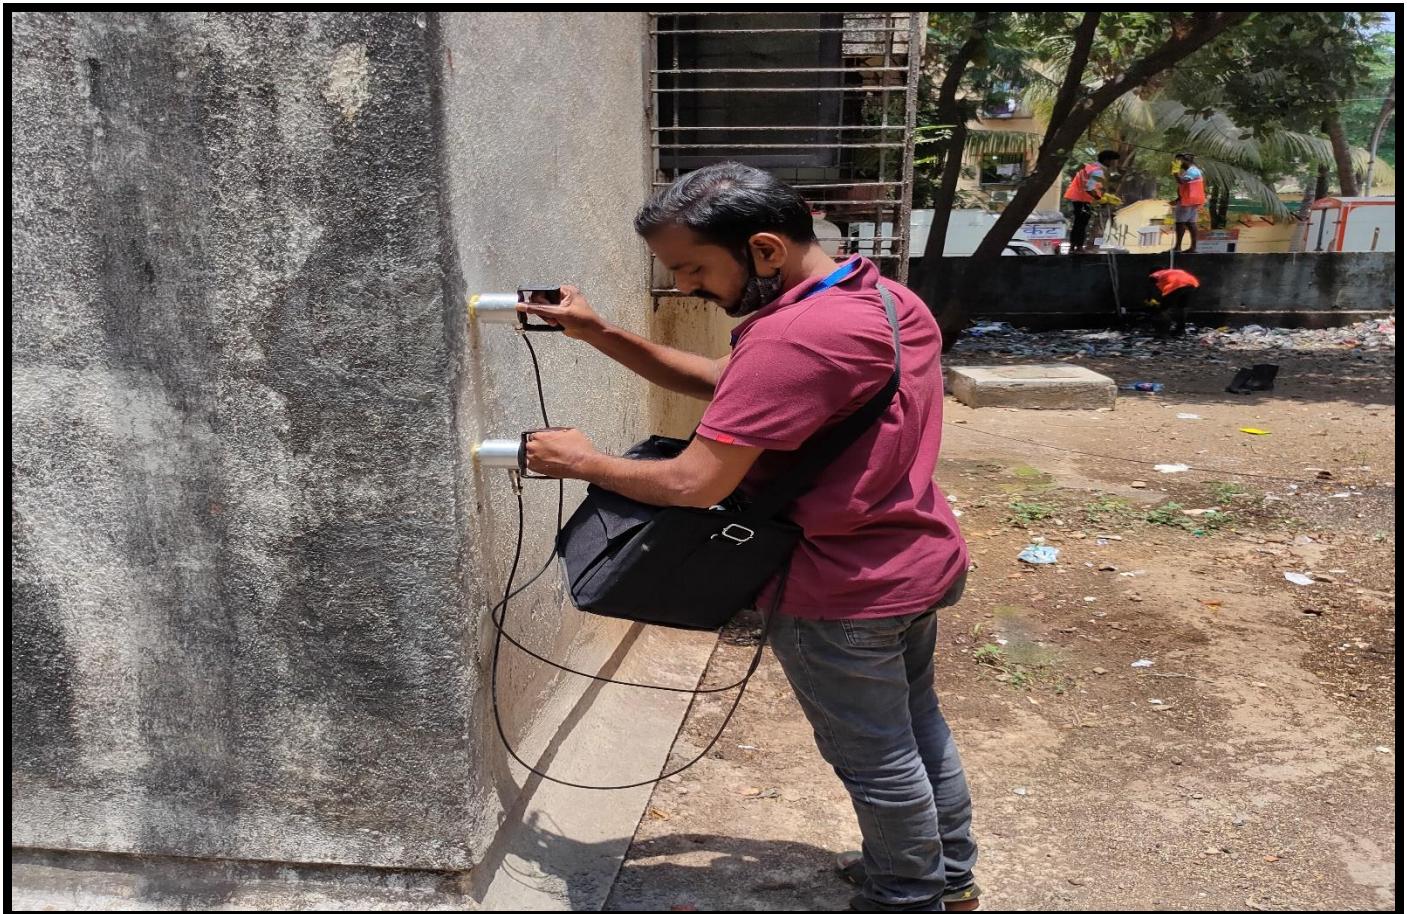
NON -DESTRUCTIVE TEST PHOTO

Rebound Hammer was tested for compressive strength at surface by Schmidt rebound hammer. Results indicate the compressive strength at surface of all the RCC columns is ranging between 16.20 MPa to 18.90 MPa.

The UPV values are ranging between 2.30 Km/Sec to 2.50 Km/Sec.

Out of 4 locations all 4 locations was below 3.0 Km/Sec means concrete quality is poor.

This indicates there are progressive internal cracks in the RCC members due to corrosion of reinforced steel. These members are under distress condition.

Half Cell Potential tested for corrosion activity by half – cell potential tests. Values are taken on Column. The result on tested column is – 340 mV.

Carbonation test was conducted to assess carbonation depth. Readings are taken on Column. Result indicates the carbonation penetration depth is 45.00 mm. Carbonation depths have reached to the reinforcement level in all of the RCC elements. It is essential to give a suitable anti-corrosion treatment to all the RCC members to stop further carbonation and corrosion of concrete.

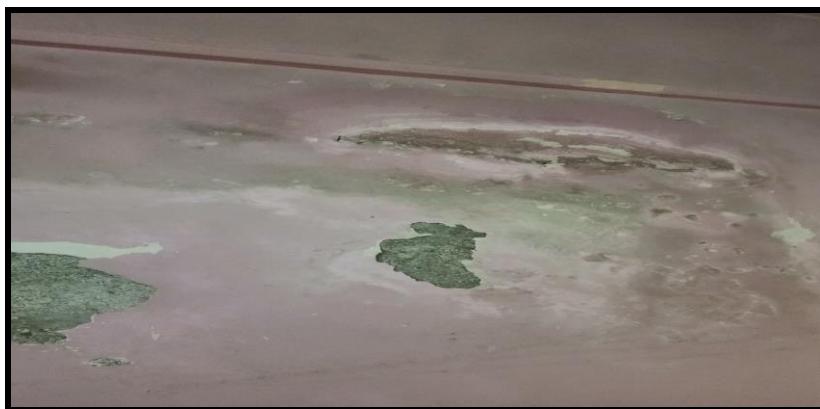
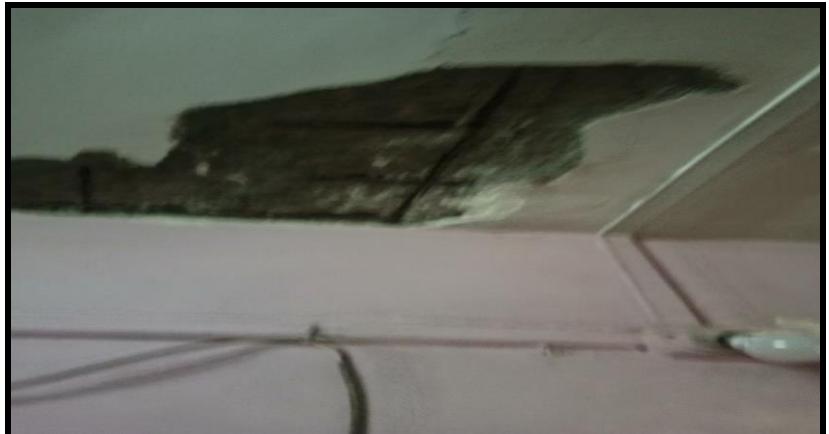
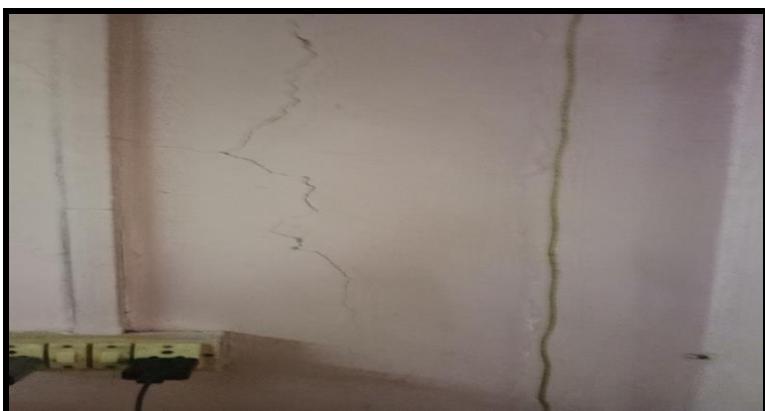
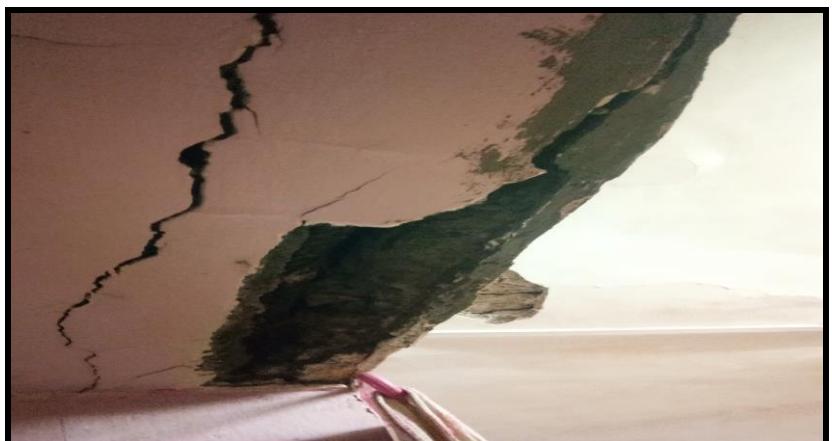
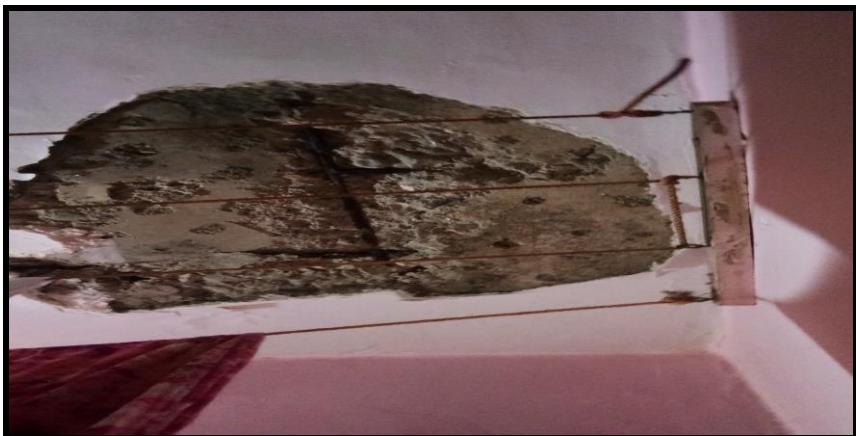
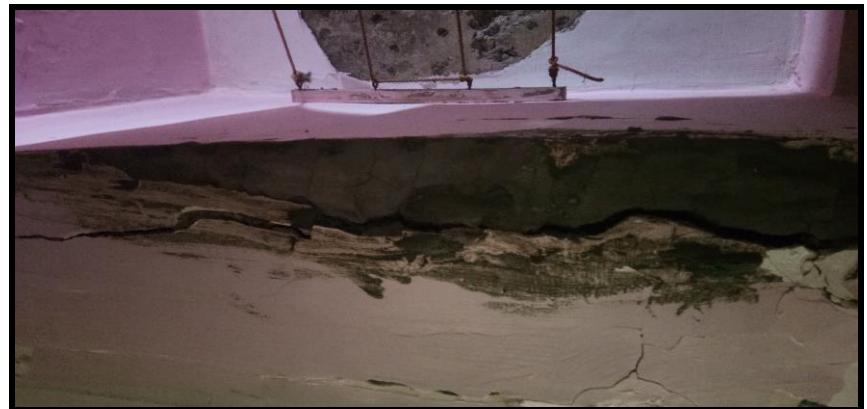
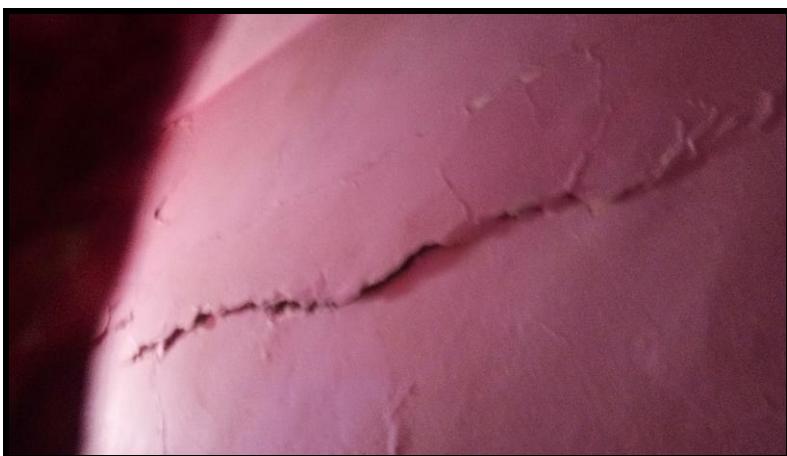
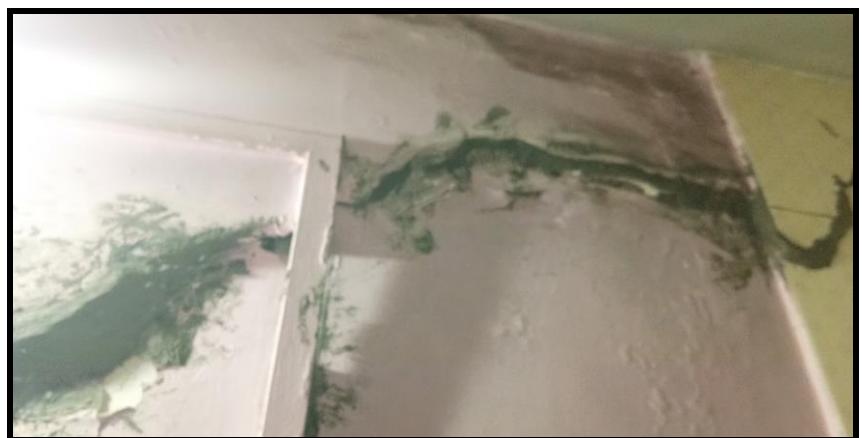
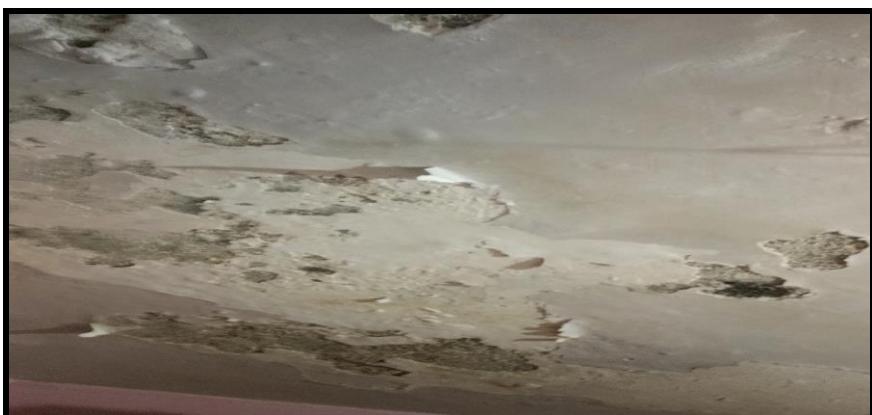
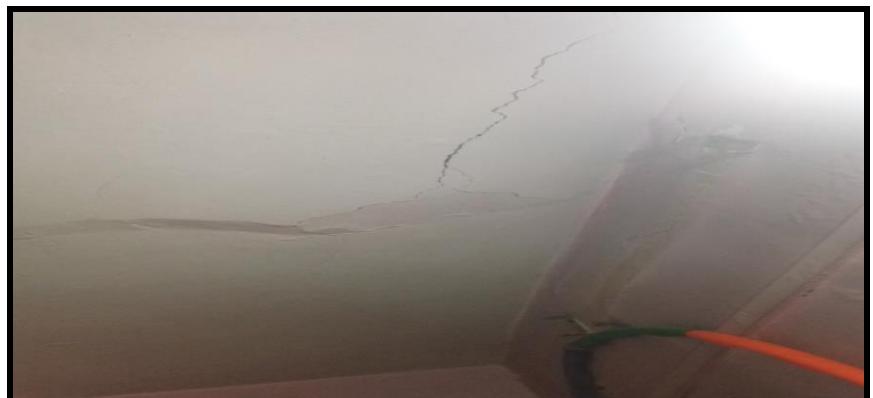
FLAT NO – 02

- ❖ **HALL** – Major structural crack observed on beam.
 - Hallow sound observed on wall. (**It may fall**)
 - Plaster gets removed and steel gets exposed. (**It may fall**)
- ❖ **KITCHEN** – Hallow sound observed on beam. (**It may fall**)
 - Major structural crack observed on beam.
 - Major structural crack observed on column.
- ❖ **PASSAGE** – Plaster gets removed. (**It may fall**)
- ❖ **TOILET & BATH ROOM** – Seepage mark observed on wall.
 - Peeling of paint observed on wall.

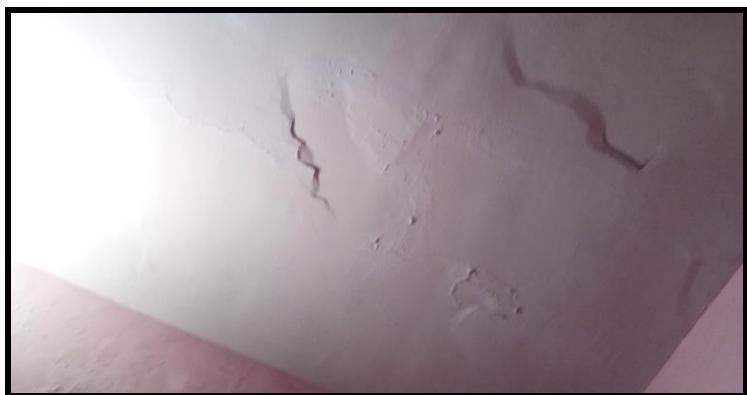
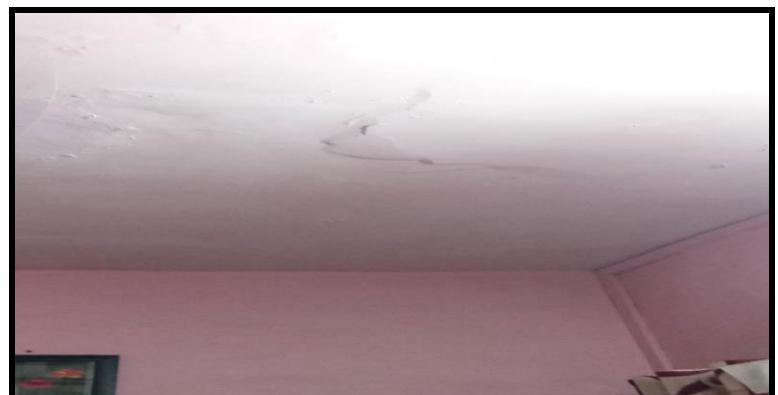
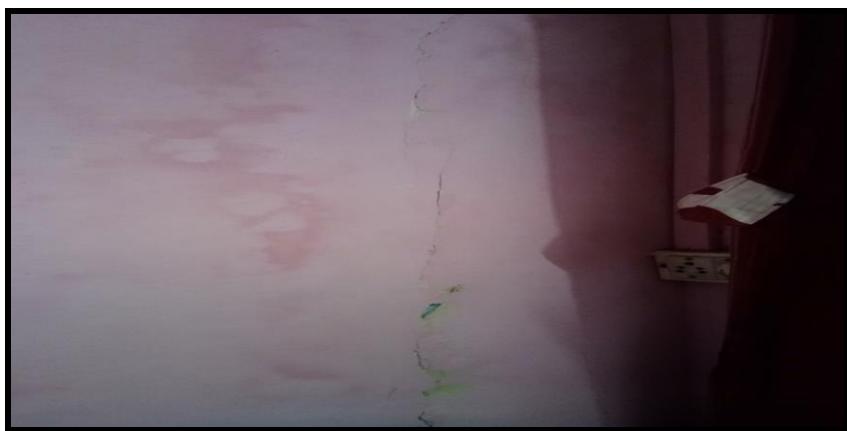
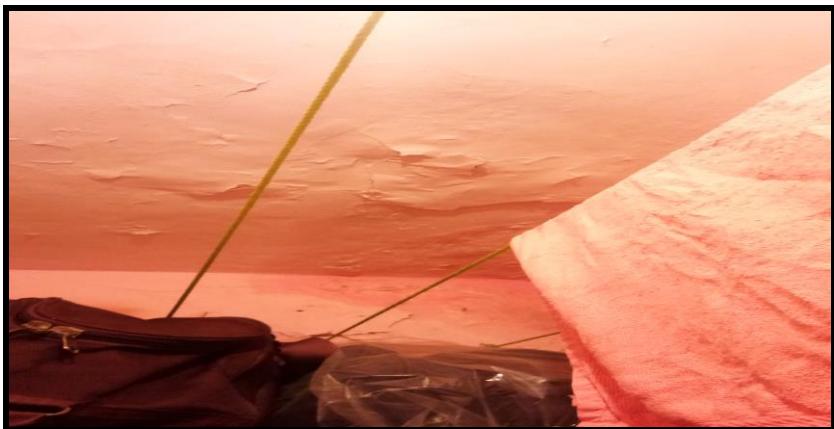
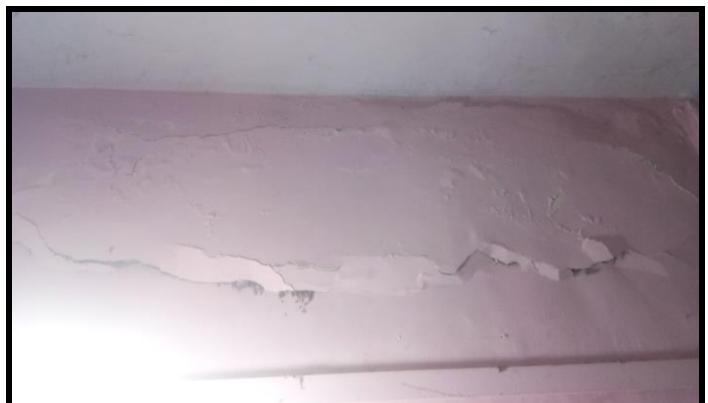
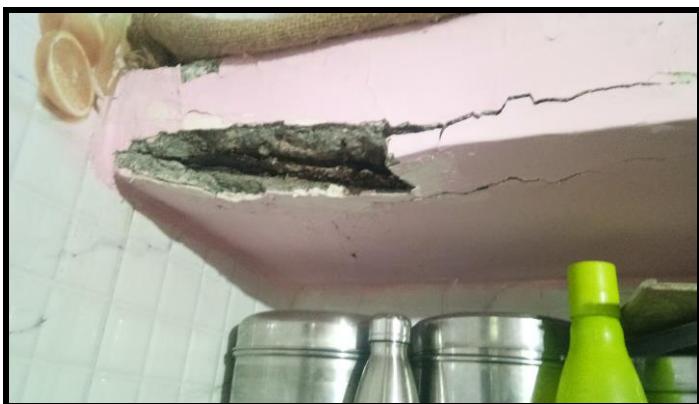
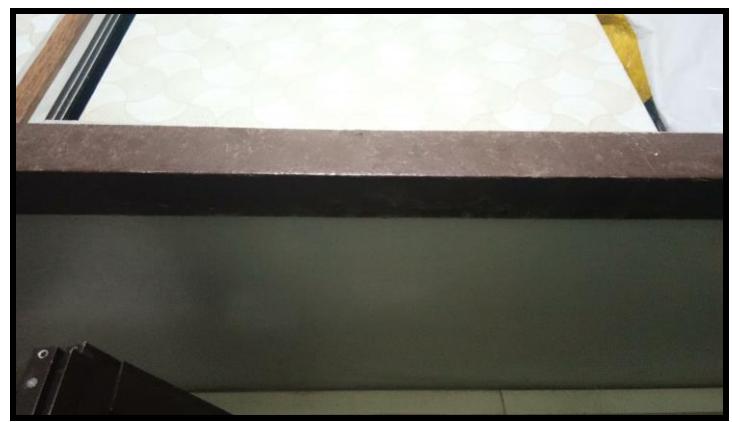
FLAT NO – 10

- ❖ **HALL** – Hollow sound observed on beam.
 - Ceiling gets damages.
- ❖ **KITCHEN** – Major structural crack observed on wall.
- ❖ **PASSAGE** – Seepage mark observed on wall.
- ❖ **TOILET & BATH ROOM** – Peeling of paint observed on ceiling.

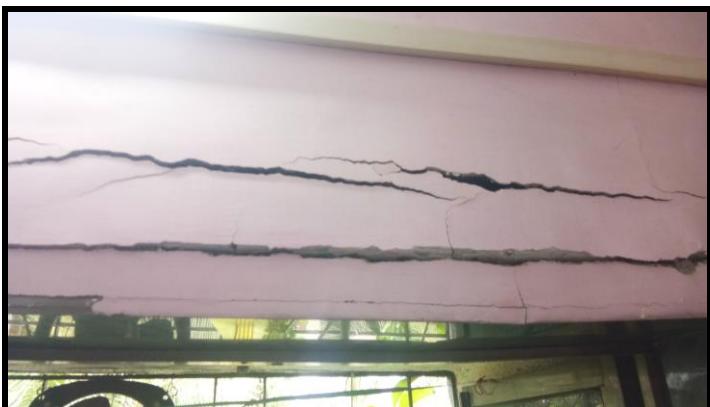
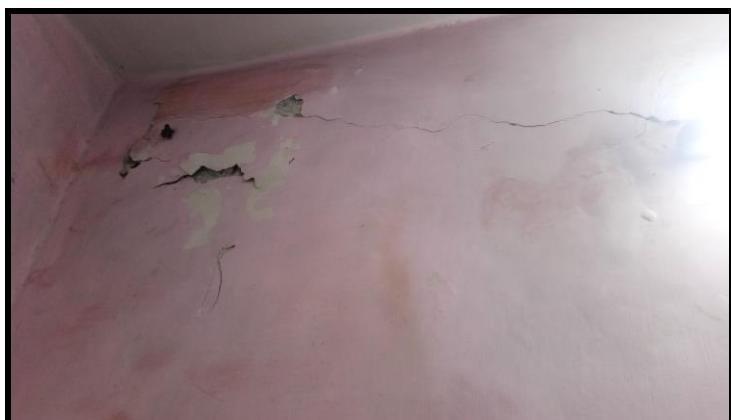
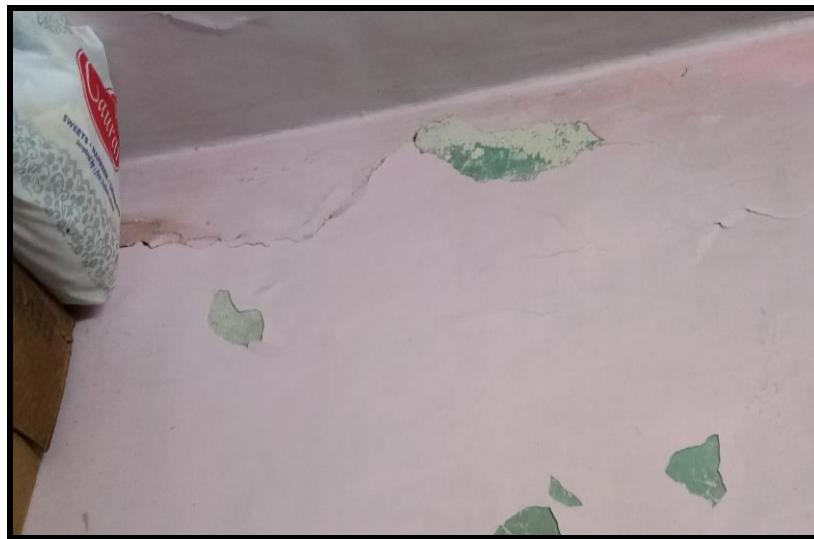
FLAT NO – 27

- ❖ **HALL** – Leakage mark observed on wall.
 - Leakage mark observed on ceiling.
- ❖ **KITCHEN** – Major crack observed on wall.
- ❖ **PASSAGE** – Hallow sound observed on wall. (**It may fall**)
 - Hallow sound observed on beam. (**It may fall**)
- ❖ **TOILET & BATH ROOM** – Seepage mark observed on wall.
 - Peeling of paint observed on ceiling.

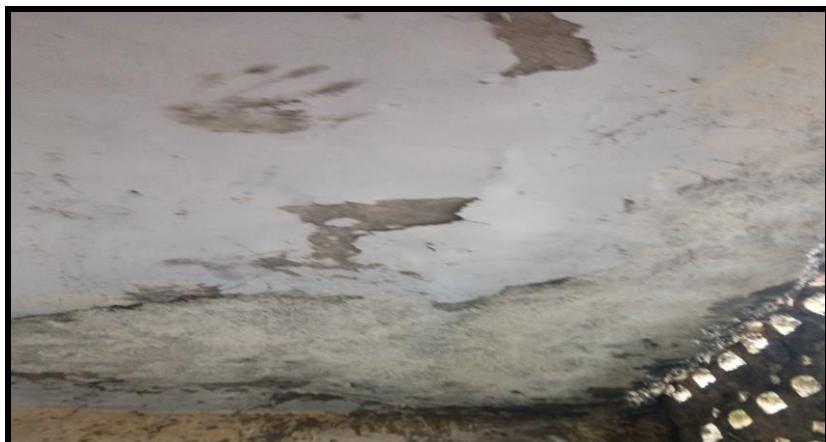
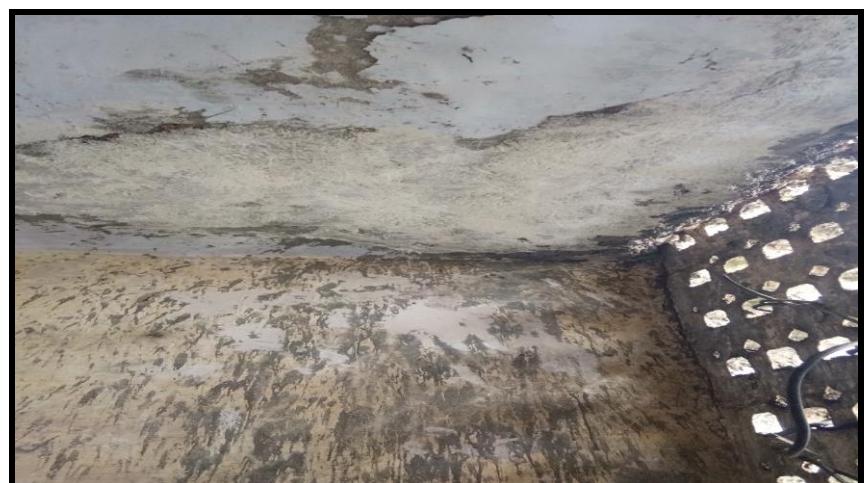
Fourth floor to third floor:-

- ❖ Ceiling gets damage.
- ❖ Crack filling observed on wall.

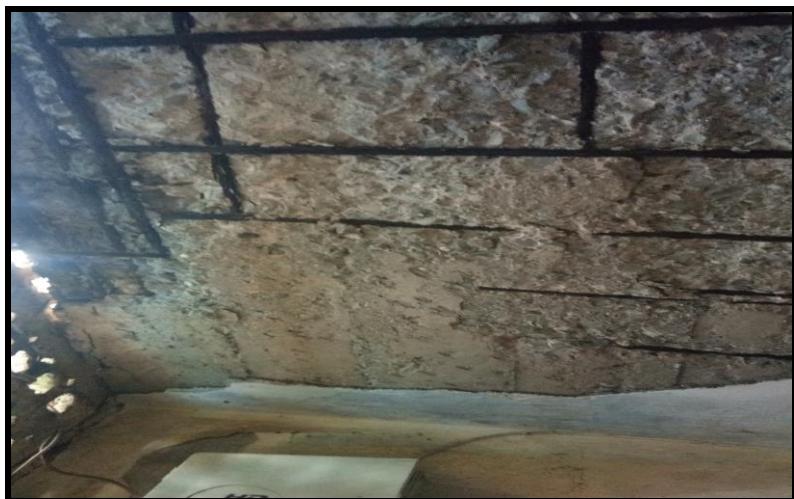
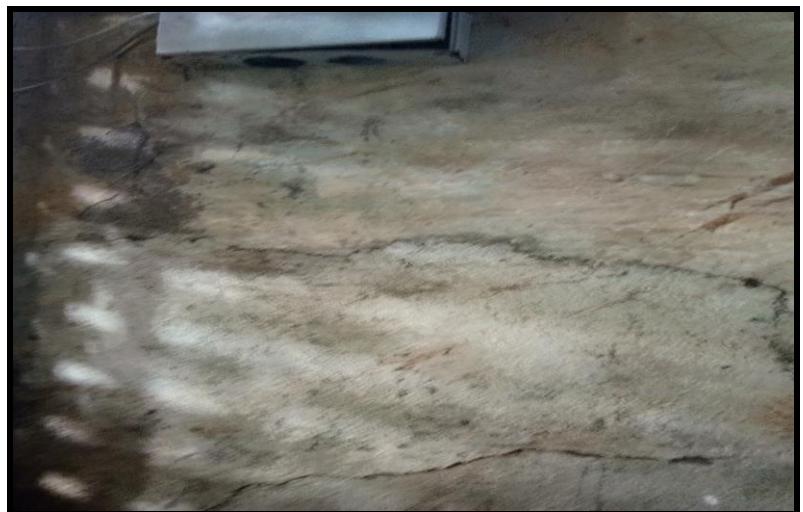
First floor to Ground floor:-

- ❖ Ceiling gets damage.
- ❖ Steel gets exposed. (It may fall)

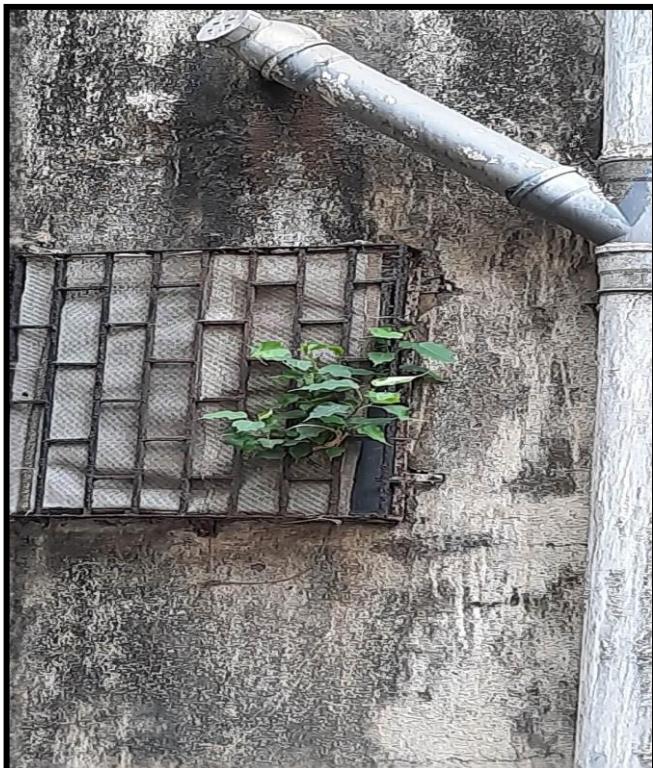
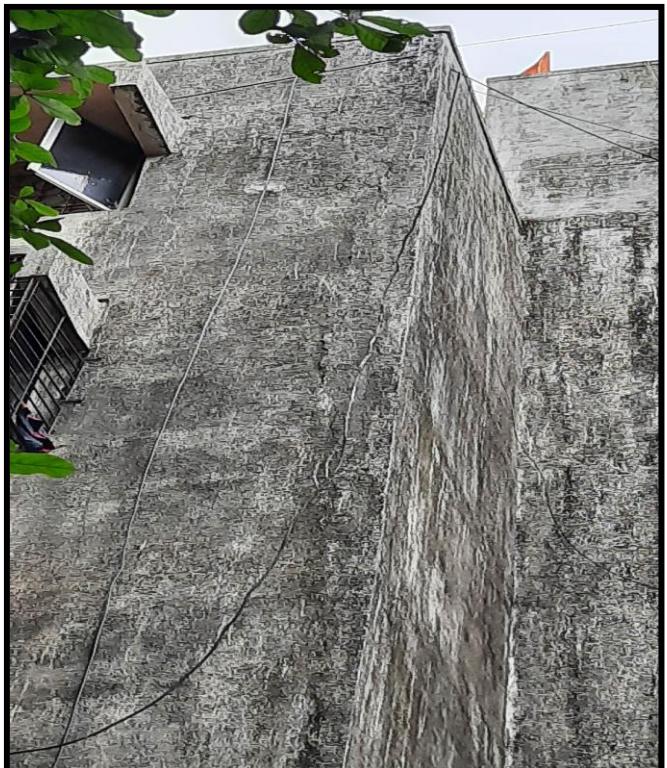
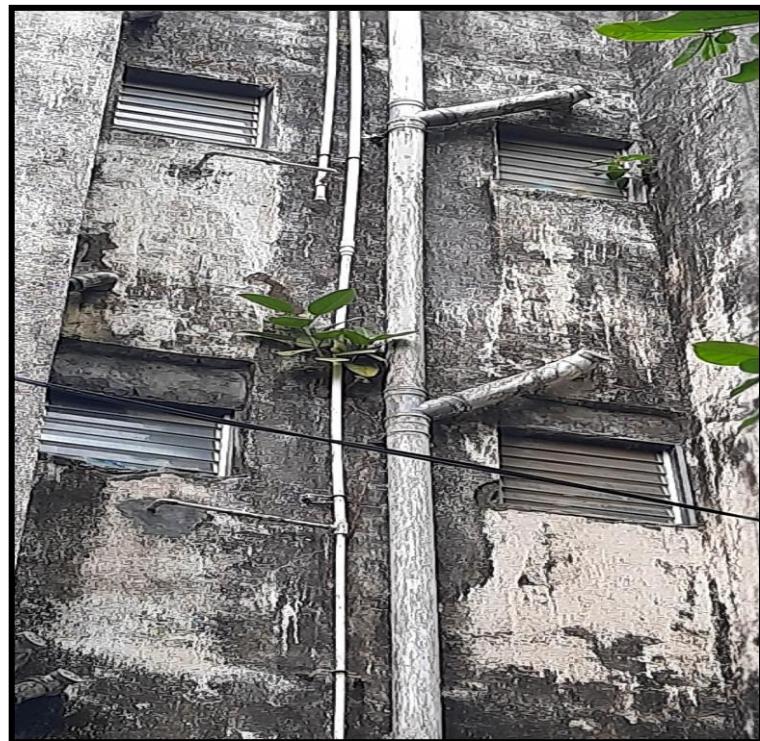
FRONT SIDE

- ❖ Structural crack observed at several places on column.
- ❖ Major crack observed at several places on wall.
- ❖ Vegetation growth observed at several places on wall.

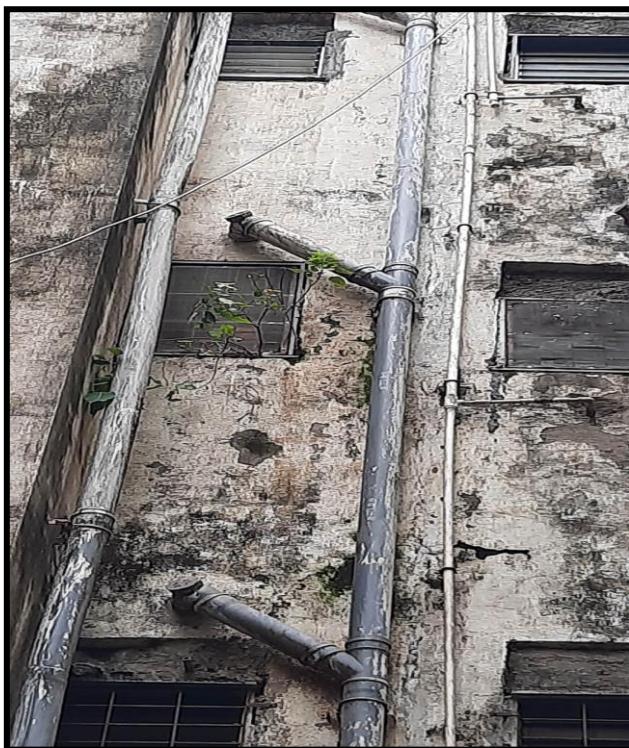
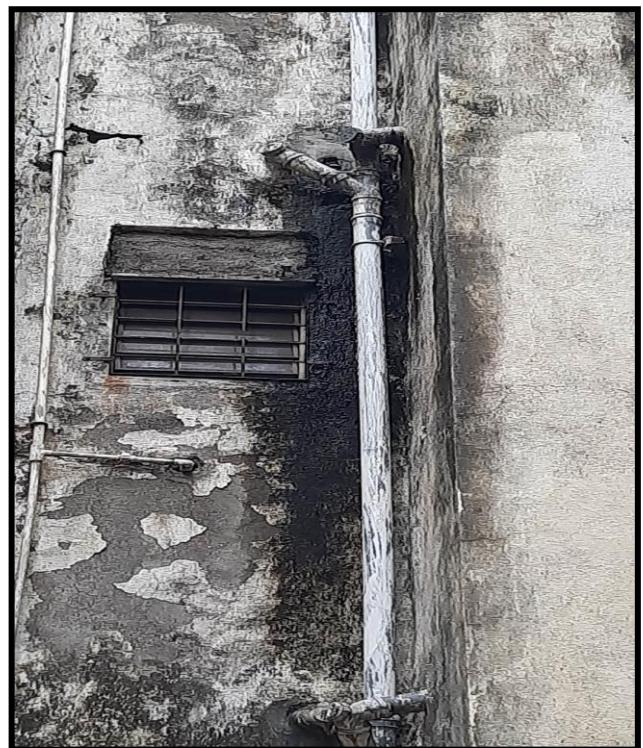
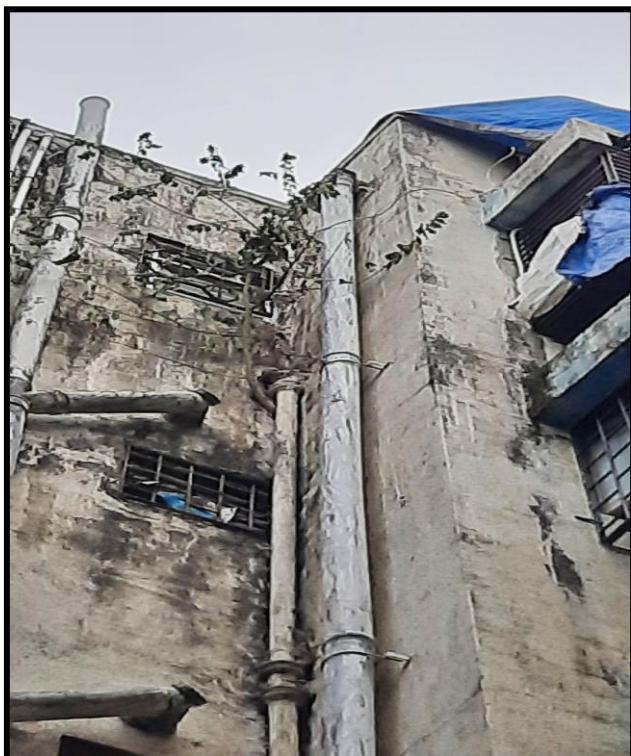
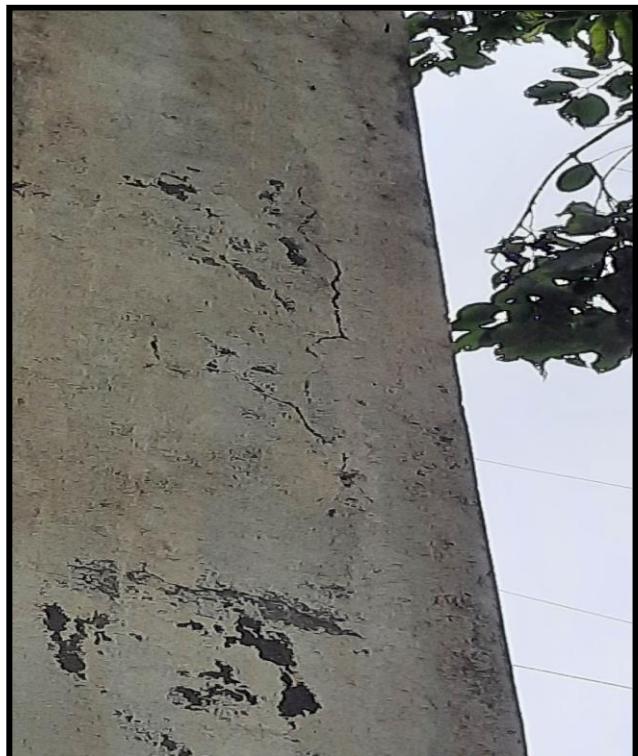
BACK SIDE

- ❖ Structural crack observed at several places on column.
- ❖ Major crack observed at several places on wall.
- ❖ Vegetation growth observed at several places on wall.

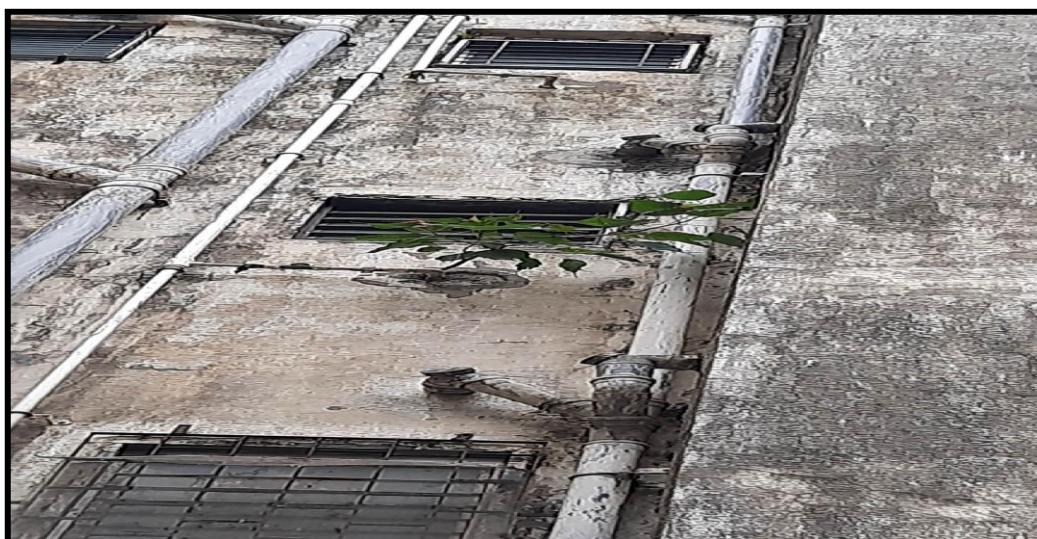
SOUTH SIDE

- ❖ Major crack observed at several places on wall.
- ❖ Vegetation growth observed at several places on wall.
