STRUCTURAL AUDIT REPORT
FOR
“VISHAL SAHYADRI CO – OP HSG. SOC. LTD”,
“D3 – F WING”
SITUATED AT
SAHYADRI NAGAR, CHARKOP,
KANDIVALI (W) MUMBAI – 400 067

978/D3/LSS/2021

JULY 16, 2021

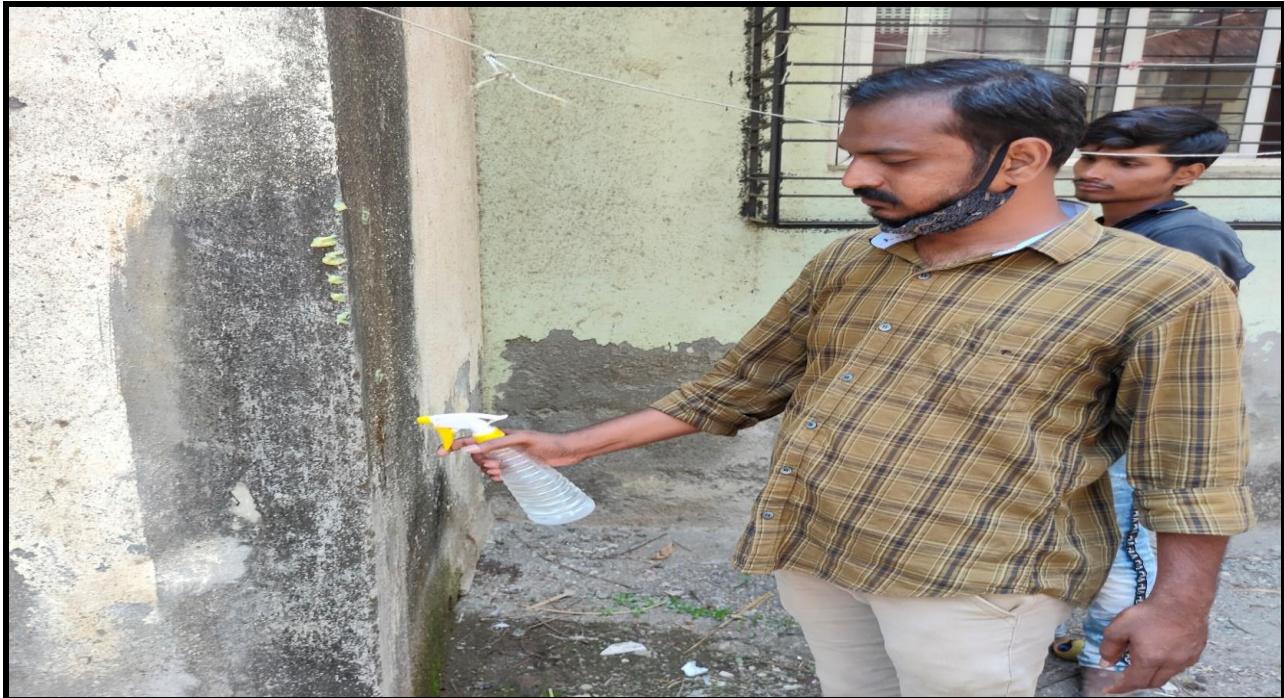
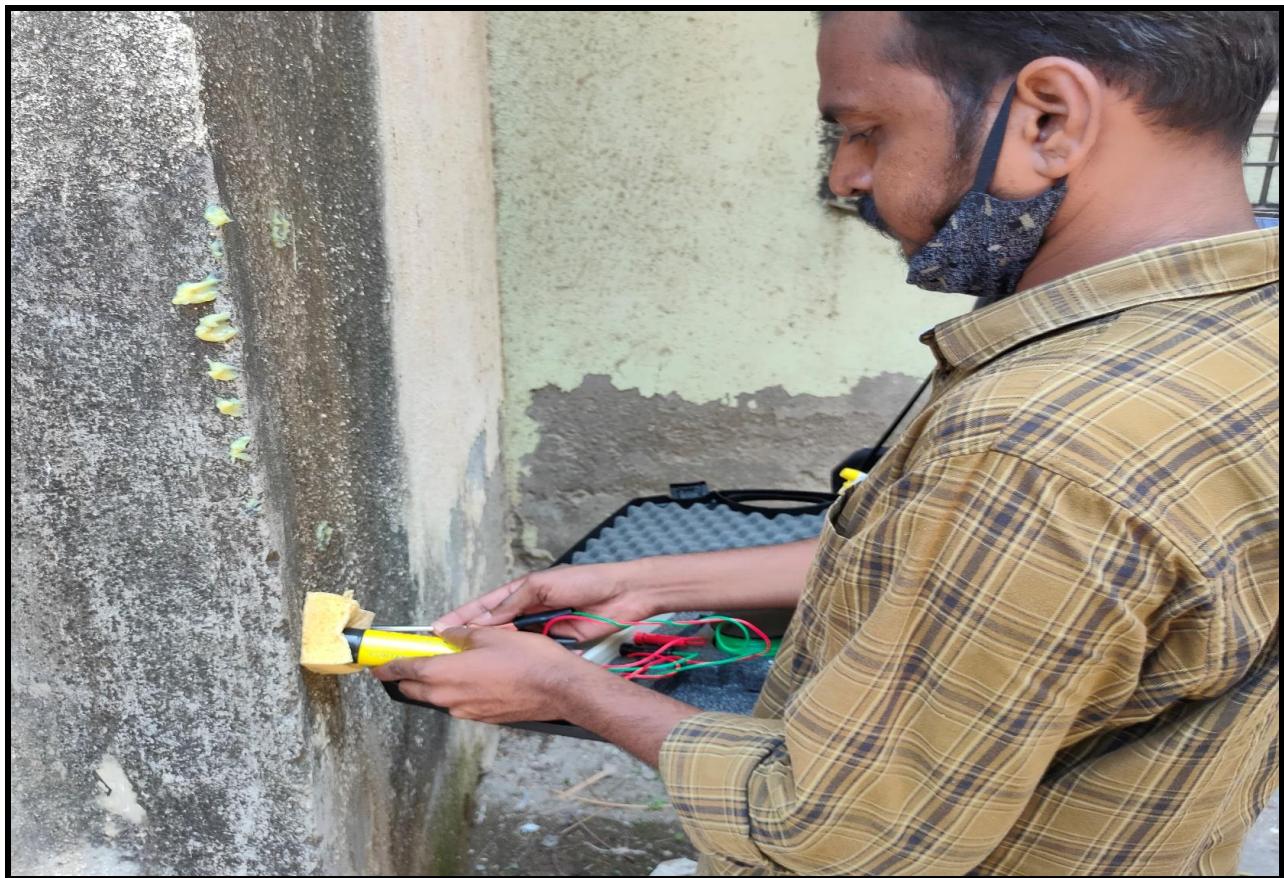
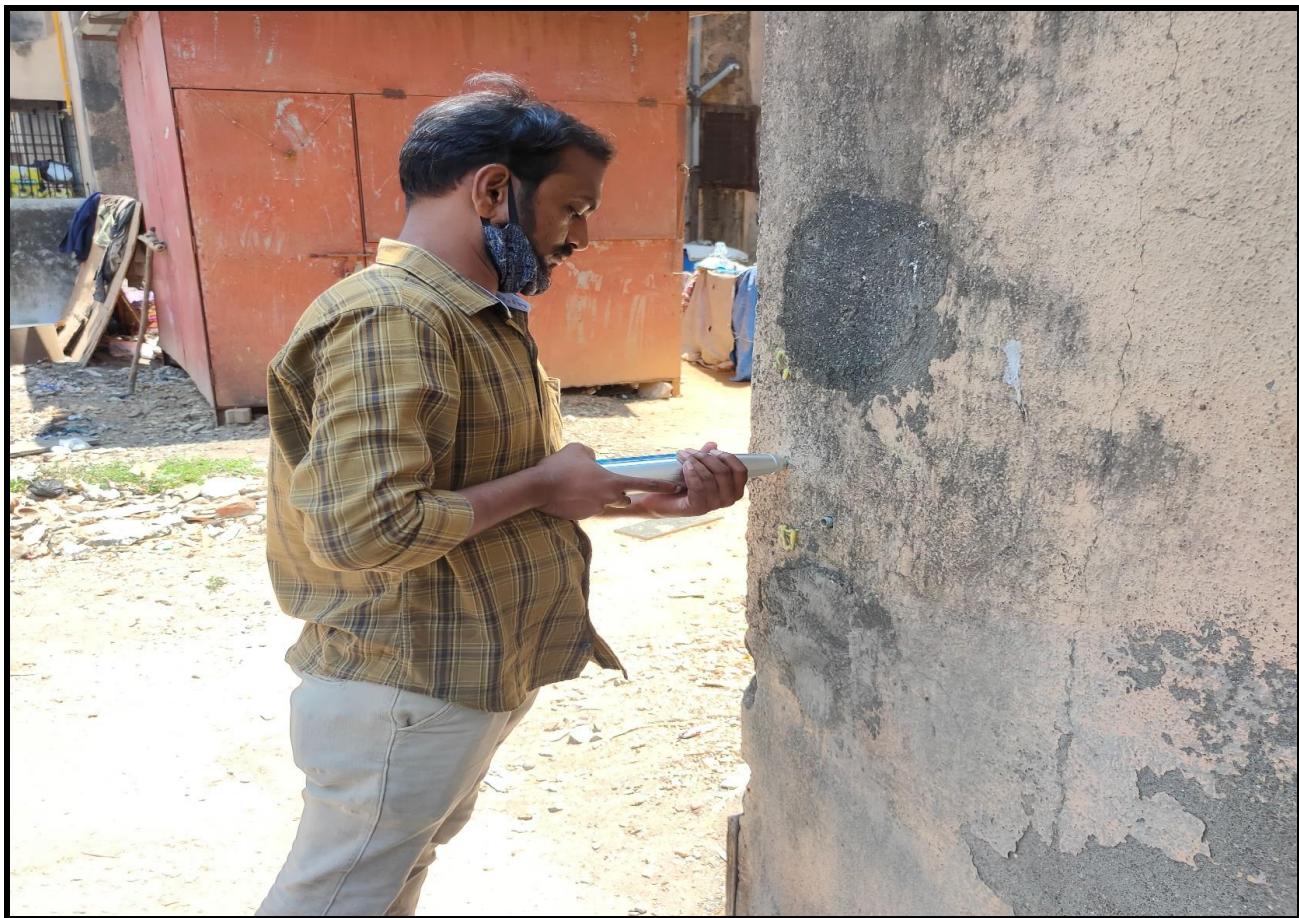
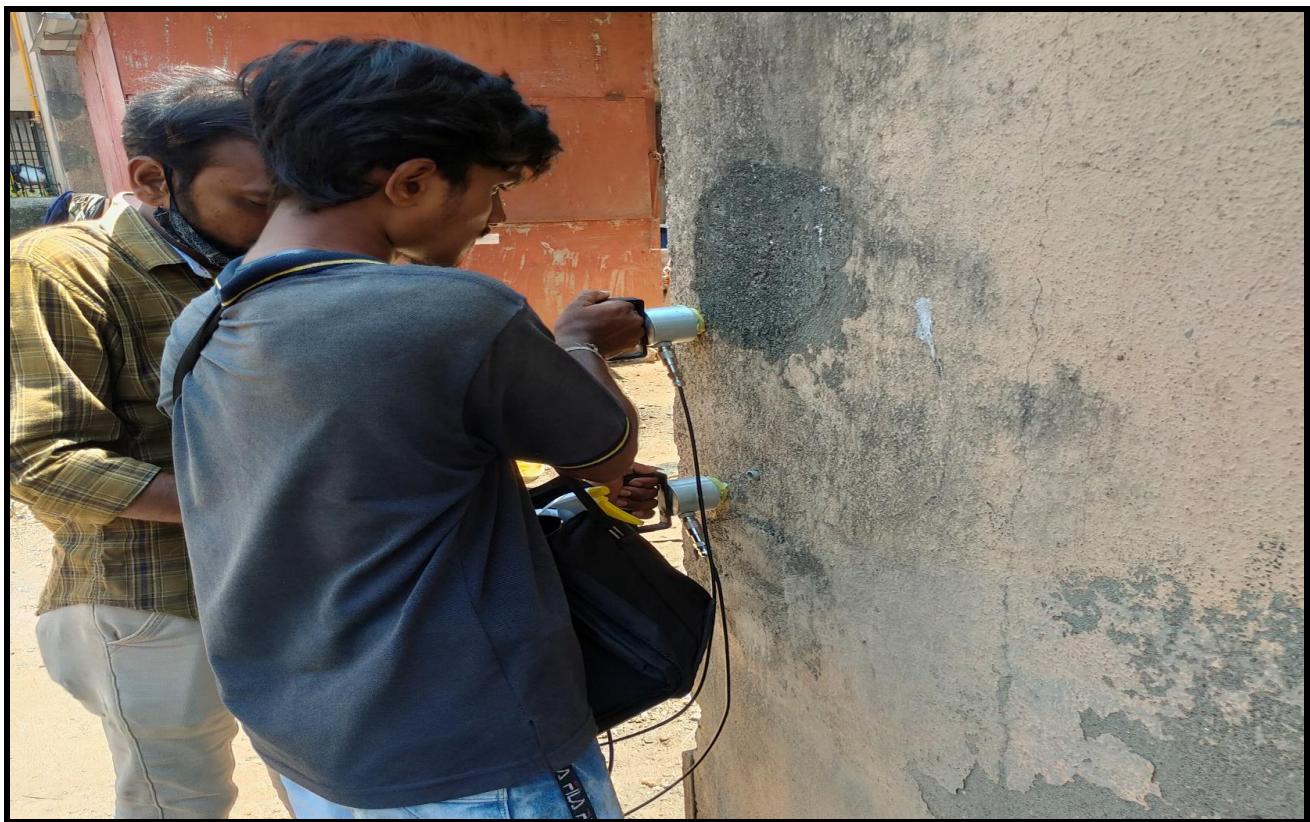
NON -DESTRUCTIVE TEST PHOTO

Rebound Hammer was tested for compressive strength at surface by Schmidt rebound hammer. Results indicate the compressive strength at surface of the RCC columns & beam in is ranging between 13.70 MPa to 18.90 MPa.

The UPV values are ranging between 2.60 Km/Sec to 3.20 Km/Sec.

Out of 4 locations 2 locations was below 3.0 Km/Sec means concrete quality is poor and 2 location ranging between 3.0 to 3.75 Km/Sec means concrete quality is doubtful.

This indicates there are progressive internal cracks in the RCC members due to corrosion of reinforced steel. These members are under distress condition.

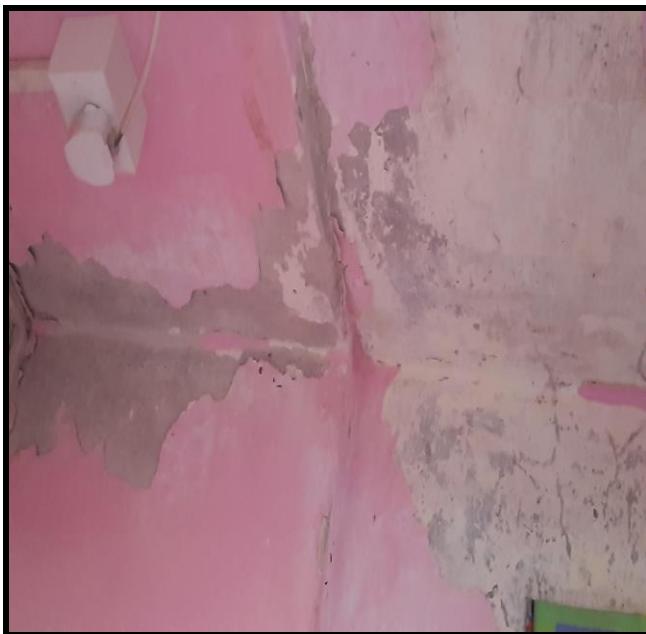
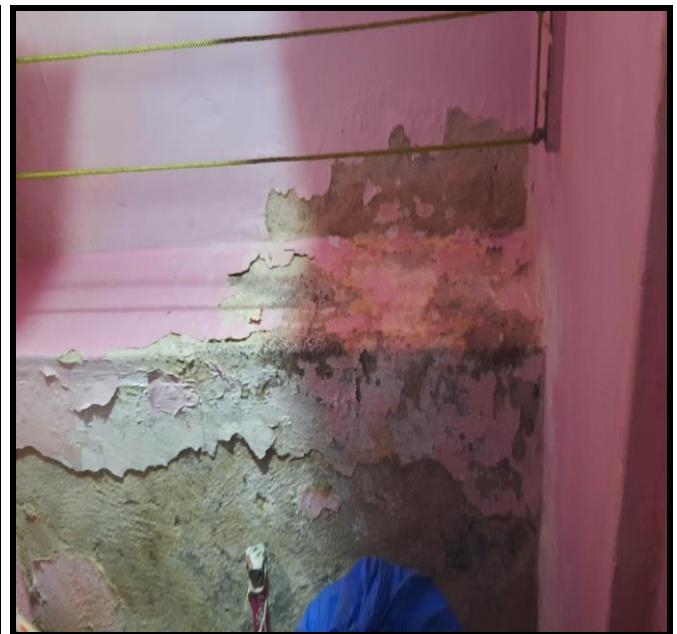
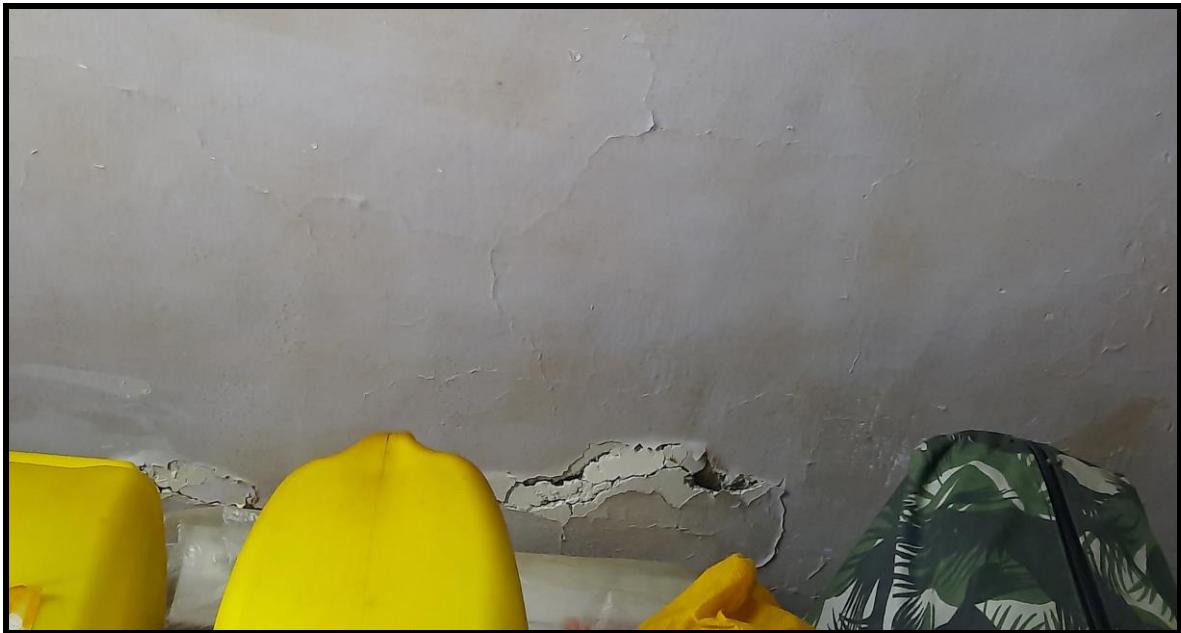
FLAT NO - 10

- ❖ **HALL** – Leakage mark observed on wall.
- ❖ **KITCHEN** – Structural damage observed on ceiling.
- ❖ **PASSAGE** – Leakage mark observed on ceiling.
- ❖ **TOILET & BATH ROOM** – O.K.

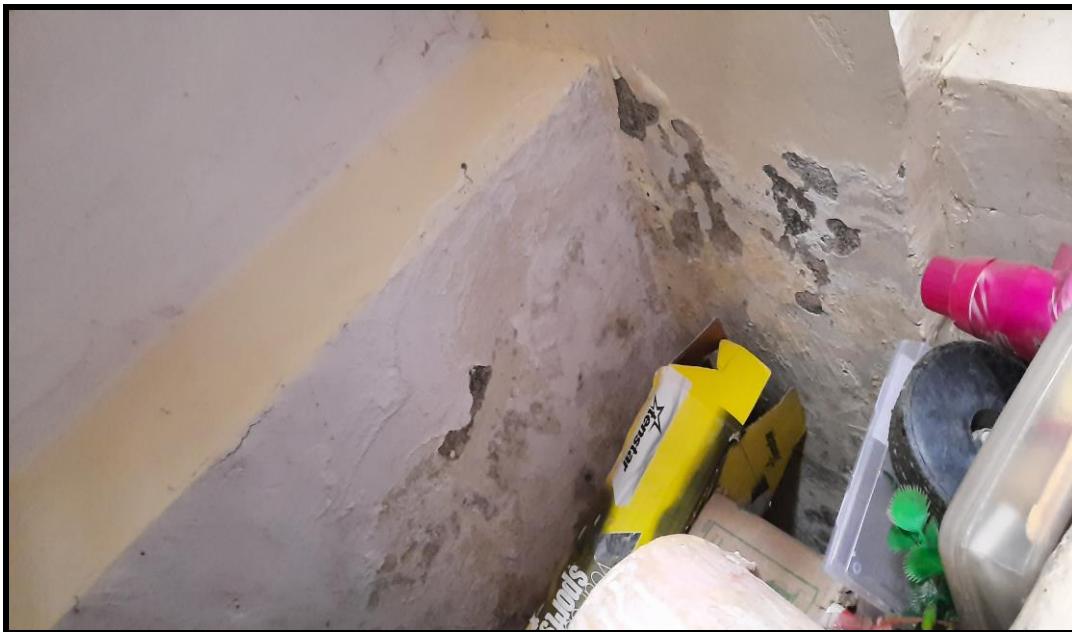
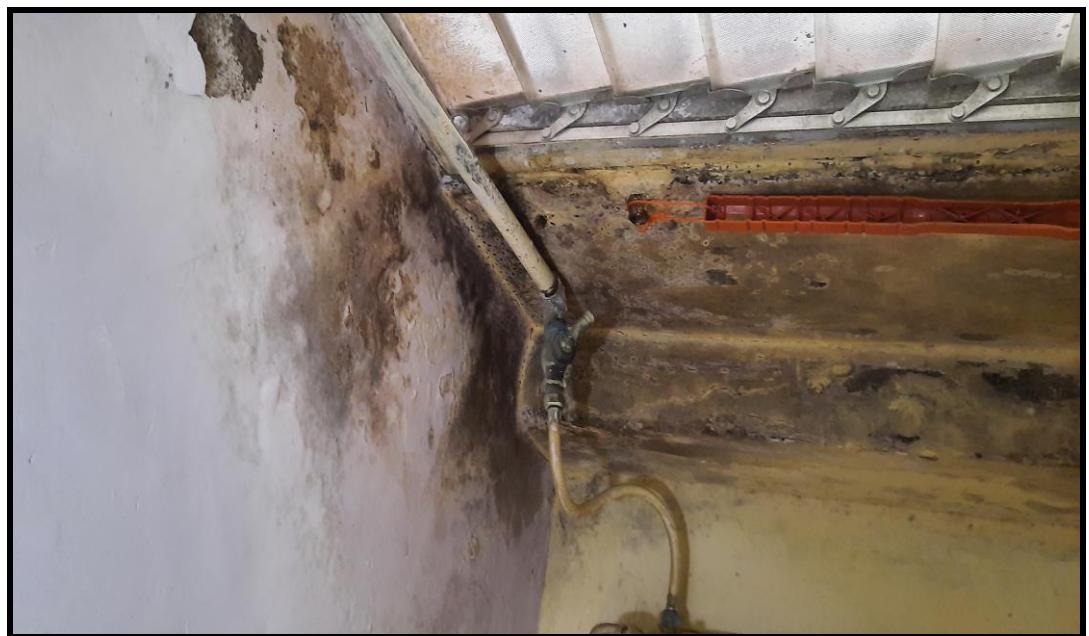
FLAT NO – 12

- ❖ **HALL** – O.K.
- ❖ **KITCHEN** – O.K.
- ❖ **PASSAGE** – Leakage mark observed on ceiling.
- ❖ **TOILET & BATH ROOM** – Leakage mark observed on wall & ceiling.

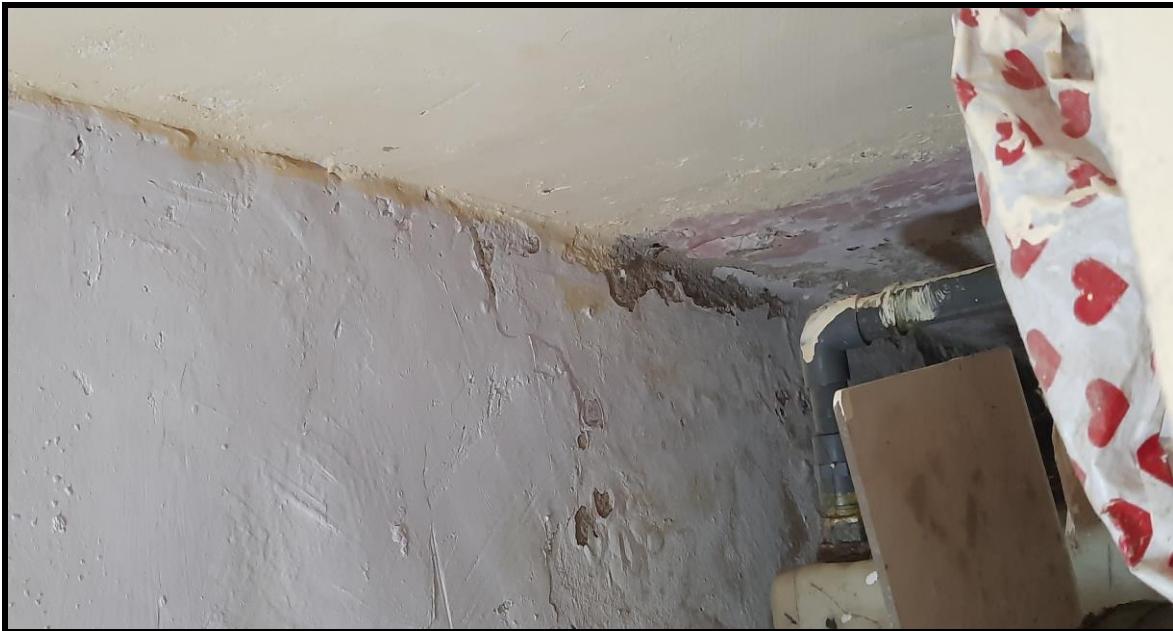
FLAT NO – 13

- ❖ **HALL** – O.K.
- ❖ **KITCHEN** – O.K.
- ❖ **PASSAGE** – Leakage mark observed on ceiling.
- ❖ **TOILET & BATH ROOM** – Dampness observed on wall in monsoon.

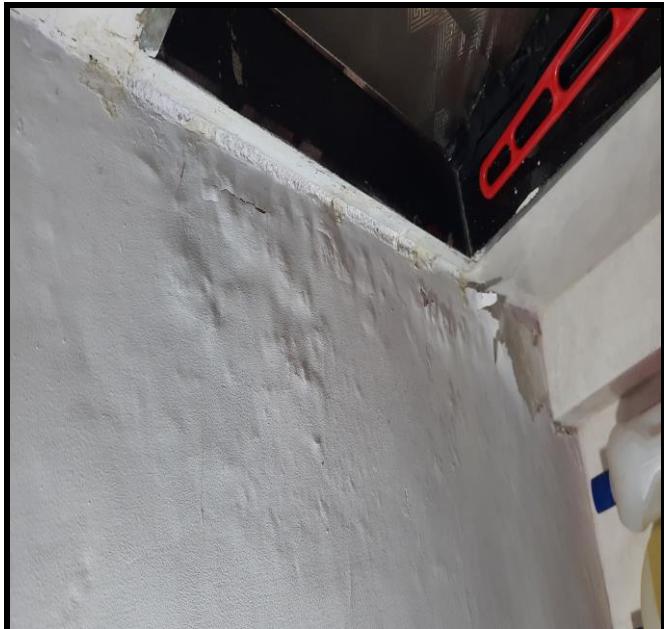
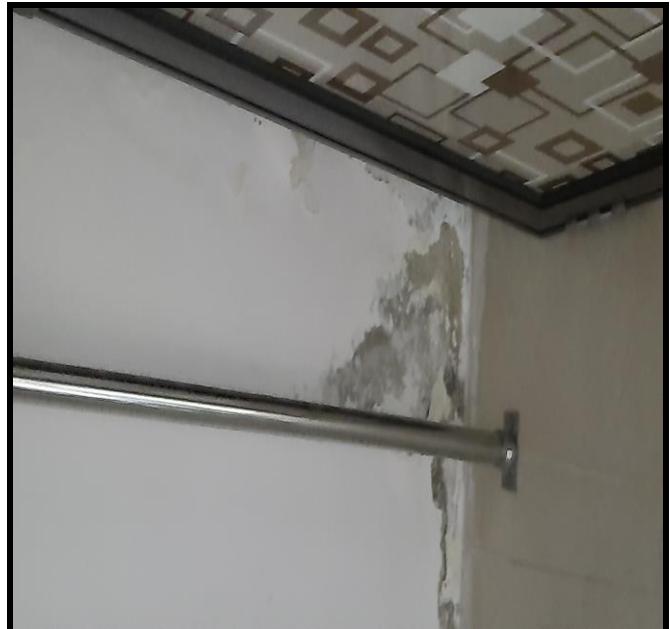
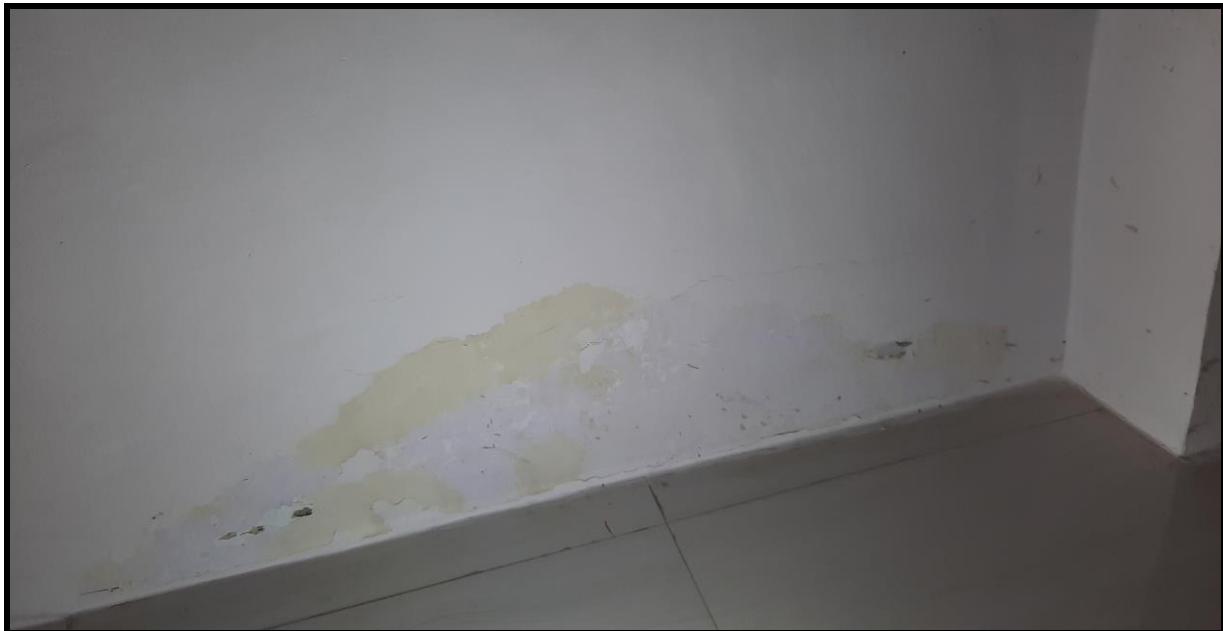
FLAT NO – 18

- ❖ **HALL** – Leakage observed on wall in monsoon.
- ❖ **KITCHEN** – Leakage mark observed on ceiling.
- ❖ **PASSAGE** – Leakage mark observed on ceiling.
- ❖ **TOILET & BATH ROOM** – Leakage mark observed on ceiling.

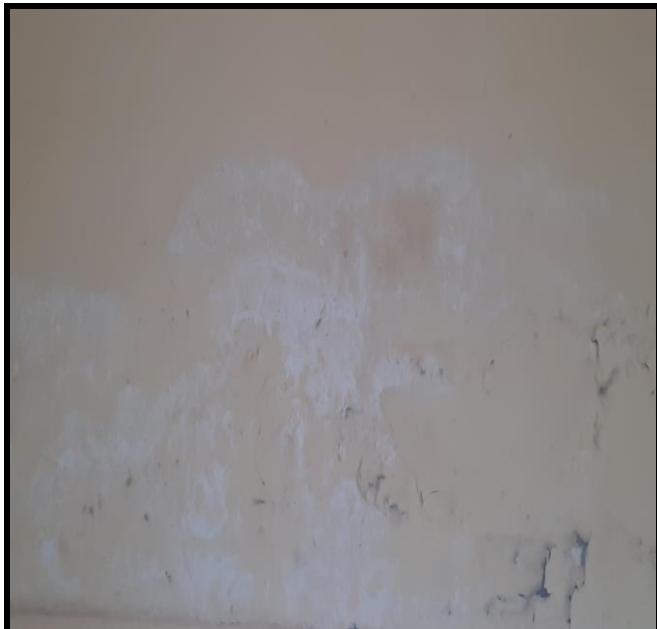
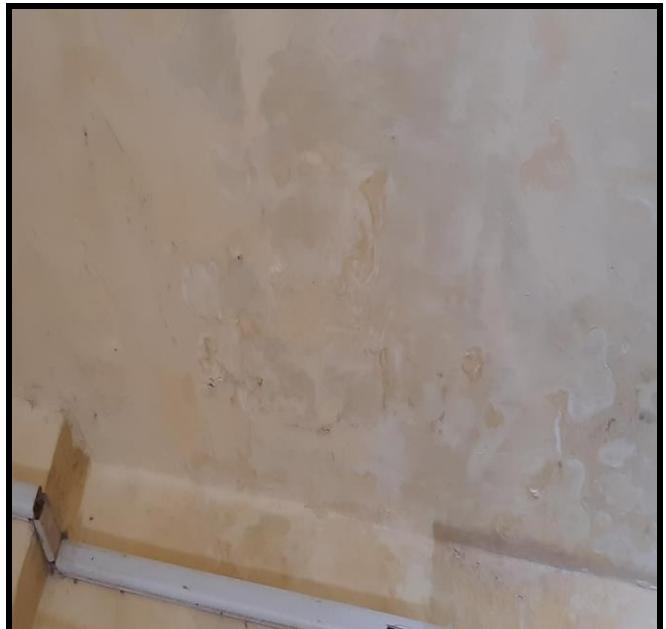
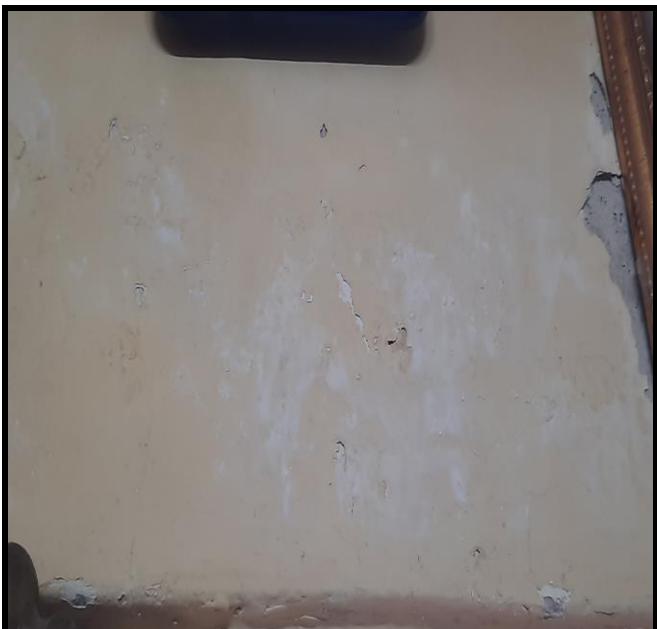
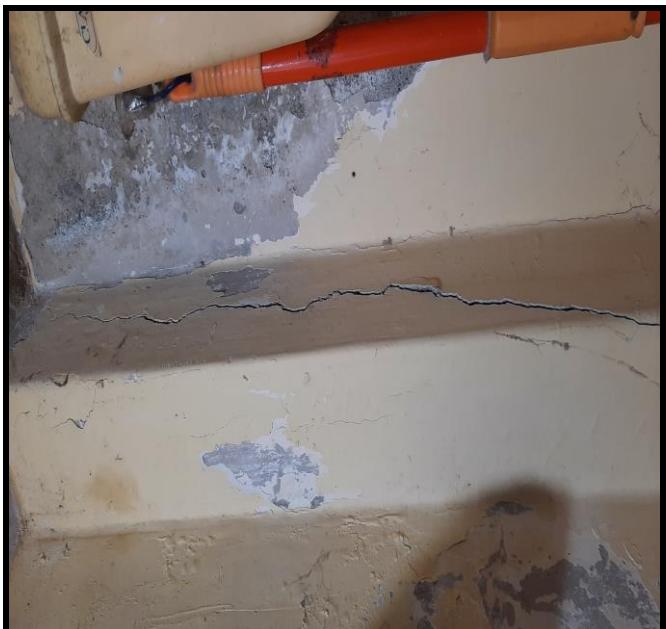
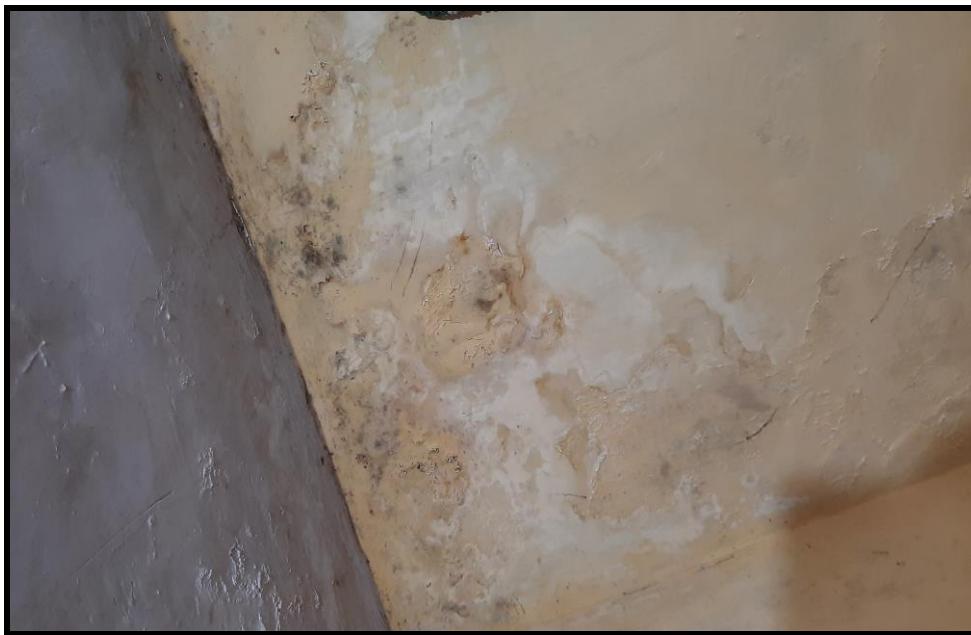
FLAT NO – 19

- ❖ **HALL** – Leakage mark observed on wall.
- ❖ **KITCHEN** – Leakage mark observed on wall.
- ❖ **PASSAGE** – O.K.
- ❖ **TOILET & BATH ROOM** – Leakage mark observed on wall & ceiling.
 - Structural crack observed on column.

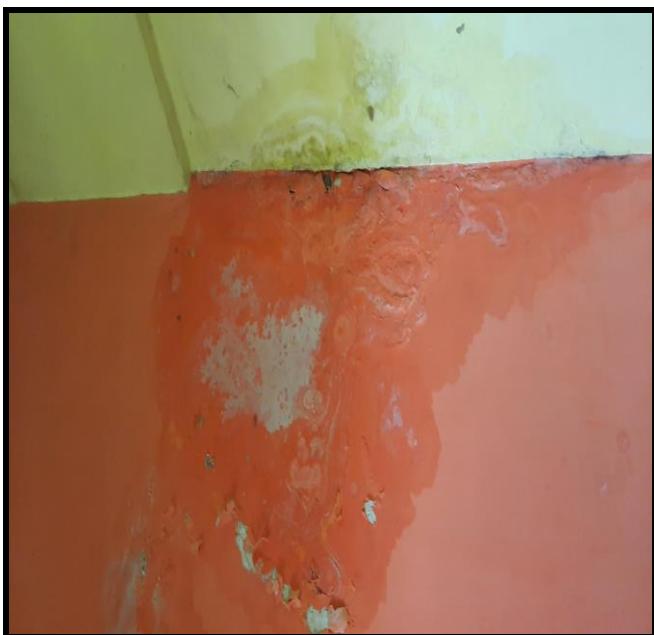
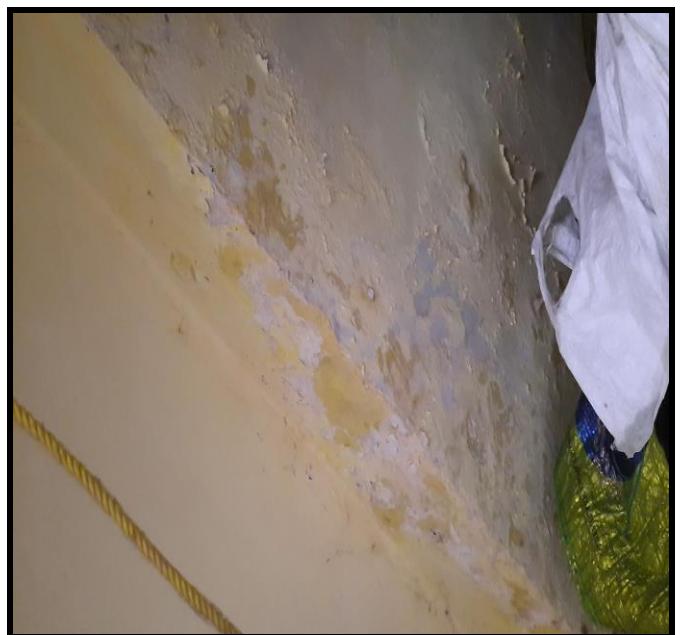
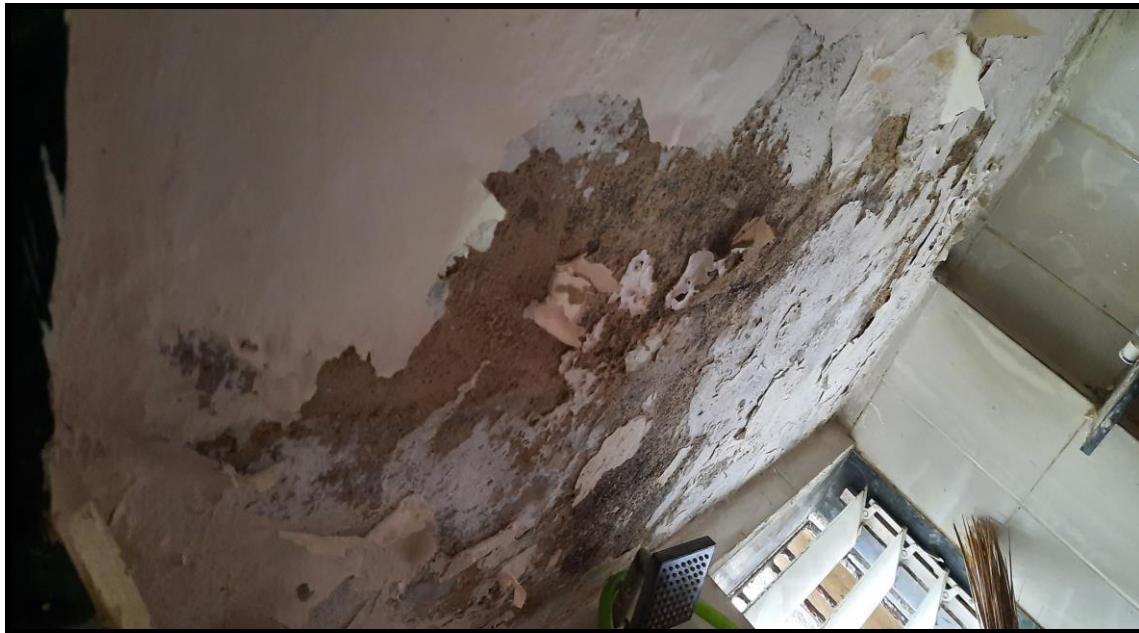
FLAT NO – 20

- ❖ **HALL** – Dampness observed on wall.
- ❖ **KITCHEN** – O.K.
- ❖ **PASSAGE** – Dampness observed on ceiling.
- ❖ **TOILET & BATH ROOM** – Dampness observed on ceiling.

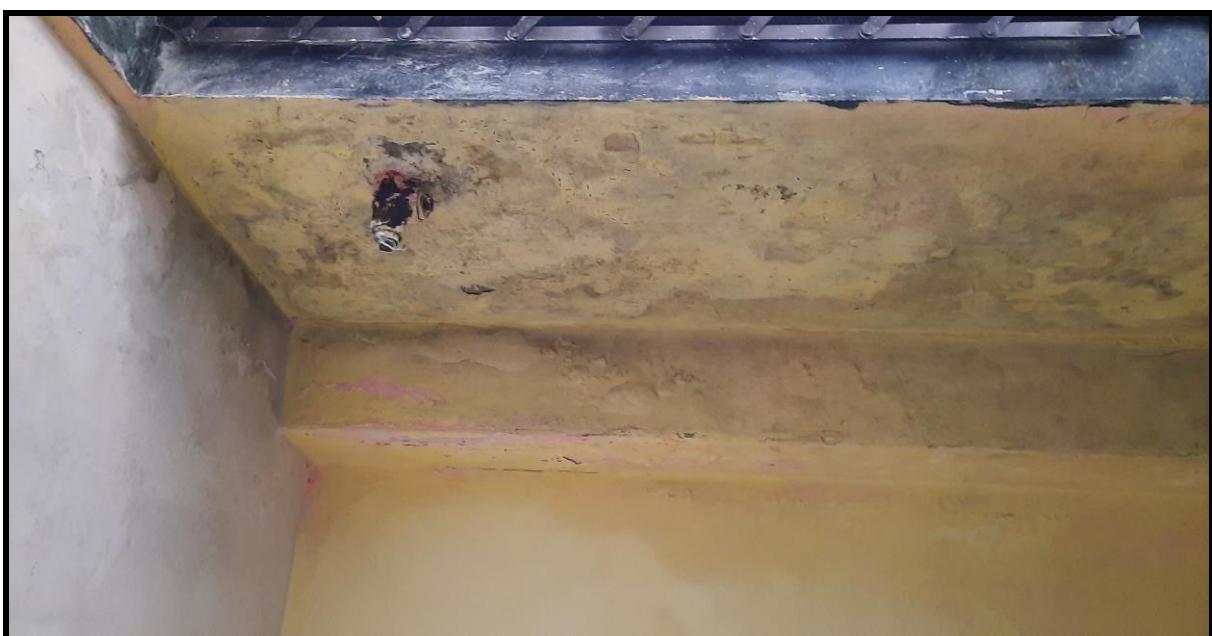
FLAT NO - 24

- ❖ **HALL** – O.K.
- ❖ **KITCHEN** – O.K.
- ❖ **PASSAGE** – O.K.
- ❖ **TOILET & BATH ROOM** – Leakage mark observed on wall & ceiling.

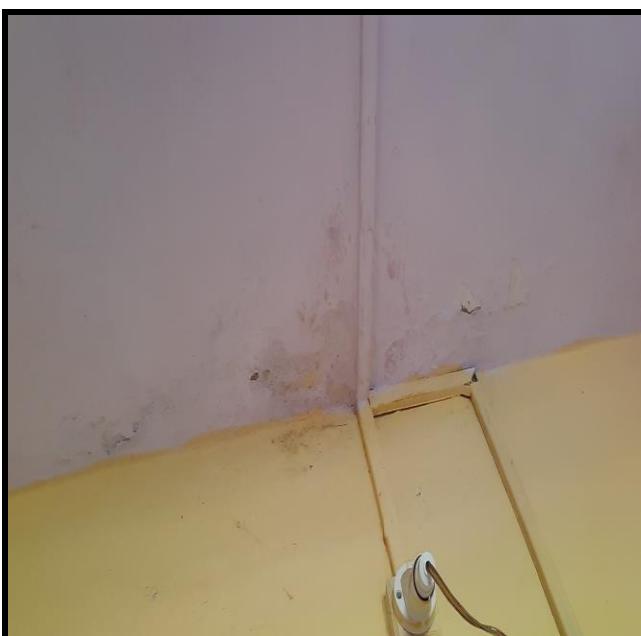
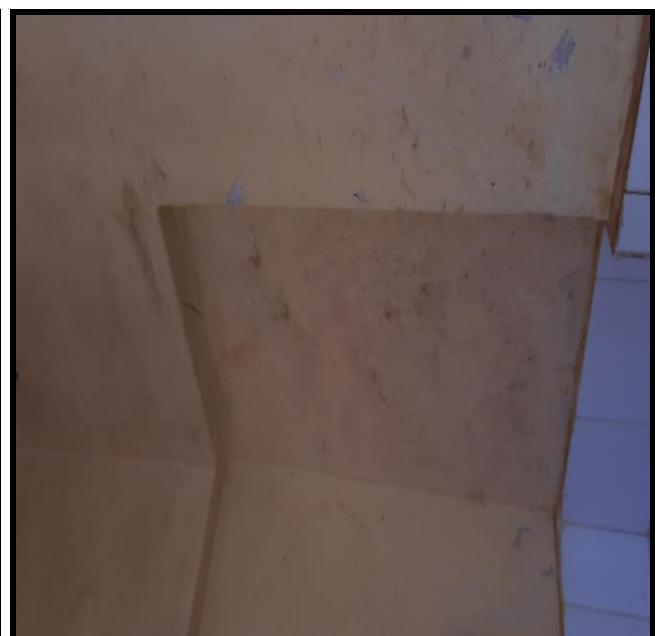
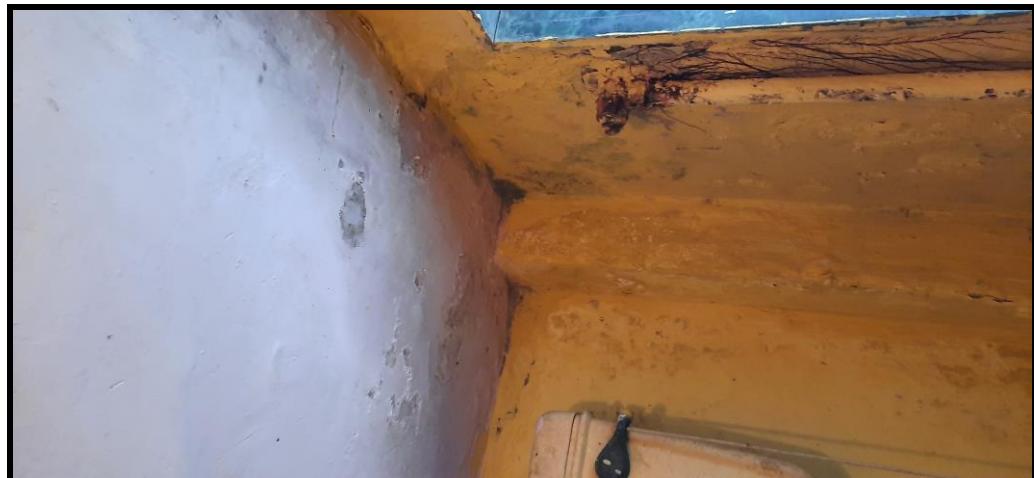
FLAT NO - 28

- ❖ **HALL** – O.K.
- ❖ **KITCHEN** – Leakage mark observed on wall & ceiling.
- ❖ **PASSAGE** – O.K.
- ❖ **TOILET & BATH ROOM** – Dampness observed on wall & ceiling.

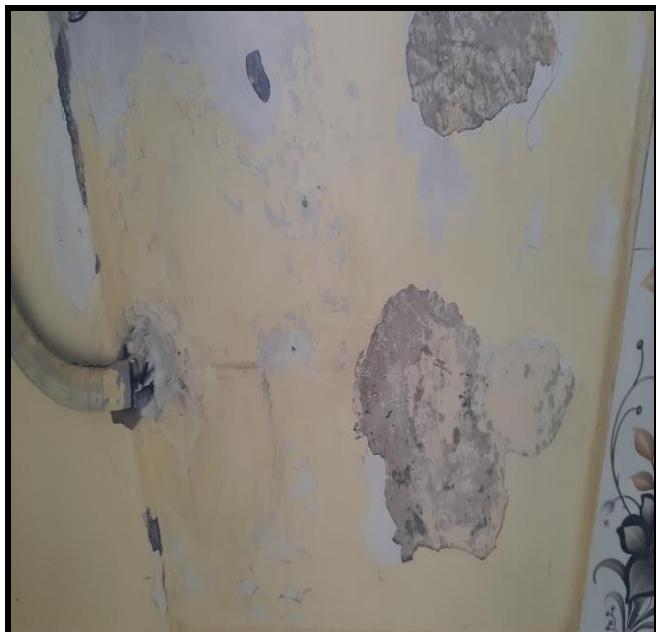
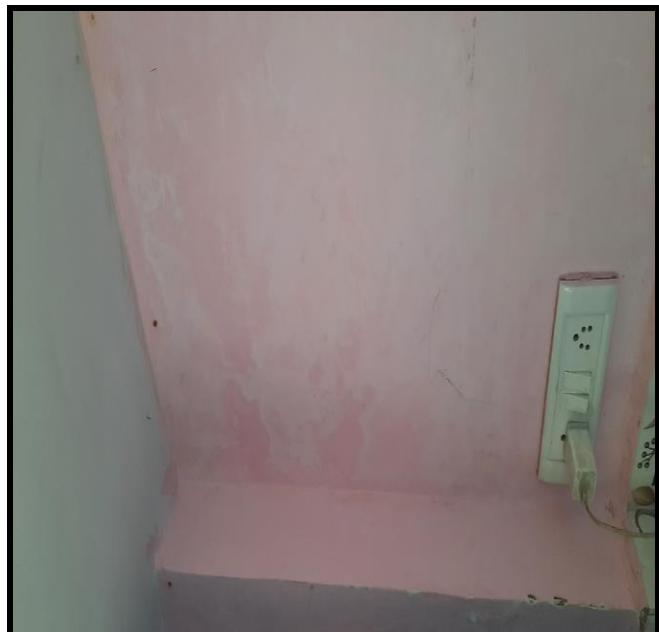
FLAT NO – 29

- ❖ **HALL** – Leakage mark observed on wall.
- ❖ **KITCHEN** – Leakage mark observed on wall.
- ❖ **PASSAGE** – Leakage observed on ceiling in monsoon.
- ❖ **TOILET & BATH ROOM** – O.K.

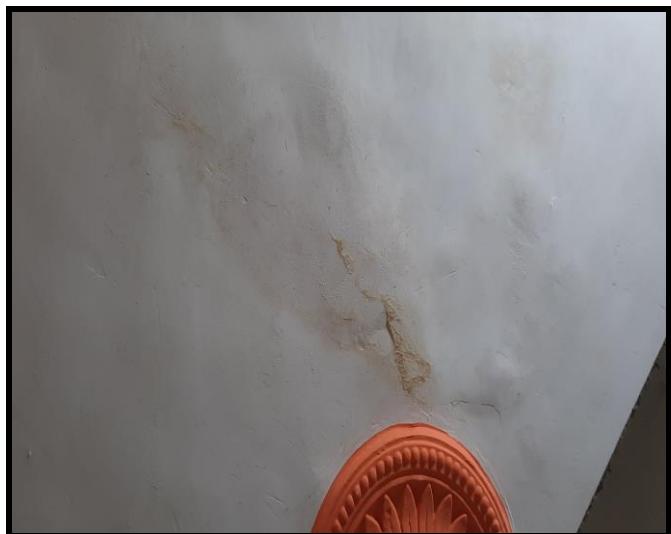
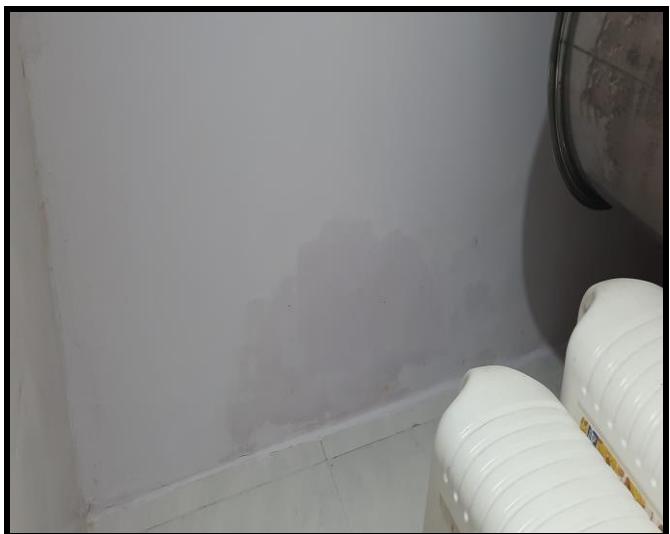
FLAT NO – 30

- ❖ **HALL** – O.K.
- ❖ **KITCHEN** – Leakage mark observed on ceiling.
- ❖ **PASSAGE** – Leakage mark observed on ceiling.
- ❖ **TOILET & BATH ROOM** – O.K.

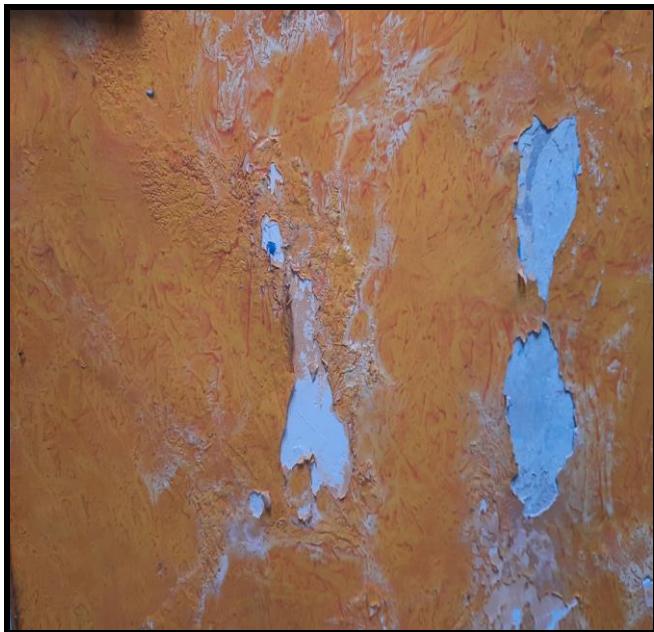
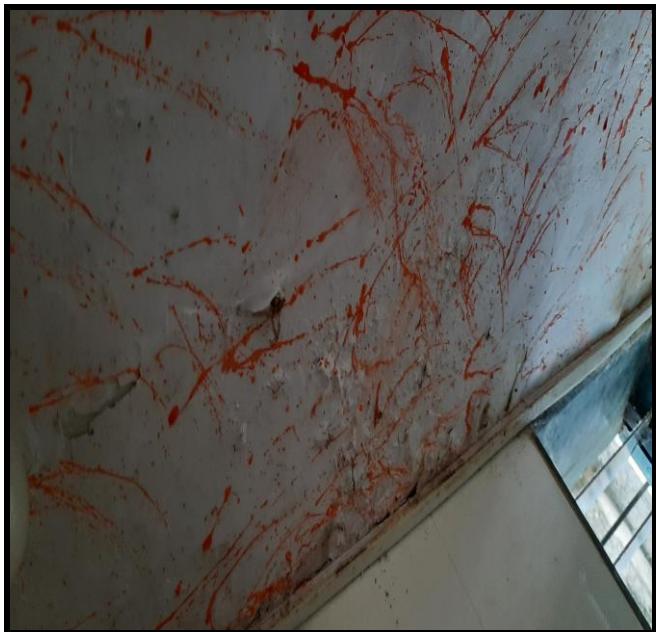
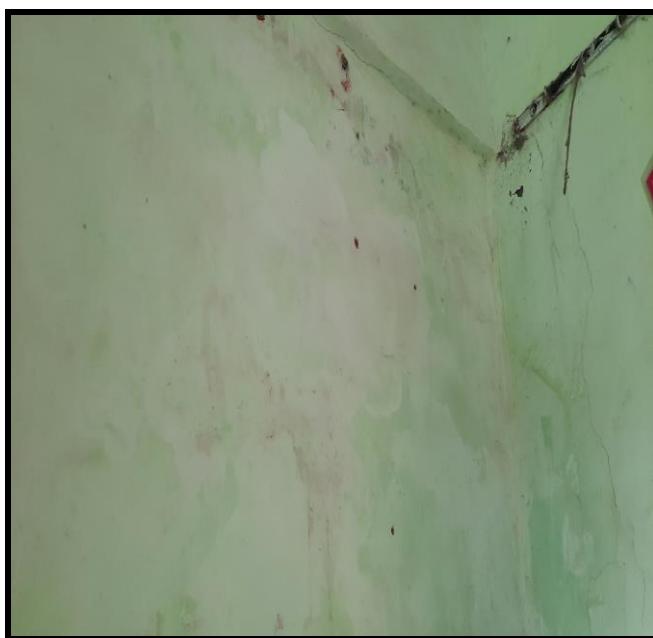
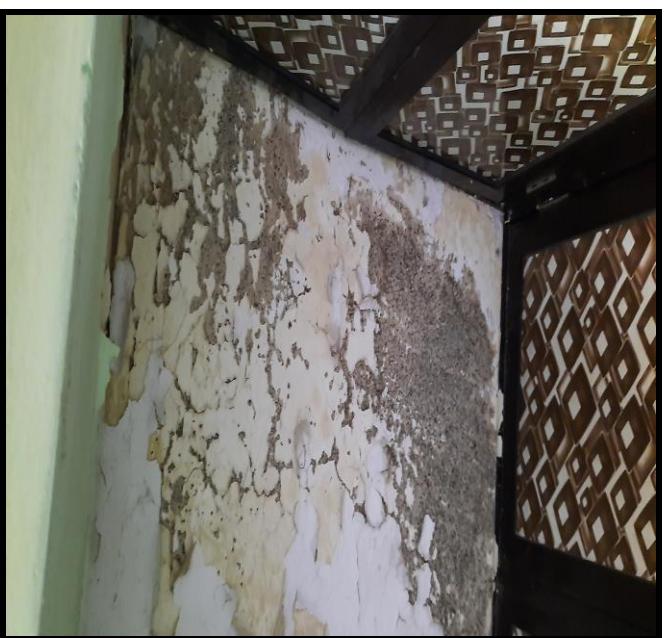
FLAT NO – 32

- ❖ **HALL** – Leakage mark observed on wall.
- ❖ **KITCHEN** – Leakage mark observed on wall.
- ❖ **PASSAGE** – Leakage mark observed on ceiling.
- ❖ **TOILET & BATH ROOM** – Leakage mark observed on ceiling.

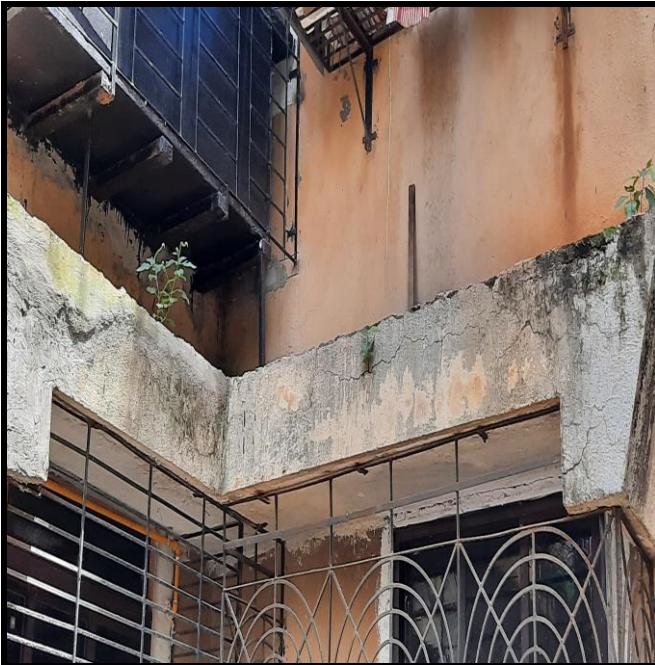
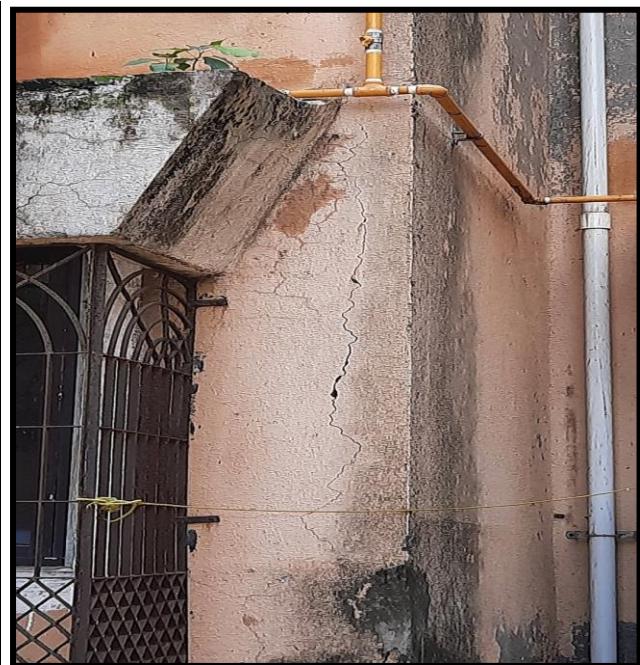
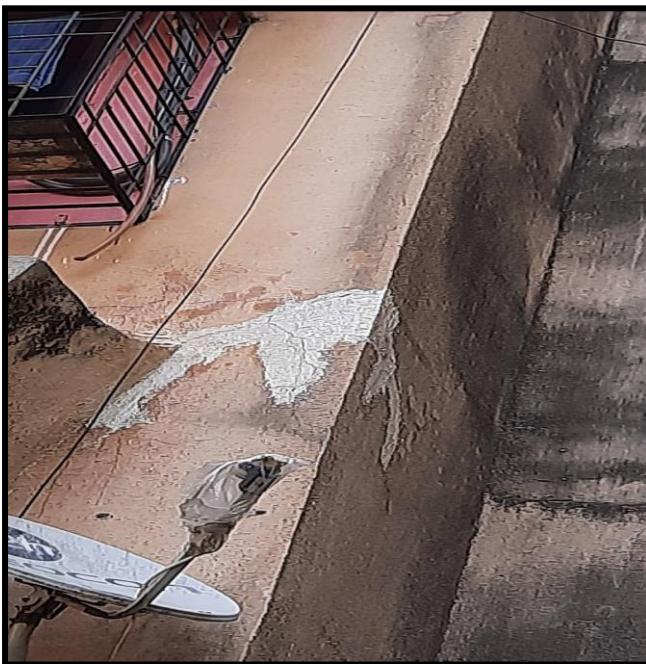
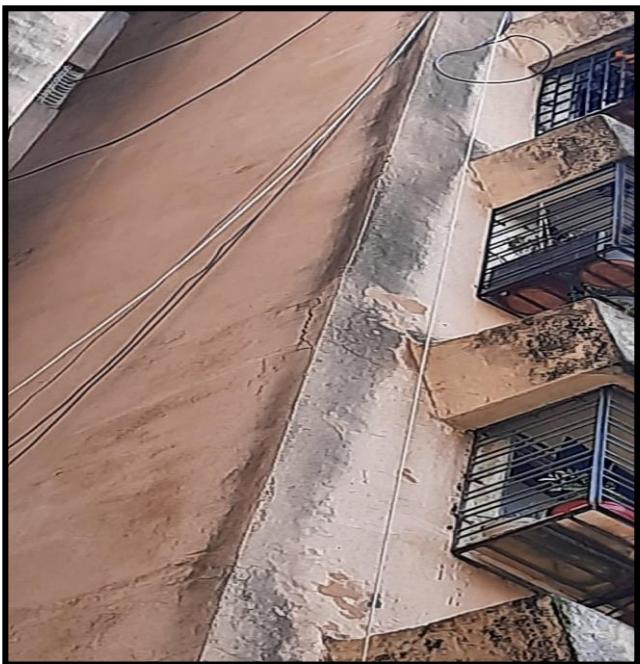
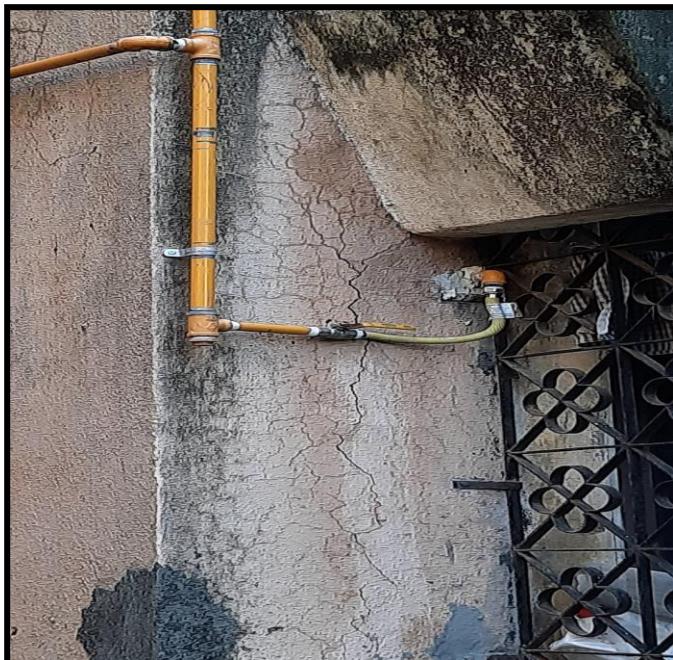
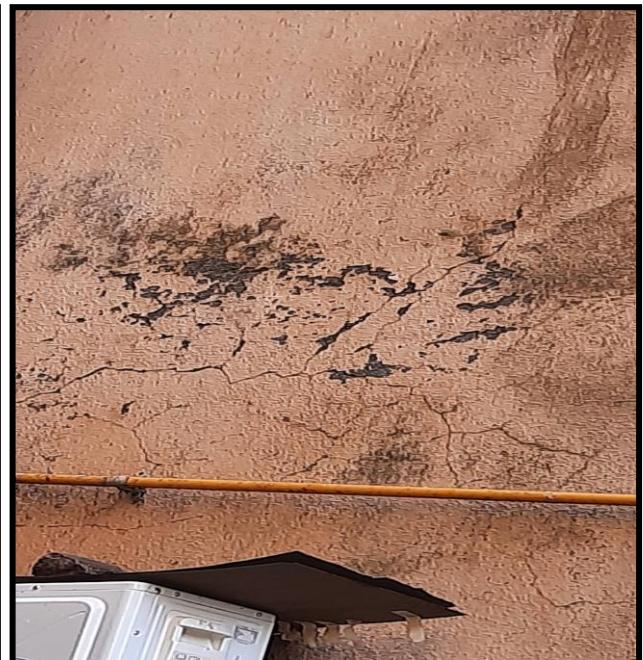
FRONT SIDE

- ❖ Structural crack observed at several places on column & chajjas.
- ❖ Vegetation growth observed at several places on chajjas.
