STRUCTURAL AUDIT REPORT
FOR
“VISHAL SAHYADRI CO – OP HSG. SOC. LTD”,
“D3 – F WING”
SITUATED AT
SAHYADRI NAGAR, CHARKOP,
KANDIVALI (W) MUMBAI – 400 067

978/D3/LSS/2021

JULY 16, 2021

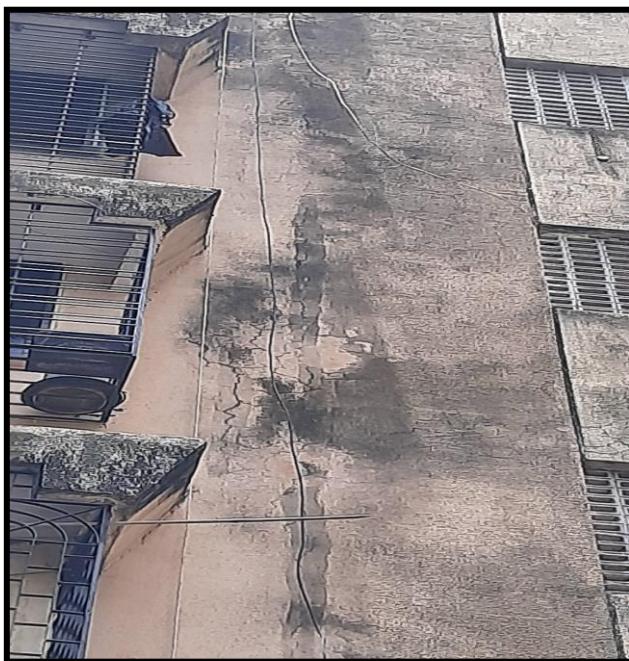
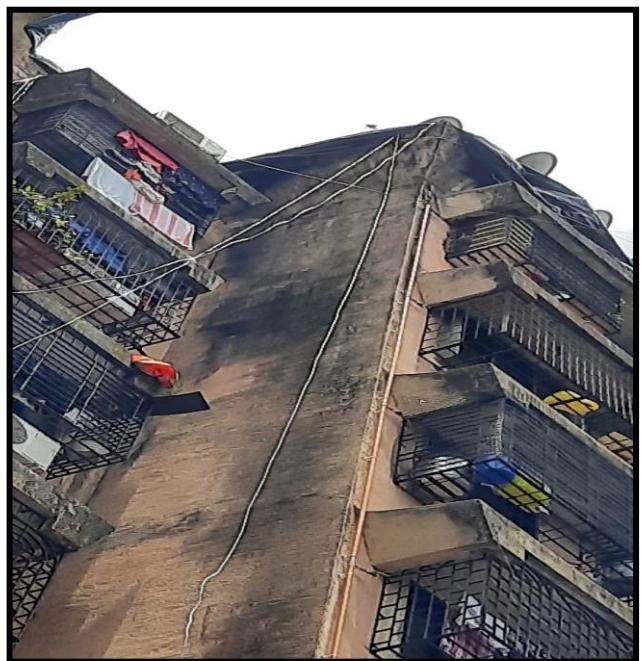
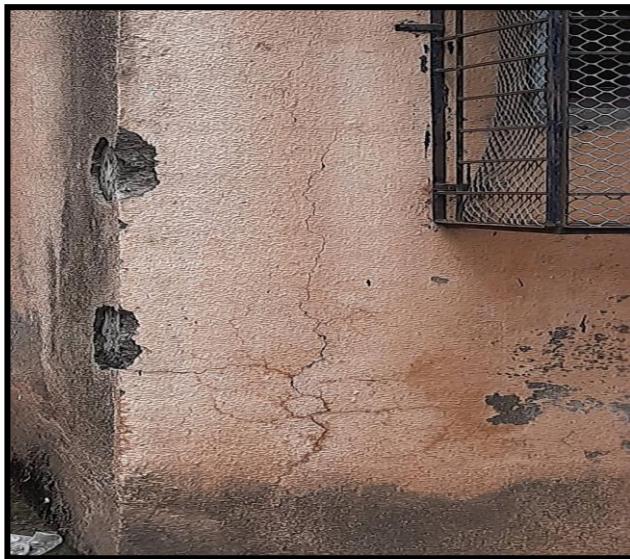
BACK SIDE

- ❖ Structural crack observed at several places on column.
- ❖ Algae observed at several places on wall.
- ❖ Major crack observed at several places on wall.

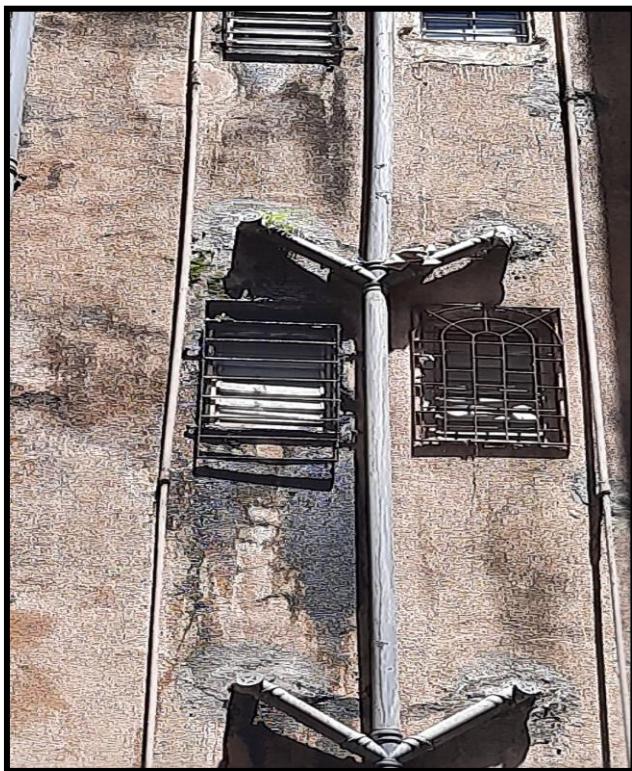
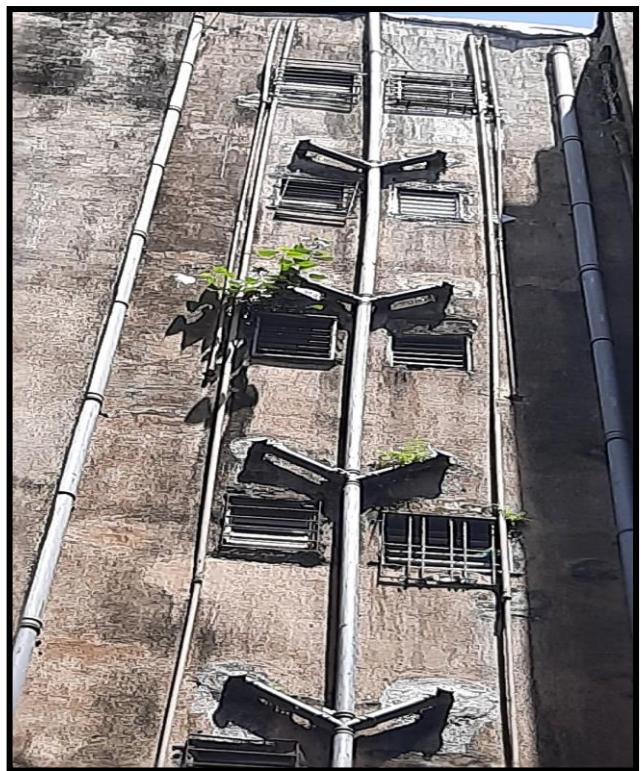
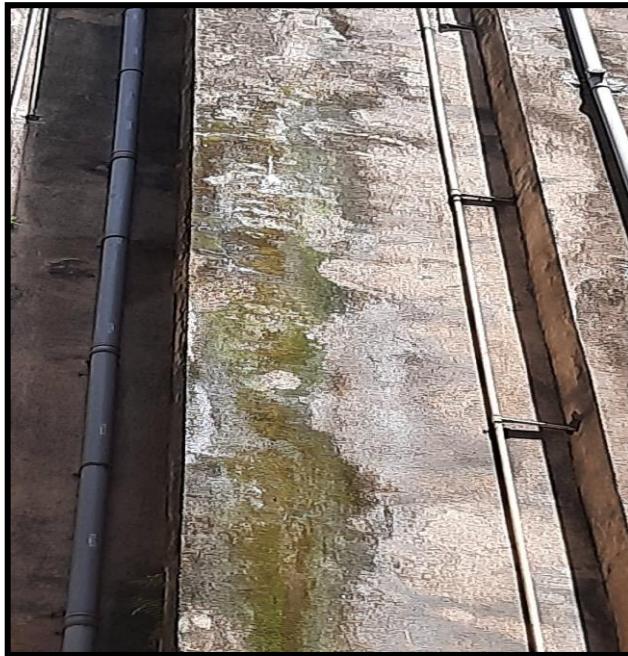
EAST SIDE

- ❖ Vegetation growth observed at several places on wall.
- ❖ Algae observed at several places on wall.

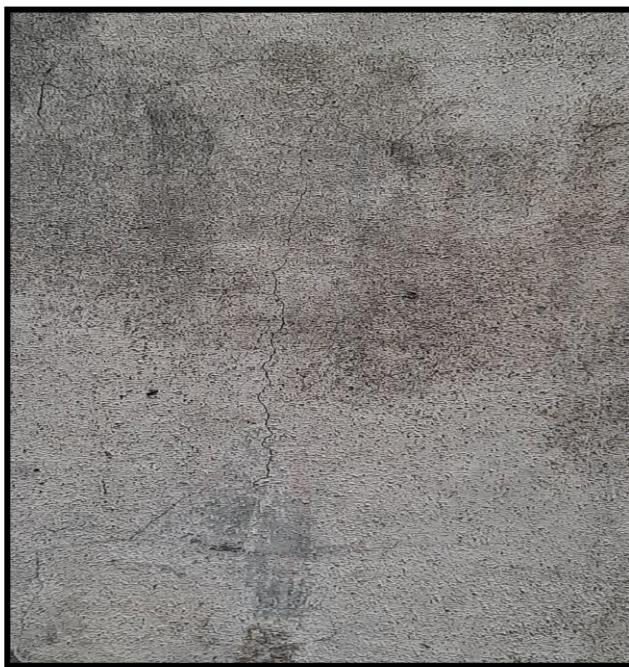
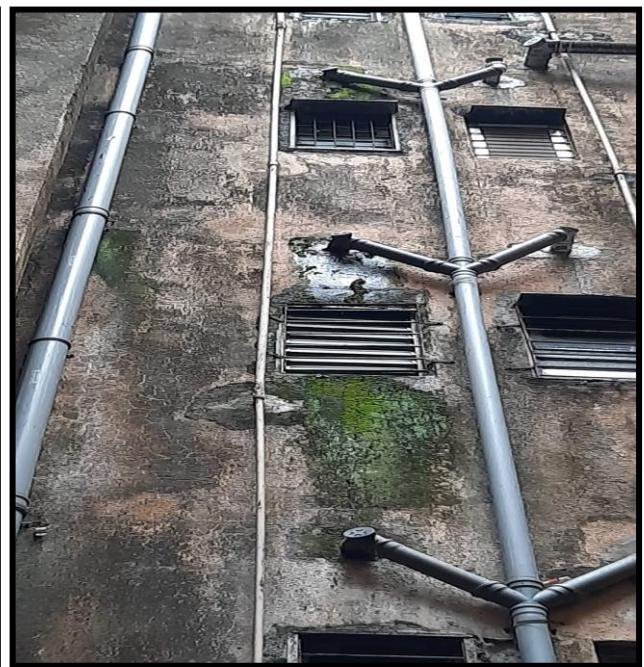
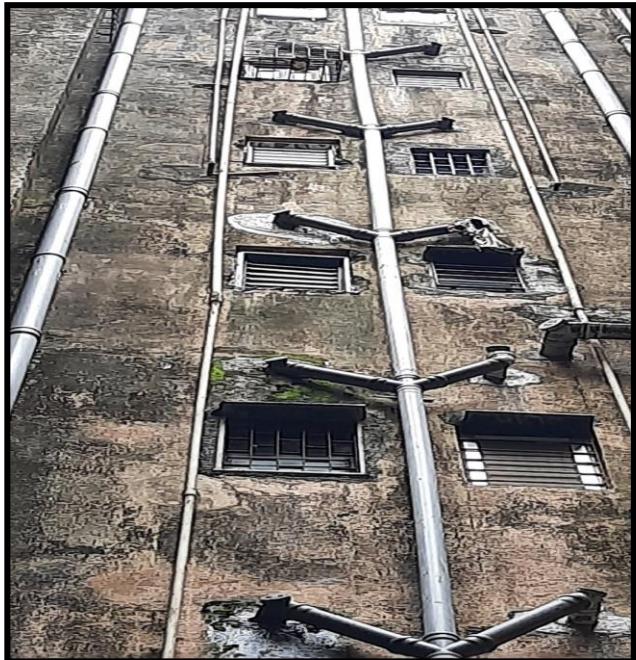
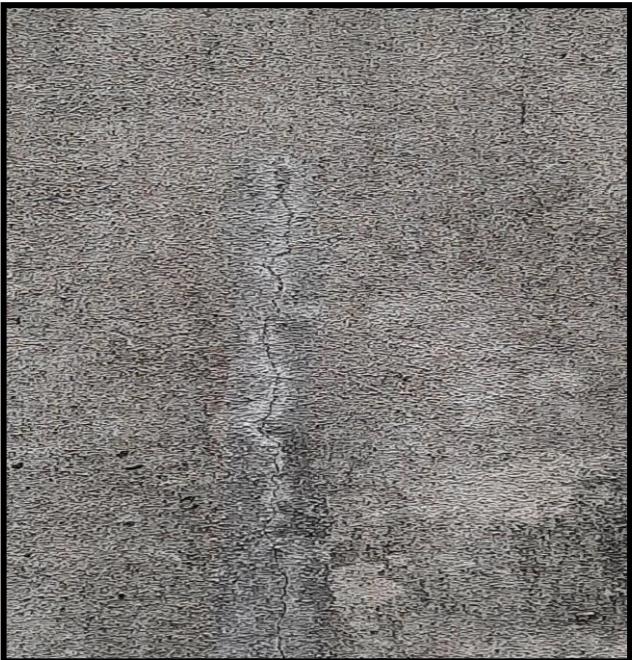
WEST SIDE

- ❖ Algae observed at several places on wall.
- ❖ Major crack observed at several places on wall.
